The Bahamas
Maritime Authority

THE COMMONWEALTH OF THE BAHAMAS

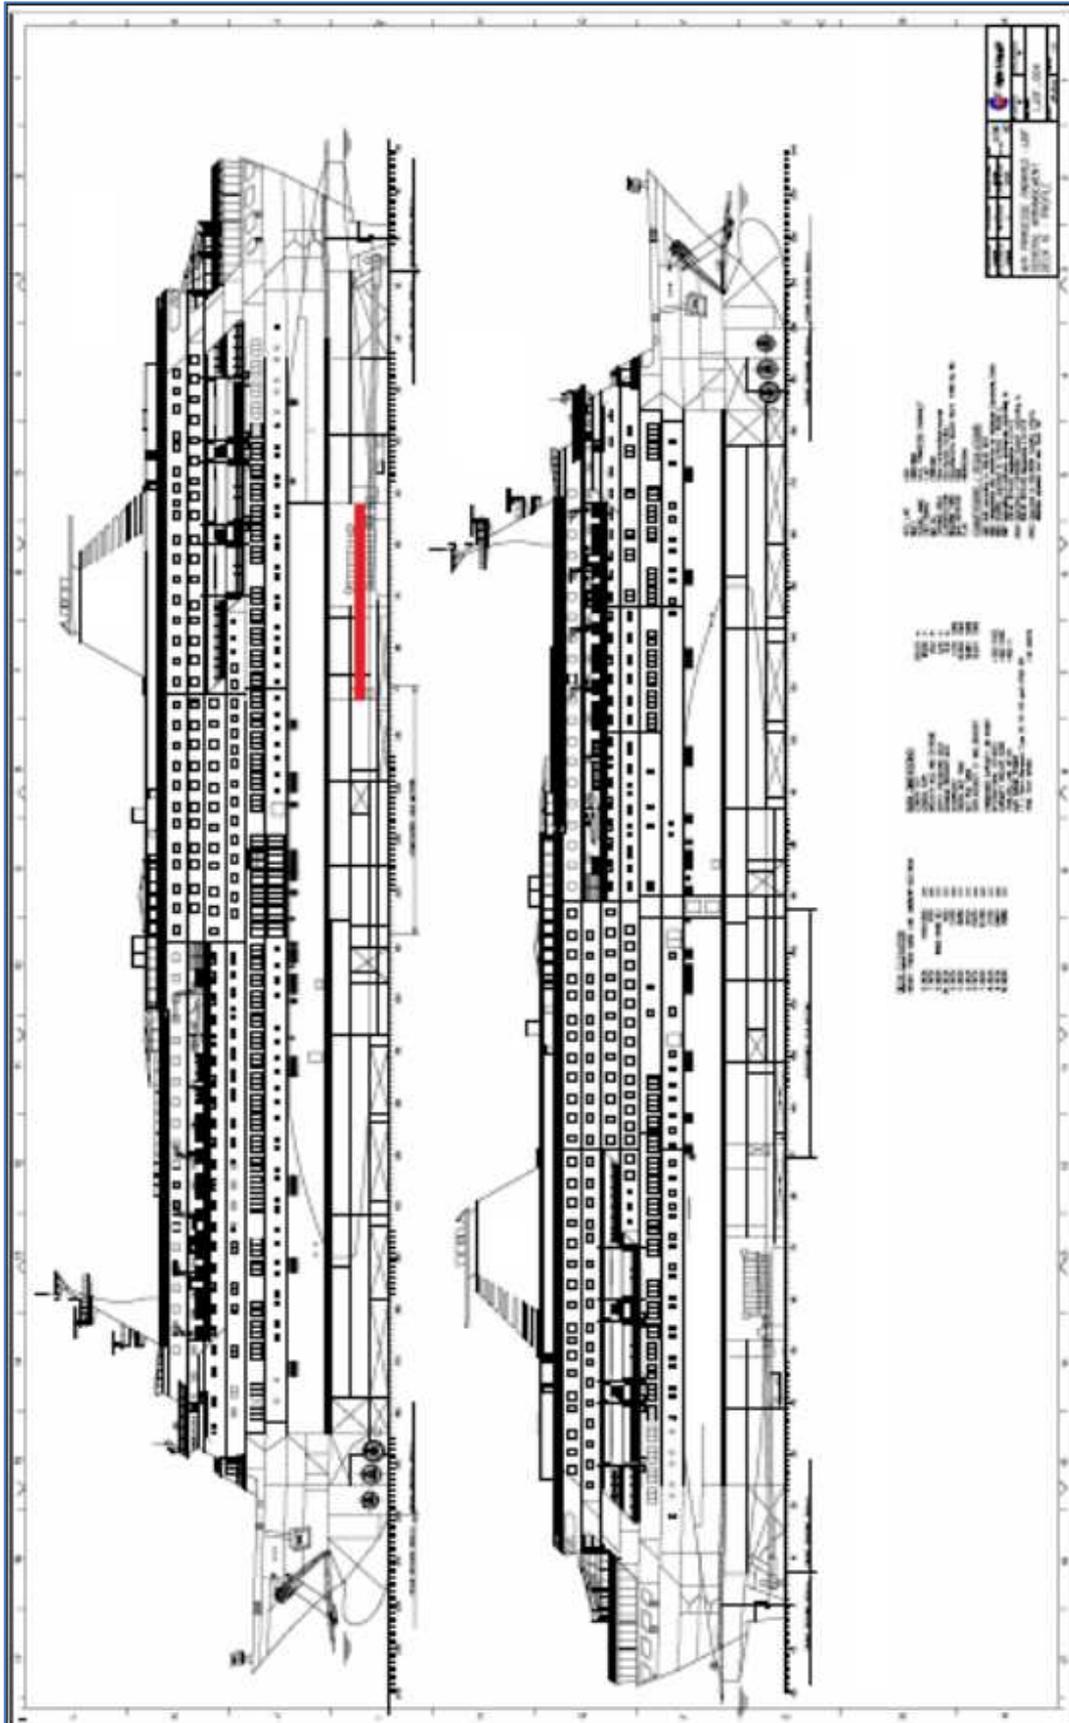
Fig: 1 Bahamas Celebration General Arrangement Plan – area of damage

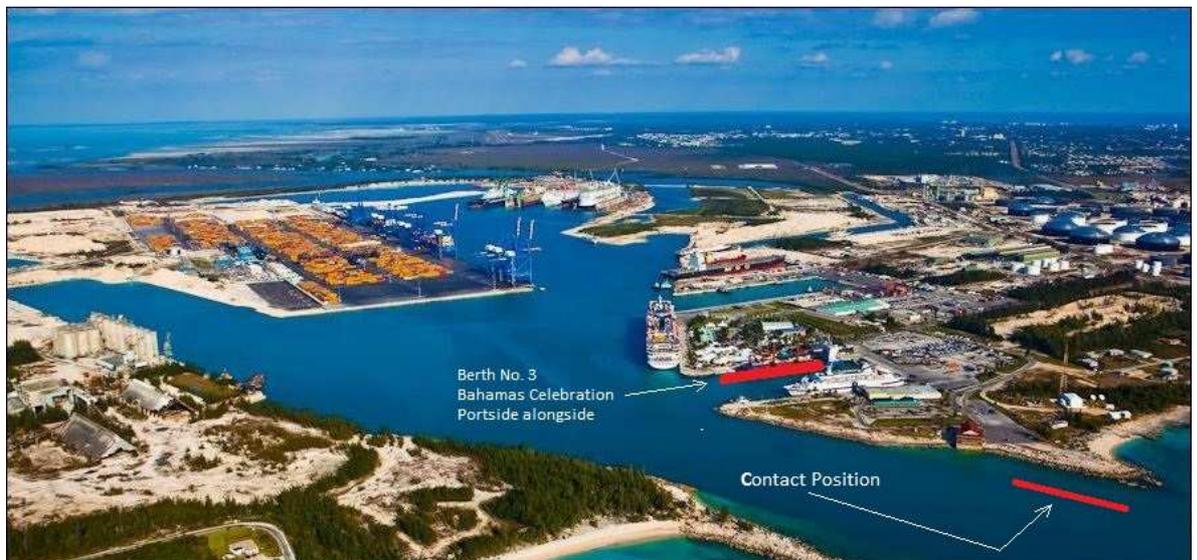
Fig: 2 Freeport – *Bahamas Celebration* berthed Berth No. 3

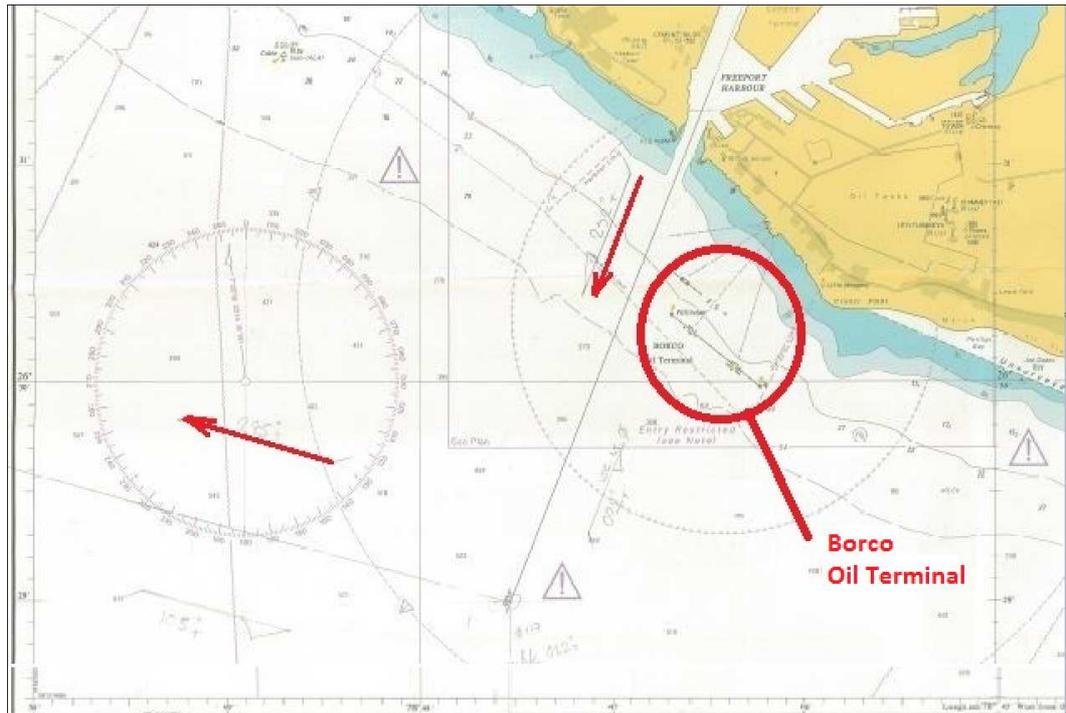
Fig: 9 Approaches to Freeport – Departure

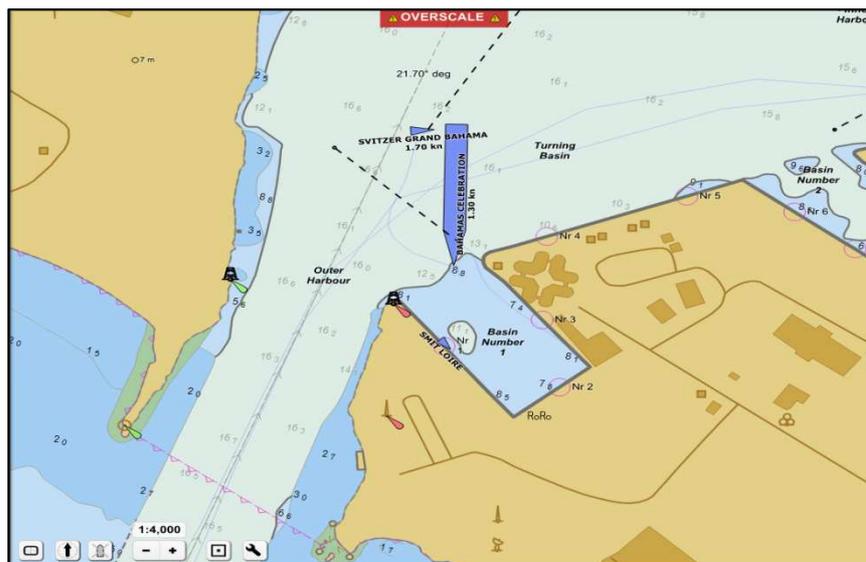
Fig: 10: 31st October Time: 2014

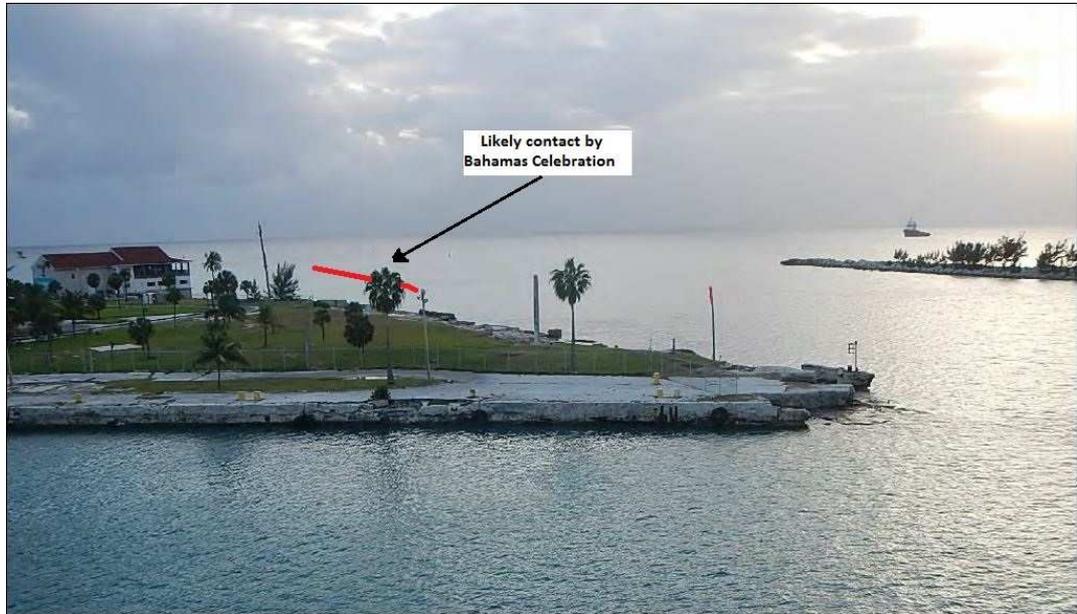
Fig. 11 Entrance Channel, eastern knuckle

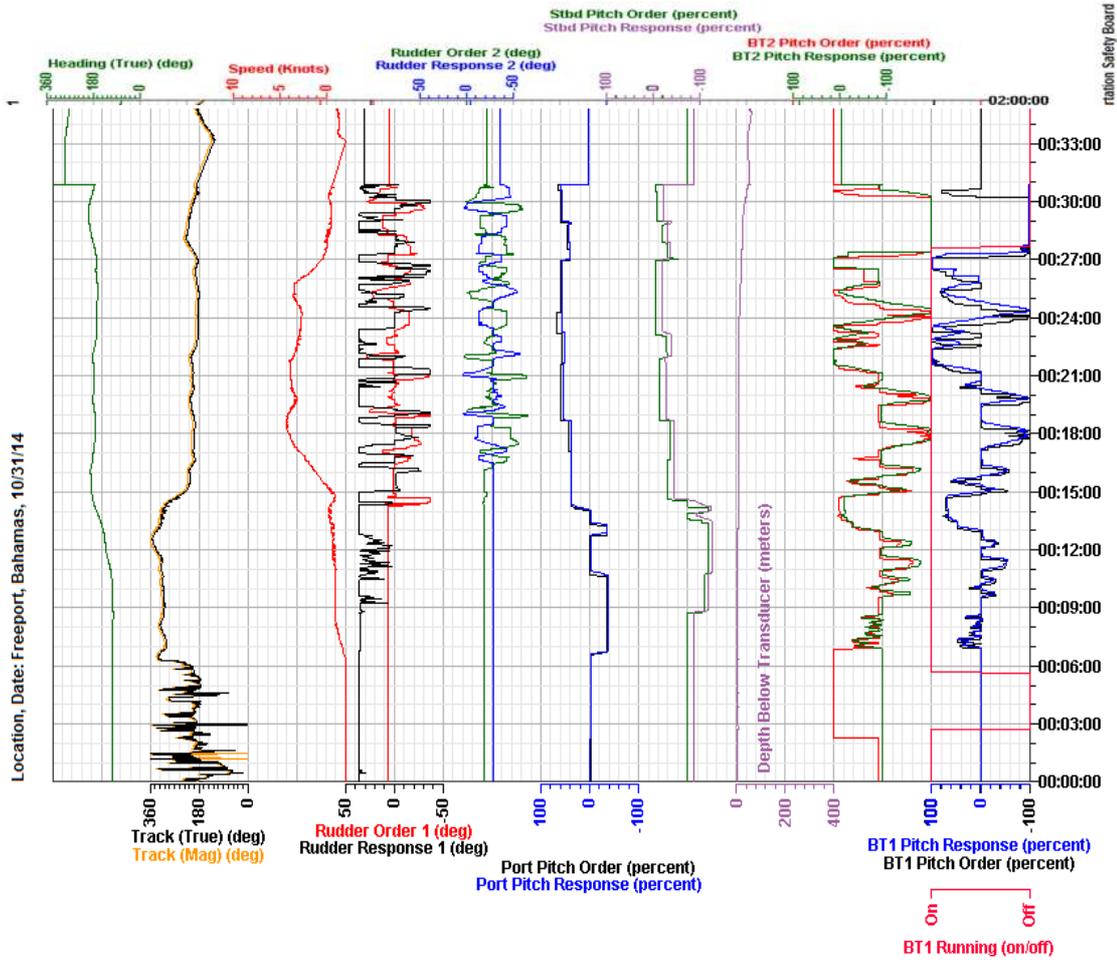
Fig: 19 Parametric data recorded by VDR between 20:00 and 20:33

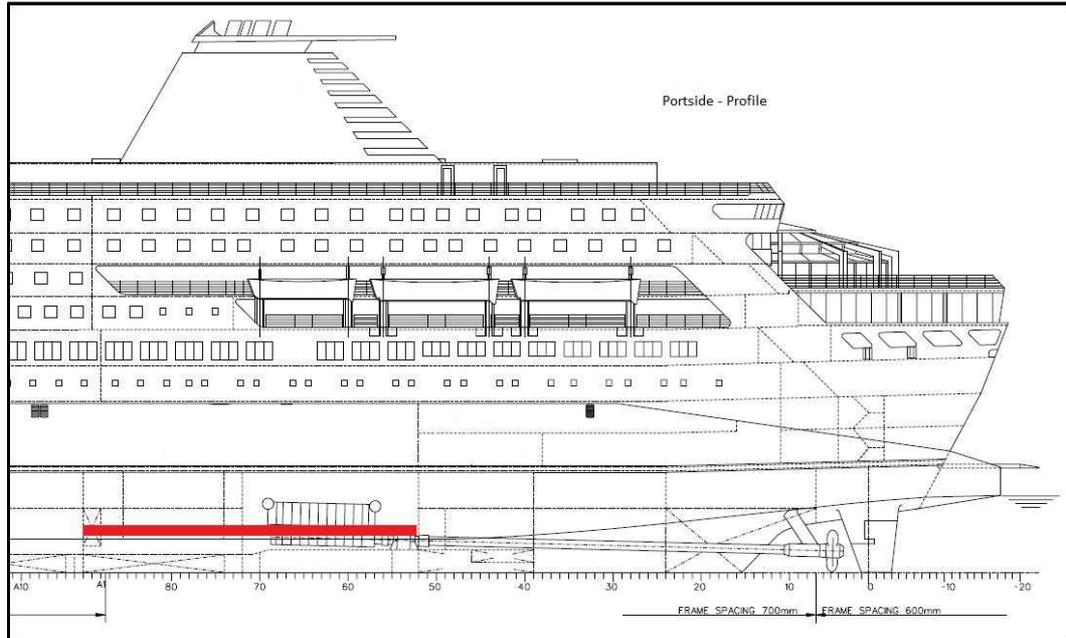
Fig: 21 Area of damage
