THE COMMONWEALTH OF THE BAHAMAS

“TOMFIELD”

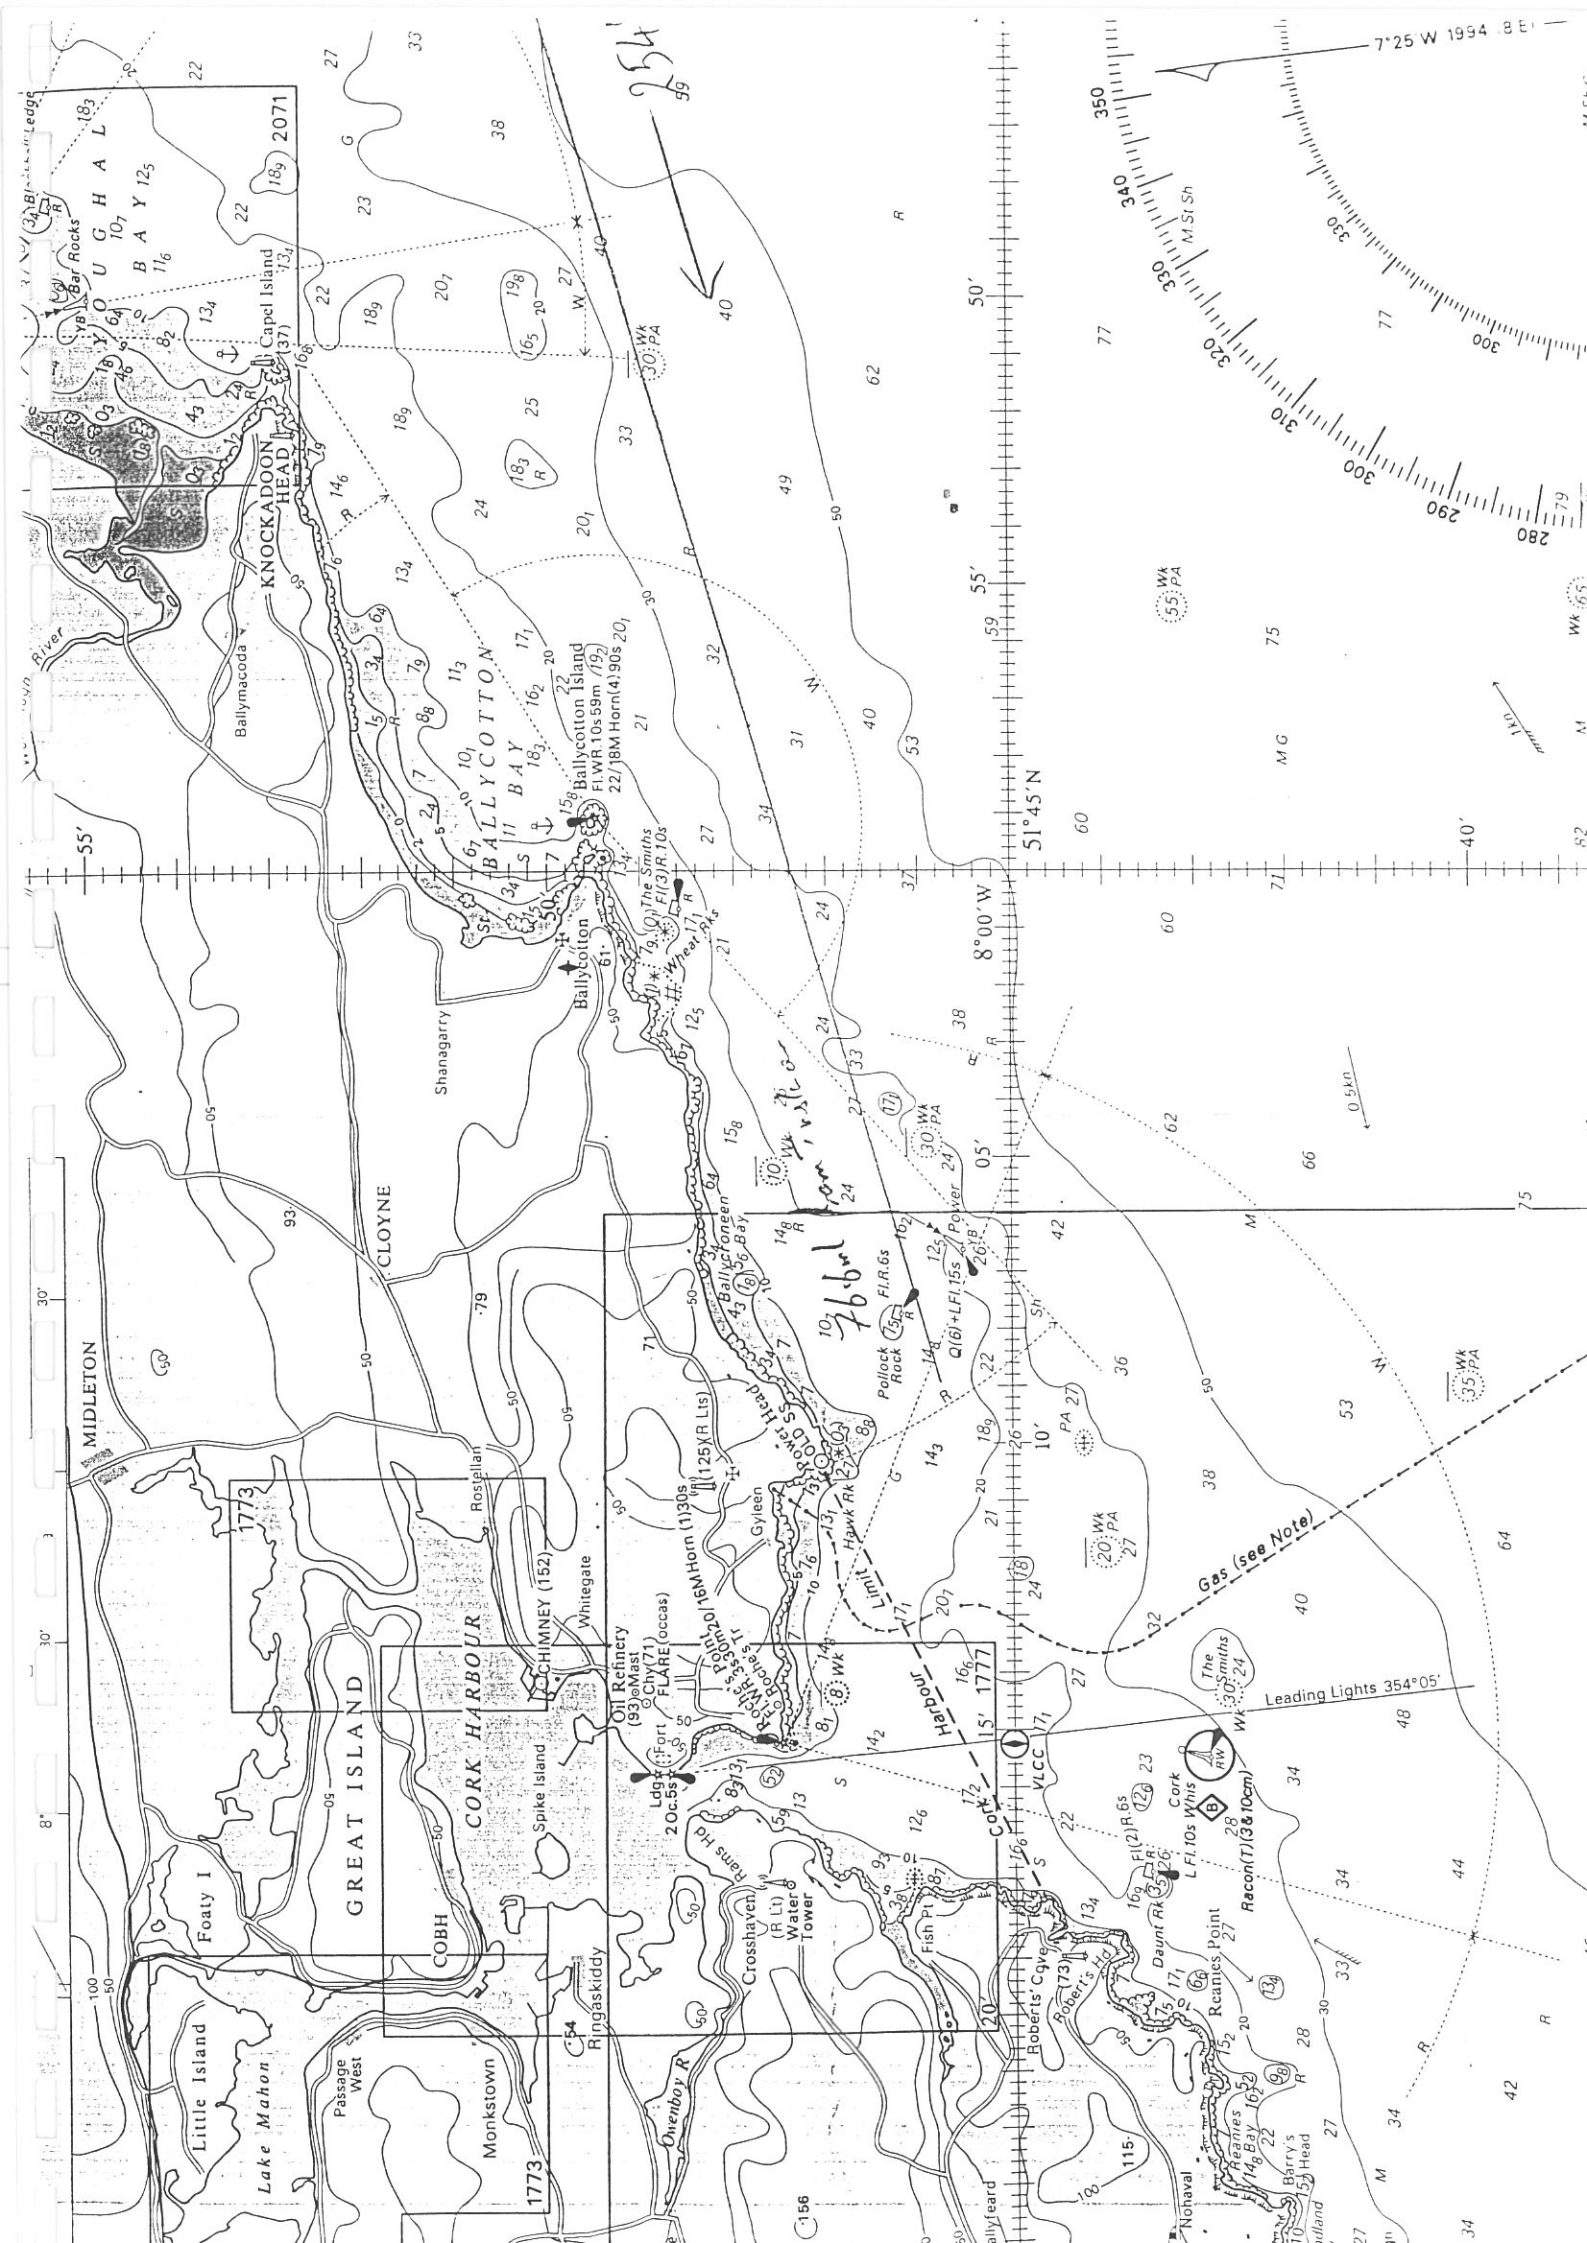
SEE TIDE / ALTITUDE / NOTICES / MARINE / CENTRAL / PORTAL / DIRECTIONS (local conditions, directions, regulations, port information), List of Lights, List of Radio Signals (navigational warning and weather transmissions, vessel traffic services, port operations, pilot services, radio beacons), Tide Tables, Tidal Stream Atlases, The Mariner's Handbook (general information), 5011 (symbols and abbreviations), etc.

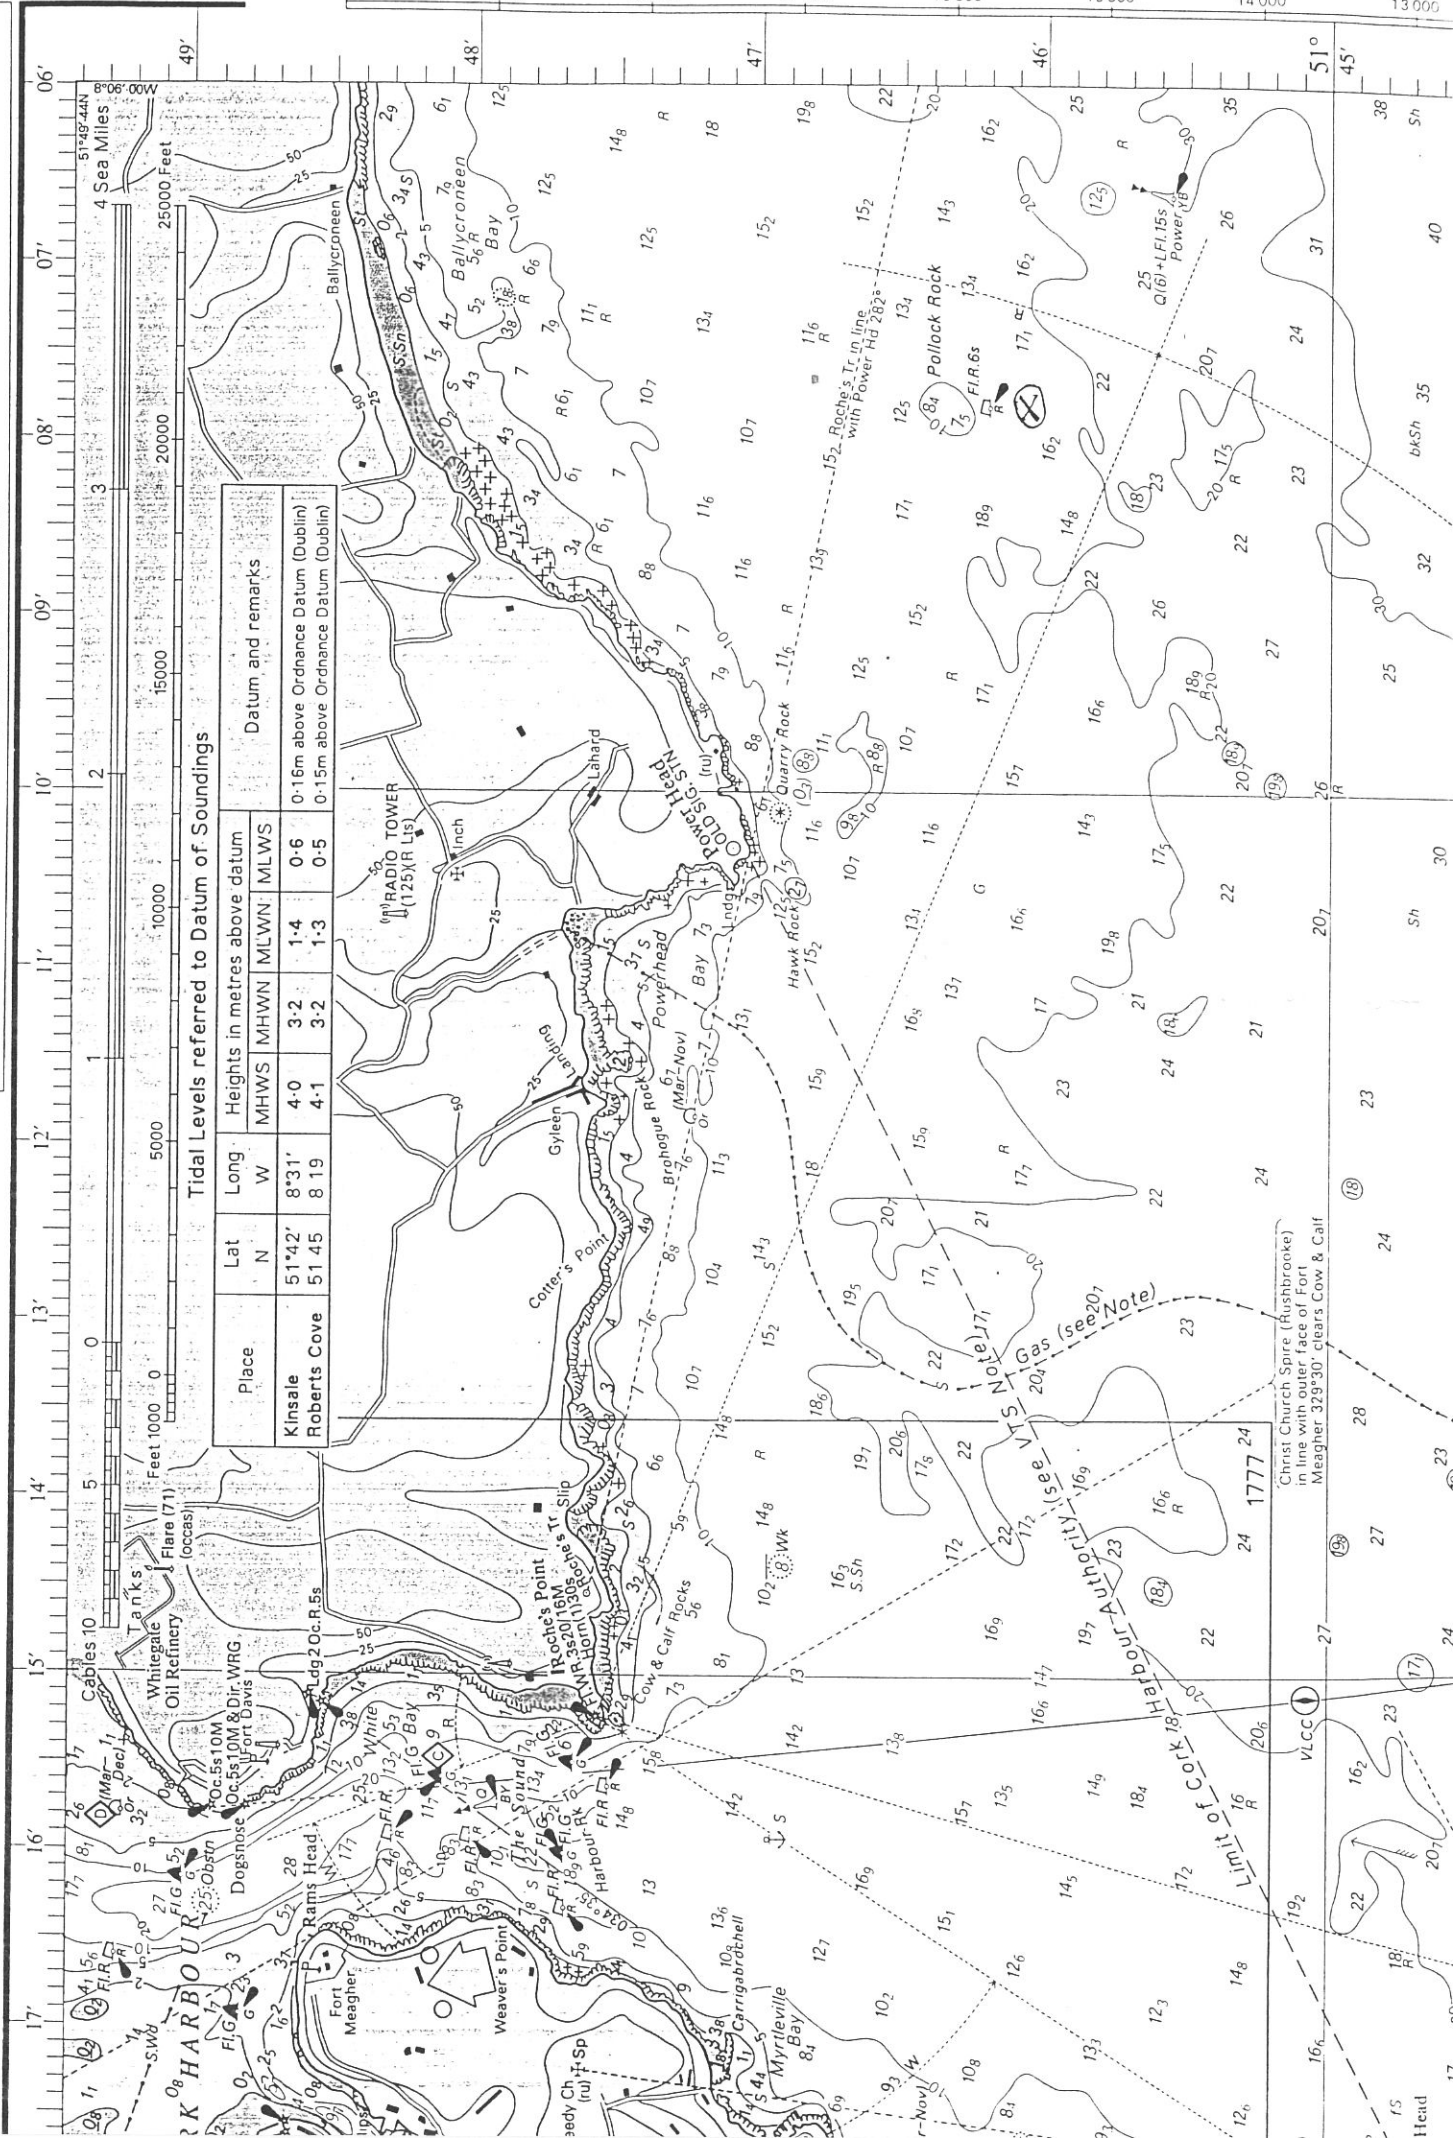
Christ Church Spire (Rushbrooke) in line with outer face of Fort Meagher 329°30' clears Cow & Calf
