# The Bahamas Maritime Authority

## **“Explorer” and “Voyager”**

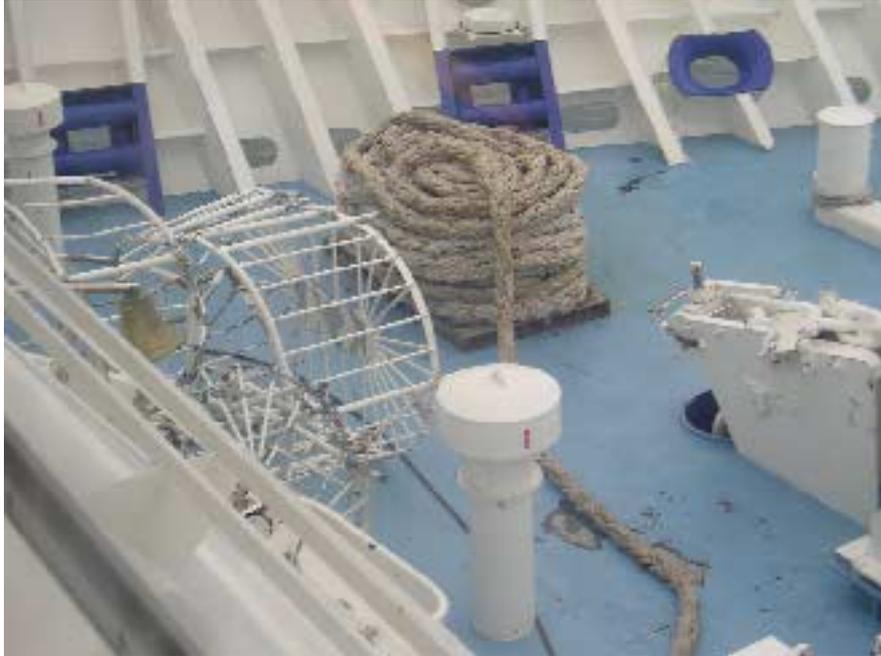
6. Chief Engineer's Window External view

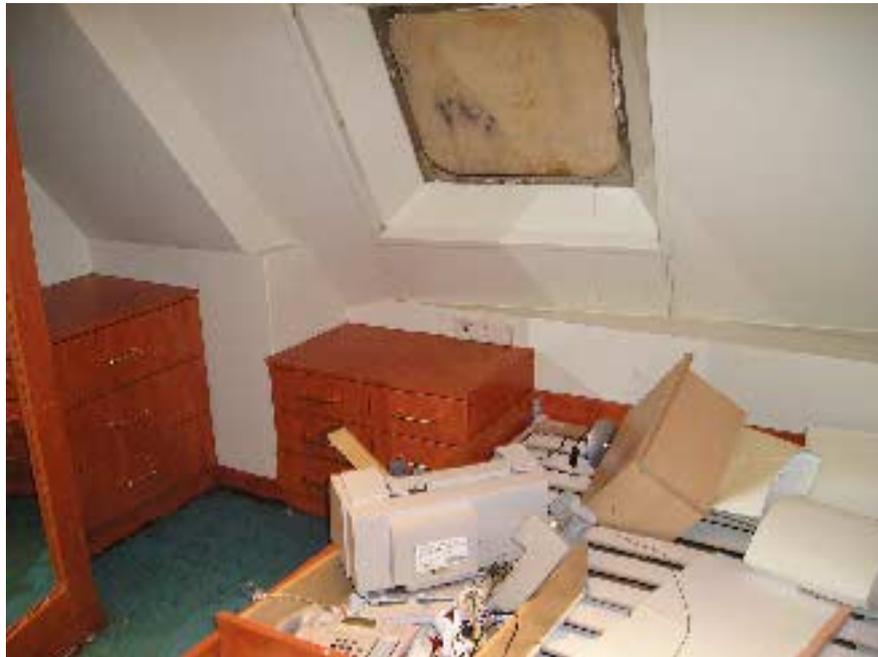
8. Damage to shell plating x 3

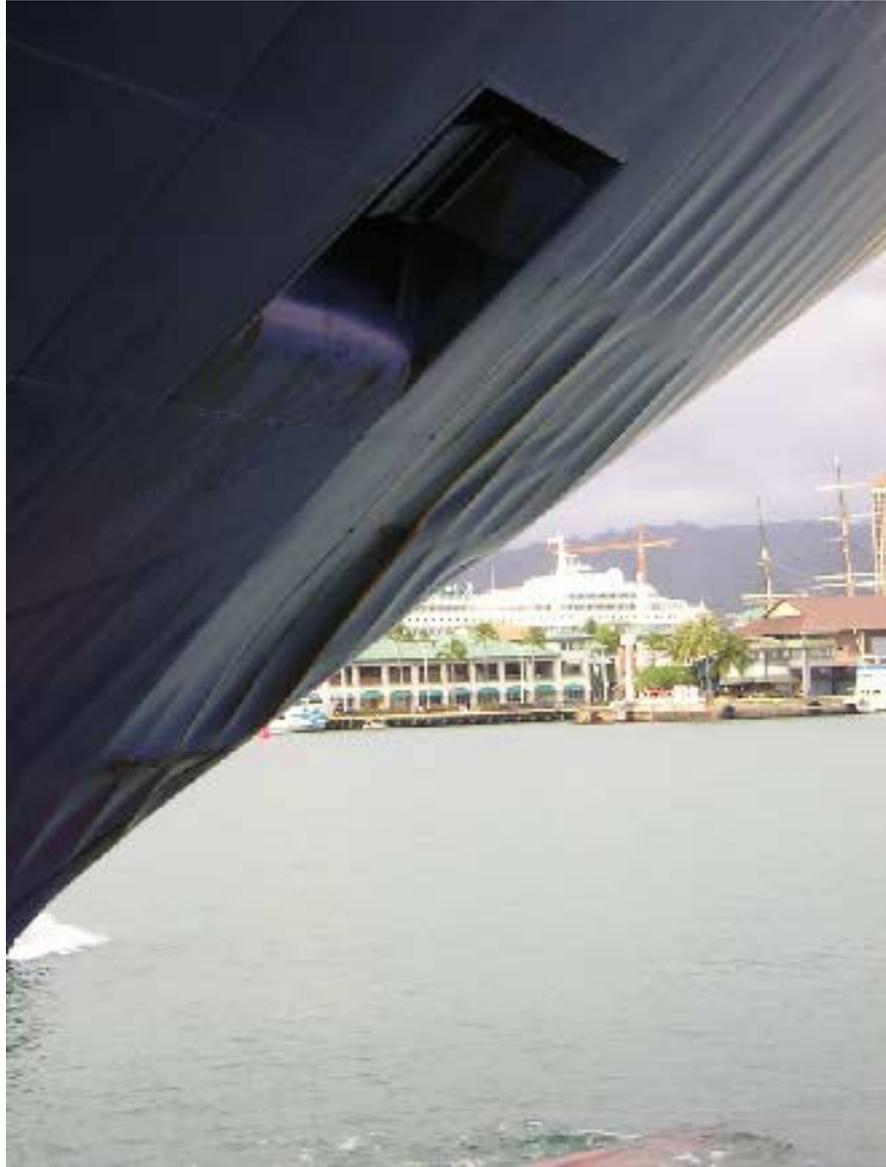
9. Fore Peak internal damage

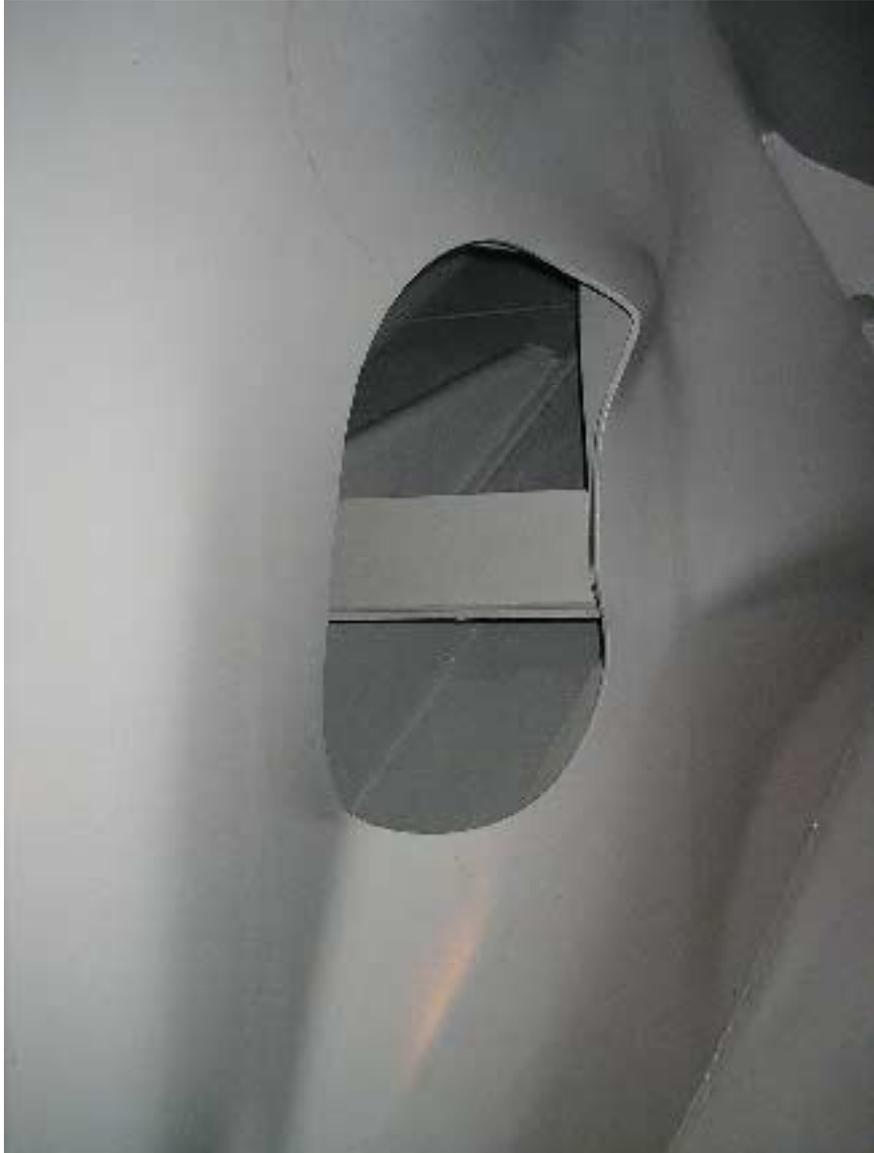
10. Fore Peak internal damage

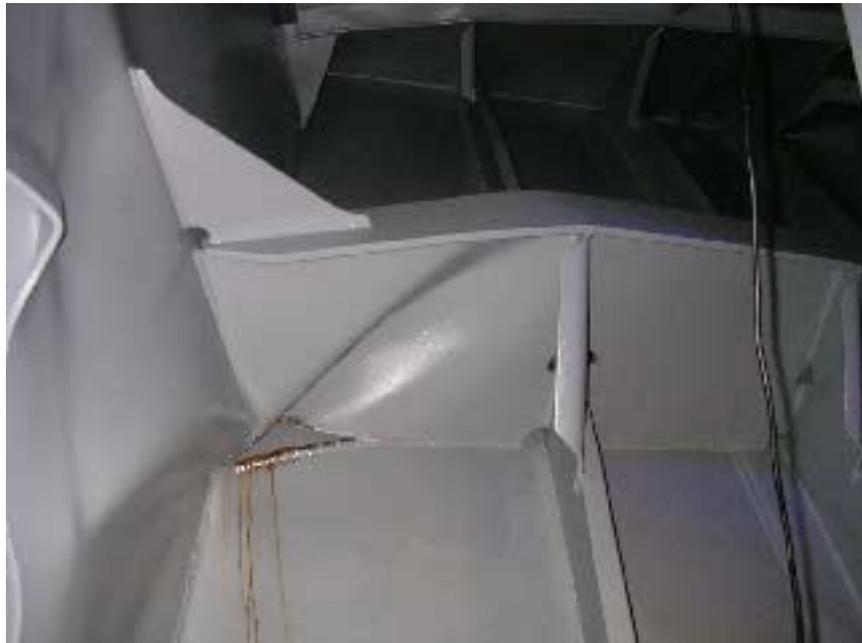
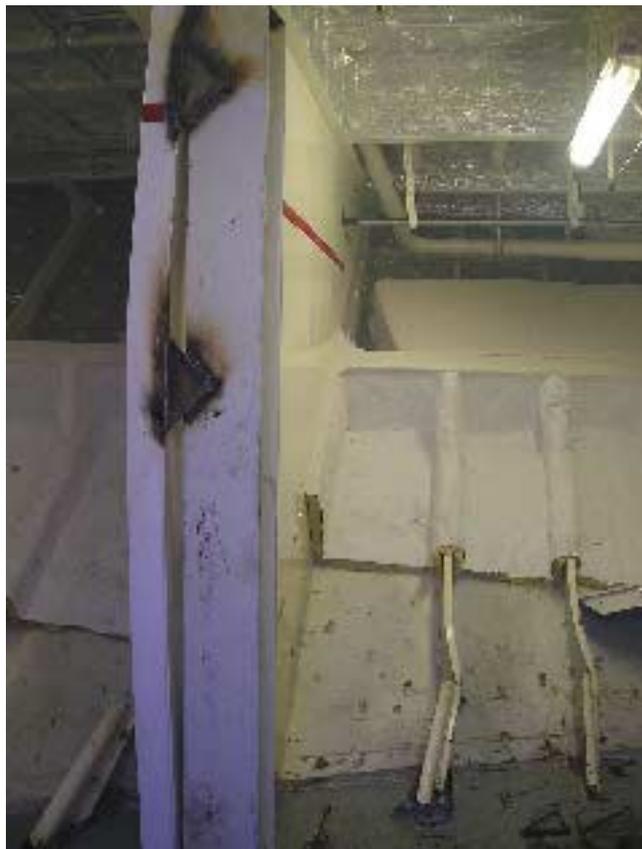
11. Centre Bridge Window

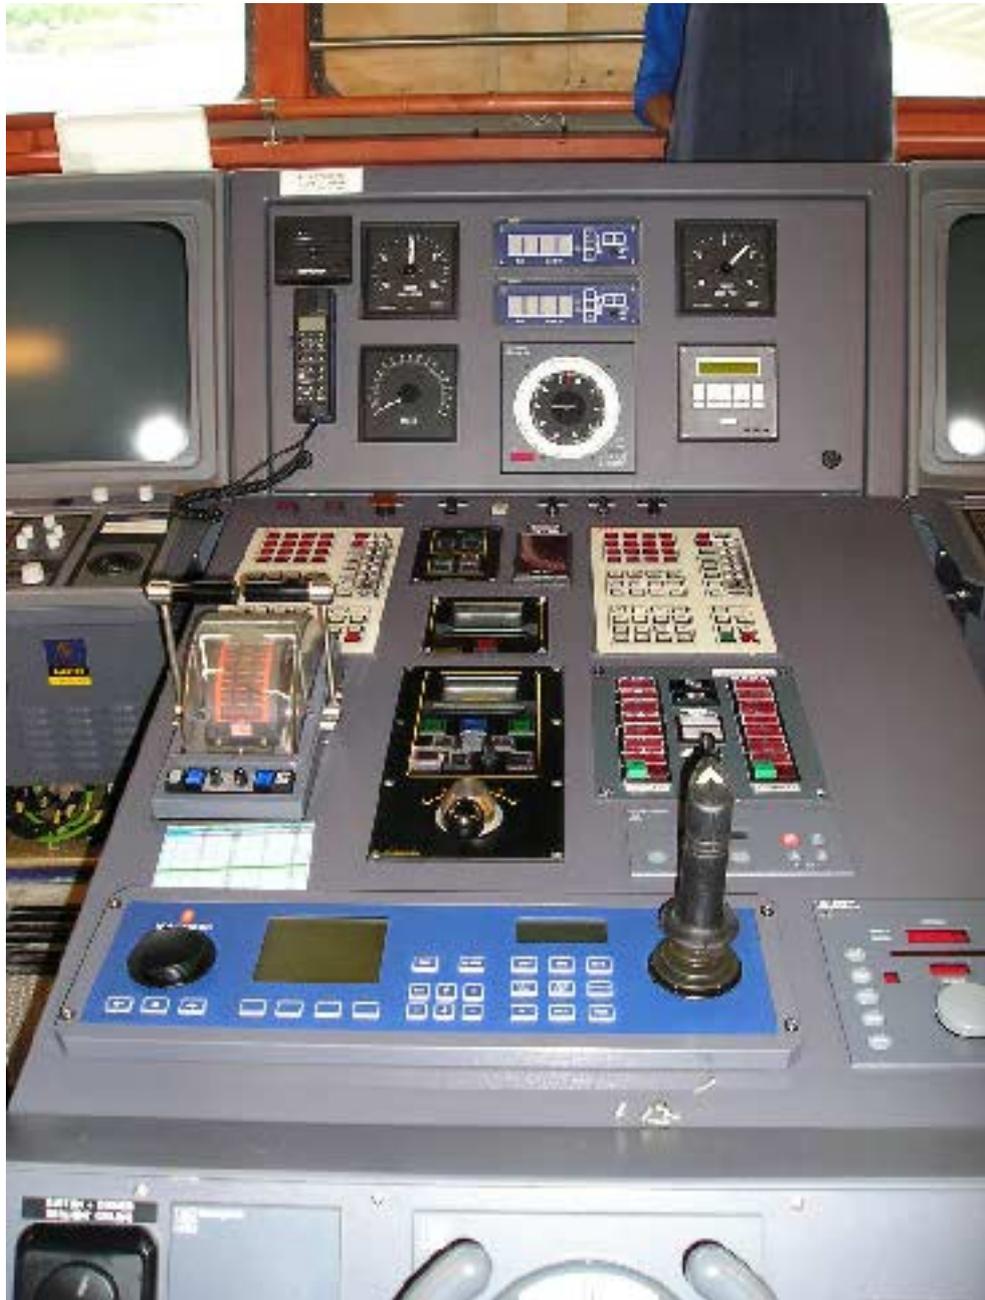
14. Temporary repair to Bridge Window

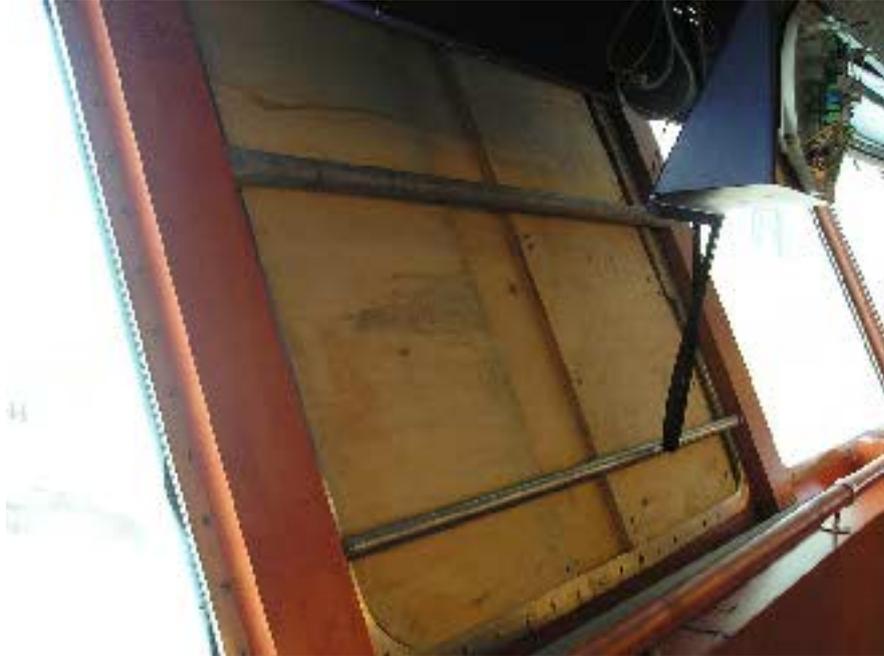
15. Damage to deckhead paneling on bridge

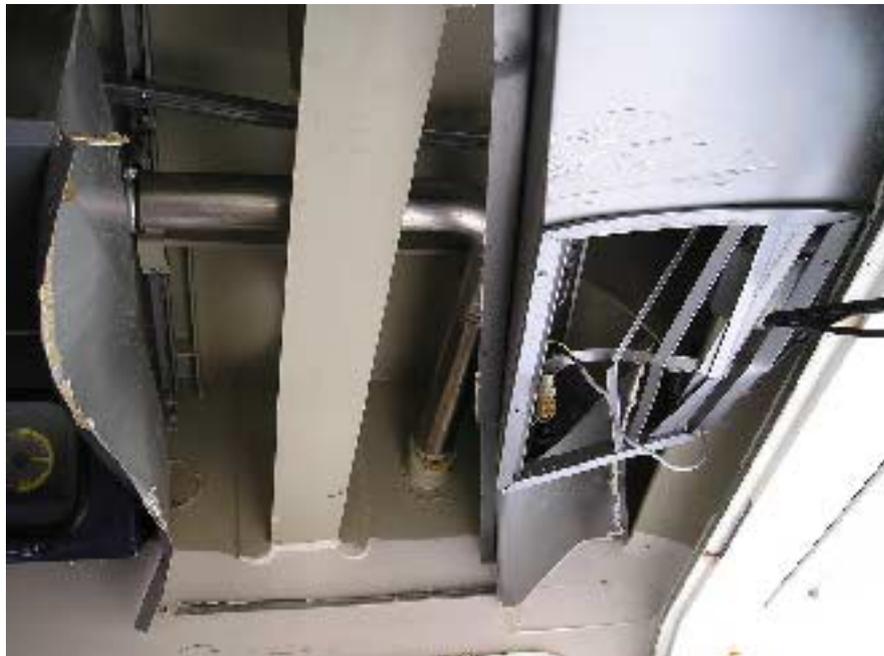
16. Winch torn from mountings

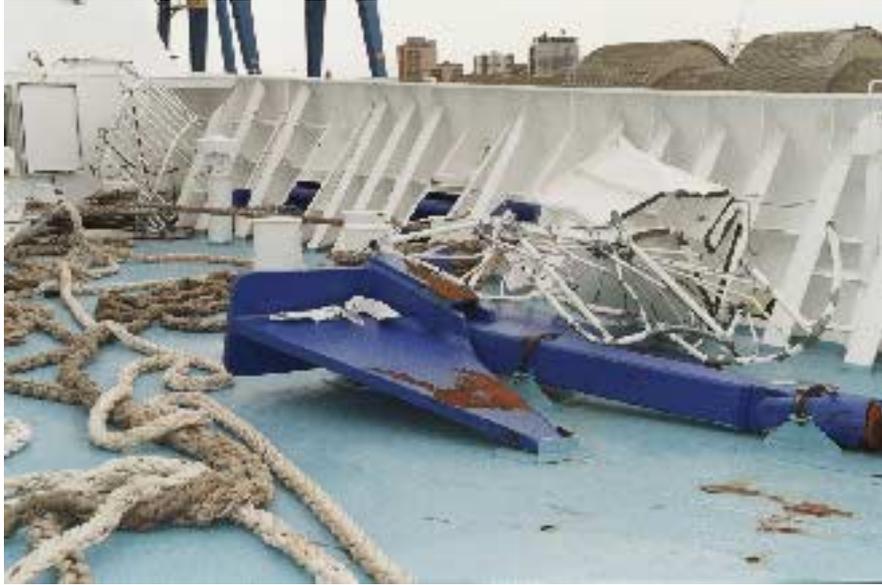
2. Bridge front showing broken window

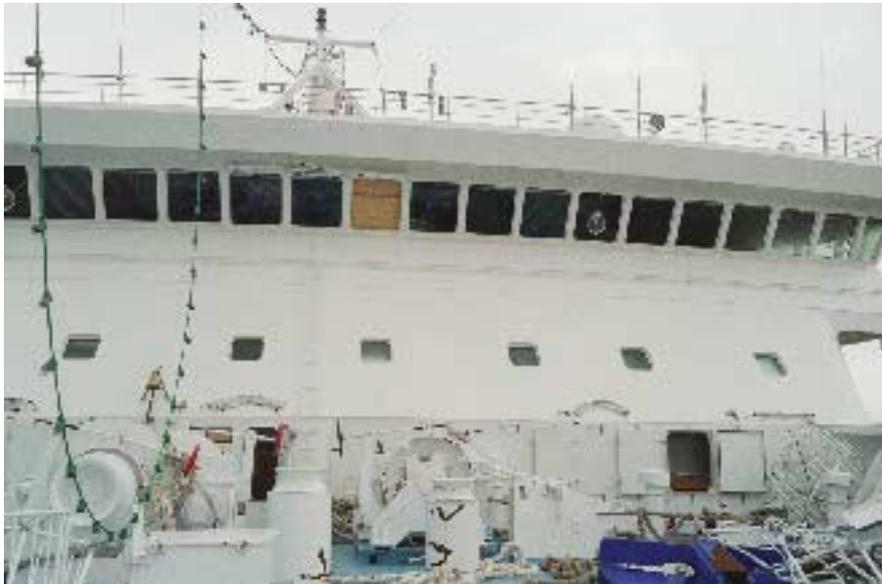
3. Bridge control console

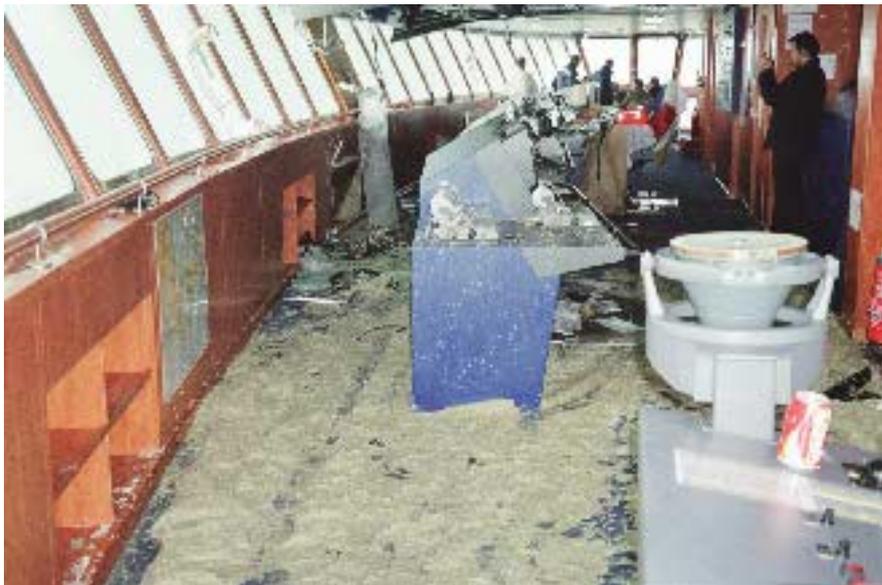
5. Broken bridge window

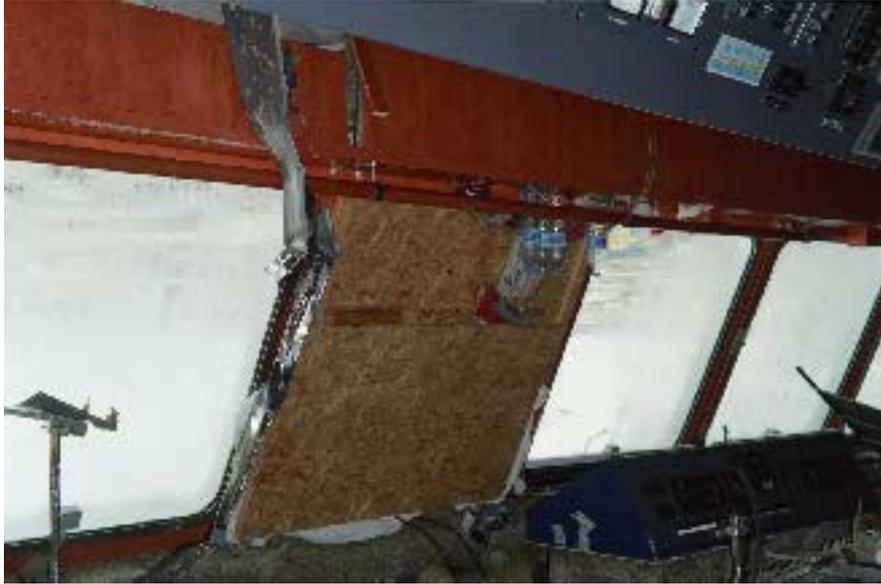
6. Damage to bridge deckhead

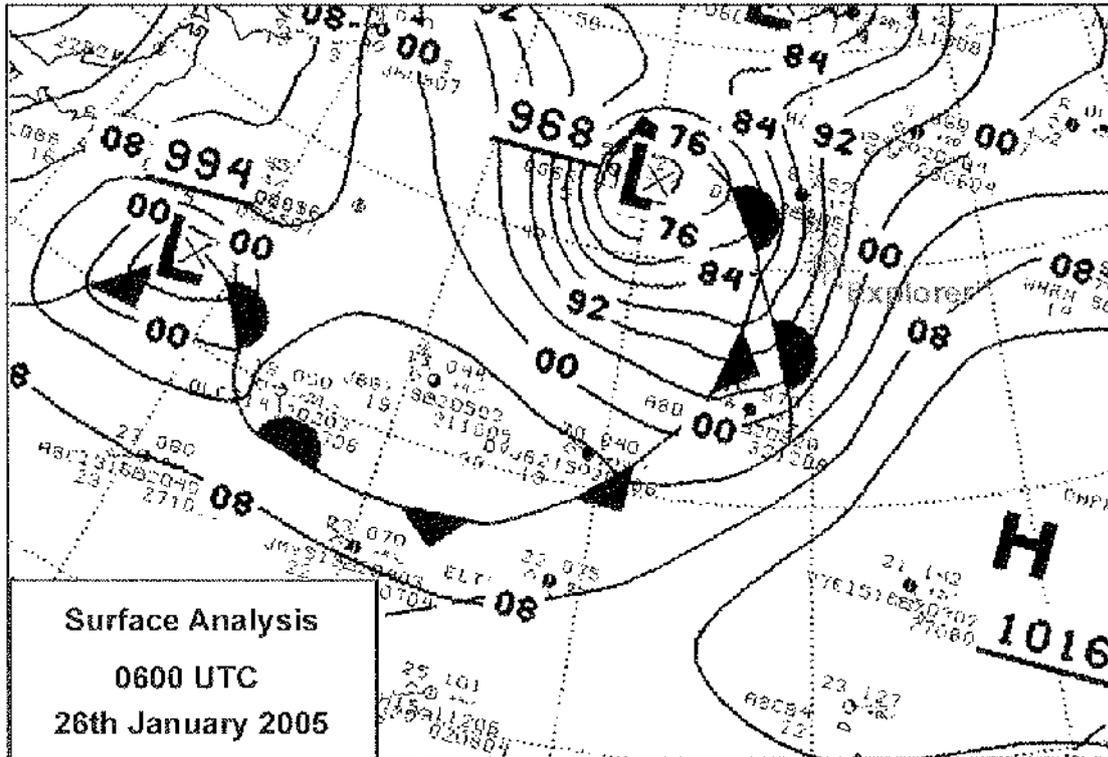
Fig. 5.15. Surface Analysis at 0600 UTC 26<sup>th</sup> January 2005
