"m.v. Marco Polo" IMO Number 6417097 Official Number 716438

Report of the marine safety investigation into a passenger fatality following a large wave strike off Ouessant (Ushant) on February 14th 2014 The Bahamas conducts marine safety or other investigations on ships flying the flag of the Commonwealth of the Bahamas in accordance with the obligations set forth in International Conventions to which The Bahamas is a Party. In accordance with the IMO Casualty Investigation Code, mandated by the International Convention for the Safety of Life at Sea (SOLAS) Regulation XI-1/6, investigations have the objective of preventing marine casualties and marine incidents in the future and do not seek to apportion blame or determine liability.

Date of Issue 27th October 2014

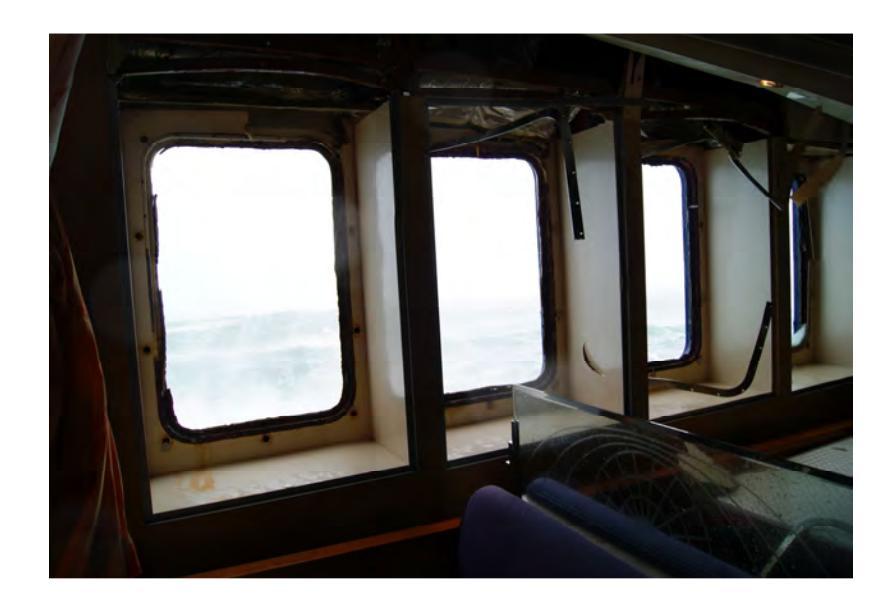
- 3.28. They went immediately to the restaurant to find that two panes of glass had been completely shattered, with pieces of glass of up to 25 cm² having been scattered up to 10 metres towards the centre-line of the ship, and two other panes dislodged from their positions and lying on the deck near a half-height partition some two metres from the ship side. A substantial amount of water had entered and wind and spray was entering the Restaurant.

Photograph of four displaced or shattered windows and securing arrangements (stated to have been taken directly after the wave strike)

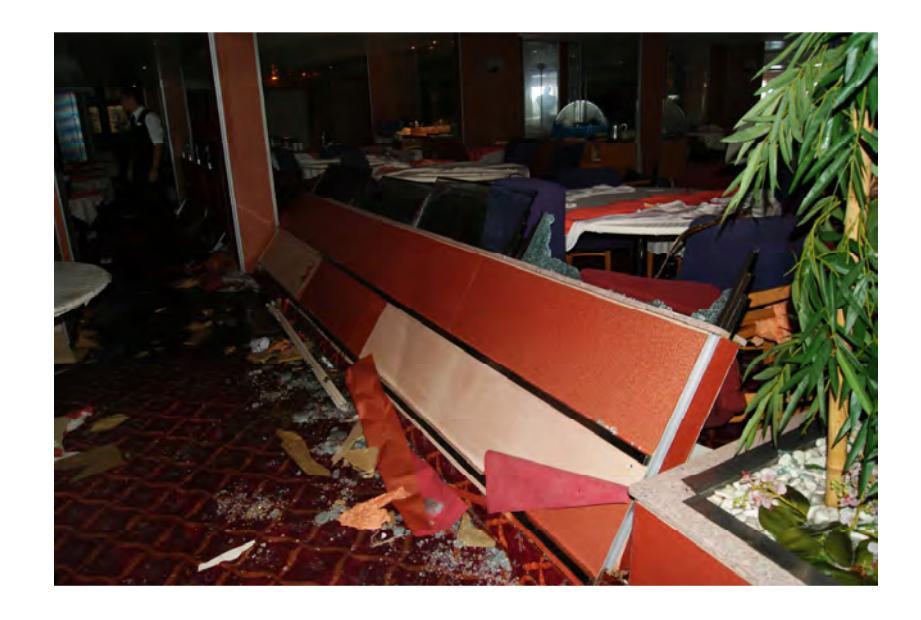
Damage in Waldorf Restaurant

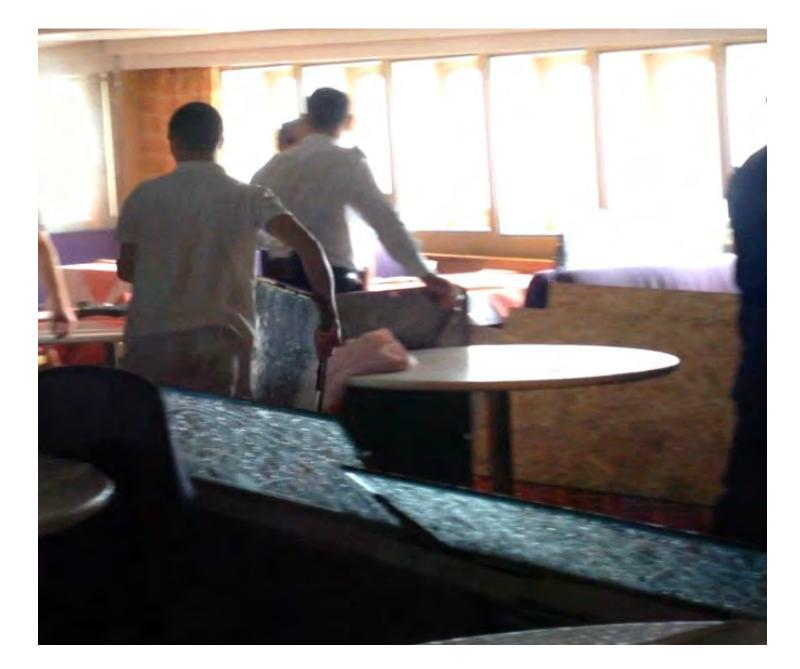
Video still – undamaged pane of glass being carried away

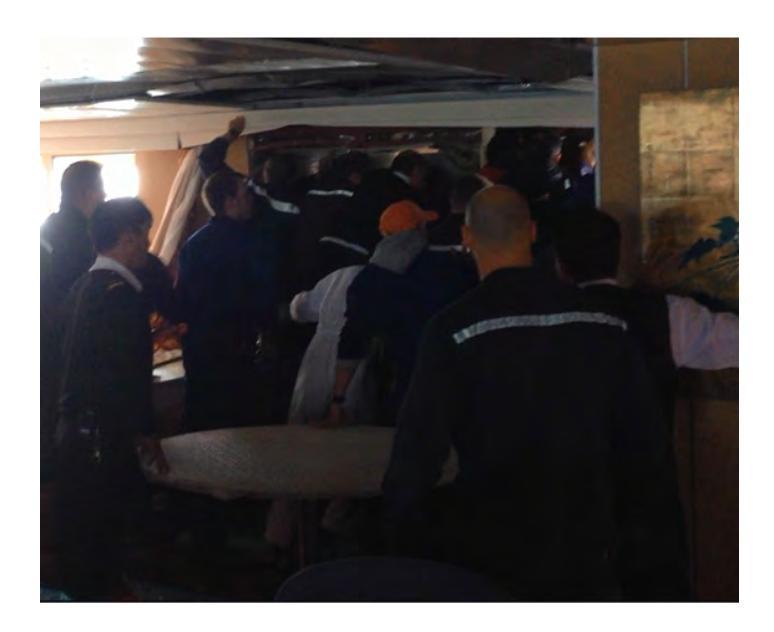
Video still illustrating crew efforts to block window openings

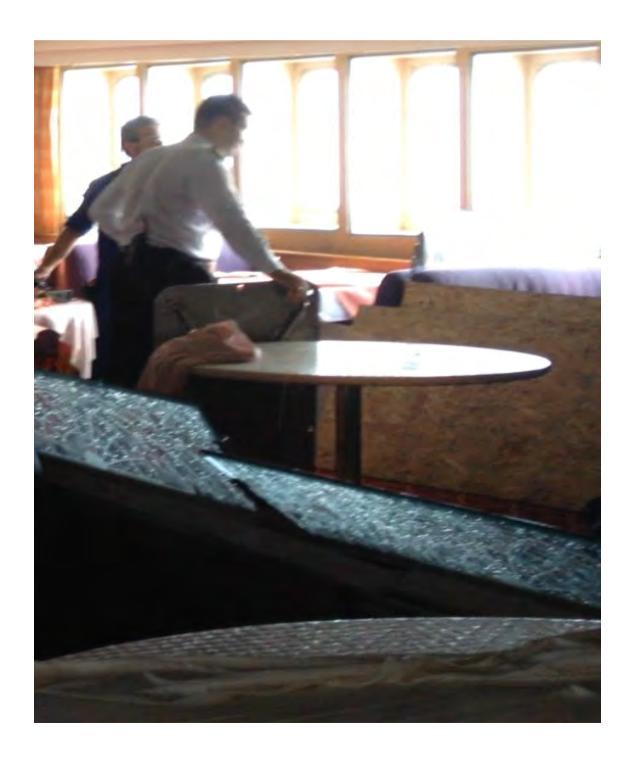
Video still – closing plate retrieved from store for fitting into opening

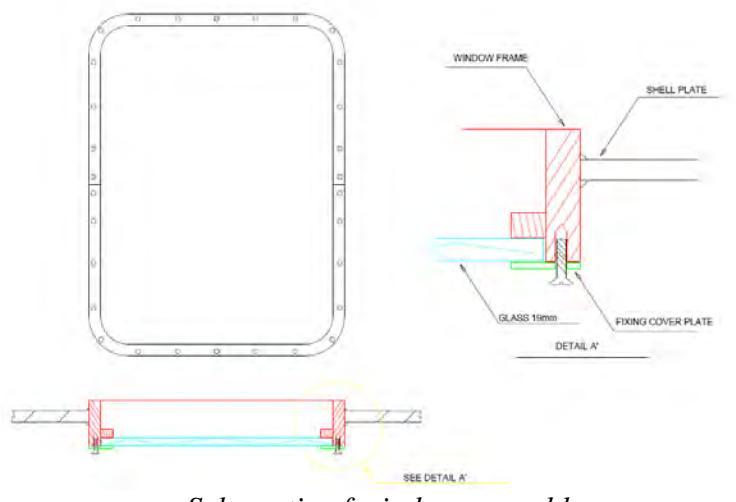
- 4.7.9. No thickness is given in the standard for the retaining flat bar which is estimated as being 3-5mm and, consequently, having a very limited resistance to external force. It is concluded that the strip is to retain the glass in place in normal conditions rather than to resist any significant direct external impact.

Schematic of window assembly

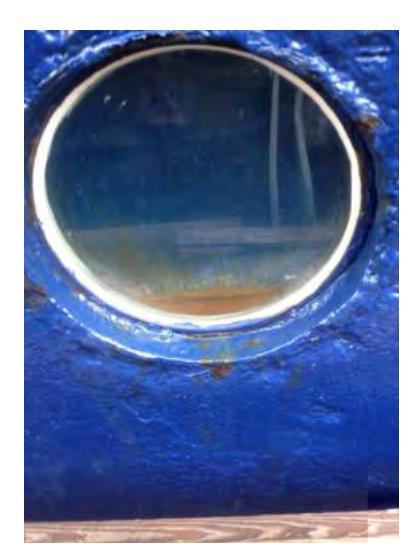
with leaks or rust stains. A subsequent Load Line survey carried out in March 2014 by DNV and the Bahamas Maritime Authority discovered cracks in some window frames and unidentified glass in use. A small number of windows in other locations were using non-glass glazing material. While no windows were recorded as leaking when subjected to a hose test, this was not the case with side scuttles as some of these were found with signs of leaks, corrosion and missing sealing gaskets.

Side scuttle showing internal tide mark, poor sealing and general corrosion

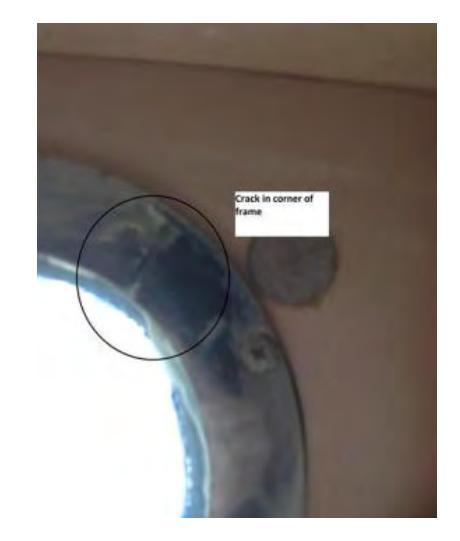
Crack in corner of window frame

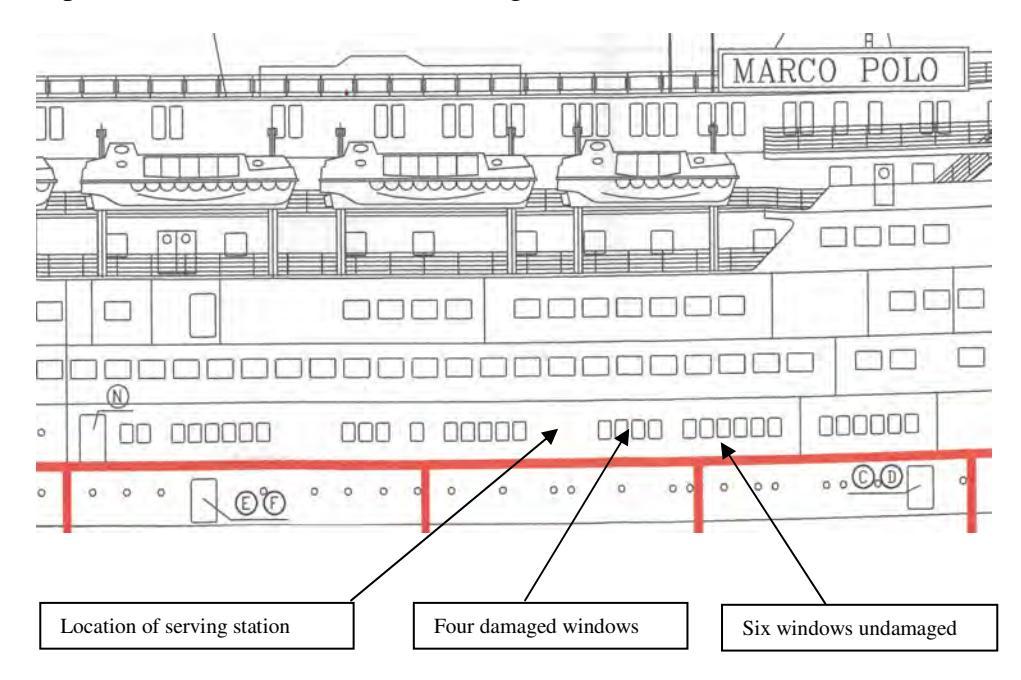
Side elevation of Marco Polo – Deck 6 windows

- 4.9.10. The windows which were affected in this incident are located between Frame 116 and Frame 120 i.e. from 67 m to 70 m from the forward end of the ship (i.e. within approximately 2/5 of length from forward.) The lower edge of the windows is approximately 6.5 m above the waterline.

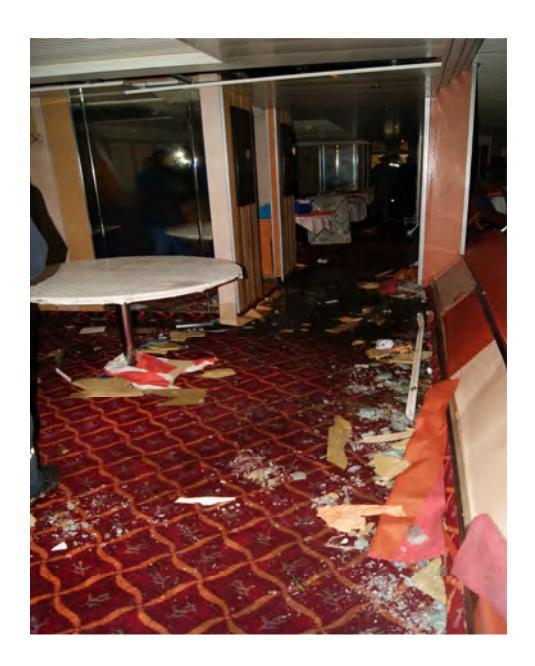
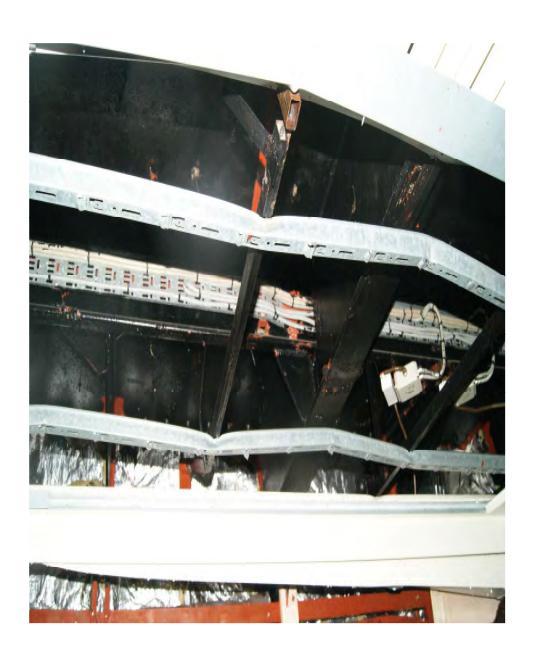
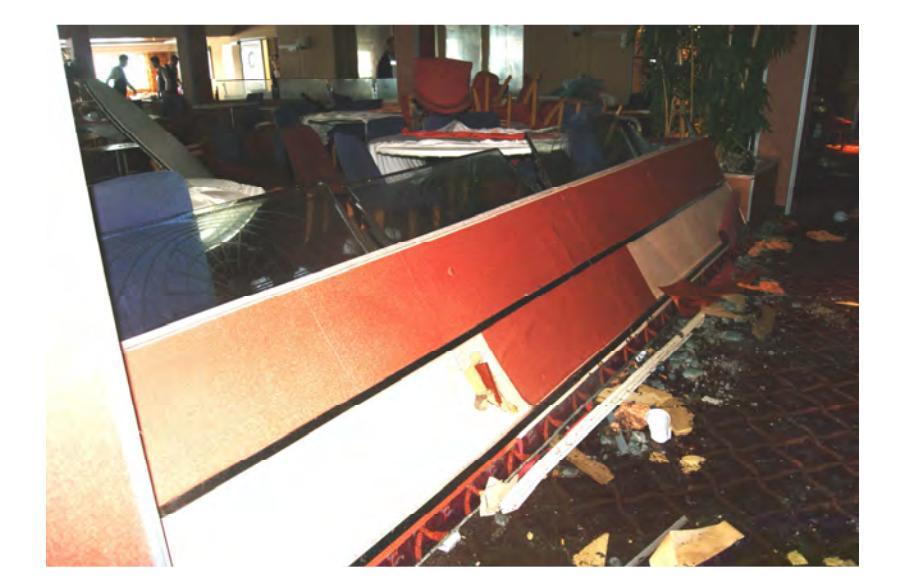
Photographs 1-3

Damage in Waldorf Restaurant

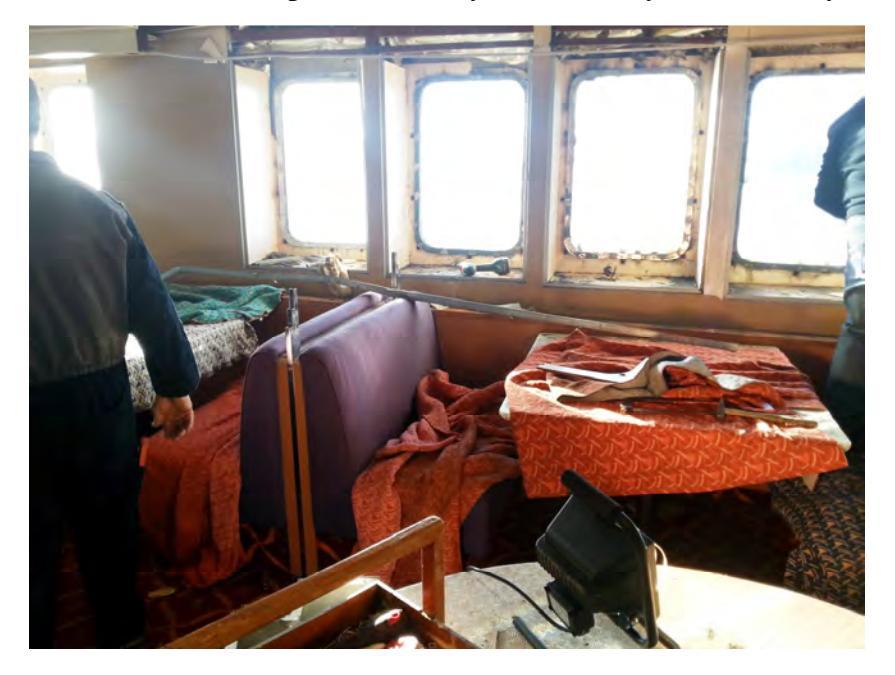
Waldorf Restaurant – repairs underway 0830 Sunday 16th February 2014

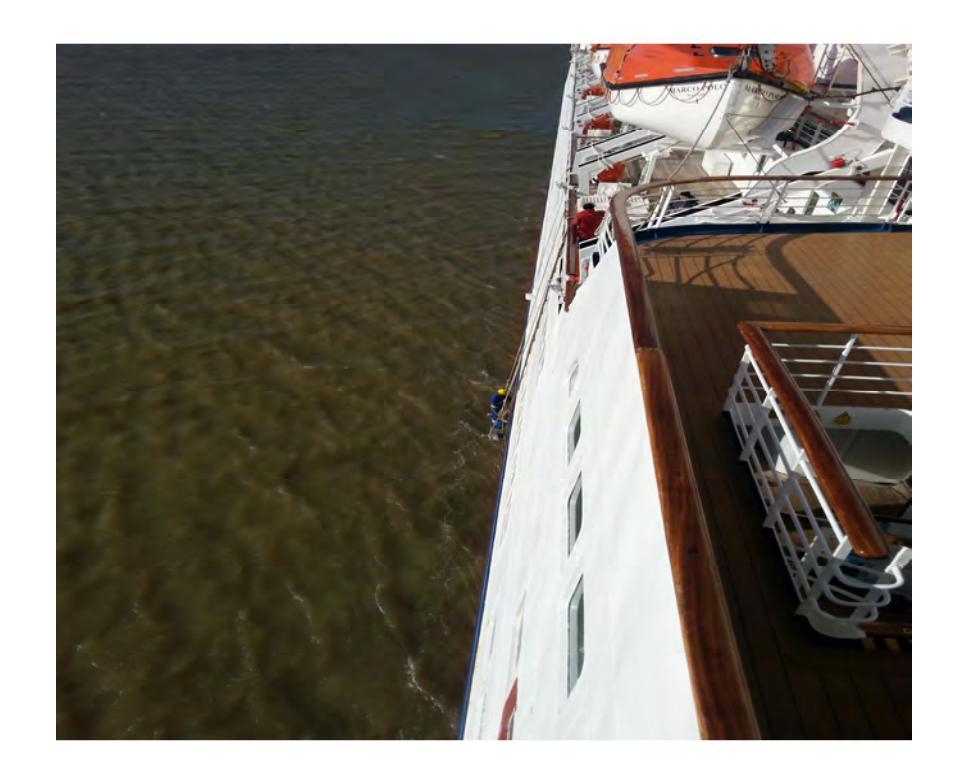
Repairs underway at Tilbury – view from navigating bridge deck towards the waterline

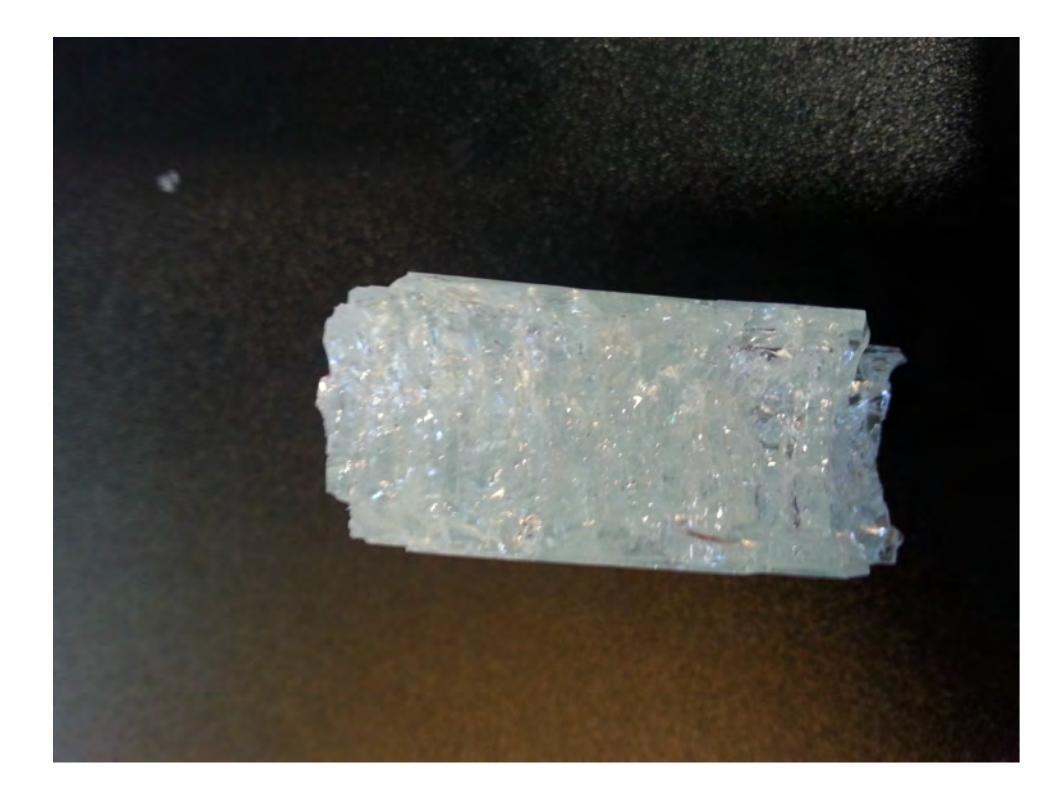
Window glass fragment (19mm thickness)
