Report of the investigation into the loss of the Bahamian registered tanker "Prestige" off the northwest coast of Spain on 19th November 2002

Bahamas Maritime Authority Latham House 16 Minories London EC3N 1EH +44 (020) 7264 2550

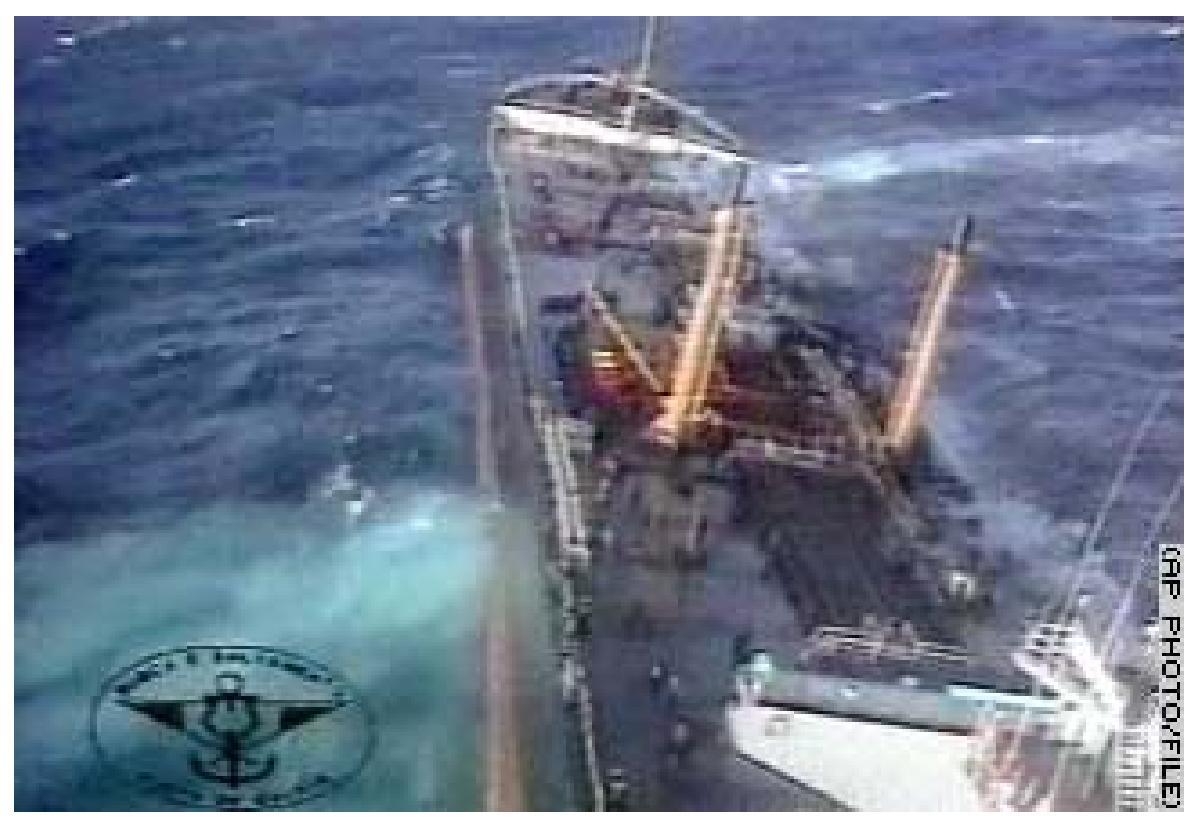
November 13 2002 - Initial list

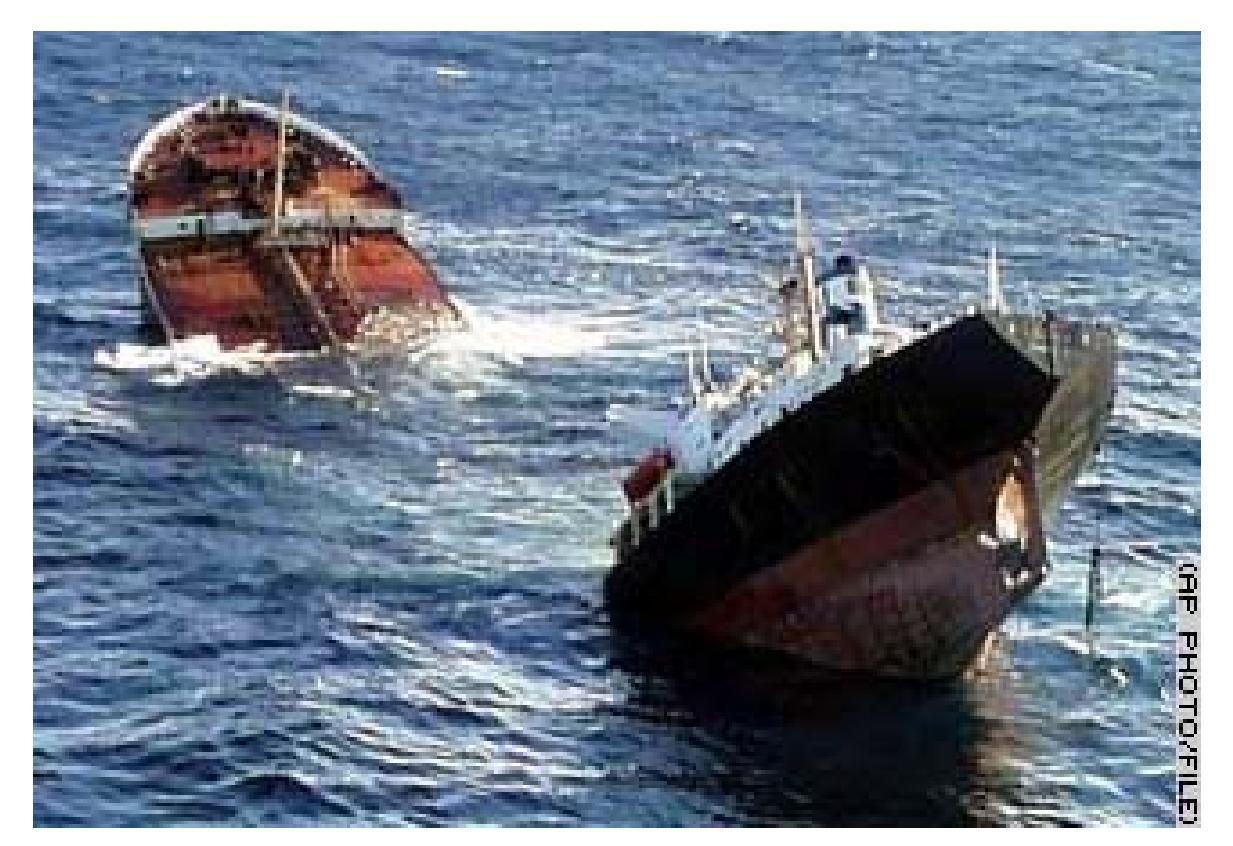
Figure 2

November 19 2002 – The final breaking up

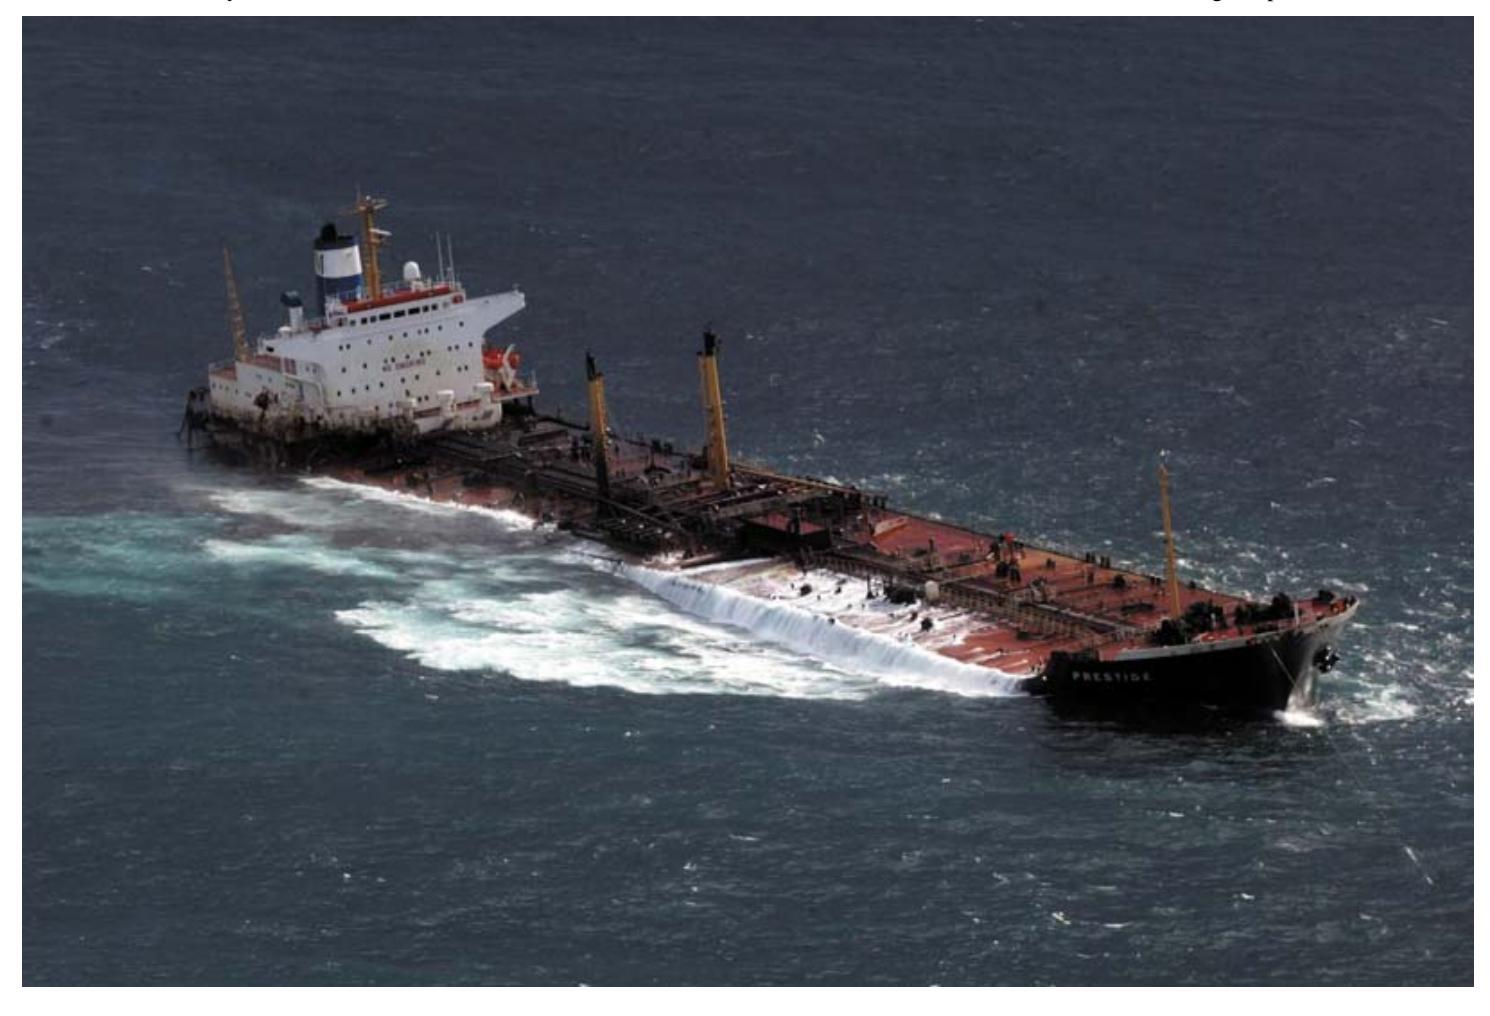
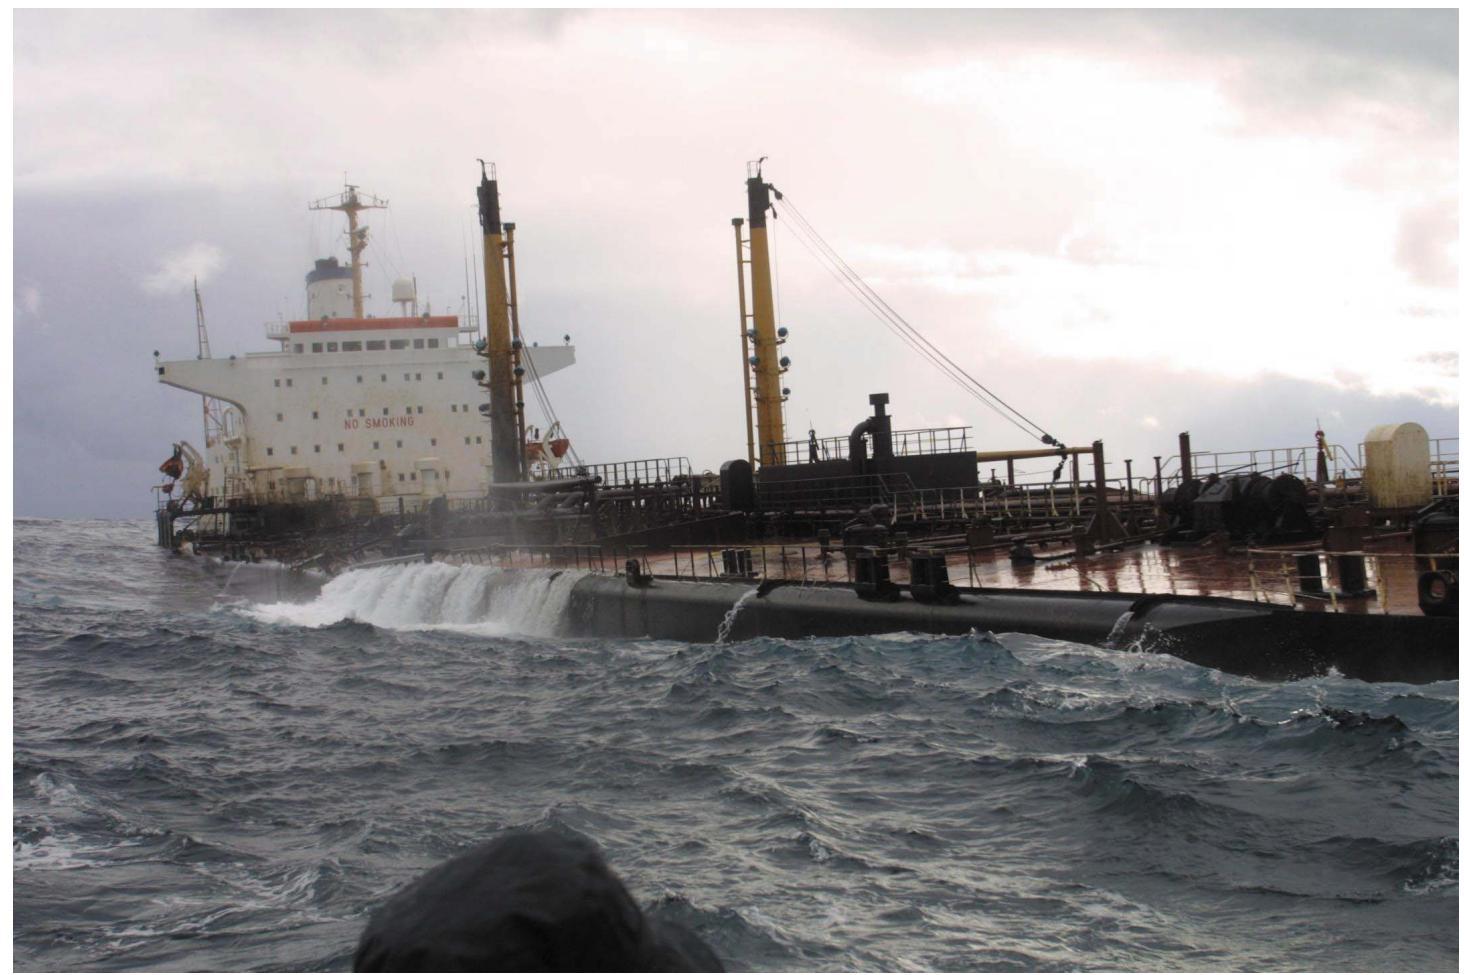
November 14 2002 - General views of the starboard side

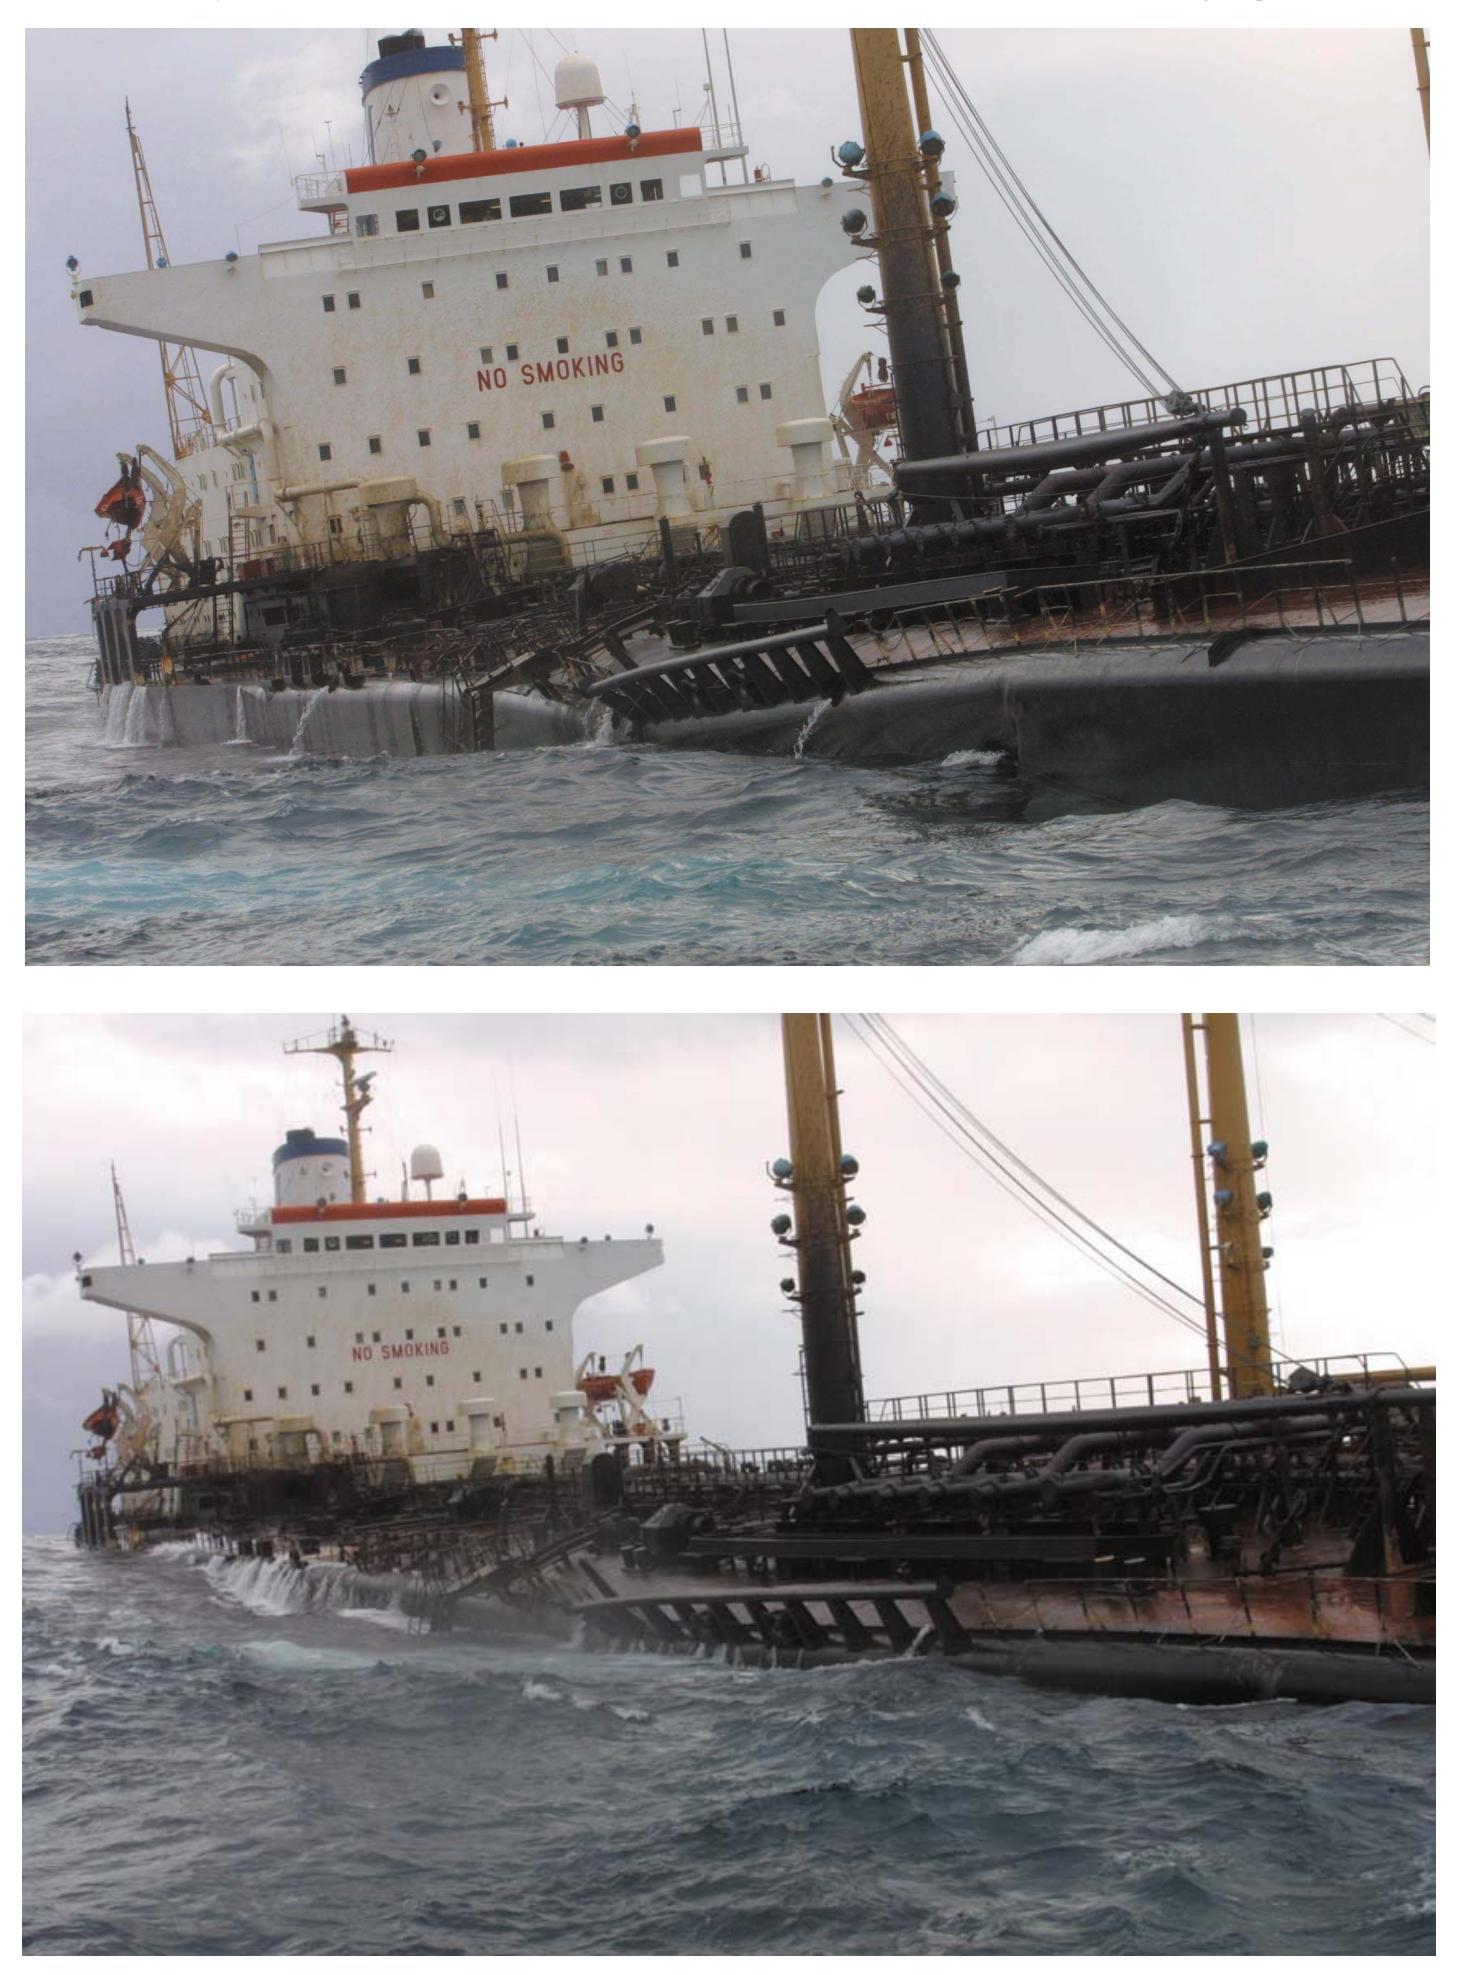
November 14 2002 - Damage to the starboard side (See enlarged views in Figure 9)

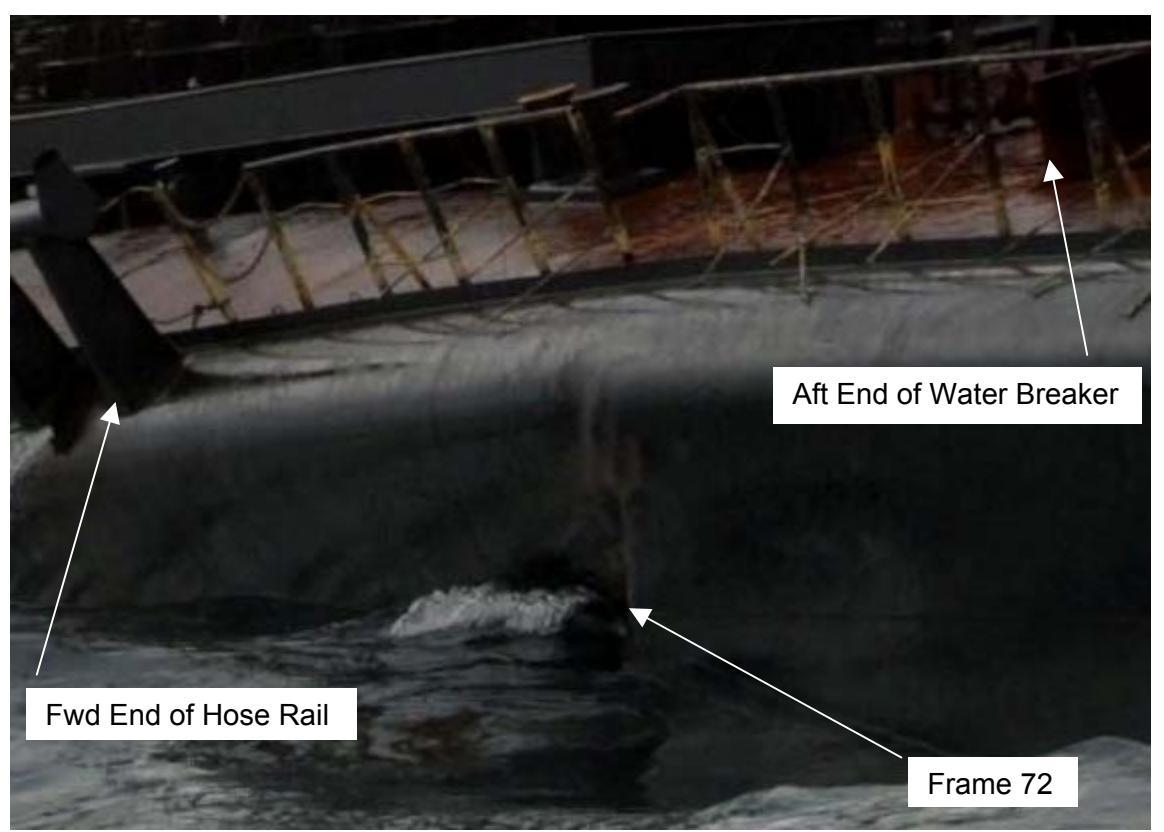
Forward most deformation of main deck edge and side in way of 3 Starboard Ballast Tank and 2 Starboard after wing tank

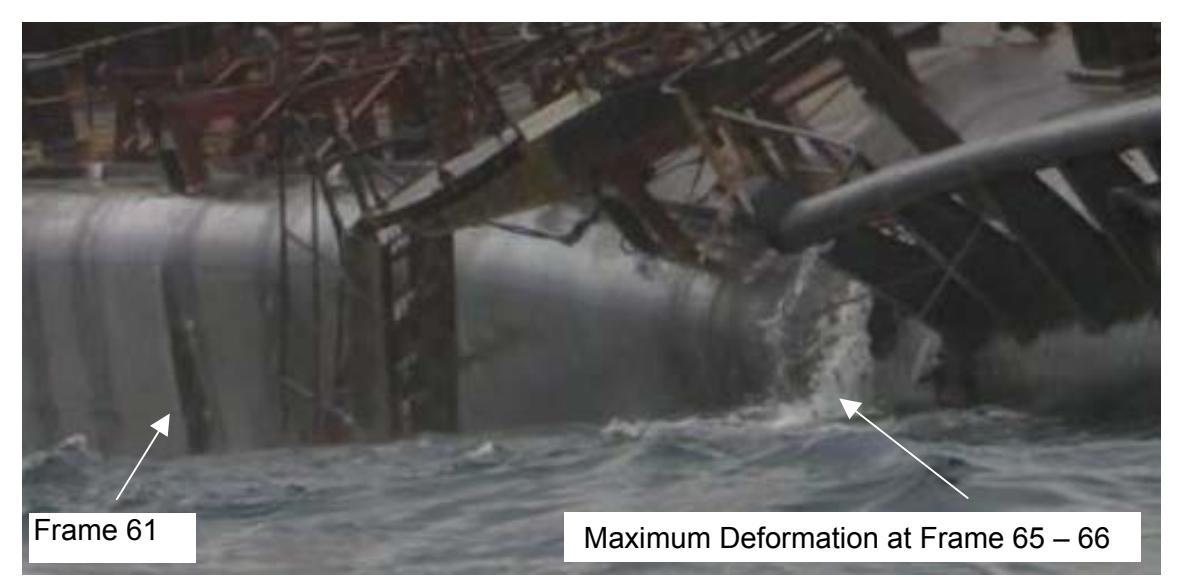
Main deck edge from aft end of 3 Starboard wing tank (Frame 61) to mid length of tank (Frame 65)

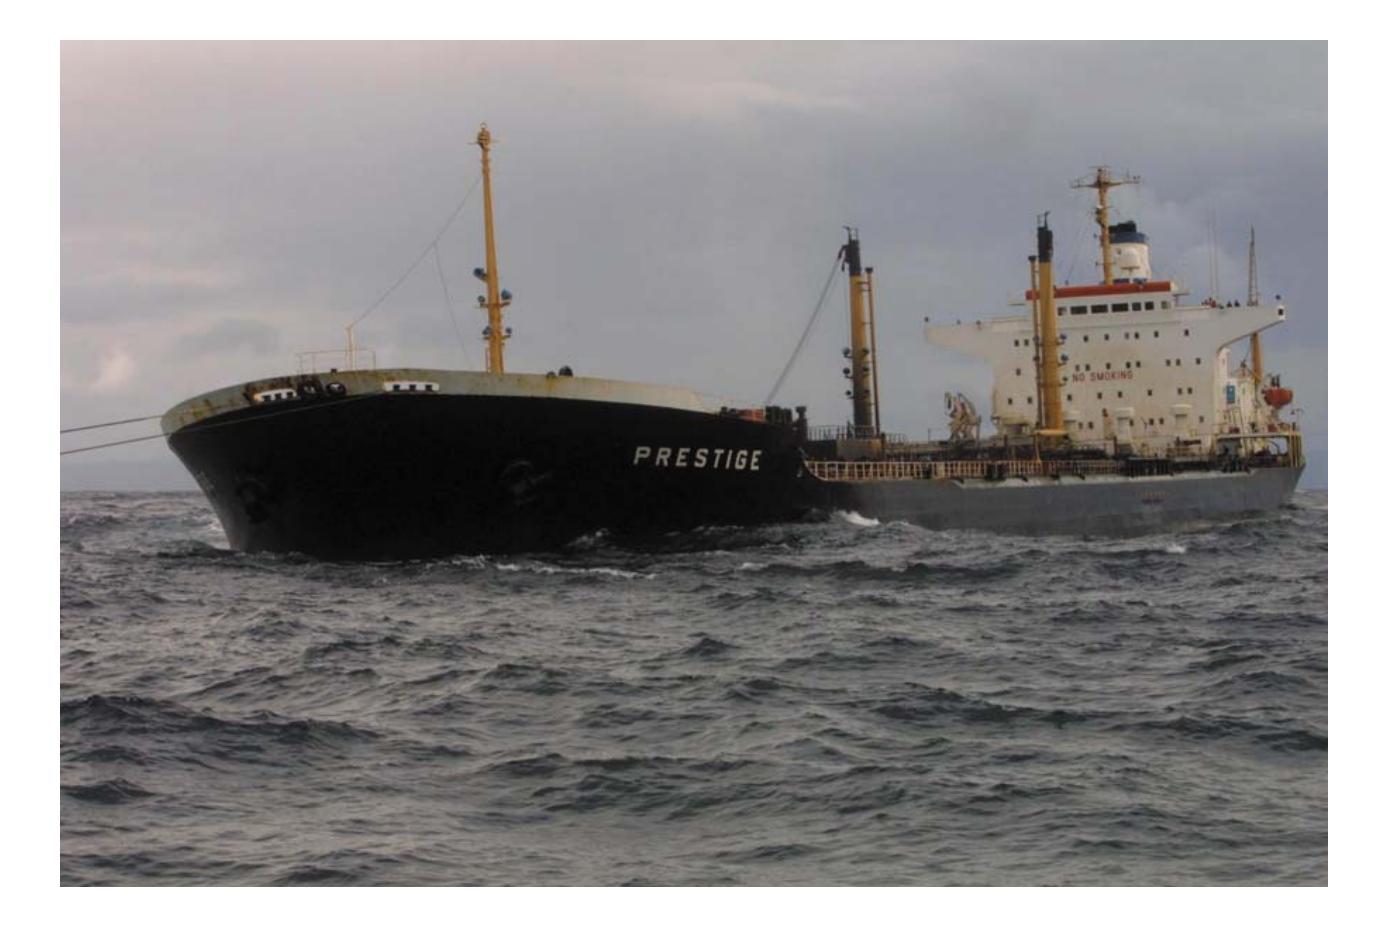
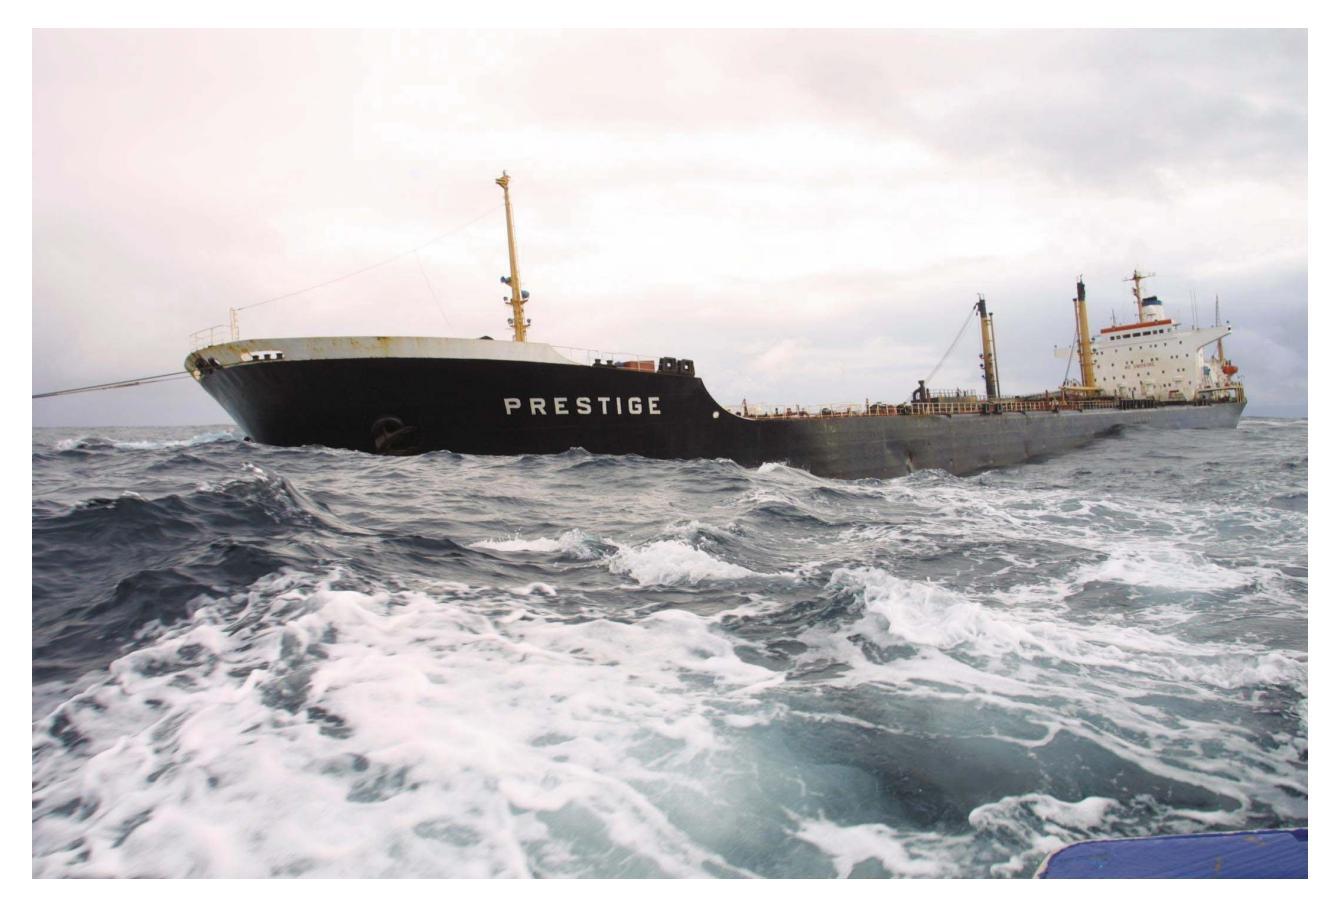
Figure 10

General views of the port side showing setting in of shell plating (See enlarged views in Figure 11)

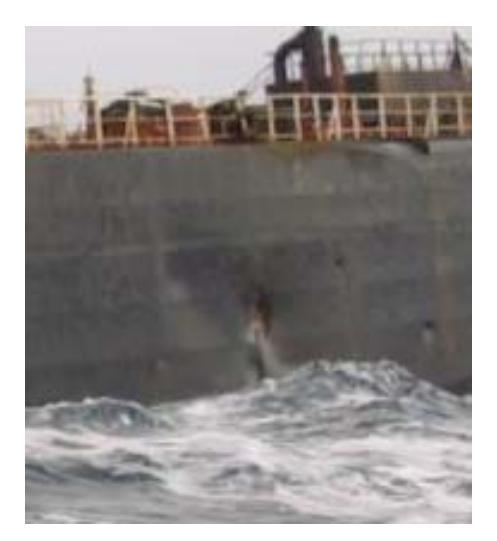
Setting in of shell plating at Frame 85 on port side of the vessel
