M.v SUNMI

Report of the marine safety investigation into a fatal accident during pilot transfer between Sunmi and Patrol on 05 October 2016 in London, United Kingdom The Bahamas conducts marine safety or other investigations on ships flying the flag of the Commonwealth of the Bahamas in accordance with the obligations set forth in International Conventions to which The Bahamas is a Party. In accordance with the IMO Casualty Investigation Code, mandated by the International Convention for the Safety of Life at Sea (SOLAS) Regulation XI-1/6, investigations have the objective of preventing marine casualties and marine incidents in the future and do not seek to apportion blame or determine liability.

Date of Issue: 12th October 2017 Bahamas Maritime Authority 120 Old Broad Street LONDON EC2N 1AR United Kingdom Report on the investigation into the fatal accident during

VERY SERIOUS MARINE CASUALTY REPORT NO 21/2017

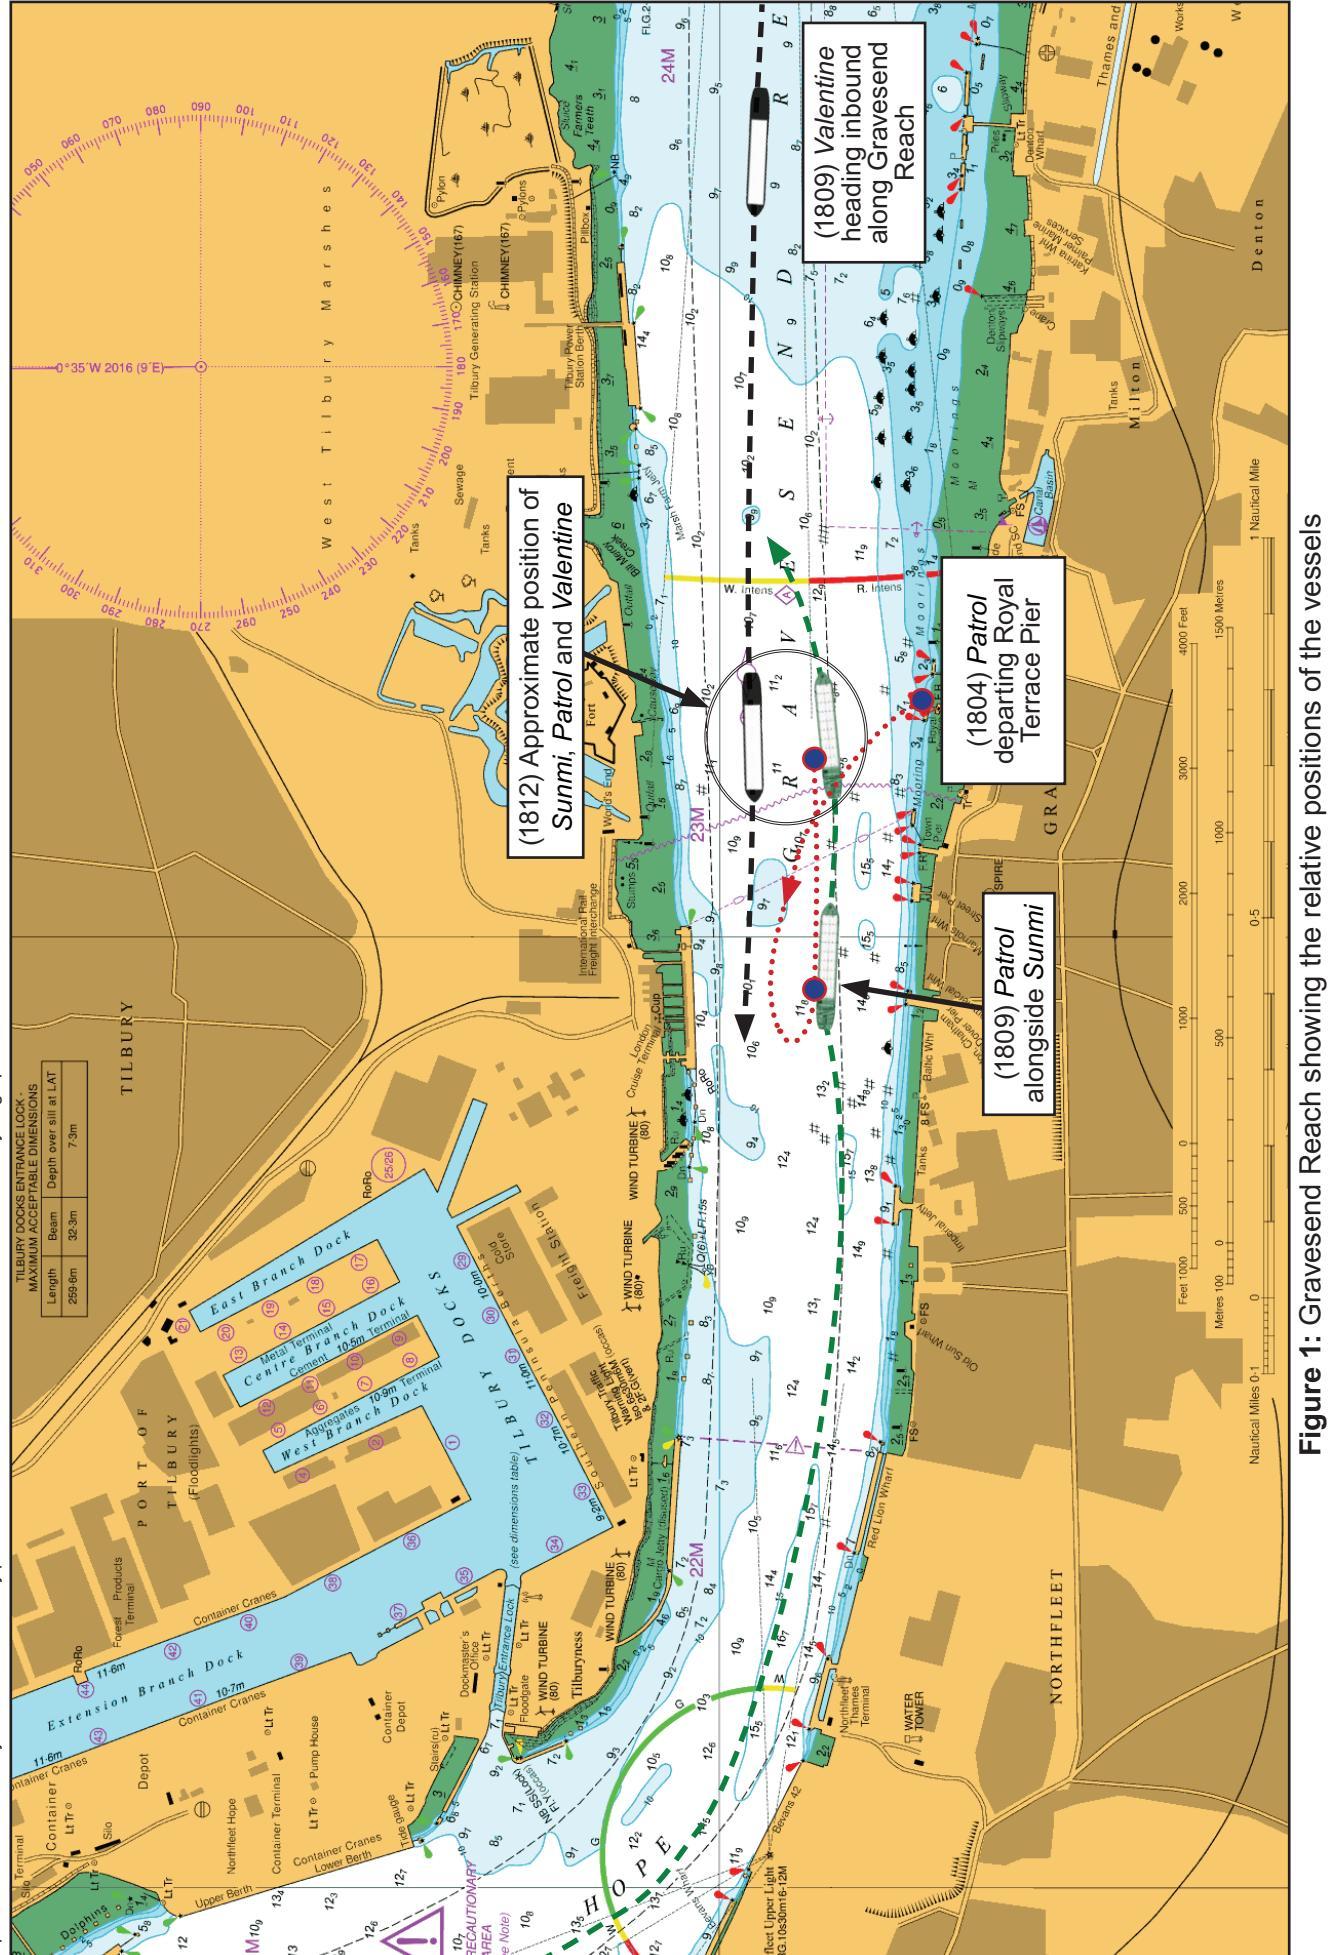
At 1803, *Sunmi* approached Tilburyness and began its turn into Gravesend Reach, where the sea pilot would board the vessel to take over the pilotage from the river pilot. Its speed over the ground (SOG) was 10.4 knots (kts). One minute later, the pilot launch *Patrol* departed Royal Terrace Pier and headed west, towards *Sunmi* (Figure 1). On board *Patrol* were its coxswain, deckhand and the sea pilot, Gordon Coates, who was to transfer to *Sunmi* to take over from the river pilot. At the same time, the inbound ro-ro vessel *Valentine* entered Gravesend Reach.

At 1812:09, *Valentine*'s stern was in line with *Patrol*'s bow and passing clear of the pilot launch and ship **(Figure 1)**.

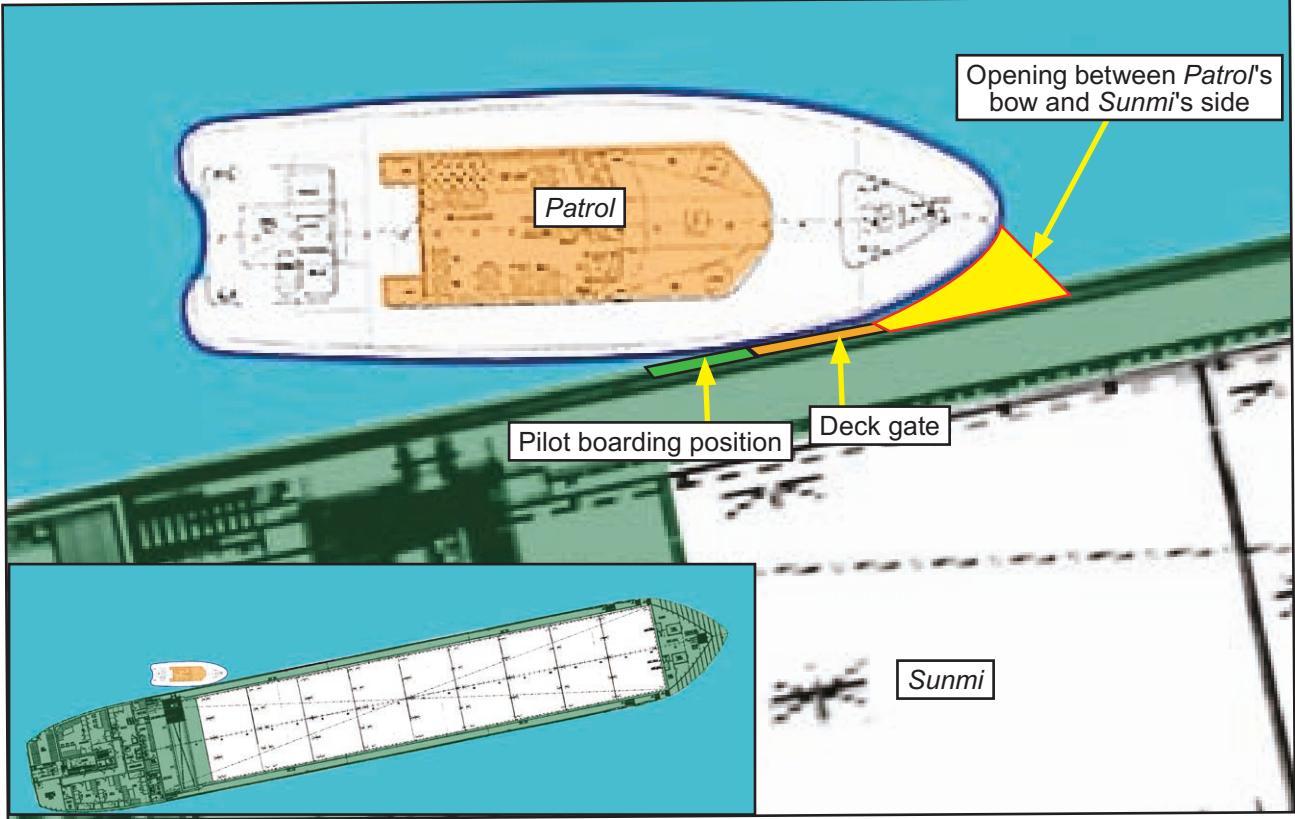
Figure 2: Patrol's position alongside Sunmi

The coxswain brought *Patrol* alongside *Sunmi* so that the launch's starboard bow was resting against the cargo ship's hull just forward of the pilot ladder in line with the deck gate in the main deck handrail, which *Sunmi*'s crew had secured open (**Figure 2**). Immediately aft of the gate, a pilot ladder had been rigged in accordance with the river pilot's instructions (**Figure 3**).

Constructed in 1982 by Halmatic Ltd, the vessel was built on an Arun lifeboat hull. Powered by twin Scania diesel engines, the launch had a service speed of approximately 15kts. The engines were controlled by separate throttle controls, which enabled the coxswain to place the launch at an angle to a ship's side under power, thereby holding it fast against the hull (Figure 2).

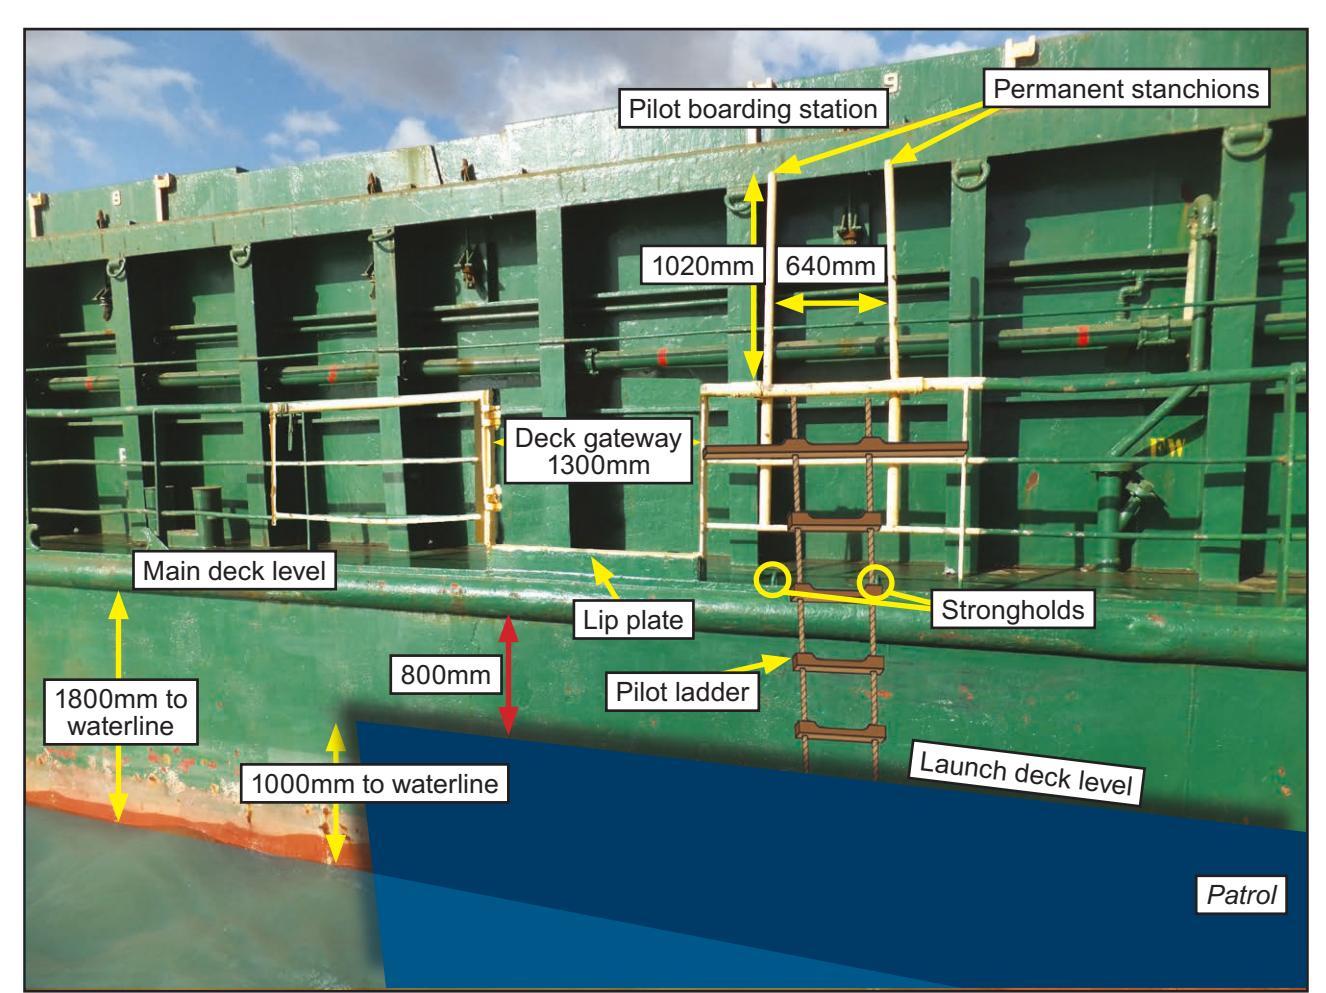
Figure 3: Representation of Sunmi's deck gate and pilot boarding arrangements

Directly in front of the sea pilot was *Sunmi*'s open deck gate. On board *Sunmi* a deck rating was standing by the deck gate ready to assist the pilot if required.

Shortly before 1812 the sea pilot lifted his right foot onto *Sunmi*'s deck and grasped the deck gate's uprights with both hands. He then appeared to brace himself to step up and across when the pilot launch dropped against *Sunmi* without warning, causing him to be left hanging by his arms. He was stopped from falling into the water when both *Patrol*'s deckhand and *Sunmi*'s deck rating grabbed hold of him. The sea pilot was then almost sitting on the pilot launch's deck with his legs between the two vessels in the 'V' formed by *Patrol*'s bow and *Sunmi*'s side. As the deckhand and rating struggled to lift the sea pilot onto *Sunmi*, the angle between the two vessels changed, crushing the sea pilot's legs between them. When the angle opened up again, the deck rating and deckhand manhandled the sea pilot onto *Sunmi*'s deck. He was bleeding profusely from his left leg and in obvious pain.

Sunmi had two designated pilot boarding stations, one on either side of the main deck approximately one quarter of the ship's length forward of the stern. Each station had two permanent stanchions that extended 1020mm above the rail and were 640mm apart. A pilot ladder could be deployed over the top of the rail and then secured to the strongholds that were welded to the deck. Typically, a bulwark ladder (as shown in **Figure 4**) would be used to facilitate the pilot in climbing over the rail and safely onto the deck. At the time of the accident there was not a bulwark ladder rigged. When deployed for the pilot transfer with *Patrol*, the freeboard difference between the vessels was such that there was a maximum of two ladder steps showing between the two deck levels (**Figure 3**).

Immediately adjacent to the pilot ladder was a deck gate in the main deck railing designed to take the ship's gangway while alongside. The deck gate opened outboard and could be secured against the rail when fully opened, leaving an opening that was 1300mm wide. There was also a welded lip-plate across the width of the deck gate (**Figure 3**) to enable the gangway to be 'hooked' onto the deck.
