Bahamas Maritime Authority

Marine Safety Investigation Report

into an inadvertent steam release, resulting in a fatality on Navigator of the Seas, 14 July 2020

Date of Issue: 27 September 2022 Bahamas Maritime Authority 120 Old Broad Street LONDON EC2N 1AR United Kingdom

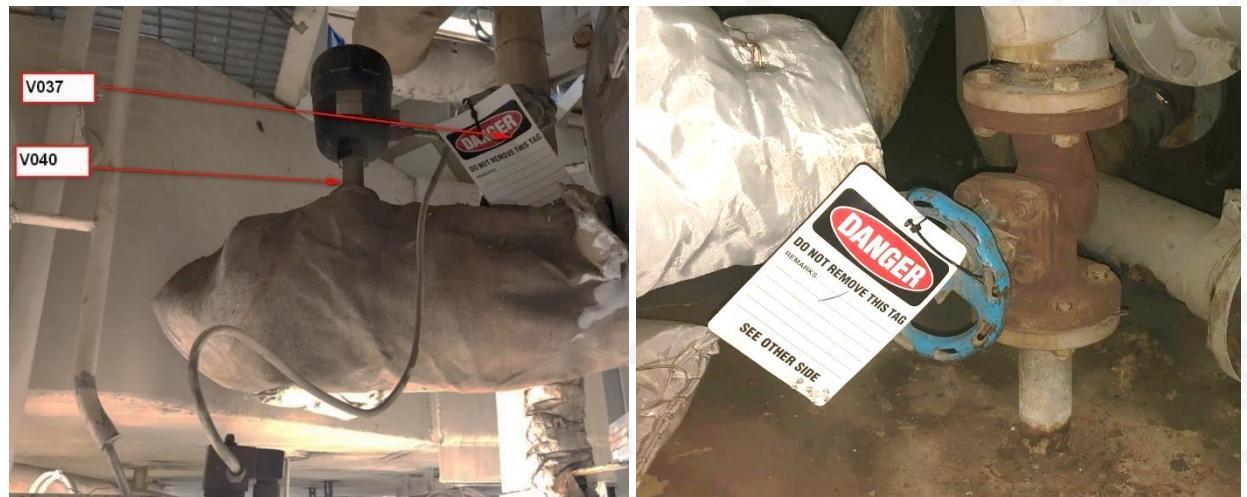
Testing identified that one manual valve could not be fully closed due to internal corrosion and the other was not fully closed.

Valves V037, V040 and (right) V134 post-casualty

The tagout procedure was ineffective due to the pneumatic valve being left "live," valve V037 being physically unable to be closed and V134 not being fully closed.

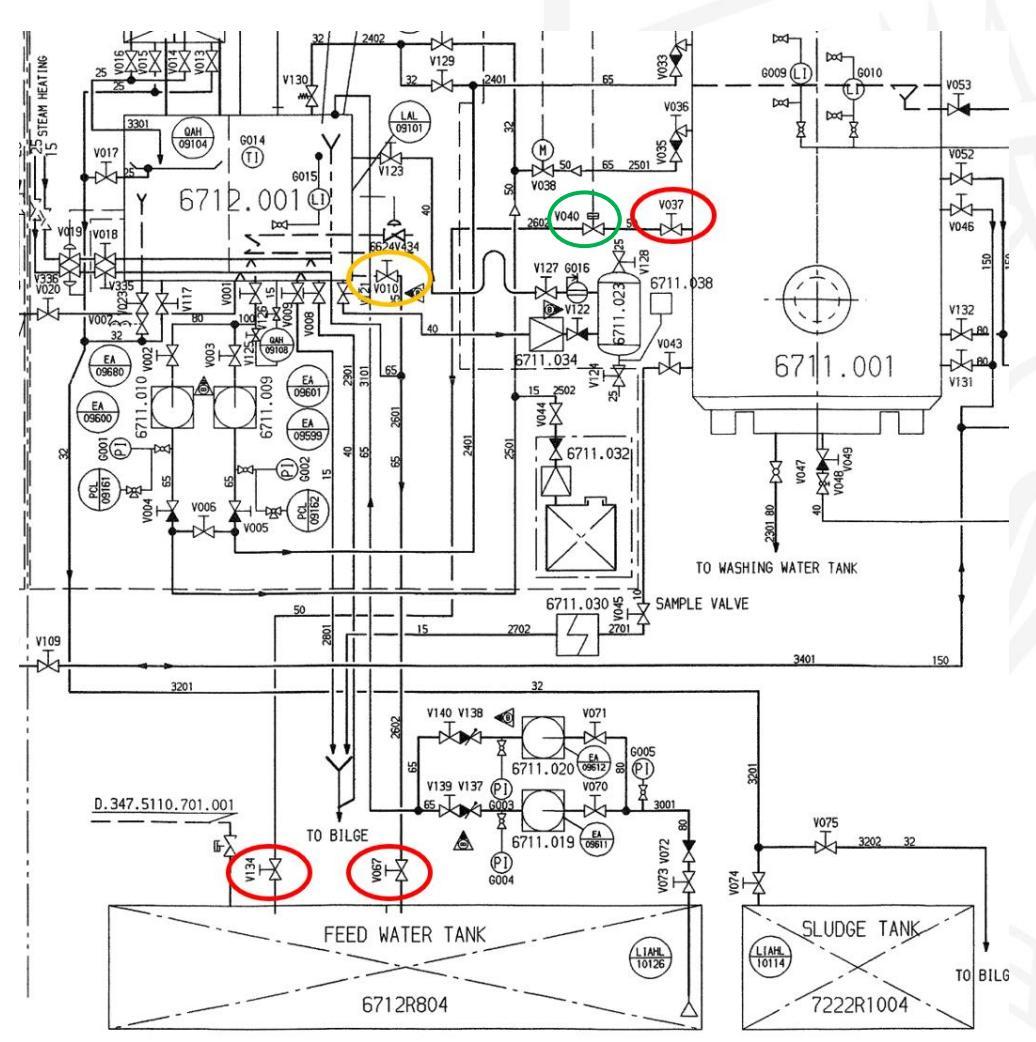
Whilst the bosun set up the pneumatic pump, the second engineer (environment) and third engineer split the task of isolating the tank: one closed valves V037 and V067. One closed valves V134 and V010. The second engineer (environment) then put the tags on the valves V037, V067 and V134. Valve V010 was not tagged. A further valve on the blow-out line (V040) was pneumatically operated and was not isolated.

Valve locations: valves marked in red were reported closed and tagged out. The valve in marked in amber was closed but not tagged. The valve marked in green was not isolated

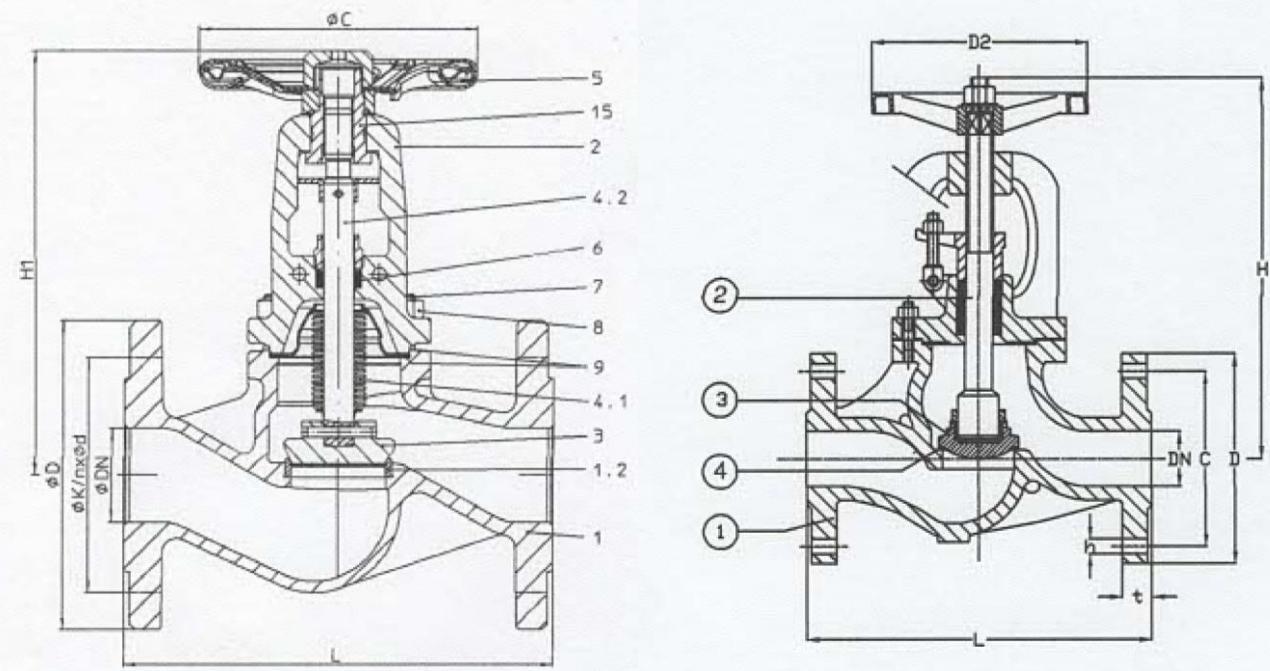
Cross-section drawings of V037 (left) and V134 (right)

The blow-out line from boiler #1 had three isolation valves: two manual globe valves (V037 and V134) and one pneumatic gate valve (V040). During normal operation of the boiler, the manual globe valves were open and the pneumatic valve was operated automatically by the boiler's control system: if the boiler water level rose above the determined high level (80% of capacity), the pneumatic valve would open allowing the excess water/steam to blow to the feedwater tank.

There was no position indicator on any of the valves on the system.

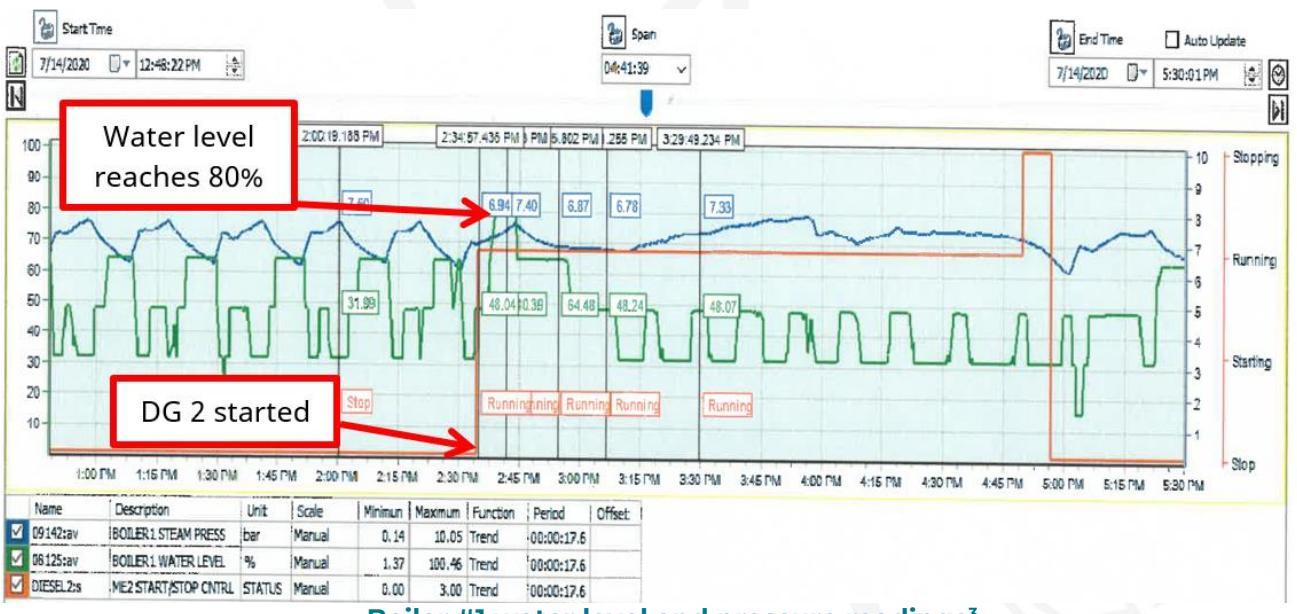
At the time of the casualty, boiler #1 was operating and in master mode. When diesel generator 2 was started in preparation for departure, its exhaust gases raised the economiser temperature which in turn heated the boiler's circulating water and increased pressure.

Boiler #1 water level and pressure readings³

When the boiler water level reached 80% the pneumatic valve (V040), which had not been electronically or physically isolated, automatically opened. The passage of steam was not halted by the manual valves (V037 or V134) on the blow-out line, allowing steam to enter feedwater tank 1.

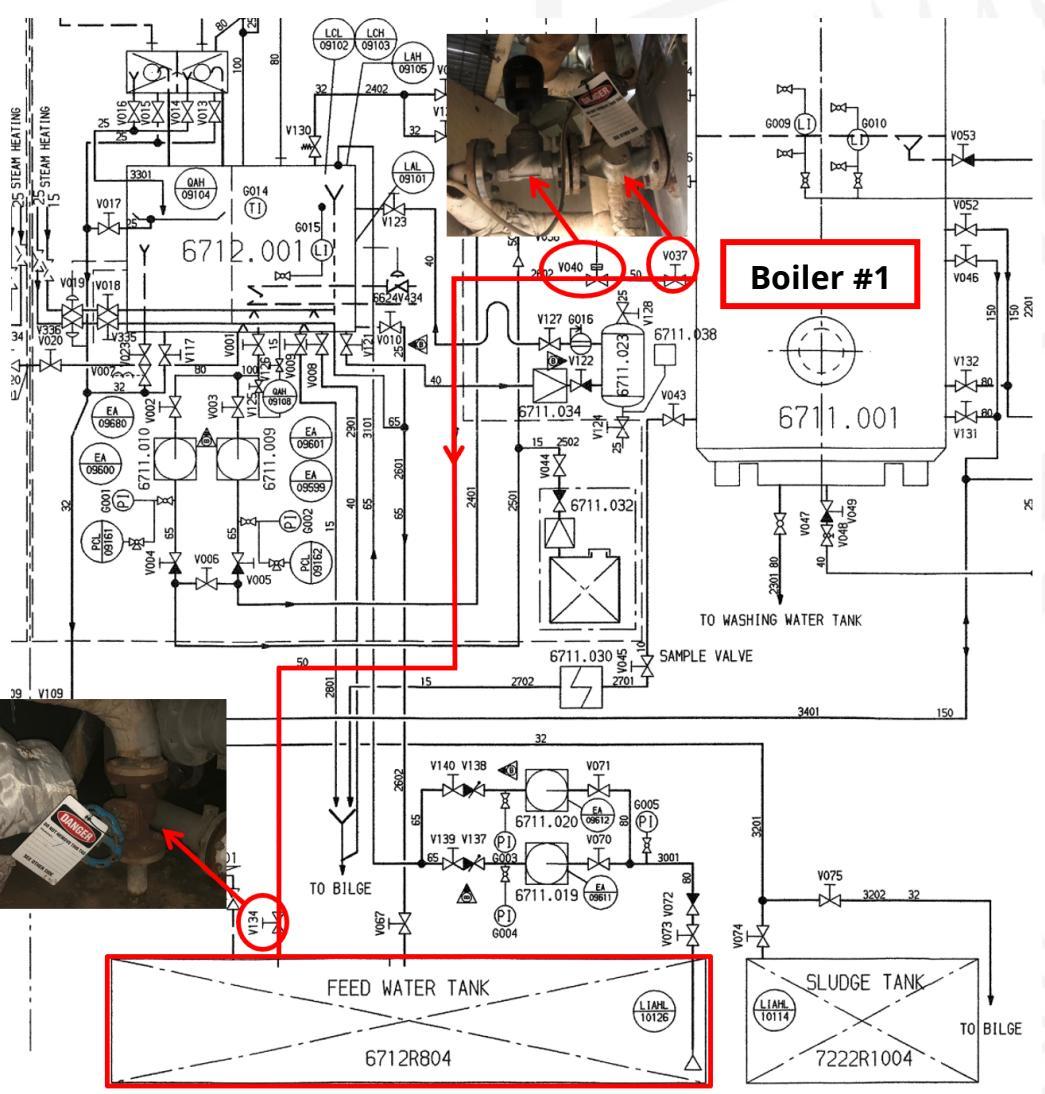
Boiler #1: blow-out line to feedwater tank, valves ringed

- pneumatic valve V040 was operating as designed
- manual valve V134 held pressure when exposed to blow-out
- manual valve V037 did not hold pressure when exposed to blow-out

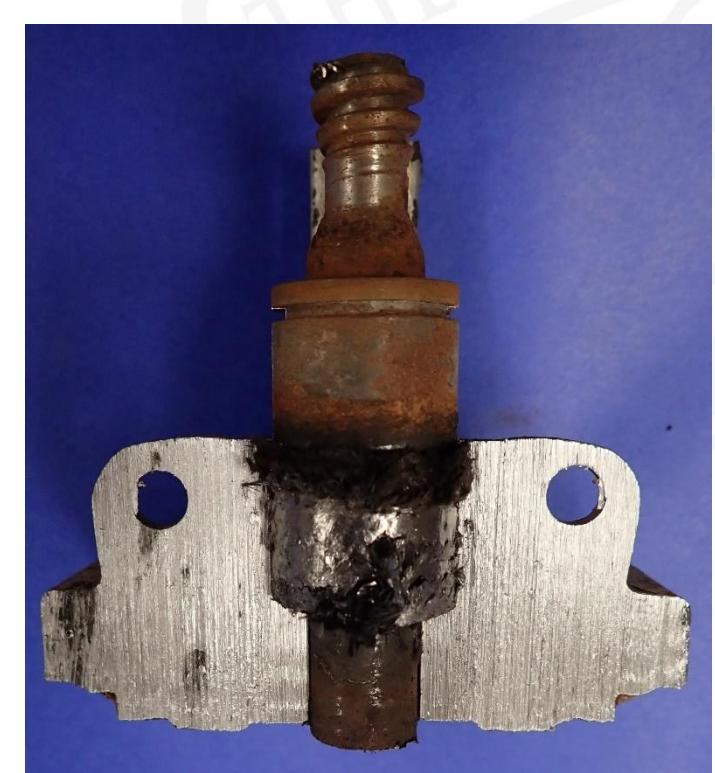
V037 was disassembled and found to have corrosion on the stem and bushing. On turning the valve stem with mechanical assistance, it was found to be slightly bent. The valve could not be fully closed due to the excessive corrosion on the stem and bonnet and degradation of the graphite packing.

Cross-section of valve V037 - significant corrosion to stem and bonnet, degraded packing

Metallurgical testing found that the valve's metal components were within specification. Testing of the packing identified the presence of chlorine. There were no traces of salt.

Shipboard tests indicate that valve V037 was free but unable to fully close at the time of the casualty. Testimony from the crew indicates that the valve wheel could be turned a sufficient number of times to lead the operator to believe it was closed.

- Shipboard tests indicate that valve V037 was free but unable to fully close at the time of the casualty. Testimony from the crew indicates that the valve wheel could be turned a sufficient number of times to lead the operator to believe it was closed. Destructive inspection found the valve to be severely corroded.

• Taking into consideration the degradation of valve V037, review the extent and frequency of its auxiliary boiler surveys.
