Bahamas Maritime Authority

Marine Safety Investigation Report

into the failure of a wire sling on board the Baltic Pearl with the loss of one life

Date of Issue: 26 October 2022 Bahamas Maritime Authority 120 Old Broad Street LONDON EC2N 1AR United Kingdom

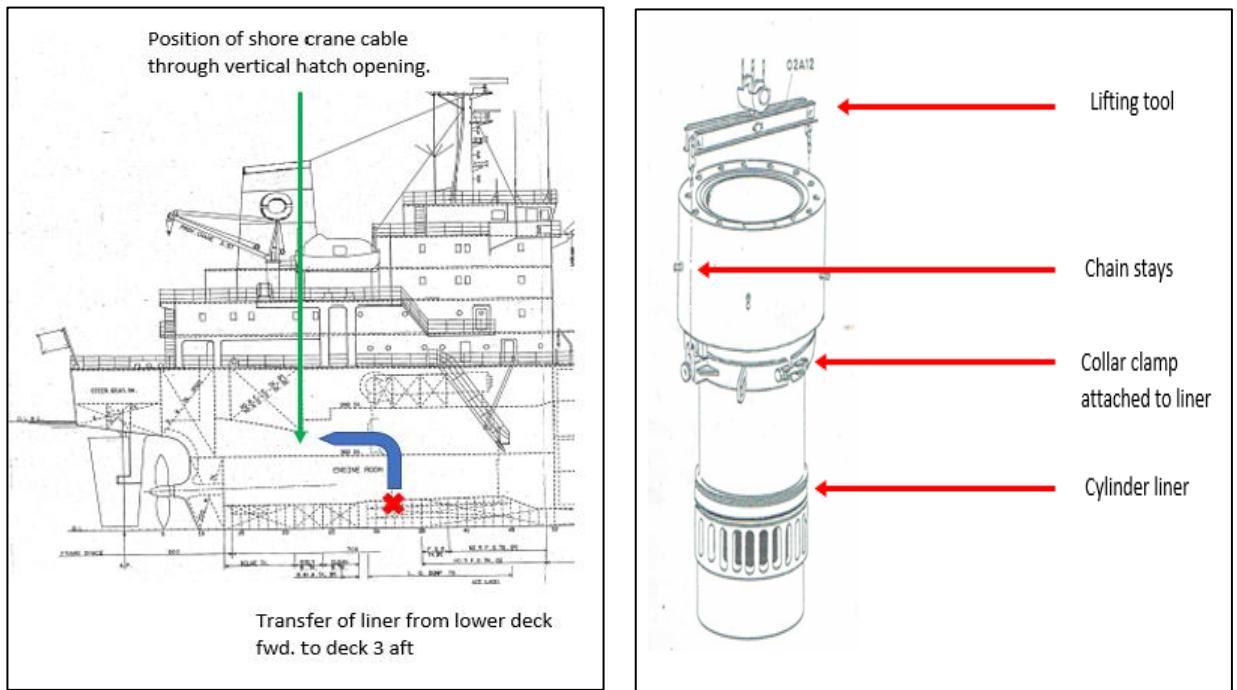
Lifting of the liner was via a lifting tool and collar clamp the total weight of the suspended load was 3314kg.

Figure 1. Relocation of cylinder liner

Figure 2. Complete rigging of cylinder liner

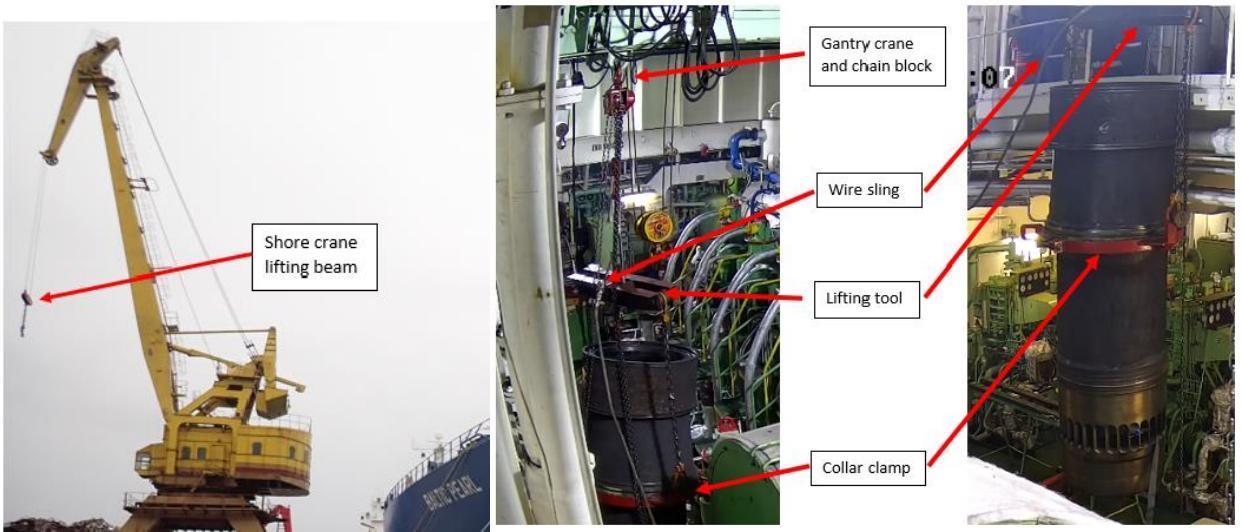
The shore crane's hook suspended from the lifting beam could only pass through the upper three deck openings due to the size of a permanently rigged lifting beam. It was decided that the ship would provide an 8m long wire sling to enable the lift, replicating the arrangement used for the removal of the first liner ashore and the loading of its replacement in to the engine room on 18 September 2021.

Figure 3. Shore crane

Figure 4. Liner rigged (L) and in position below hatch (R)

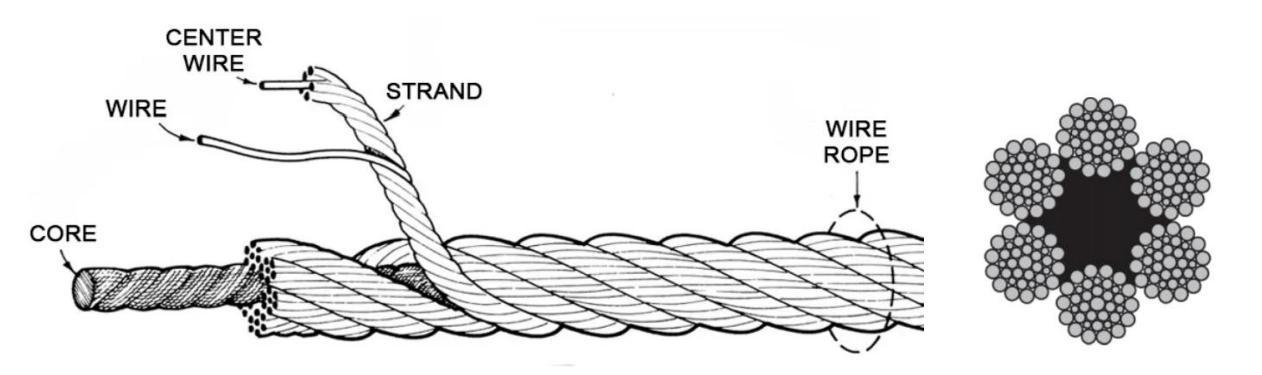
Figure 6. Composition of standard wire rope Figure

Figure 7. Sling's cross section

The wire rope was 18mm diameter with 6 x 36 construction and a fibre rope core. Whilst deformed in places (in line with use in a U-type and basket type lifts), the wire rope was found undamaged and free of breaks.

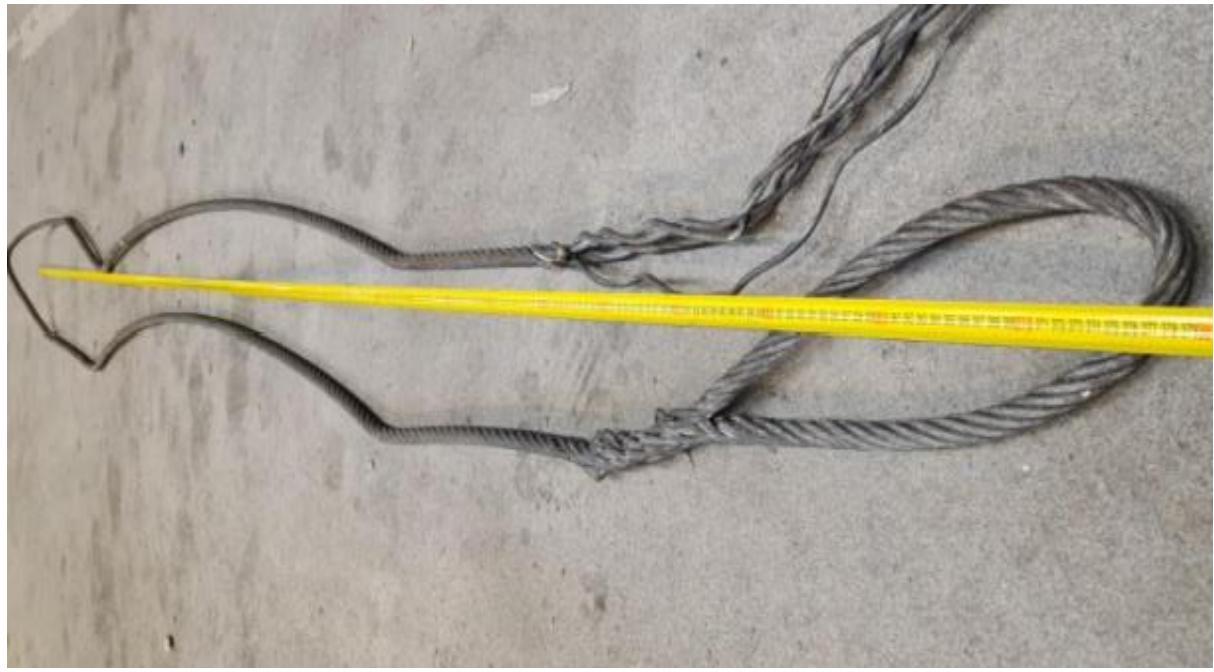
Figure 8. Recovered failed sling

The EN standard specifies the number of tucks required in a splice. For each strand, the splice shall have five load carrying tucks. At least three of the load carrying tucks shall be made with the whole strand, remainder should be made with strands comprising at least 50% of the wires. The wire rope examined did not meet any of the specified requirements:

- The splice examined comprised of 3 partial tucks and measured 20cm (figure 6). The standard minimum length for a splice with 5 tucks is 30cm (figure 7).
- All load carrying tucks inspected were made under one strand. Typically load carrying tucks are made under several strands

Some of the spliced strands' tail ends did not protrude from the splice, which indicated that the splice had begun to slip under load.

The recovered wire sling had been tampered with to such an extent that it proved difficult to determine the exact length that was originally used for the eye splice or at what point the working end of the wire was intersected with the dead ends of the wire strands.

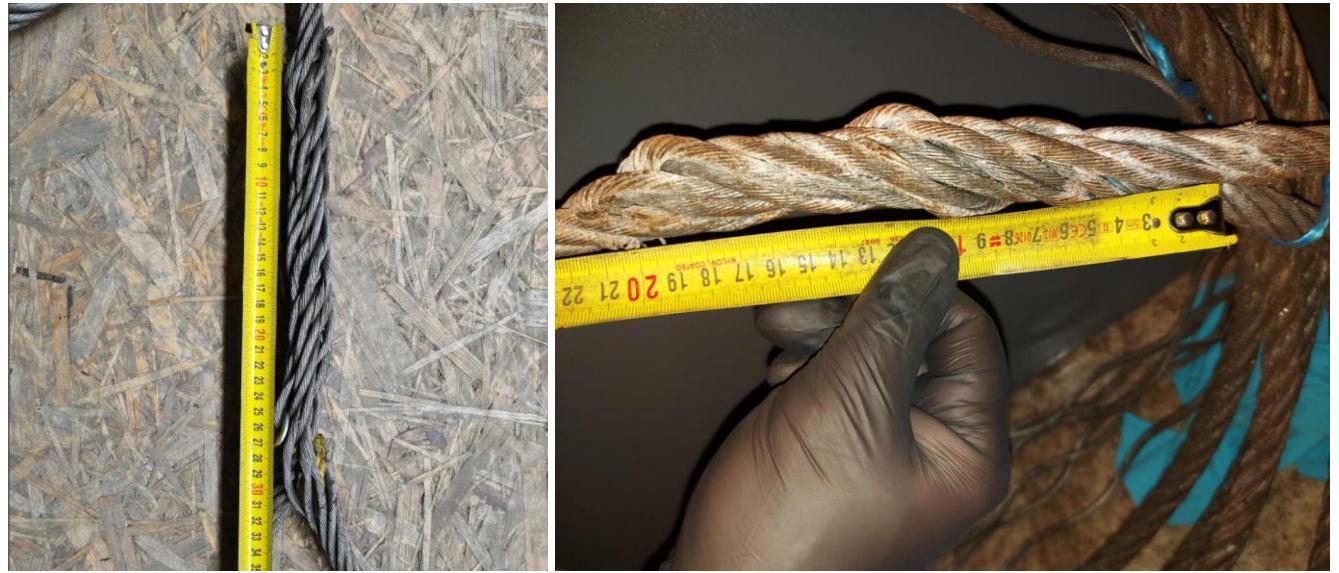
Figure 9. Correctly spliced wire with 5 tucks

Figure 10. Sling's splice with 3 tucks

- The wire sling failed because the eye splice comprised of 3 partial tucks and not the full 5 tucks as required by the standard. It was also noted that the load carrying tucks were made under one strand, and not under several strands

• Implement a system to ensure that only strops and wire slings that are load tested and certificated are carried onboard.

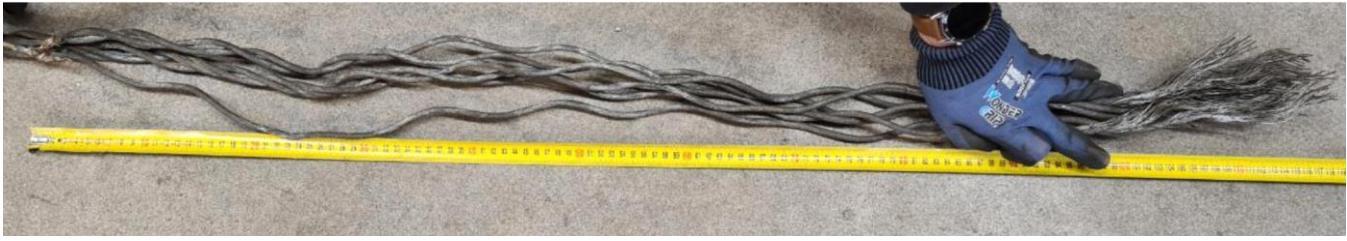
Figure 11. Diverged strands

For the free end, the strands diverged approximately 110cm from the bitter end, the length of the strands were equal and were free of breaks. The fibre core was removed at the point where the diverged strands met. On the basis of these observations, it was determined that the spice had pulled out under load. Certex estimated that when spliced, the sling would have a length of 7.5m – in line with shipboard records.
