## **Bahamas** Maritime Authority

# Marine Safety Investigation Report

into a crush incident onboard Dole Chile with the loss of one life on 19 March 2022

Date of Issue: 07 November 2022 Bahamas Maritime Authority 120 Old Broad Street LONDON EC2N 1AR United Kingdom

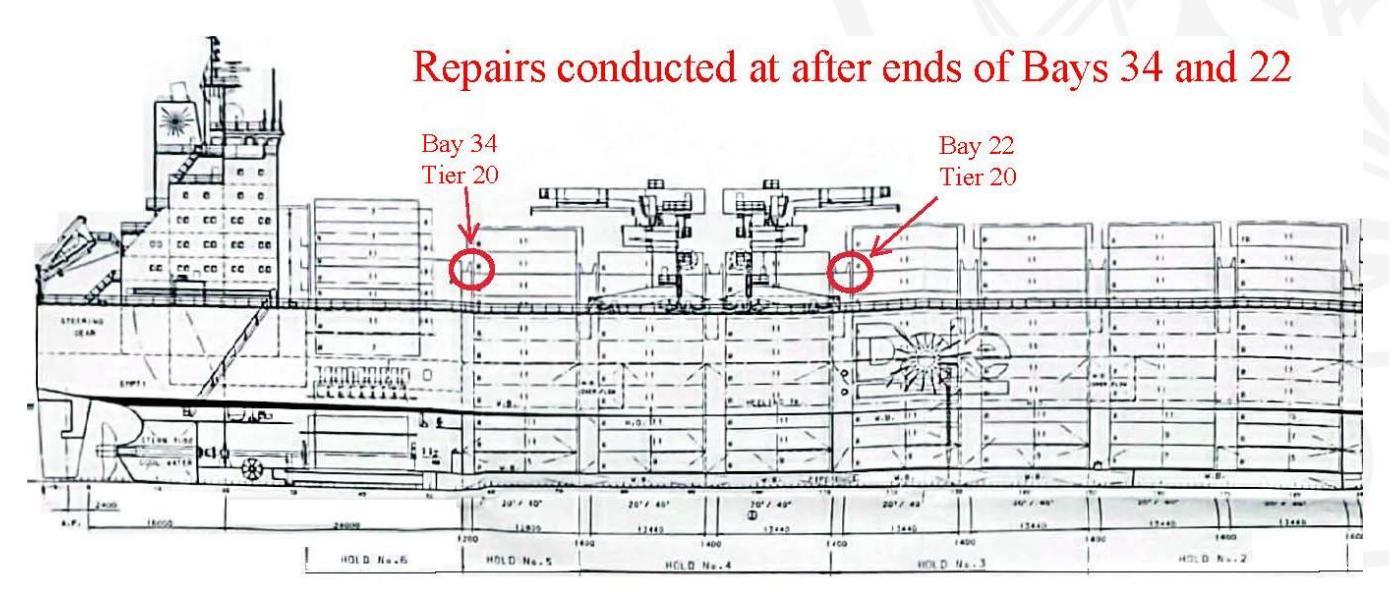
General arrangement showing locations of repairs to stoppers

For the call in Santa Marta, it was intended to replace damaged stoppers on the port side (aft) of bay 22 (rows 06, 08 and 10) and on the starboard side (aft) of bay 34 (row 09). The work was considered crucial as full stacks of laden containers were scheduled to be loaded in these locations during the port call - the stoppers would be required to keep weight loading on the tanktop within allowable limits.

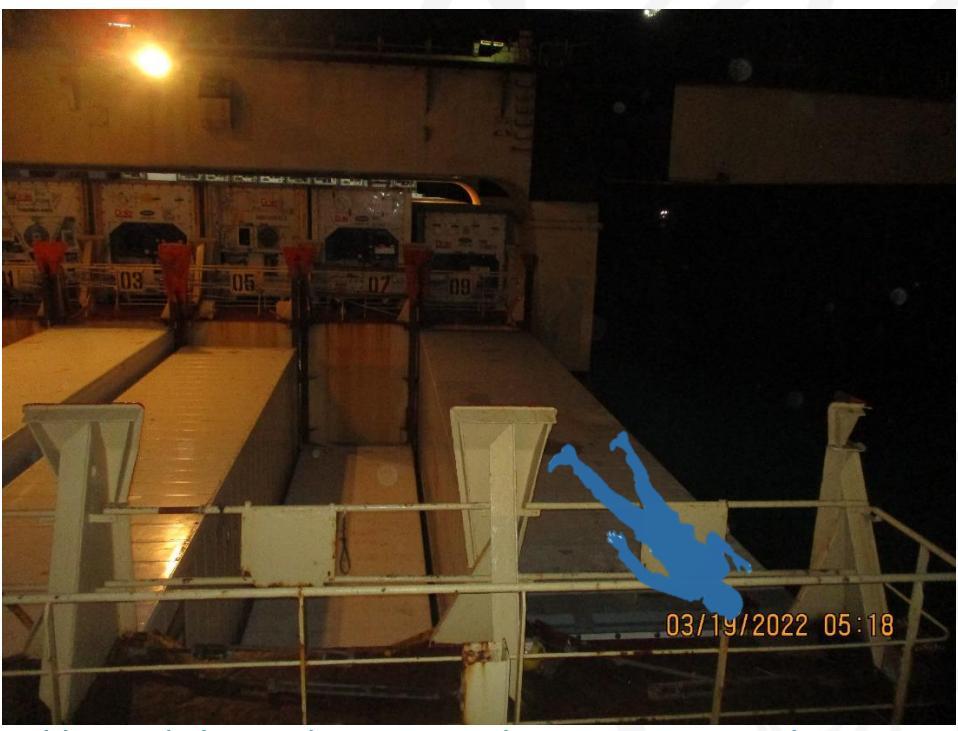
Scene examination and recreation suggests that the victim was hit by the outboard edge of the container spreader's girder as it was lowered when the victim was kneeling on top of container 340918 and facing aft. The presence of a slag removal hammer and the location of his welding equipment suggests he was inspecting his work or removing slag from welds.

Position of victim, as discovered by first responders (looking forward)

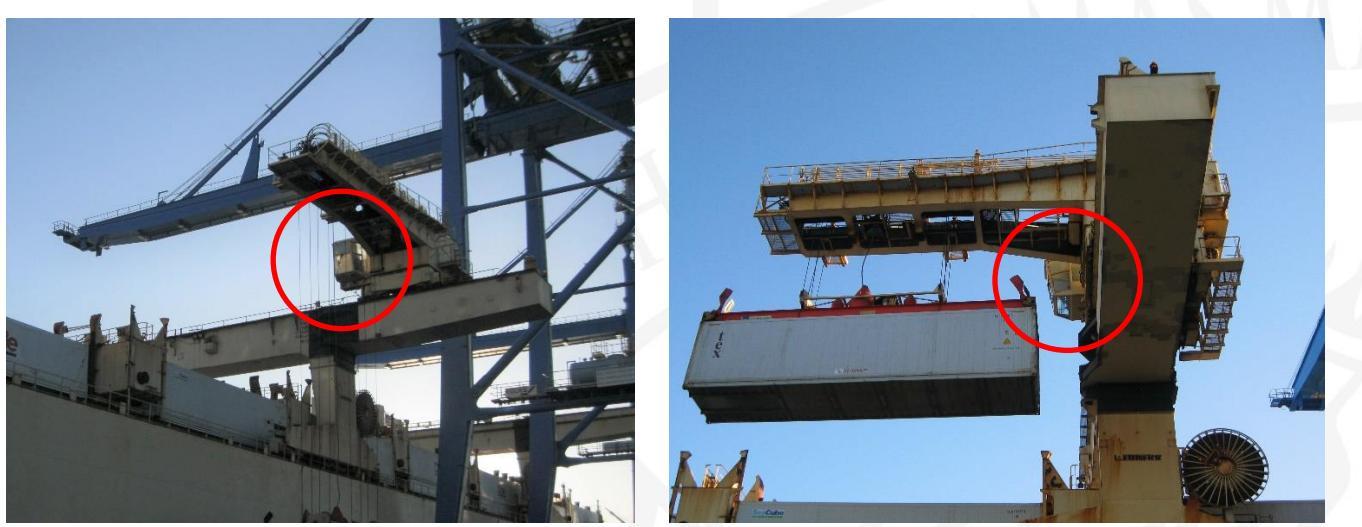
Views of aft gantry crane showing offset cab (looking from starboard)

The offset meant that the crane operator's view of the two rows to starboard of the cab was obscured. At the time of the casualty, the vessel was port side alongside, and the location where the victim was working would have been obscured when the spreader passed an area from Row 05 outboard as the gantry approached Row 09.

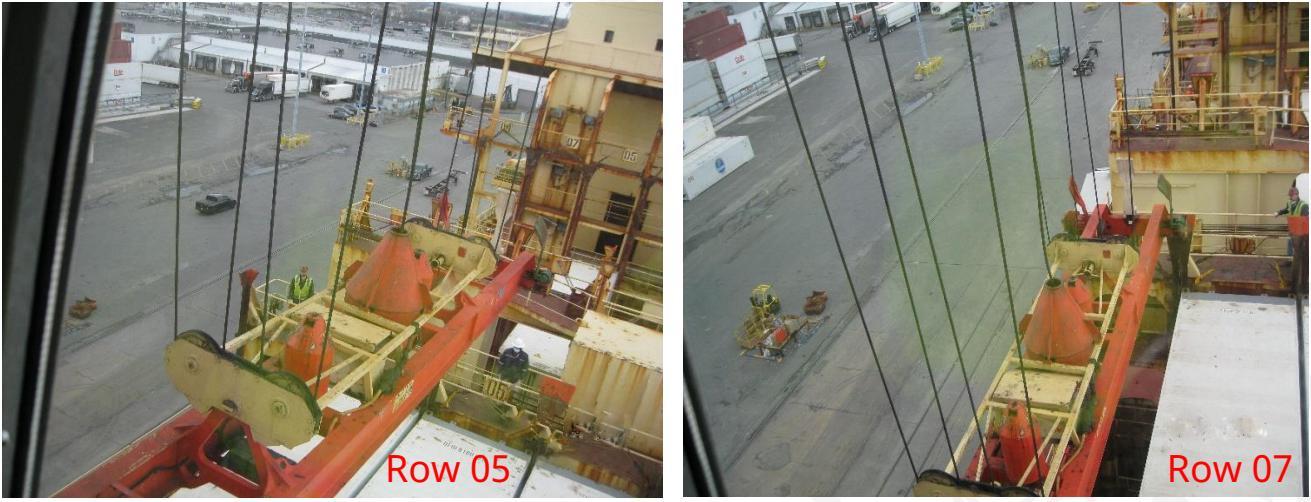
View from cab approaching, and at, location of casualty

At the time of the casualty there was no hatchman at bay 34. The gantry crane operator stated that he saw sparks at the after end of bay 34 and knew that work was being done but, after seeing no sparks for a period of time, assumed that the work had finished.

- Ensure that effective oversight is provided at all hatches when cargo is being worked.
- Establish effective communication procedures between ship and terminal to facilitate repairs or maintenance of vessels moored at their berths. This should include agreement on the precautions to complete the work safely.
