### **Bahamas** Maritime Authority

# Marine Safety Investigation Report

into the failure of a condemned fire extinguisher during decommissioning resulting in the loss of a life on 06 June 2022

Date of Issue: 27 June 2023 Bahamas Maritime Authority 120 Old Broad Street LONDON EC2N 1AR United Kingdom

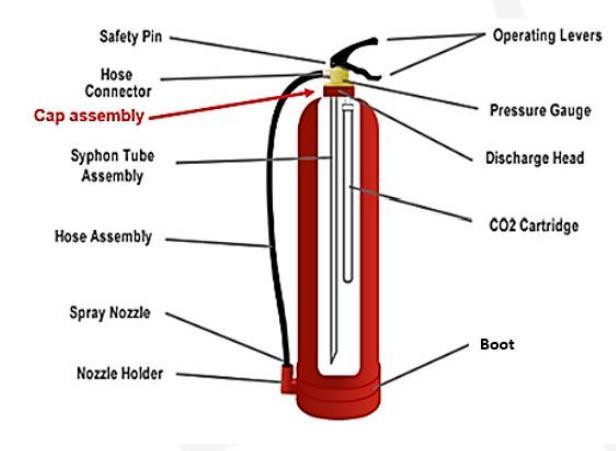
Figure 1. Diagram of extinguisher showing cap assembly

At approximately 11:00, second officer A, managed to loosen the cap assembly from one of the foam extinguishers using a wrench, followed by removal of the CO<sub>2</sub> cartridge and emptying the cylinder of foam solution.

However, the cap assembly on the second foam extinguisher proved difficult to remove and after several attempts, so second officer A informed second officer B, that it was best to depress the lever, and empty the contents out over some waste rags in the garbage locker, before transferring to the skip (Figure 2).

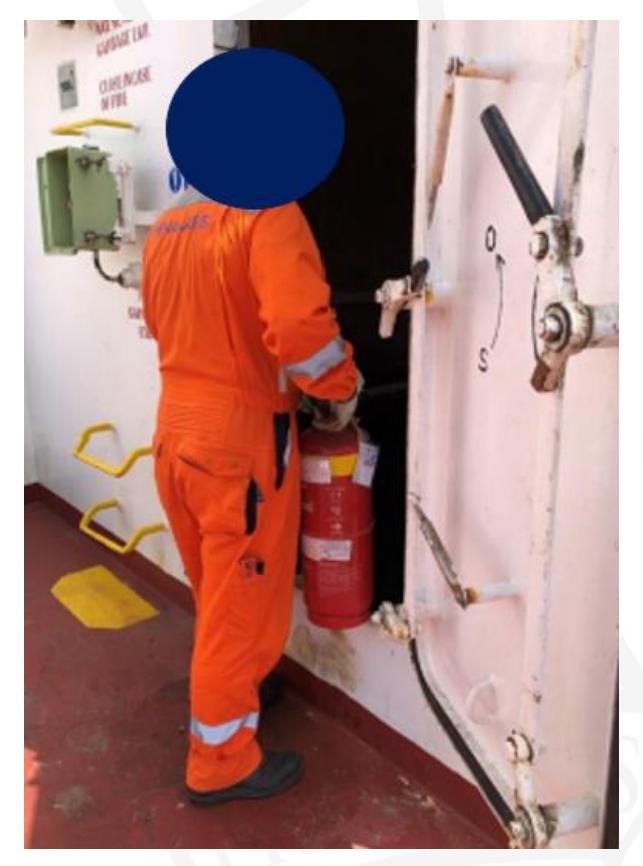
Figure 2. Position prior to depressing the extinguisher lever (reconstruction)

At 11:25 second officer A aimed the nozzle into the locker and upon pressing the lever for the first time, some water and foam solution trickled out. When he pressed the trigger a second time the extinguisher ruptured at the base, propelling the extinguisher up and into his chest (Figure 3).

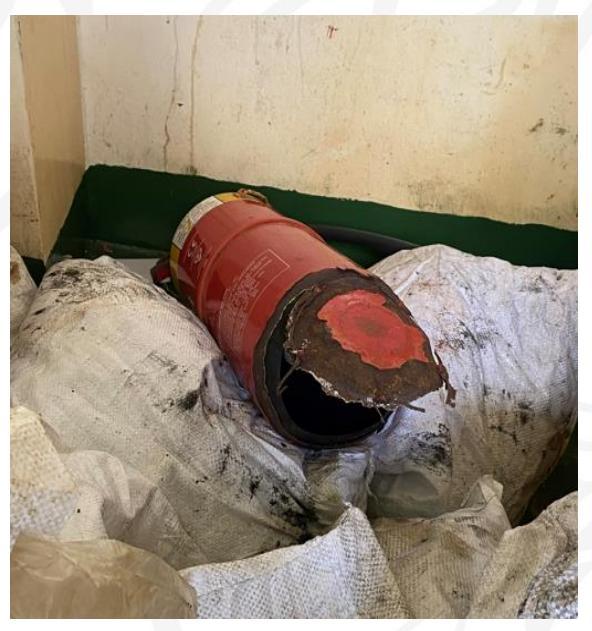
Figure 4. Ruptured foam extinguisher

The fire extinguisher failed following the release of carbon dioxide, when the handle was depressed, causing the base to rupture due to severe corrosion, propelling it upwards.

During this time the ship yard's emergency room doctor in Eleusis had been called but was attending to an ongoing incident nearby. At 12:00 an ambulance arrived at the entrance to the main gate, and was directed to the vessel, whilst at the same time, representatives from the Hellenic Bureau for Marine Casualties Investigation arrived on board, followed by two local Hellenic Coast Guard inspectors who seized the ruptured fire extinguisher from the garbage locker (Figure 4).

A second officer sustained fatal injuries when the condemned fire extinguisher he was operating failed due to corrosion at the base weld seam.

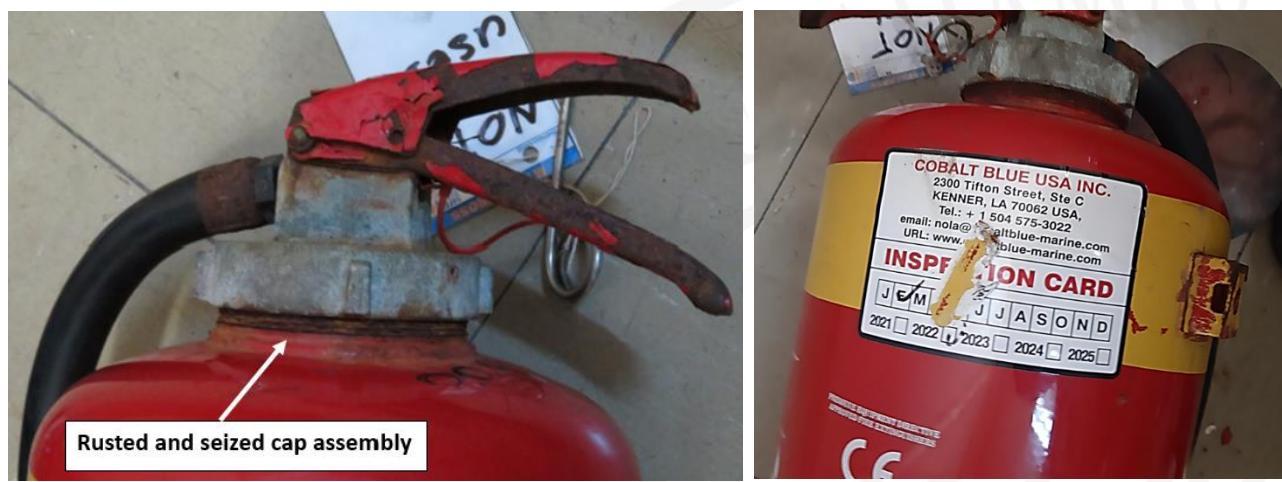
Figure 5. Level of corrosion on ruptured foam extinguisher that had been inspected by Cobalt Blue

The lifespan of a powder, foam or water extinguisher is usually between 10 and 12 years. This is based on the extinguisher being in good condition with no corrosion or damage. Fire extinguishers that show signs of damage or corrosion are more likely to pose a significant risk when operated. At the time of the casualty the foam fire extinguisher was 17 years old.

Of the 48 portable foam fire extinguishers that were inspected 18 February 2022, 3 were removed from service and declared condemned by the ship's deck officers during planned maintenance inspections on 02 March 2022. In total, 8 of the fire extinguishers inspected on 02 March 2022, were condemned and removed from service by the ships deck officers due to observed corrosion or other visible defect.

An opportunity was missed by the approved contractor to fail and remove the 8 severely corroded/damaged fire extinguishers, when they were presented for annual inspection. The failure to make recommendations to discard damaged or condemned fire extinguishers was a contributory factor.

• Review its internal policy and guidelines with respect to IMO Resolution A.951(23) where extinguishers undergoing annual inspection, showing signs of corrosion, dents or damage are to be condemned.
