**The Bahamas  
Maritime Authority**

**M.v. Carnival Inspiration**

**Report of the marine safety investigation into the  
disappearance of a crew member off the coast of  
Southern California on 9<sup>th</sup> November 2017**

## M.v. Carnival Inspiration – Marine Safety Investigation Report

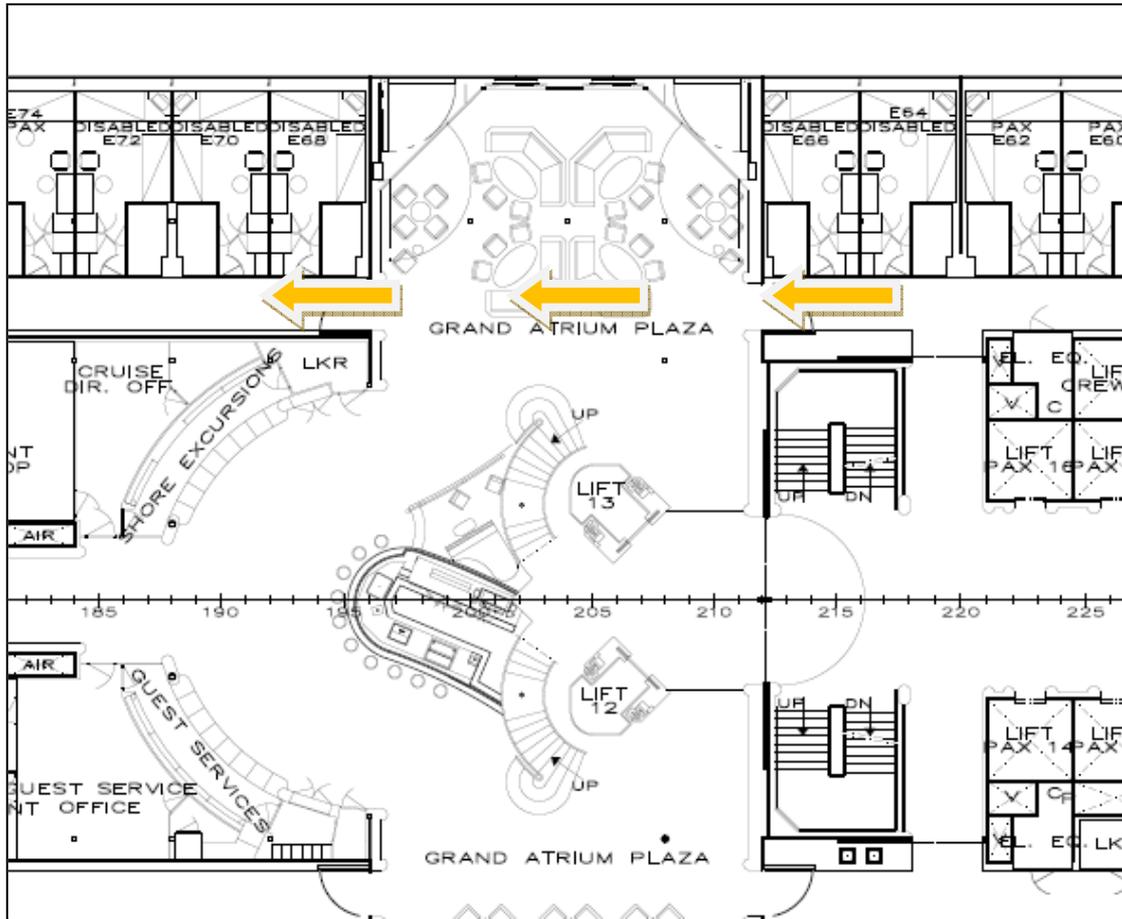
- 3.22 A review of internal CCTV cameras revealed the crew member leaving the crew smoking area outside the crew bar at 07:00 hours and passing through the Deck 7 Atrium lobby at 07:05 hours on 9<sup>th</sup> November.

**Figure 1: Route followed by the crew member seen on CCTV on 9<sup>th</sup> November at 07:05 hours, passing aft along the port side through the Atrium lobby on Deck 7**

- 5.1 The crew member was last seen on CCTV passing through the Deck 7 Atrium. To access an external deck area he would be visible on CCTV cameras. These were reviewed by ships security personnel confirming that he did not appear on any external deck on 9<sup>th</sup> November.

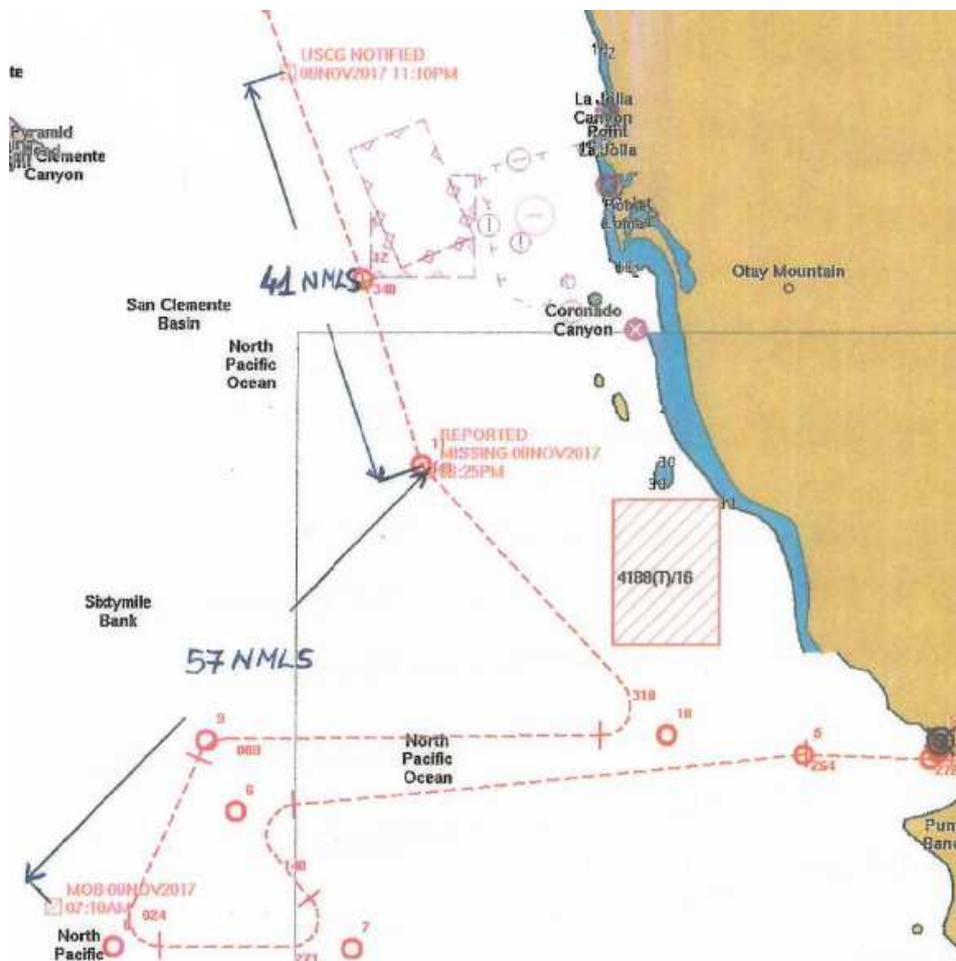
4.1 The vessel’s transit from Ensenada to Long Beach on 9<sup>th</sup> November was as follows:

Figure 2: Route from Ensenada to Long Beach, California

- 4.6 The vessel was slow steaming from Ensenada to Long Beach, the arrival was timed for 04:30 hours on 10<sup>th</sup> November and speeds ranged from 7-10 knots. A man overboard is expected to have been clearly visible at this relatively slow speed and favourable weather condition.

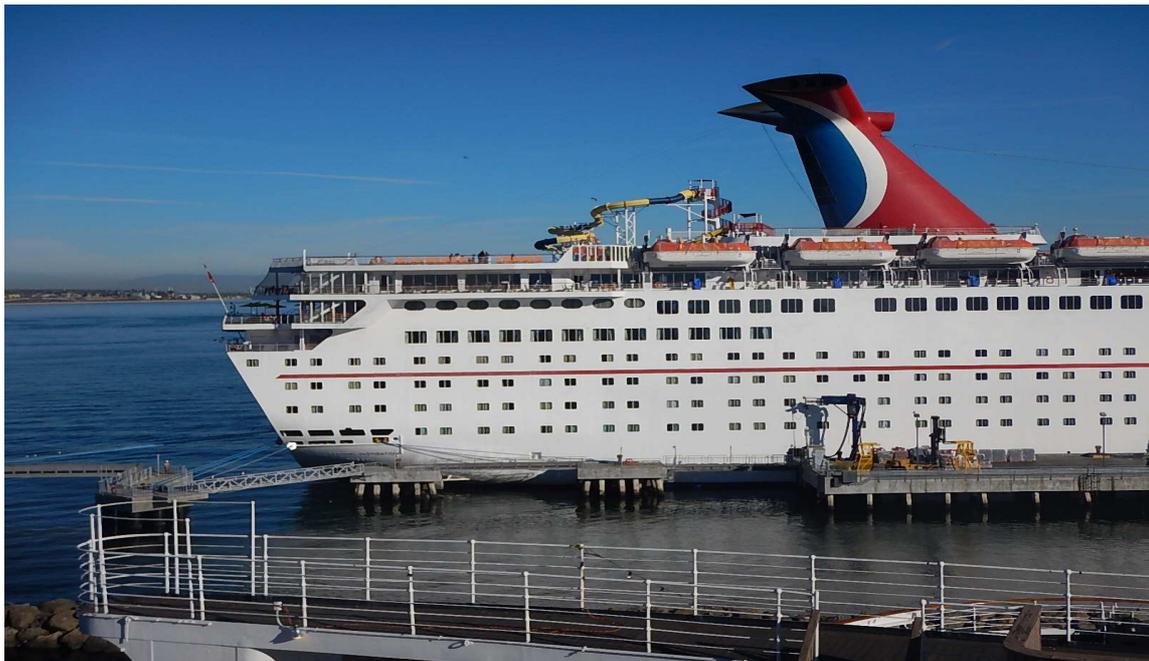
Figure 5: Starboard side view at the berth in Long Beach, California

- 5.3 For a crew member to disembark the vessel via a crew gangway requires the individual to scan their crew member identification card and pass through a security checkpoint. At the Long Beach terminal the fender aft affords an easy route to leave the vessel undetected by climbing down from the mooring deck thus avoid passing through a security checkpoint if intended.

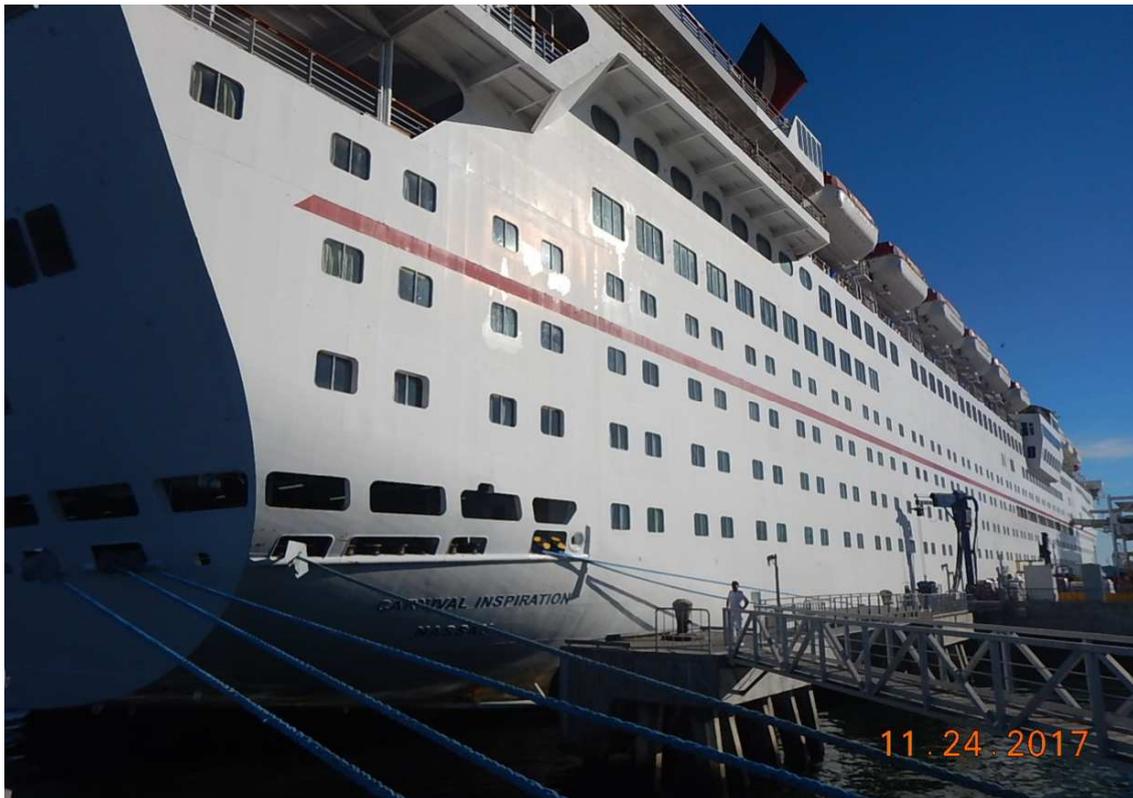
Figure 6: Starboard quarter view at the berth at Long Beach, California

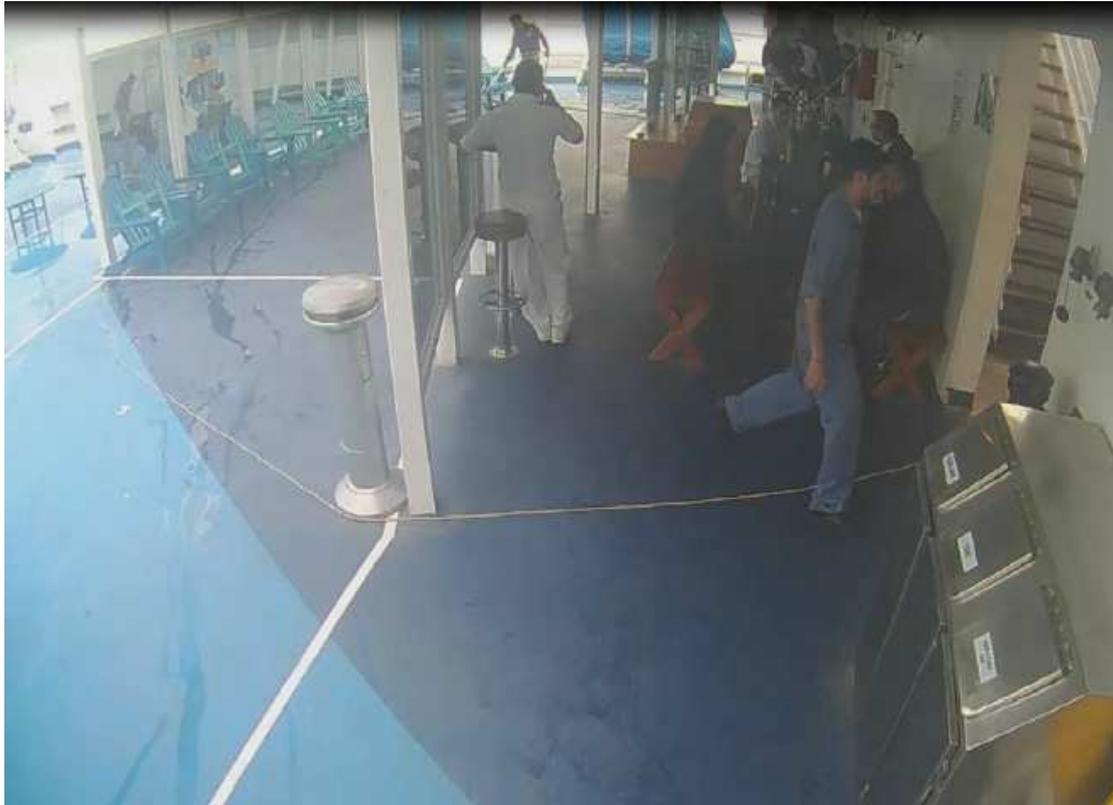
1. Crew member leaving the crew smoking area at 07:00 hours November 9<sup>th</sup>

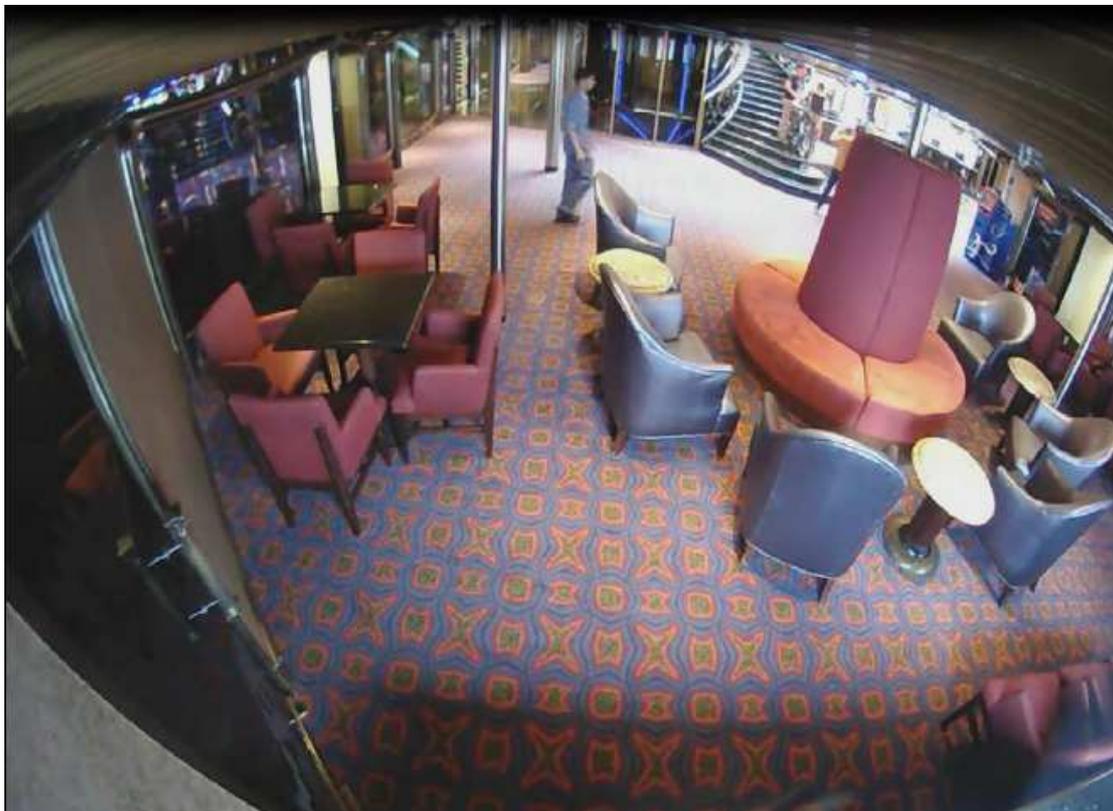
2. Crew member transiting the Atrium at Deck 7 walking aft on the port side

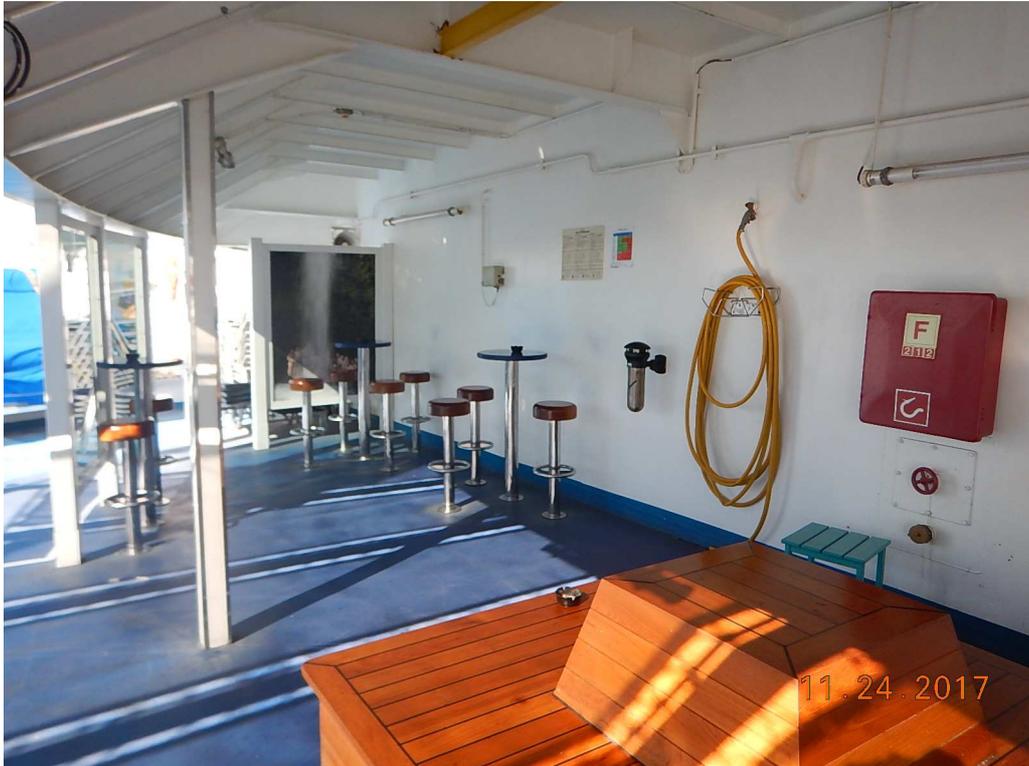
**1. Location of smoking area at crew bar forward**

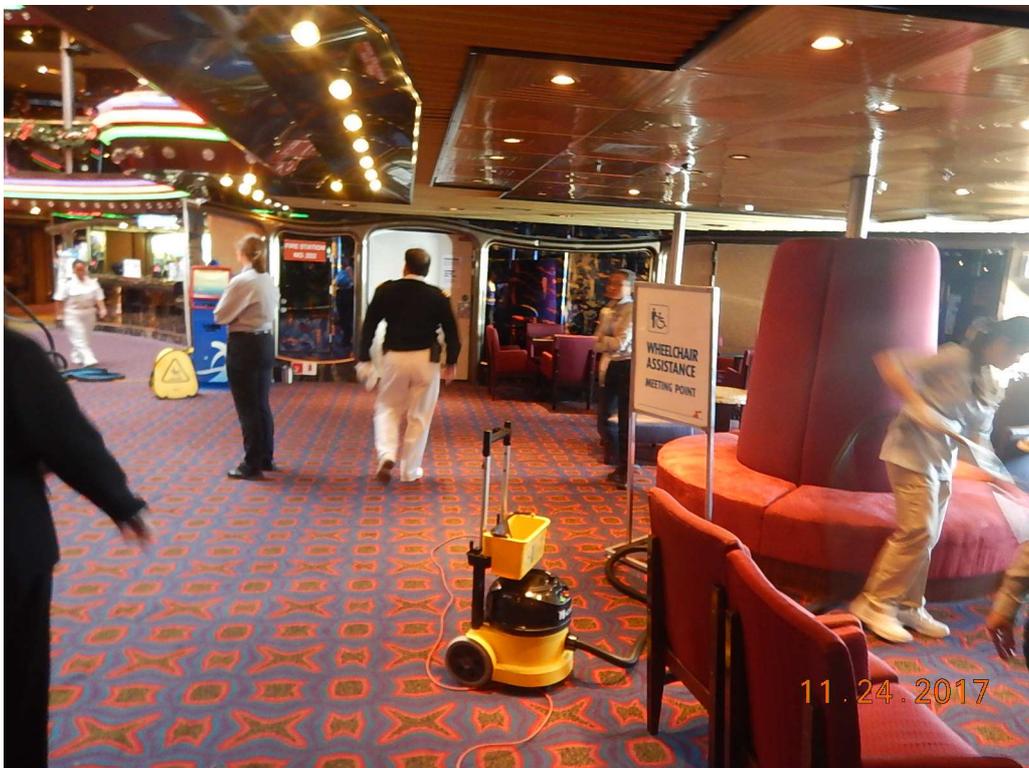
**2. Route followed by crew member through Deck 7 Atrium lobby**

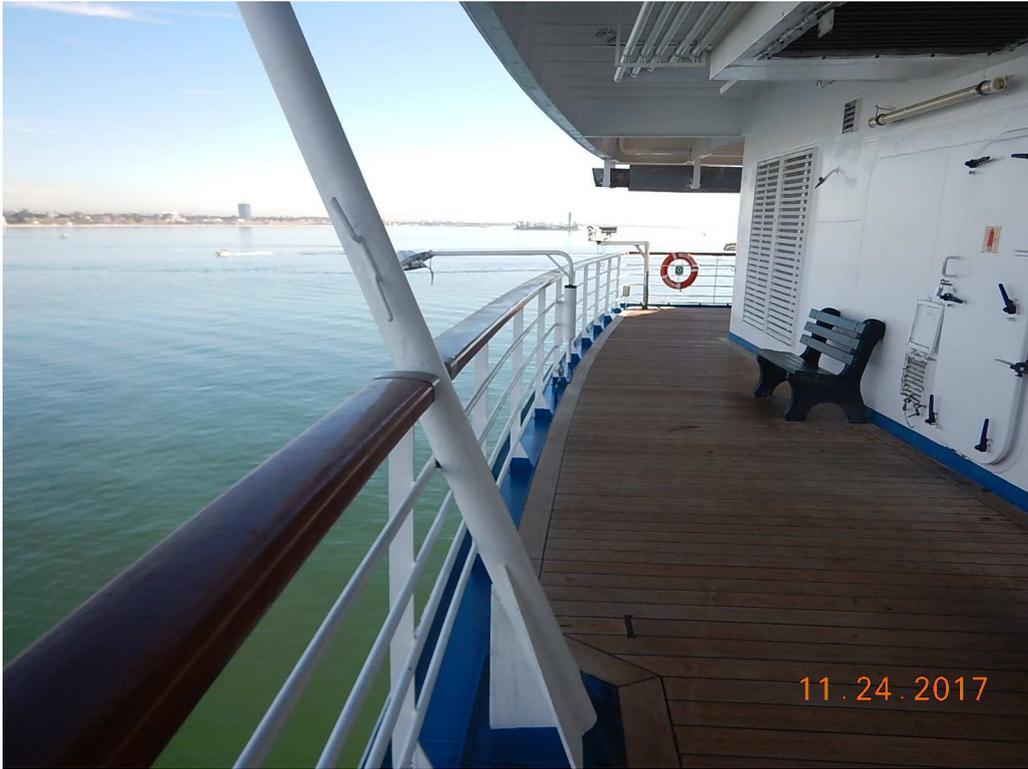
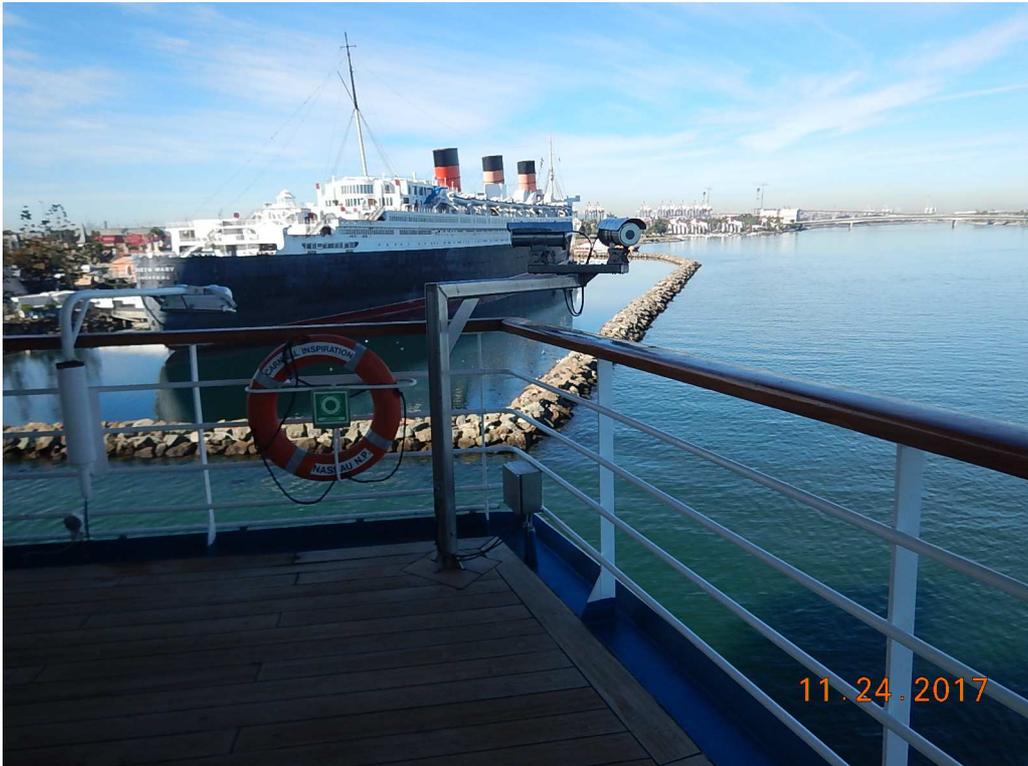
3. External areas port/starboard and aft at Deck 8 has 100% CCTV coverage

- 4.4 The entire exterior of the vessel is covered by infrared MOB cameras, these were reviewed by the watch officer and by the vessel's Captain and did not reveal any sightings of the crew member on 9<sup>th</sup> November.

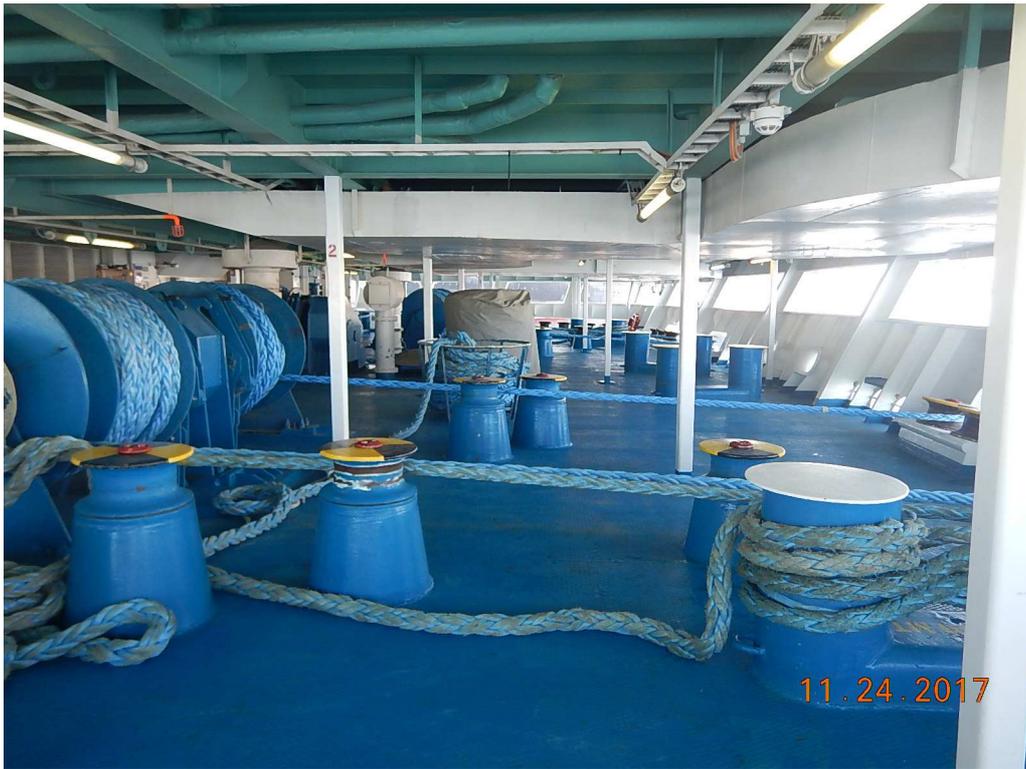
4. Aft mooring deck is CCTV covered

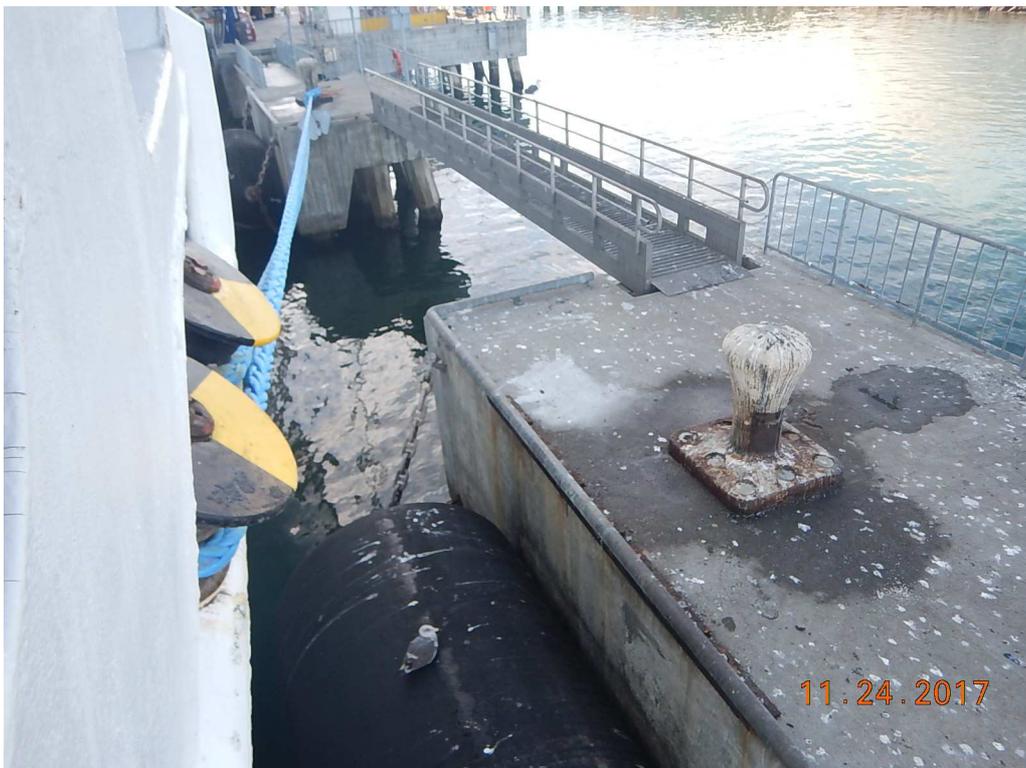
5. Aft mooring deck and stern fender at Long Beach, California

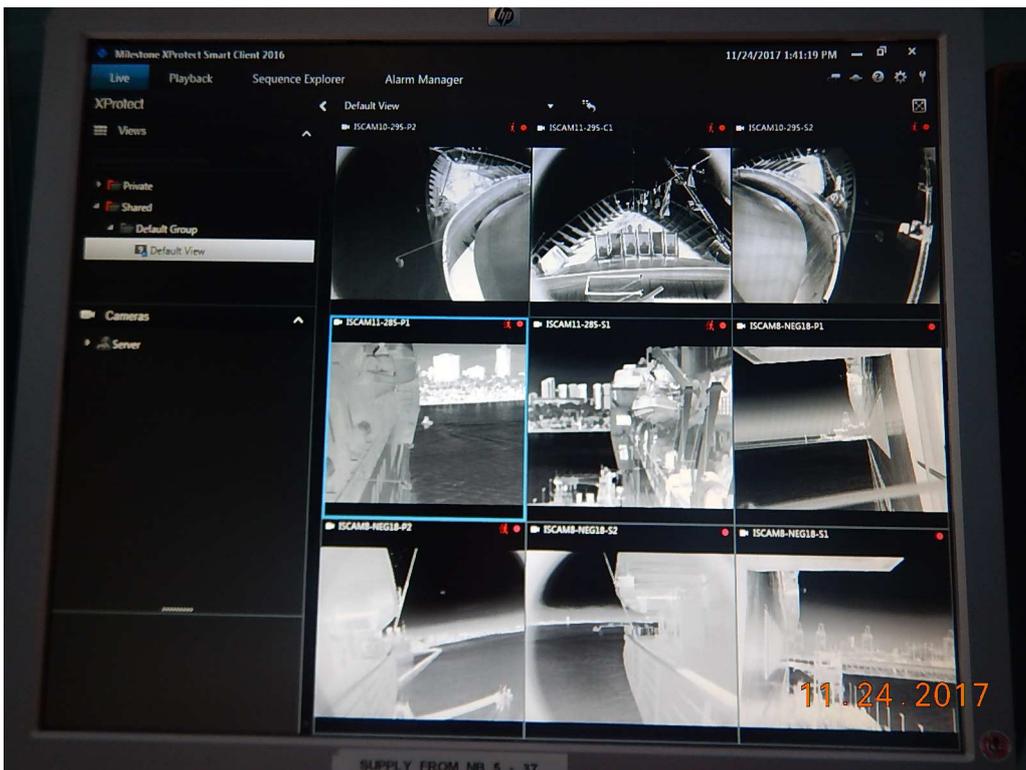
7. Man overboard camera display at the wheelhouse

- 4.5 To determine whether MOB cameras have shadow sectors or gaps in coverage, the Captain arranged for a crew member to test the systems effectiveness outside of the vessel – the cameras do not have any shadow or blind sectors. Camera clarity is such that the Captain reported seagulls were visible on the seas around the vessel.
