**KAREN DANIELSEN**  
**Collision with the Great Belt West Bridge**  
**3 March 2005**

The joint Bahamas Maritime Authorities & Danish  
Division for Investigation of Maritime Accidents report

**The casualty report was issued on 17 August 2005.**

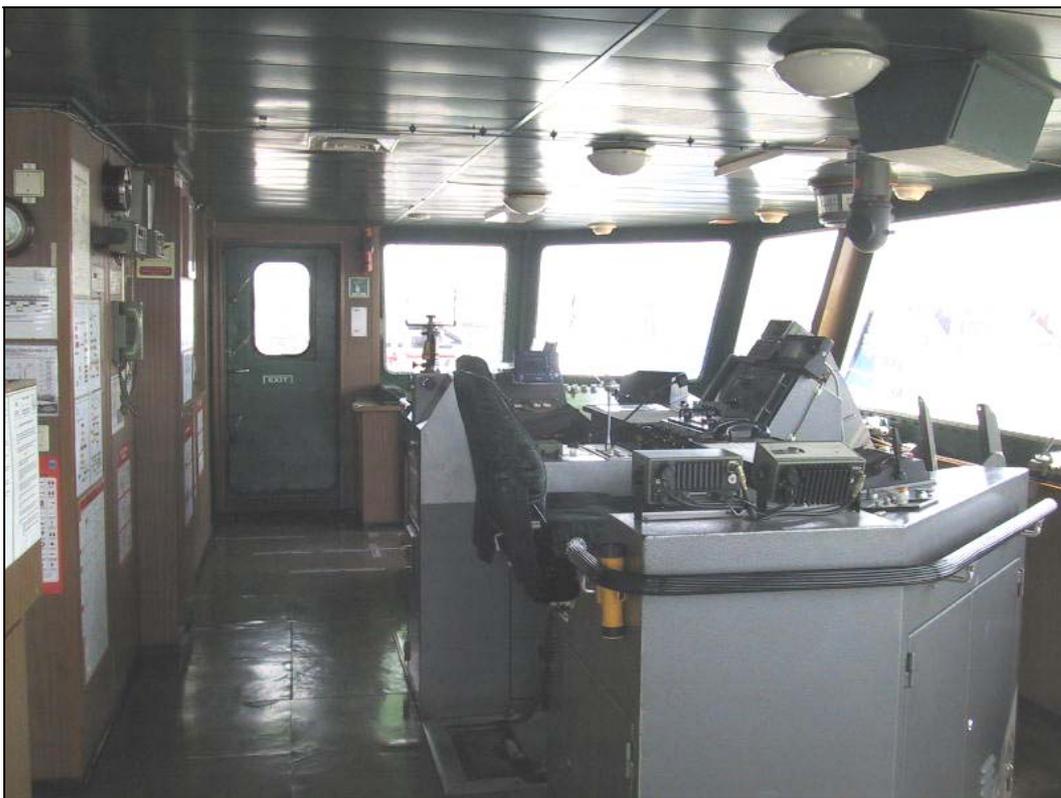
During the examination of the wheelhouse wreckage the day after the collision, it was found that the chief officer was sitting in the portside seat of the wheelhouse when the collision occurred.

*KAREN DANIELSEN wheelhouse, photographed from starboard to port side.*

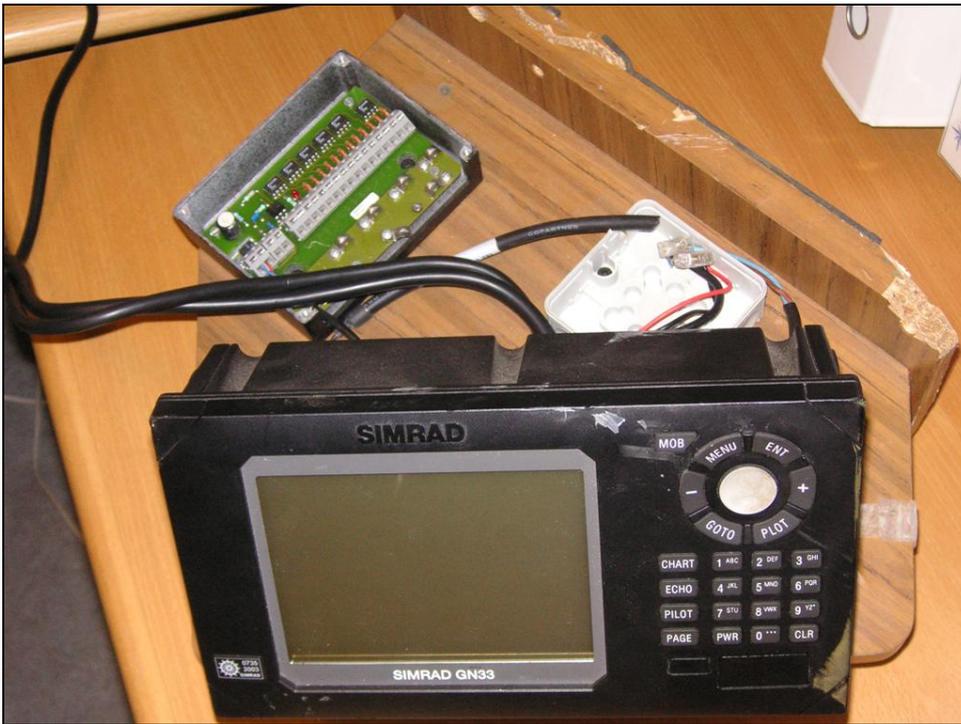
*SIMRAD GN33 GPS Navigator*

Detailed route information for the voyage in question was, however, stored in the GPS Navigator, which was found in the remains of the destroyed wheelhouse. The GPS Navigator proved to be fully operational.

The manufacture, SIMRAD AS, advised that the GPS Navigator was installed on the ship on 3 March, 2003 and that the GPS antenna was an ordinary "GPS 4" antenna without differential features. The GPS equipment had a position accuracy of approx. 15 meters. The antenna was placed on top of the after part of the wheelhouse on the starboard side, above the GPS Navigator.

The GPS Navigator was examined and tested by the investigators in co-operation with the manufactures technicians in their service department.
