**The Bahamas
Maritime Authority**

Norbe VIII

**Report of the marine safety investigation into a
boiler explosion leading to three fatalities on a
drill ship on 09 June 2017**

Date of Issue: 18 March 2020
Bahamas Maritime Authority
120 Old Broad Street
LONDON
EC2N 1AR
United Kingdom

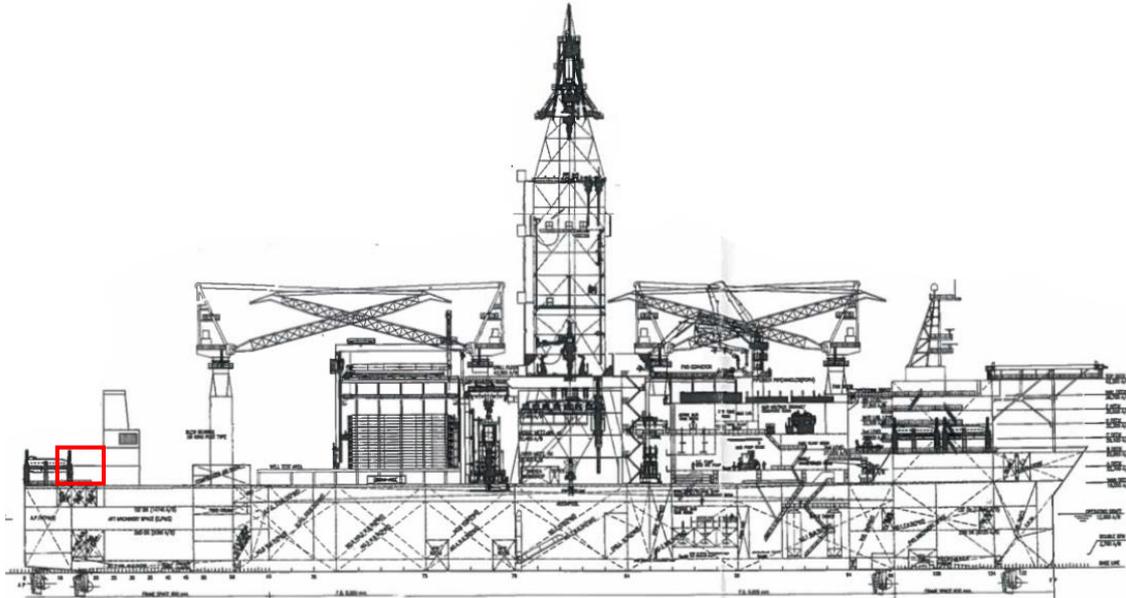
Figure 1: Norbe VIII general arrangement, auxiliary boiler room in red

The vessel's two auxiliary boilers were model PA 0201P32, manufactured by KangRim Heavy Industries. Co. Ltd of South Korea, in 2008. The boilers were solely used for well test operations and were not considered to be part of the vessel's machinery by the vessel's Classification Society, DNV GL. The auxiliary boiler room was located at the stern of the vessel, on main deck level (marked in red, on figure 1).

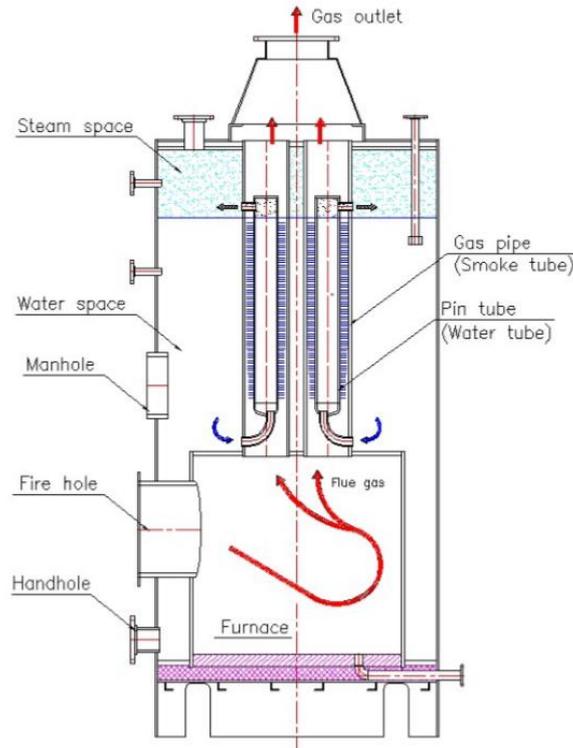
The boilers were divided into two chambers, the water chamber where superheated water¹ is stored and converted to steam and the furnace where diesel is burned to create exhaust gas. Heat exchangers (with water on the cold side and exhaust gas on the hot side) are used for steam generation.

Figure 2: Boiler cross-section
