**The Bahamas
Maritime Authority**

**M.v. Baltic Ace
IMO Number 9386213
Official Number 8001370**

**Report of the investigation into the loss of m.v Baltic
Ace following a collision with m.v Corvus J at the
North Hinder Junction Precautionary Area on the 5th
December 2012**

Date of Issue: 27th May 2016
Bahamas Maritime Authority
120 Old Broad Street
LONDON
EC2N 1AR
United Kingdom

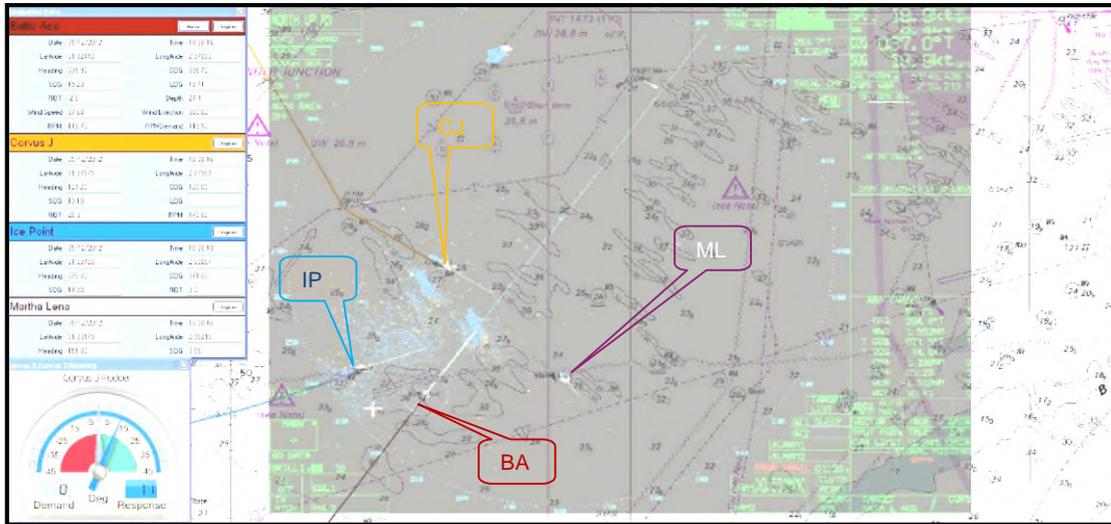
Figure 7: Position of vessels at 18:08:16

- 3.5.3 The OOW had identified the Corvus J and acquired the vessel on ARPA at approximately 12nm and later visually by the sight of her masthead lights. The first acknowledgement by the OOW onboard the Baltic Ace as to the CPA and the developing situation with the Corvus J came at 18:08:45, when the OOW was heard to say on the bridge audio recorder “*it’s close, 5 cables before my bow*”.
- 3.5.4 Having recognised that a close quarters situation was developing with the Corvus J, at 18:09:31 the Baltic Ace called the Corvus J on VHF CH 16 to establish a working channel. Whilst the OOW on board Baltic Ace establishes communication, the Corvus J commenced an alteration of course to starboard from 129° to 152° in what is believed to be in accordance with the vessel’s passage plan.

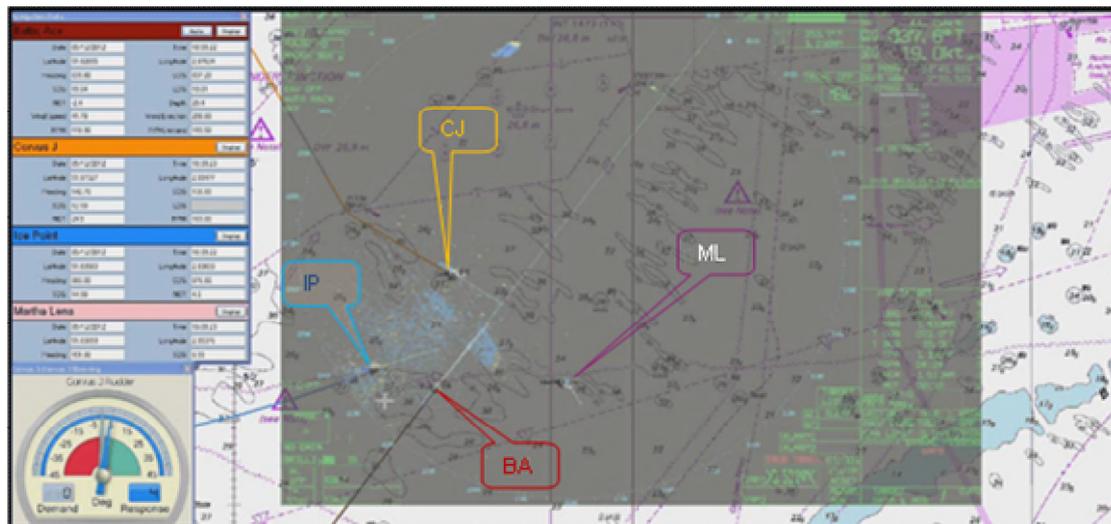
Figure 8: Position of vessels at 18:09:22

3.5.5 Both vessels agreed to communicate on VHF working channel 06 (this channel was used as the working channel between the two vessels for all further communications). At 18:09:40 the Baltic Ace OOW requested the Corvus J to maintain course “*So I see that you pass my bow very close so keep your course and I alter my course a little to port, OK, I alter to port*”, Corvus J agrees to the solution “*Yeah OK, because I am departing behind one vessel after you go behind me, OK thank you very much*”. The final acknowledgement between the two vessels as to the intended close quarters avoidance was confirmed by the OOW of the Baltic Ace stating “*Yeah I see, I alter to port, OK thank you, back to 16*”.

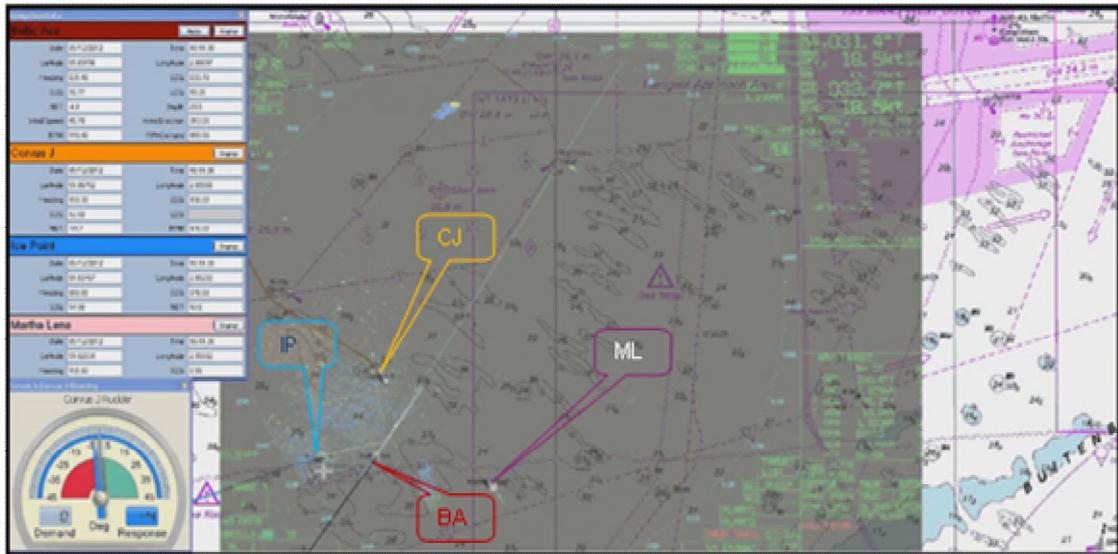
Figure 9: Position of vessels at 18:11:30

3.5.6 Between 18:09:40 and 18:11:28 the Baltic Ace altered course to port by 2° from 037° to 035° and maintained a speed of 18.5kts. Over the same period, the Corvus J commenced altering to a new course of 152° and maintained a speed of 12.5kts having altered from 129° at 18:09:55.

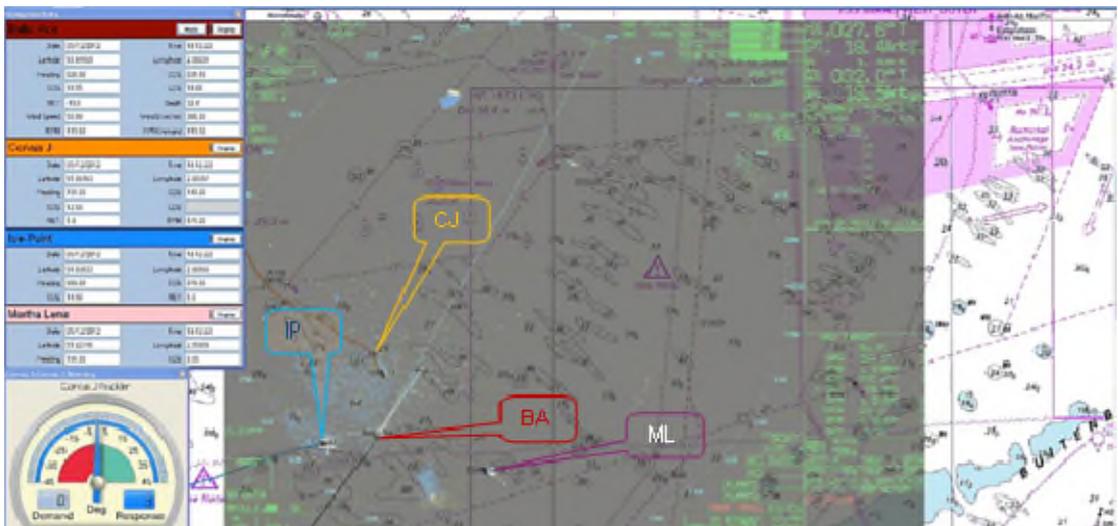
Figure 10: Position of vessels at 18:12:22

3.5.7 At 18:11:28, the Baltic Ace called the Corvus J having detected the alteration of heading by the Corvus J soon after the first VHF conversation. The call was to seek clarification about the change in course and was recorded as follows: Baltic Ace OOW asks “*So I see you alter your course to starboard now yes?*” Corvus J explains with the following: “*Yes just now, I will keep the course, because another vessel crossing my stern, she is going there behind me. If possible you change a little bit to port after we be fine*” Baltic Ace OOW acknowledges and agrees to come further to port “*OK I go more to port OK*”.

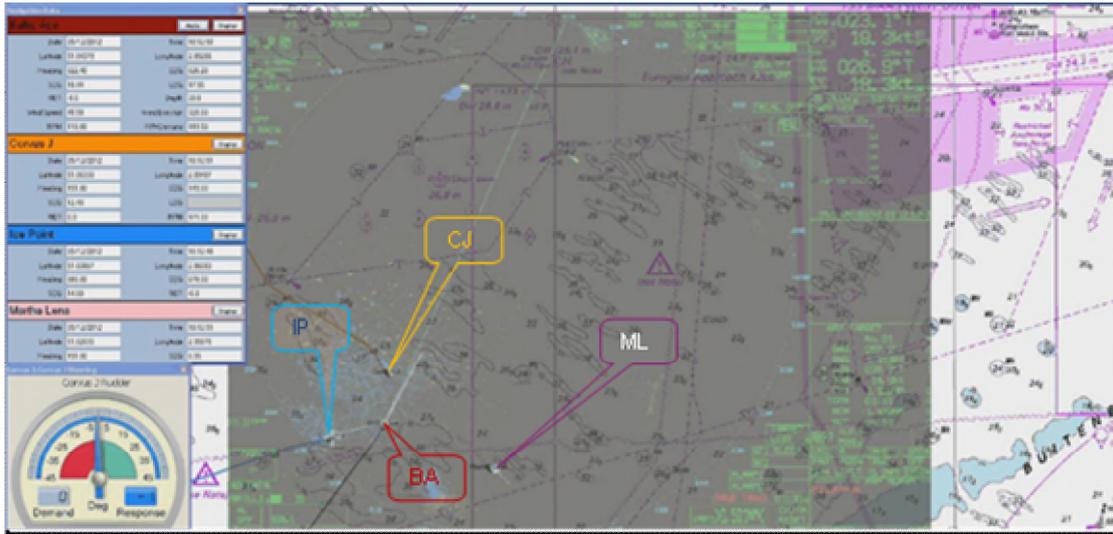
Figure 11: Position of vessels at 18:12:50

3.5.8 Between 18:11:28 and 18:12:27 the Baltic Ace altered 4° to port whilst the Corvus J maintained its course and speed. At 18:13:18 the Corvus J attempts to make VHF contact with the Baltic Ace, however, due to a conversation taking place on the bridge of the Baltic Ace at the time, the OOW did not respond to the Corvus J. The Corvus J repeats the transmission and successfully establishes communications with the OOW and asks the Baltic Ace “*you keep your course like that*”, the Baltic Ace replies “*yes I keep like that*”.

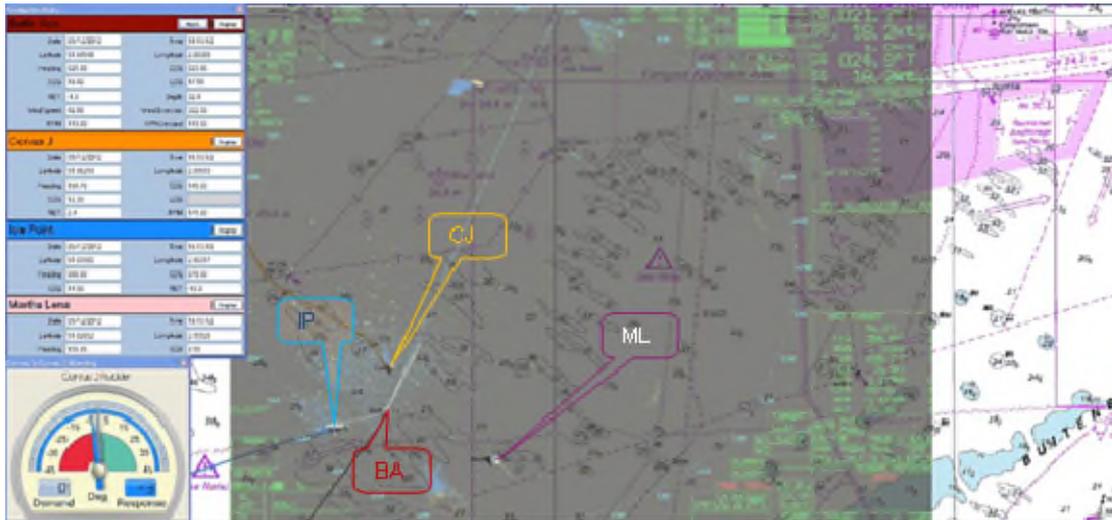
Figure 12: Position of vessels at 18:13:12

3.5.9 At 18:13:26 the Baltic Ace began an alteration of course to port, starting at 021° and by 18:14:40 had reached a heading of 010°. In the same period the Corvus J commenced a turn to starboard using 15° of rudder, from 152° to 207° which was the recorded heading at the time of impact. No reduction in speed was evident on either vessel as the distance between the two vessels closed at a speed of 31kts.

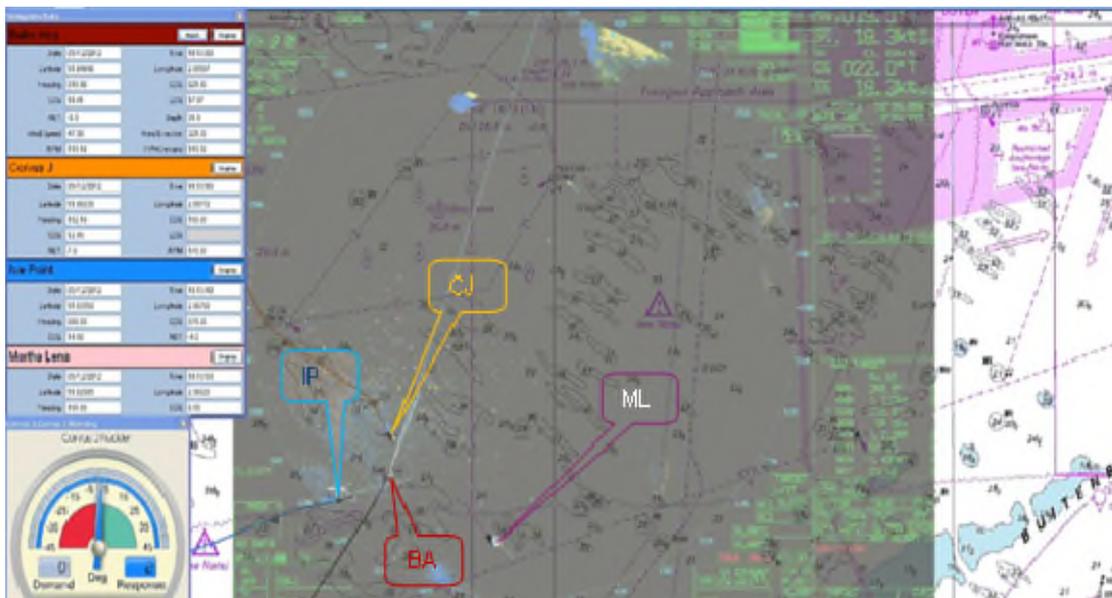
Figure 13: Position of vessels at 18:13:50

3.5.11 At 18:14:18 the OOW on the Baltic Ace stated that the crossing distance between the two vessels was now 2 cables ahead. At this point both vessels

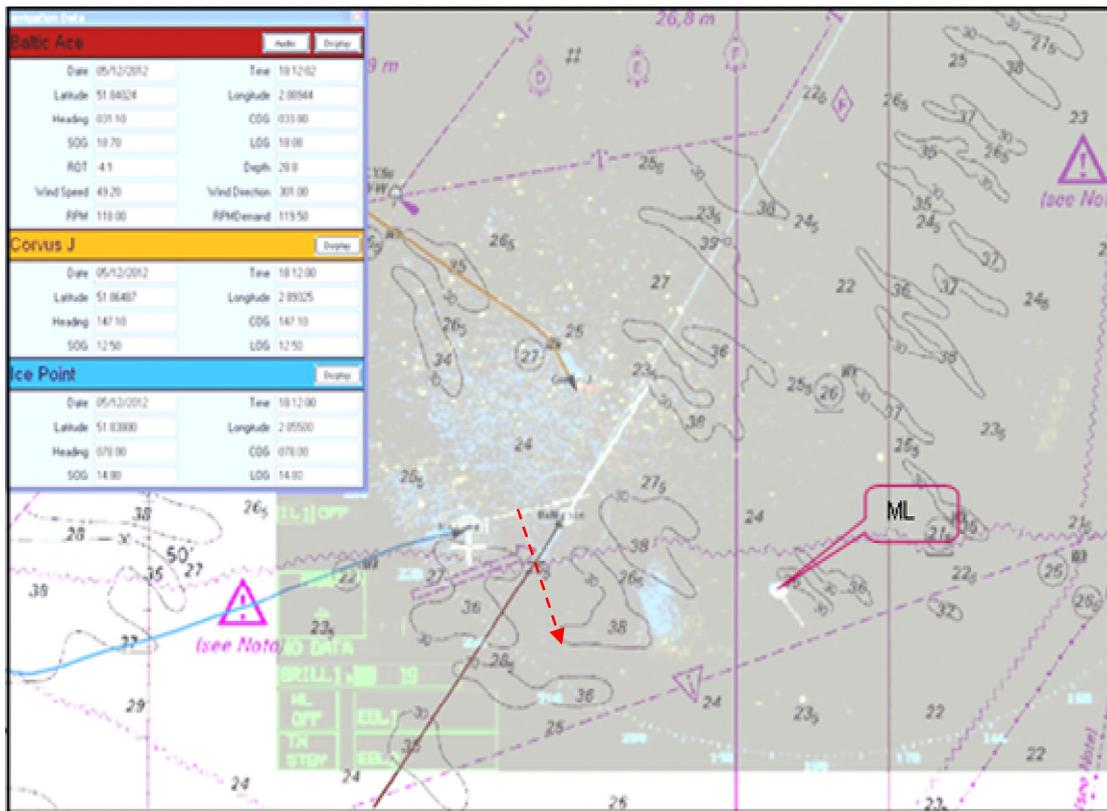
Figure 16: Time 18:12 Corvus J had altered at 18:09 to starboard

- 4.5.10 The alteration of course to starboard could have been intended in order to travel the least distance from the intended navigational plan while still maintaining speed in order to reach the pilot boarding station without delay. It is plausible that the Corvus J, in the knowledge that it was the give-way vessel decided to pass ahead of Ice Point but astern of the Baltic Ace as indicated by the relative red pecked line in figure 16.

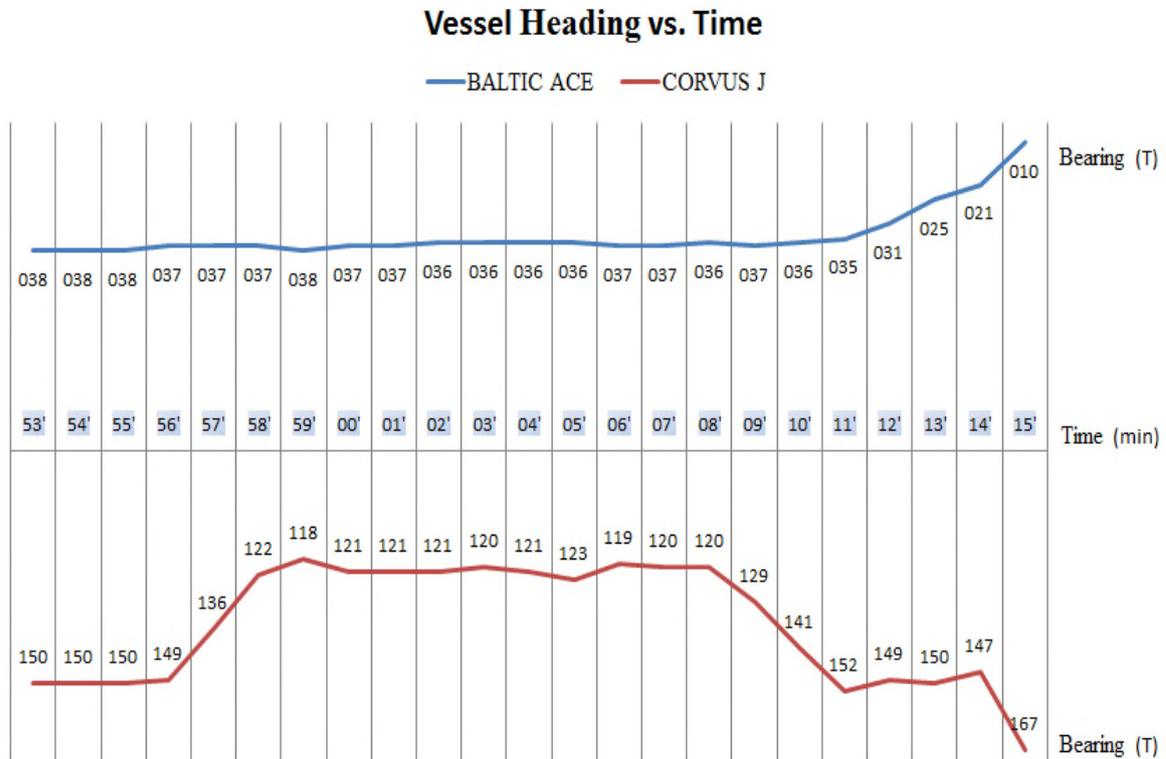
Figure 17: Baltic Ace and Corvus J heading between 17:53 and 18:15

4.5.14 Figure 17 displays the heading of both vessels over time. From this, it can be seen that at 18:10, the time the first VHF call between both vessels ended, neither vessel complied with the verbal agreement; Corvus J to remain steady on course and Baltic Ace to alter course to port. Although the Baltic Ace did commence an alteration of course to port, it could be deemed that 5° is not significant enough to be observed visually and questionable whether or not it may have been seen on ARPA. In addition and in accordance with COLREGS¹⁷, “any alteration of course and/or speed to avoid collision shall, if the circumstances of the case admit be large enough to be readily apparent to another vessel observing visually or by radar; a succession of small alterations of course and/or speed shall be avoided”. Further, the Baltic Ace, as the stand-on vessel in this crossing situation, shall in the event that a risk of collision exists “not alter course to port for a vessel on her own port side”.¹⁸

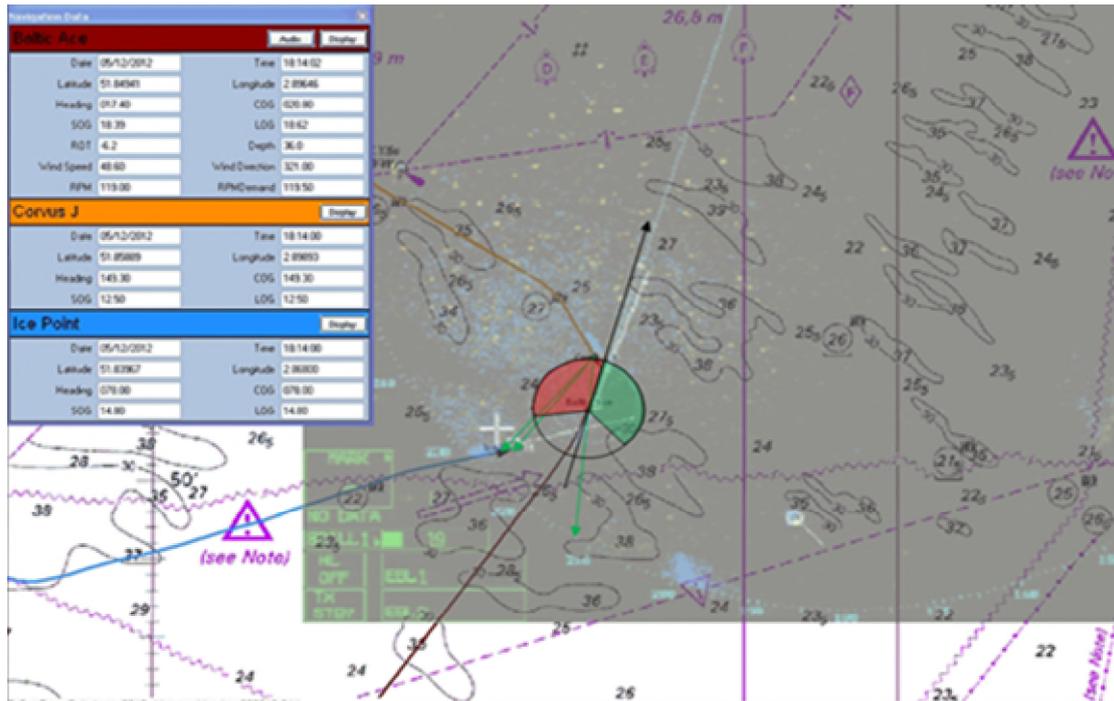
Figure 18: Relative positions of Baltic Ace and Corvus J at 18:14 illustrating Baltic Ace’s light sectors visible to Corvus J

4.5.16 This resulted in a further VHF call to clarify the intentions of the Corvus J as the OOW on the Baltic Ace had recognised that the vessel was not maintaining a steady course. At this point the Corvus J steadies on course 149° while the Baltic Ace agrees to alter further to port. The Baltic Ace alters 6° to port. At 18:13 the Corvus J attempts to call the Baltic Ace, the Baltic Ace fails to respond to the first call, this can be heard on the VDR and in particular the OOW in discussion with the lookout about the course of action taken by the Corvus J and his interpretation of what was agreed “you keep your course OK, you can pass my bow, I think you alter to starboard”. Approximately 10 seconds later the Corvus J attempts to re-establish communications, which is successful, and the Corvus J requests confirmation that the Baltic Ace will maintain its course. At this point the Baltic Ace was steering 025° however immediately after the VHF transmission the vessel alters 4° to port. This alteration provokes another transmission whereby the Corvus J requests the Baltic Ace to reconfirm whether the vessel intends to maintain that course “you keep your course like that” to which the Baltic Ace confirms, “yes I keep it like that”.

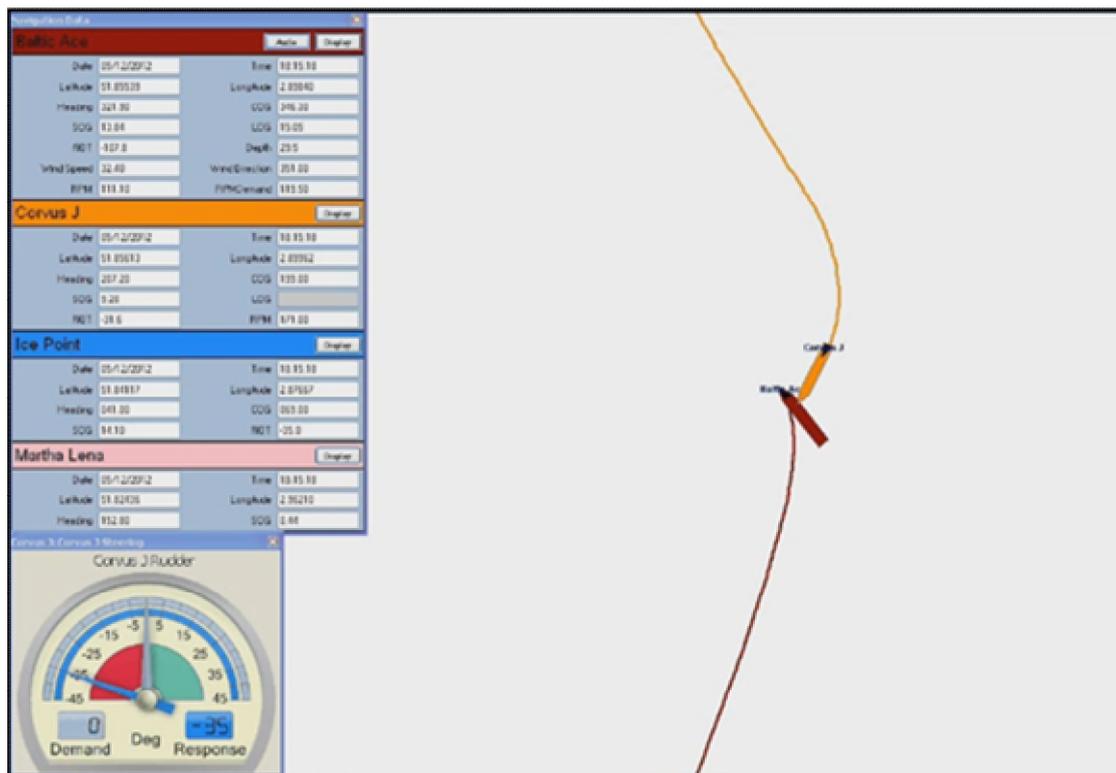
Figure 19: Point of collision: Baltic Ace heading 321°, Corvus J heading 207°

4.5.19 Analysing the more detailed replay data using the relative headings and positions of the two vessels it is estimated that Corvus J would first have been able to see both sidelights of the Baltic Ace at approximately 18:14:40. By this time the two vessels were about 3 cables (600yds) apart as the Corvus J crossed ahead of the Baltic Ace on a heading of 182° and continued its alteration of course to starboard.

4.6.2 At the point of separation (see figure 19) at 18:15:46, the accelerated opposing rotation of the two vessels had resulted in the Corvus J dragging aft and extending the initial breach longitudinally down the starboard side (see figure 20).

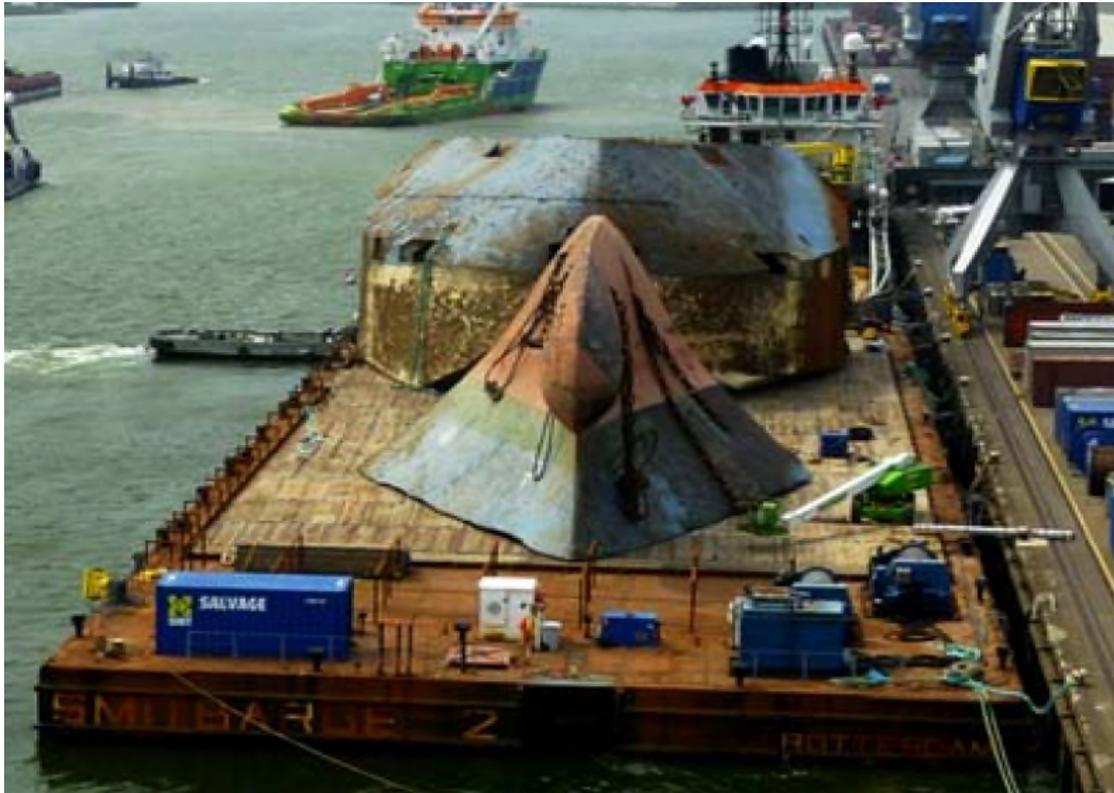
Figure 36: Bow section

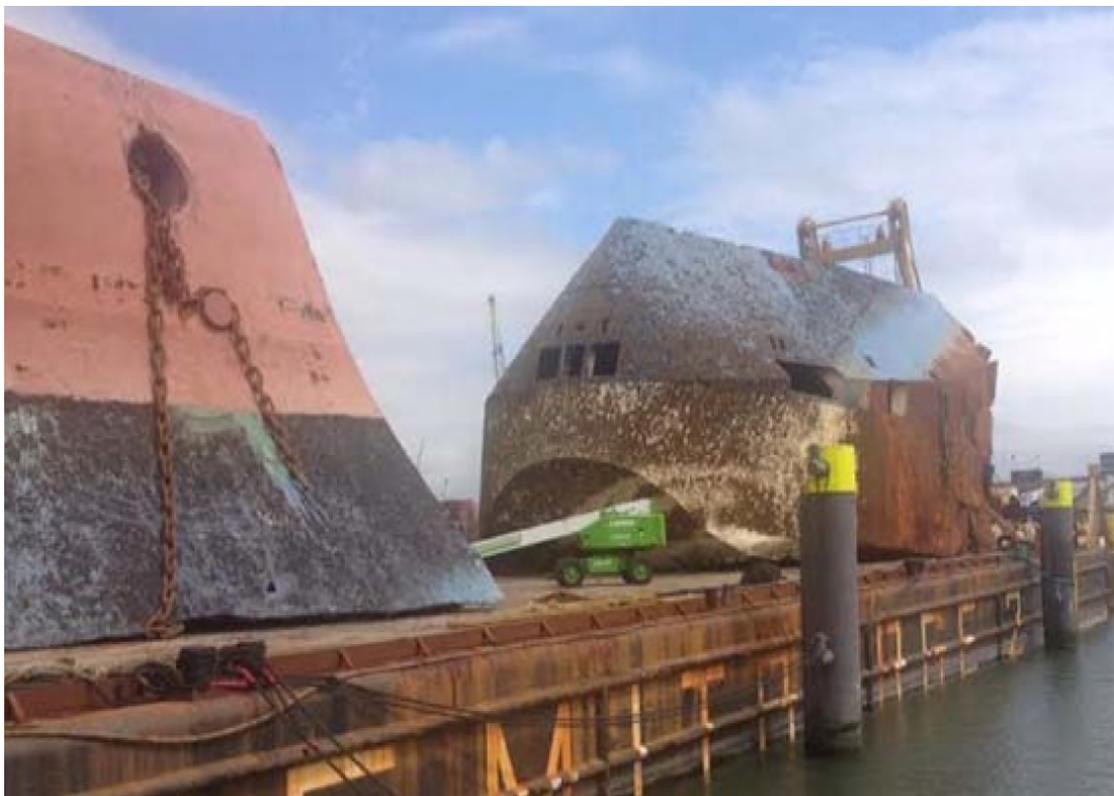
Figure 37: Bow section

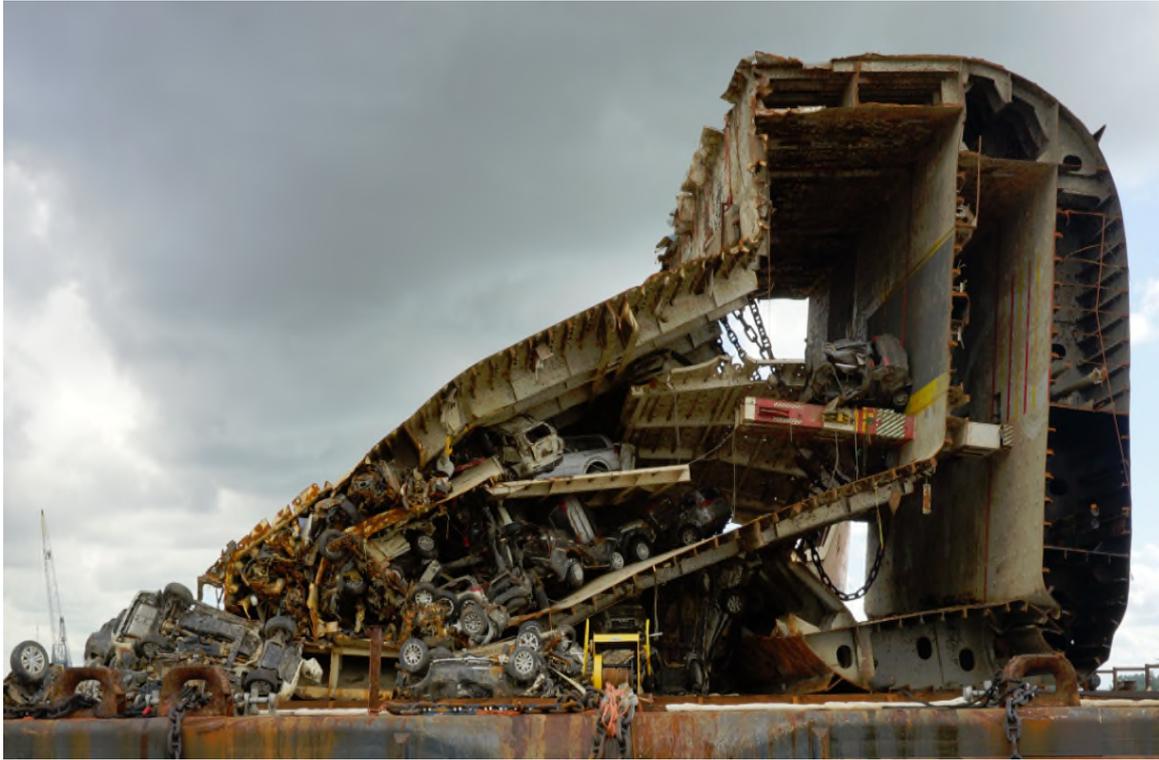
5.3.1 The speed of both vessels as they collided with one another coupled with the opposing rotation of opposite helm orders resulted in a hull plating breach that penetrated into the cargo deck spaces forward of amidships and continuing aft to frame 50. This breach coupled with the prevailing weather conditions at the time of the collision resulted in a fast and substantial ingress of water into the vessel’s cargo space.

5.3.2 The breach of the shell plating from frame 135 to frame 50 and vertically from deck 2 to deck 6 proved catastrophic resulting in the vessel’s rapid capsizing. The vessel’s structural arrangement provides for a component of reserve buoyancy above the waterline subdivision, sufficient enough to maintain the vessel’s buoyancy should the lower cargo holds become submerged. The damage sustained due to the impact resulted in the watertight integrity above the watertight subdivision to become compromised, thereby removing the designed reserve buoyancy necessary to keep the vessel afloat. With no transverse subdivision above the watertight subdivision of deck 4, unrestricted flooding occurred throughout the remaining cargo decks. The Baltic Ace could not recover from the damage sustained, the extent of which allowed little time for the crew to evacuate in a controlled and organized manner.

Figure 38: Middle section (cargo decks)

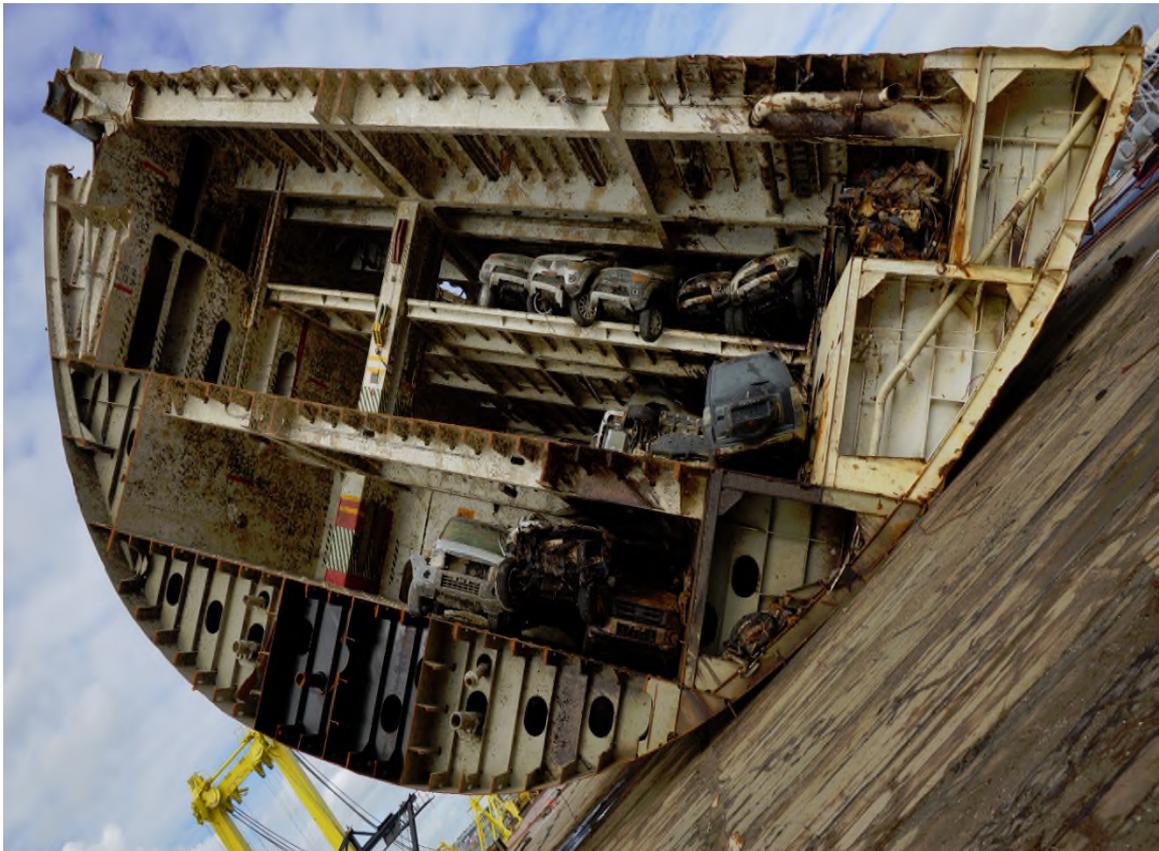
Figure 39: Middle section (cargo decks)
