**The Bahamas  
Maritime Authority**

**Report of the investigation into  
the contact between the  
High Speed Craft  
HD1**

**And the moored High Speed Craft  
CONDOR EXPRESS**

**During berthing operations  
at St Helier, Jersey on  
28<sup>th</sup> July 2007**

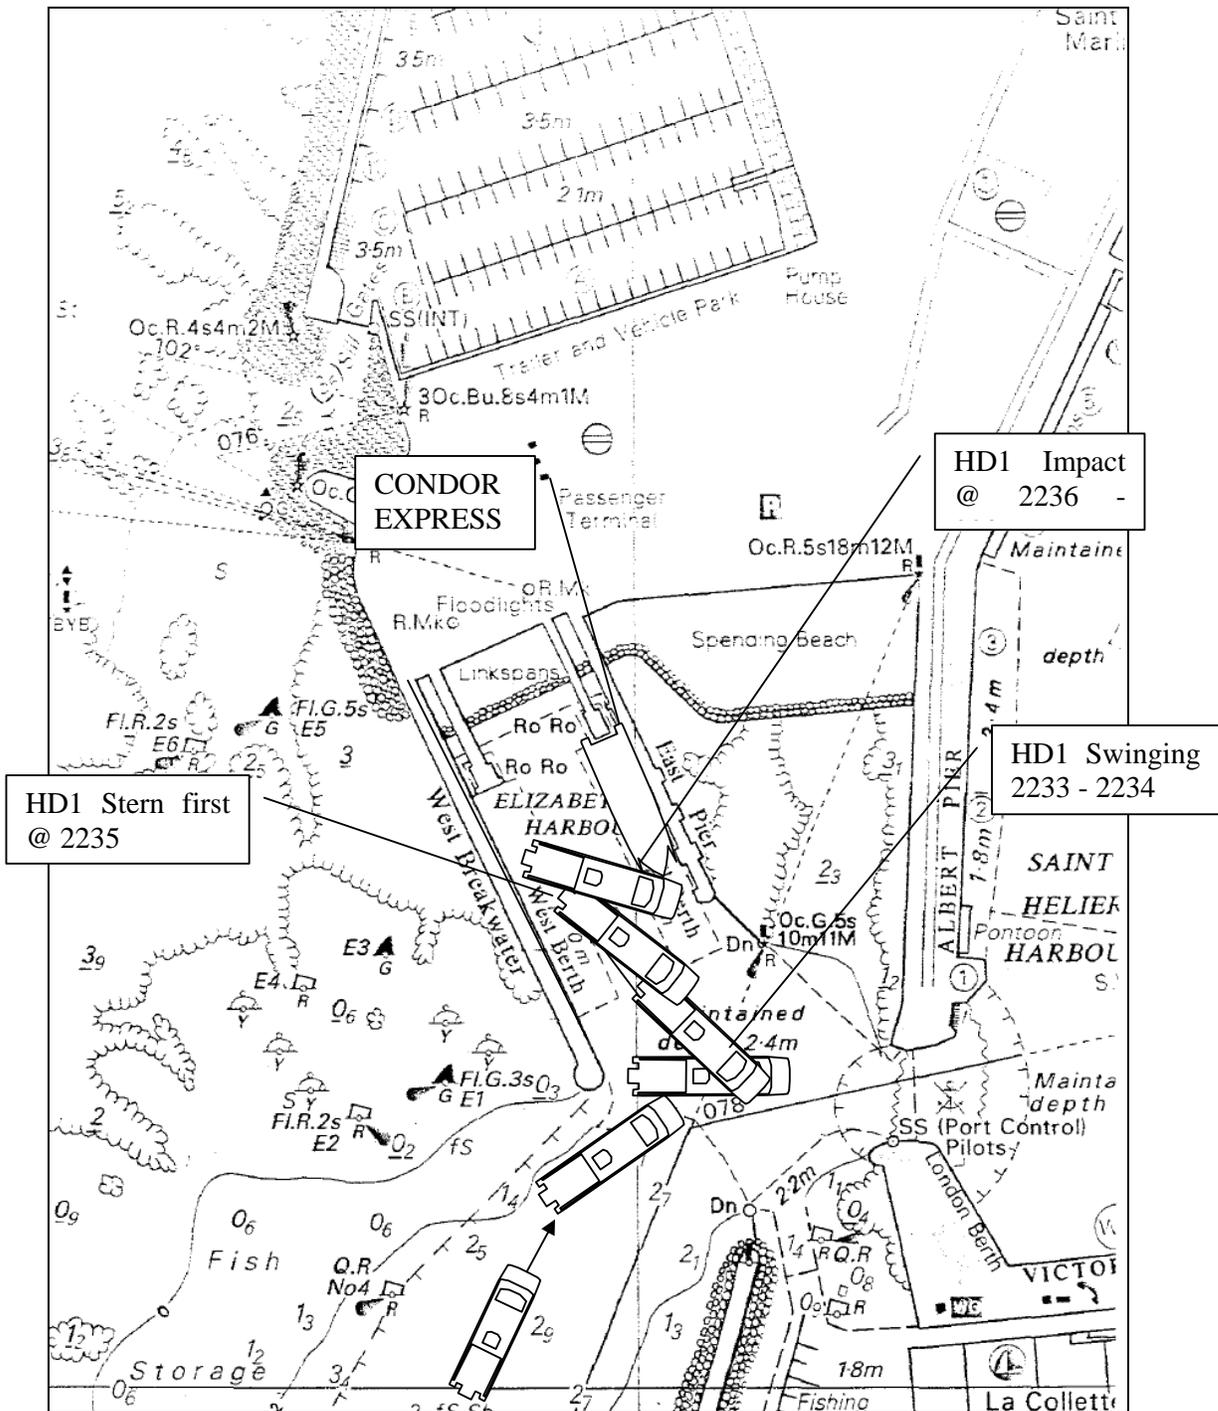
- 3.7.5** The approximate track of HD1 on the inward passage is shown in the diagram below. The inward and outward passages either side of the contact are shown in APPENDICES I, II, III and IV. APPENDIX V gives a description of techniques of manoeuvring with water jets and APPENDIX VI gives a detailed record of key engine and steering movements as extracted for VDR records.

HD1: Entrance to Impact:- Small Road (ahead) to Elizabeth Harbour (Stern First). Positions are approximate: derived from ECS (HD1), Victoria Pier CCTV, VDR voice (HD1 and CONDOR EXPRESS), and VHF Ch14 (Port Control), plus interviews and statements.

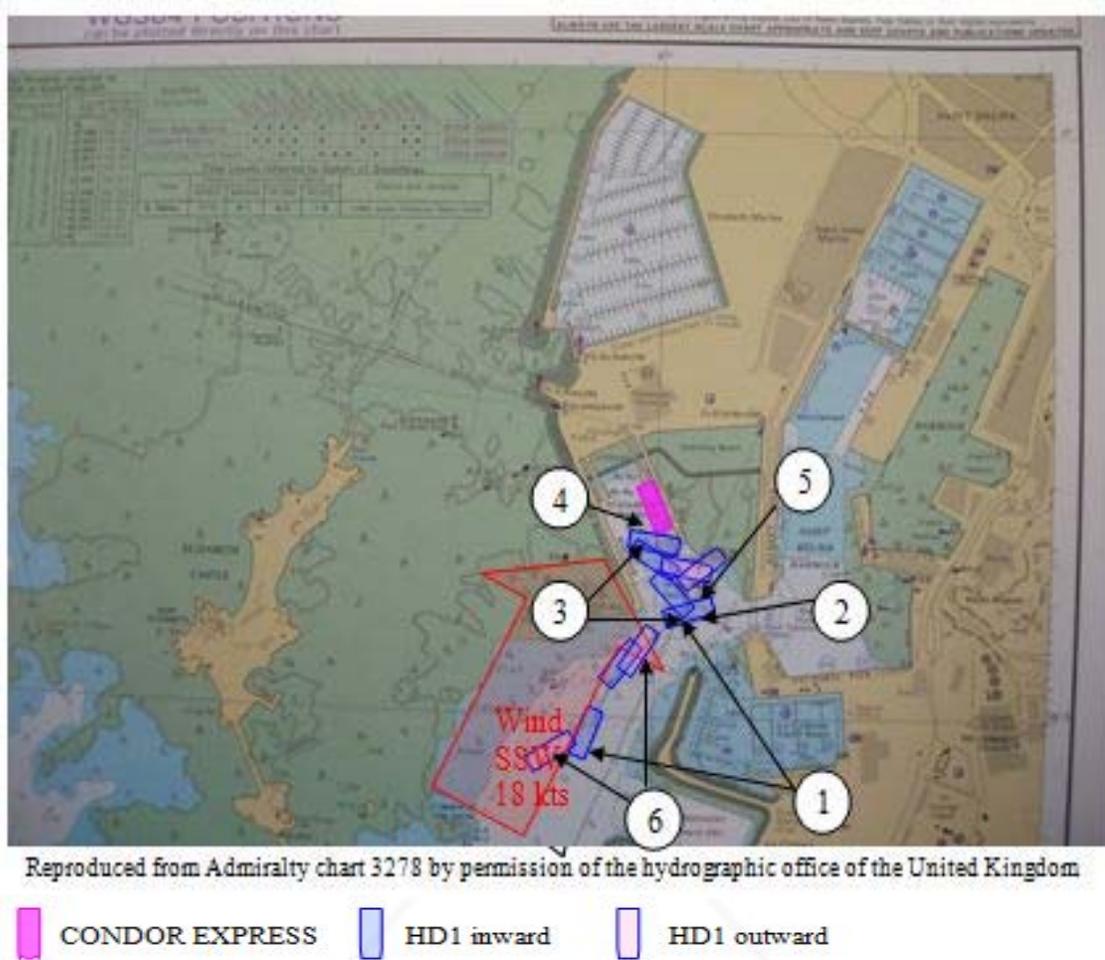
APPENDIX I

**Approximate track taken by HD1 during attempted berthing 28<sup>th</sup> July 2007.**

The track on entry to the port was a shallow turn to starboard (1) towards the turning point off the St Helier Harbour entrance (2), having positioned the vessel towards the west of the leading line to allow for any drift due to the strong south westerly wind.

After impact (4), HD1 moved ahead, incurring further contacts in the process but eventually placing the port bow on the dolphin off the East Pier end (5), against which the vessel was driven round to port so as to enable a stern-first exit back to the Small Roads (6).

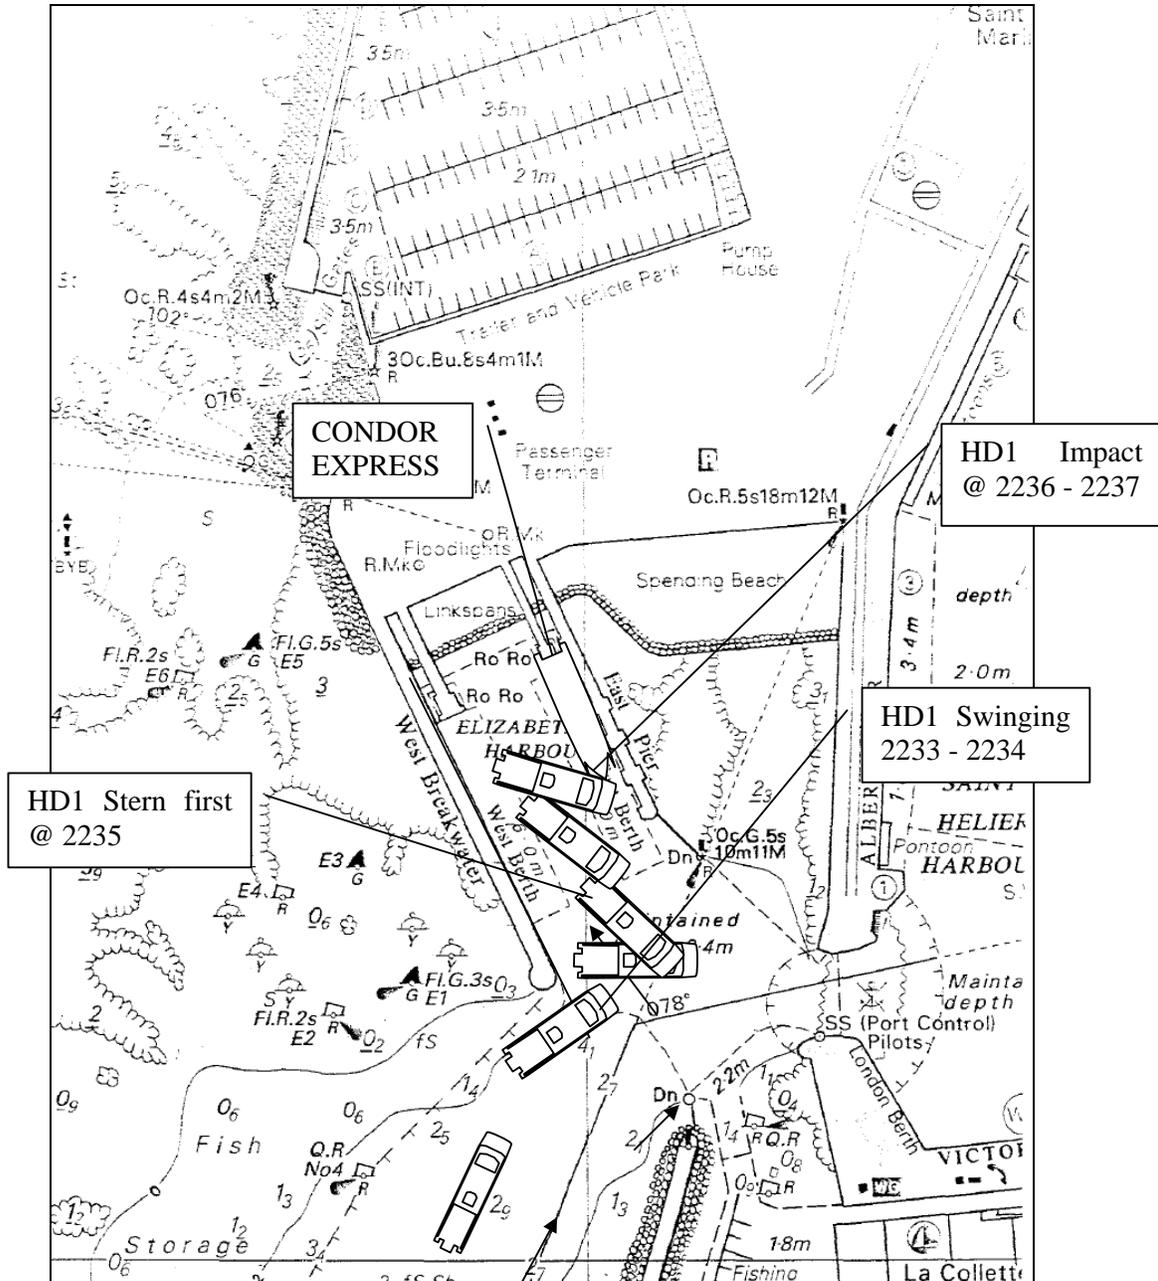
APPENDIX II

HD1: Entrance to Impact : Small Road (ahead) to Elizabeth Harbour (stern first)  
Positions approximate; derived from ECS (HD1) VDR voice (HD1 and CONDOR EXPRESS) and VHF Ch14 (Port Control) + Interviews and written statements, HD1 Master, C/O, C/E, Pilot. CONDOR EXPRESS: Master.
