**M.V SEABOURN ENCORE  
IMO NUMBER: 9731171  
OFFICIAL NUMBER: 7000860**

**Report of the marine safety investigation into a collision  
with a bulk cement carrier on 12 February 2017 at  
Timaru, New Zealand**

Marine inquiry MO-2017-204

Breakaway from wharf and collision with bulk  
cement carrier at Timaru

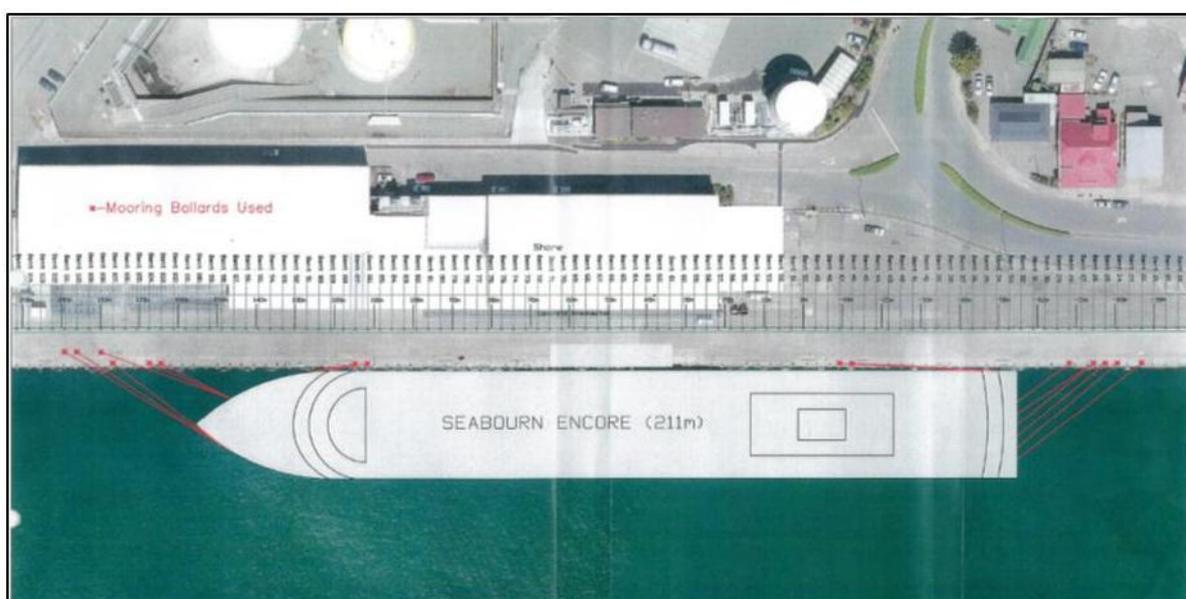
Figure 1  
Mooring arrangement alongside Number One Wharf

- 3.1.5. At 0825 the vessel was all secure with six head and six stern lines and two forward and two aft springs. The line of the berth was 048/228° (degrees) (see Figure 1).

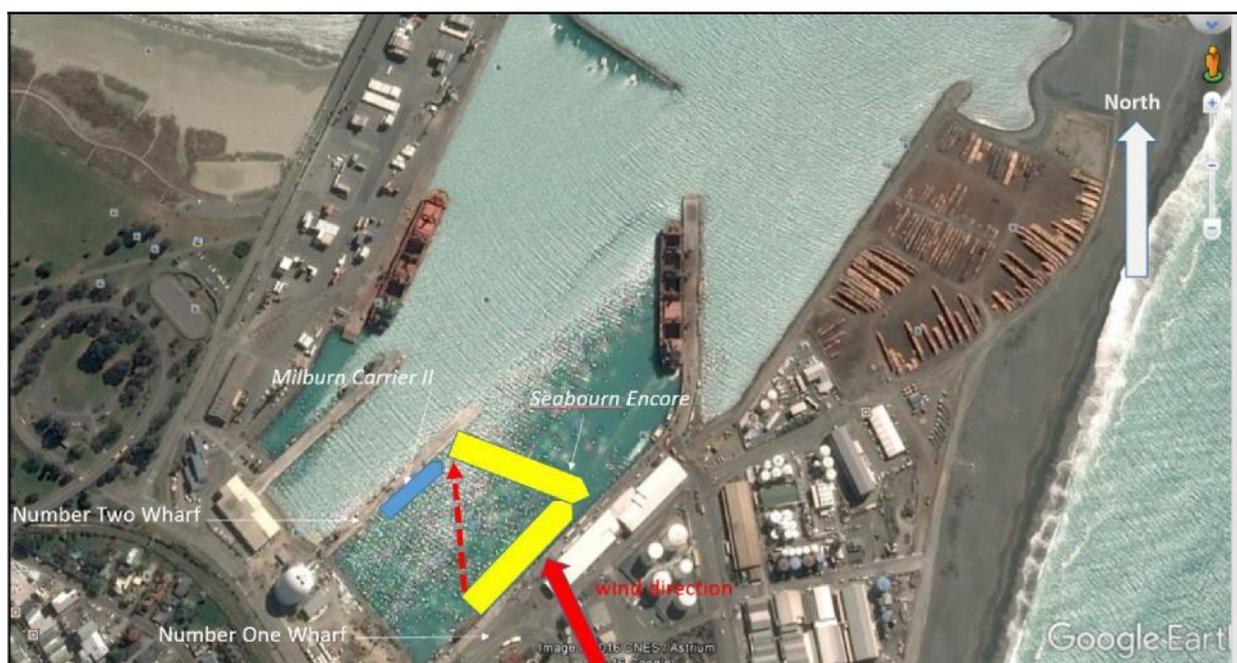
**Figure 3**  
**Movement of the *Seabourn Encore*'s stern after breaking away from Number One Wharf**

- 3.1.18. At 1521 both stern thrusters were thrusting full to starboard. The wind was gusting to 45 knots when the *Seabourn Encore*'s port quarter<sup>8</sup> made contact with the starboard side, midships, of the *Milburn Carrier II*, which was in the latter stages of berthing and already had mooring lines ashore (see Figure 3).

- 3.1.20. The port quarter of the *Seabourn Encore* continued swinging around, cleared the *Milburn Carrier II* and came to rest on the quay side of Number Two Wharf. The master used all four thrusters to keep the vessel wedged between Numbers One and Two Wharfs.

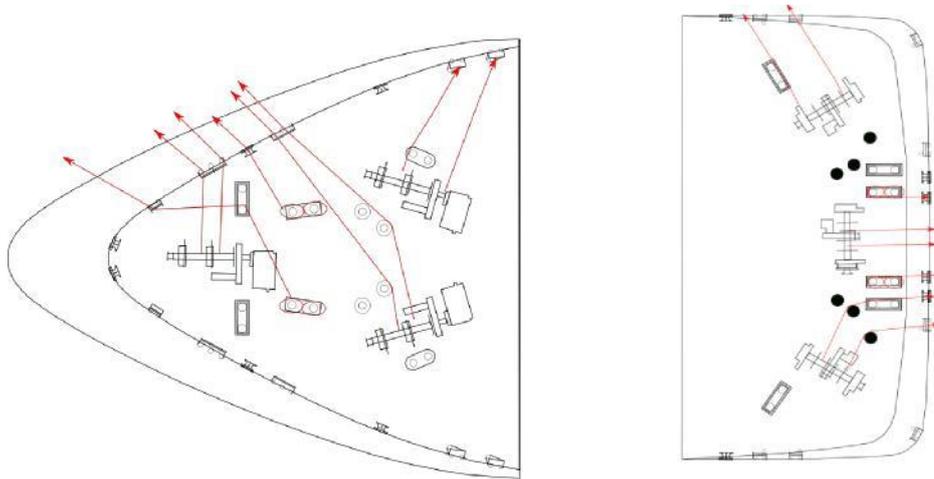
Figure 5  
Bow (left) and stern (right) mooring and securing arrangements

3.5.1. Figure 5 shows the mooring arrangements forward and aft on the *Seabourn Encore*. At the bow, six of the eight mooring lines were secured on dedicated split drum winches. The remaining two head lines were secured on mooring bitts. Seven of the eight lines were run through roller fairleads<sup>12</sup> and one head line was run through a panama fairlead.<sup>13</sup> Similarly, at the stern, six of the eight mooring lines were secured on split drum winches and the remaining two were secured to mooring bitts. Five of the eight mooring lines were run through roller fairleads and three were run through panama fairleads. All the mooring lines were fairly equally tensioned, and roller fairleads were later observed to be functioning correctly.

3.5.2. Figure 5 shows, to scale, the mooring line configuration and the shore mooring bollards used to secure the lines. All the lines were run to separate shore bollards with the exception of two stern lines placed on bollard 26.

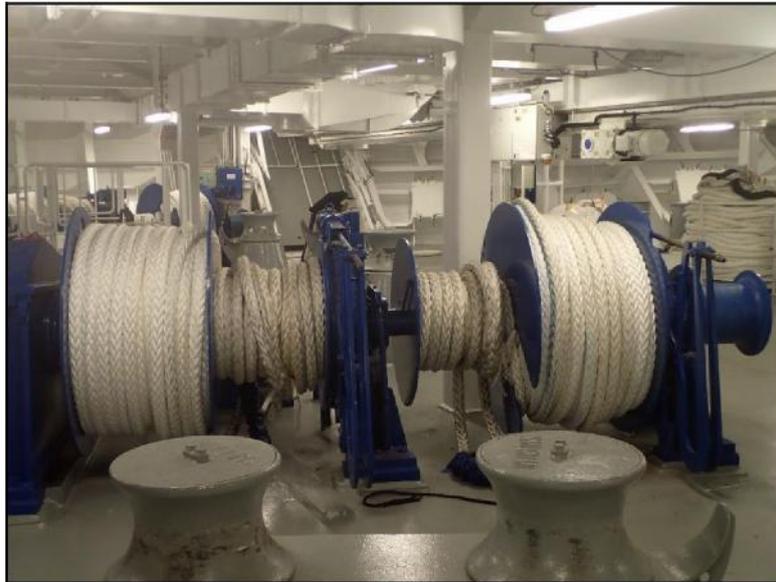
**Figure 6**  
Split drum mooring winch used to secure mooring lines on board the *Seabourn Encore*

3.5.3. The mooring winches could be used in auto-tension mode or manual mode. On the day of the accident the winches were in manual mode and the mooring ropes were secured on the brake of the split drum winches (see Figure 6). Two additional lines forward and aft were secured to mooring bitts.

- 3.6.2. Each of the split drum mooring winches were designed for a synthetic rope 64mm in diameter with a minimum breaking load of 59 tonnes. The mooring winches were certified by RINA in August 2015 and commissioned in December 2016. All mooring winches supported a static pull on the brake of 48 tonnes, which was 76% of the design mooring rope minimum breaking load (MBL) fitted on the winches.

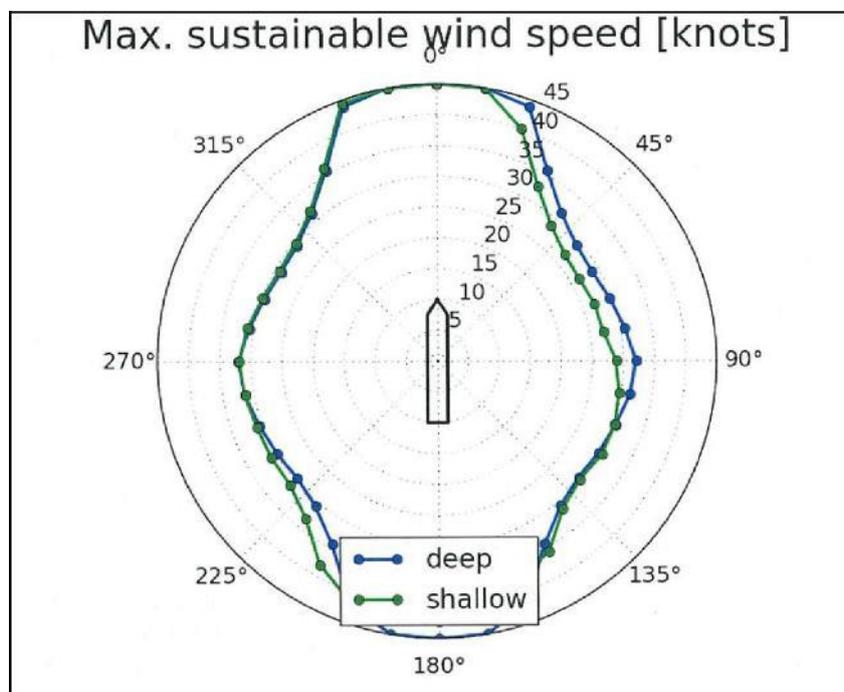
Figure 8  
Polar plot showing the crabbing capability – quay on port side shallow water

4.2.9. As the bow and stern thrusters became available, an attempt was made to stop arrest the stern swinging down onto the *Milburn Carrier !!* and subsequently Number Two Wharf. By design the vessel was only capable of moving sideways into a prevailing wind (from the same relative direction) of approximately 35 knots (see the polar diagram in Figure 8). This required all thrusters and main propellers to be available. At best it may have been possible to arrest the swing but it was more likely to have reduced the rate of drift towards Number Two Wharf.

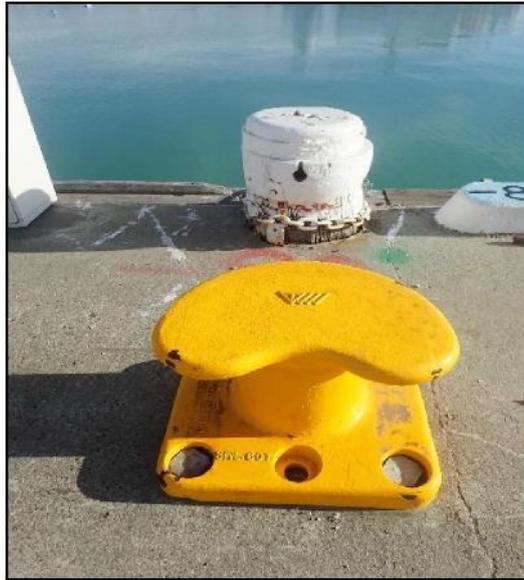
**Figure 13**  
**Newly installed steel bollard**

4.4.2. The engineering assessment did not examine bollards or the outer edge of the wharf, but as part of the work in progress for meeting the needs of cruise vessels PrimePort Timaru commenced a programme of installing some new bollards (Figure 13) and replacing some original bollard securing bolts.

4.4.3. The new bollards were set further back from the face of the wharf and had a safe working load of 80 tonnes stamped on their bases. The replaced bollard securing bolts were of the same design as those described earlier in this report.
