M.v. Skandi Pacific

**Report on the marine safety investigation into a
fatality aboard an offshore supply vessel on
14 July 2015**

M.v. Skandi Pacific – Marine Safety Investigation Report

Date of Issue: 12 December 2018
Bahamas Maritime Authority
120 Old Broad Street
LONDON
EC2N 1AR
United Kingdom

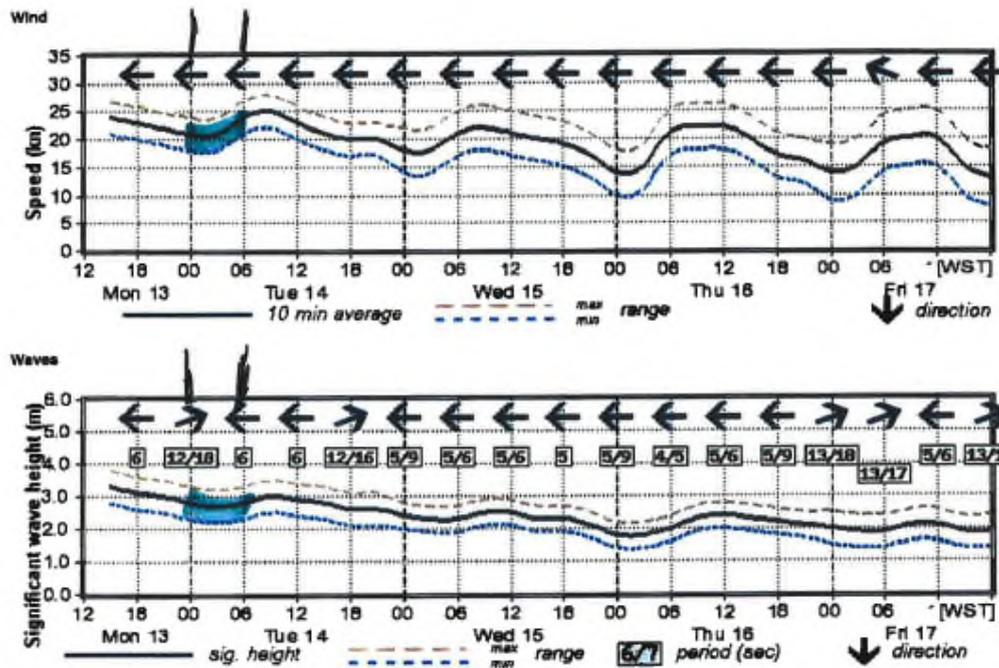
Figure 3: BoM weather forecast issued for 13th -17th July 2015

- 4.9 The Master reviewed the weather forecast information issued for 13-17 July, and in his night orders he stated that the “*weather is due to deteriorate again later in the morning*”.

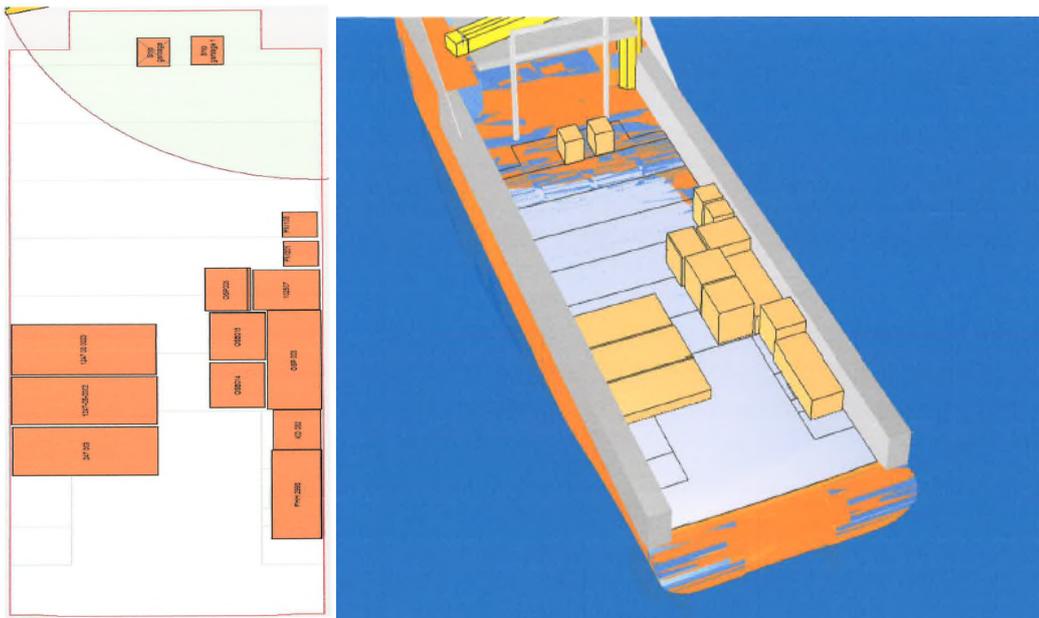
Figure 13: Cargo backload plan on 13 July 2015

- 5.1.6 While checking the starboard side cargo, the Integrated Ratings found that the fastening arrangement was inadequate to lash the two mini-containers at the forward end of the aft deck. The Integrated Ratings decided to use additional rigging by means of a smaller secondary chain to secure them. Their intended plan was to place the smaller chain around the tugger wire and secure the chain to the crash barrier rail using a shackle to tighten it in order to create a locking point around the mini containers. To carry out this plan, the tension on the tugger winch was slackened, leaving several containers unsecured.
