**The Bahamas
Maritime Authority**

M.v AMAZON
IMO Number: 9138616
Official Number: 732165

**Report of the investigation into a crew
fatality during an abandon ship drill on the 12th April
2016**

Date of Issue: 14th September 2016
Bahamas Maritime Authority
120 Old Broad Street
LONDON
EC2N 1AR
United Kingdom

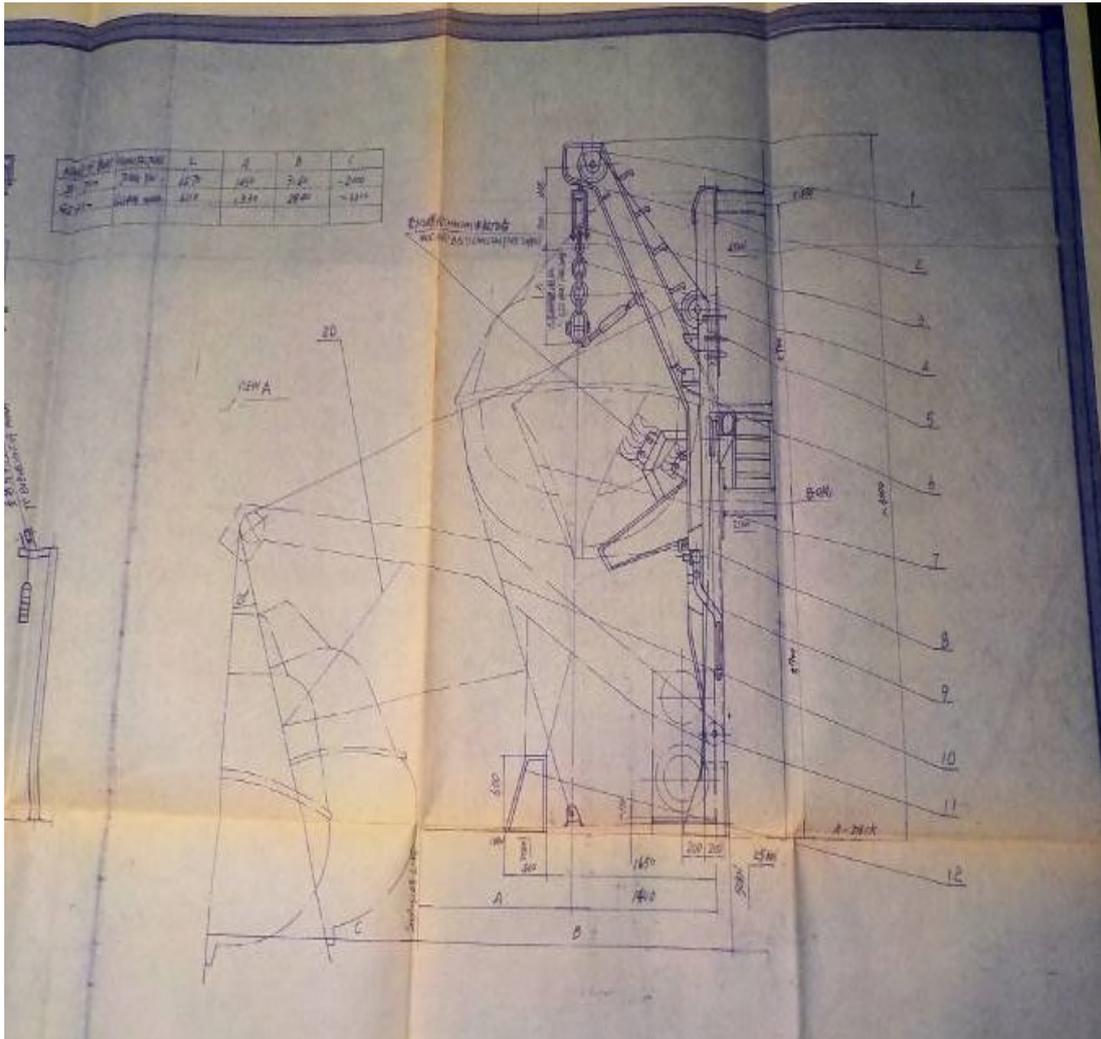
- 3.5.2 The lifeboat davits (LE 65-2) are of the hinged-type incorporating a luffing arm design. They are freestanding and deck mounted, designed to swing-out by a single pivot movement and lower the lifeboat by gravity⁵. The launching/lowering action can be operated either from inside the lifeboat or from the boat deck.

1. Head tackle
2. Davit Arm
3. Floating block
4. Boat fall unit
5. Boat fall unit& tackle

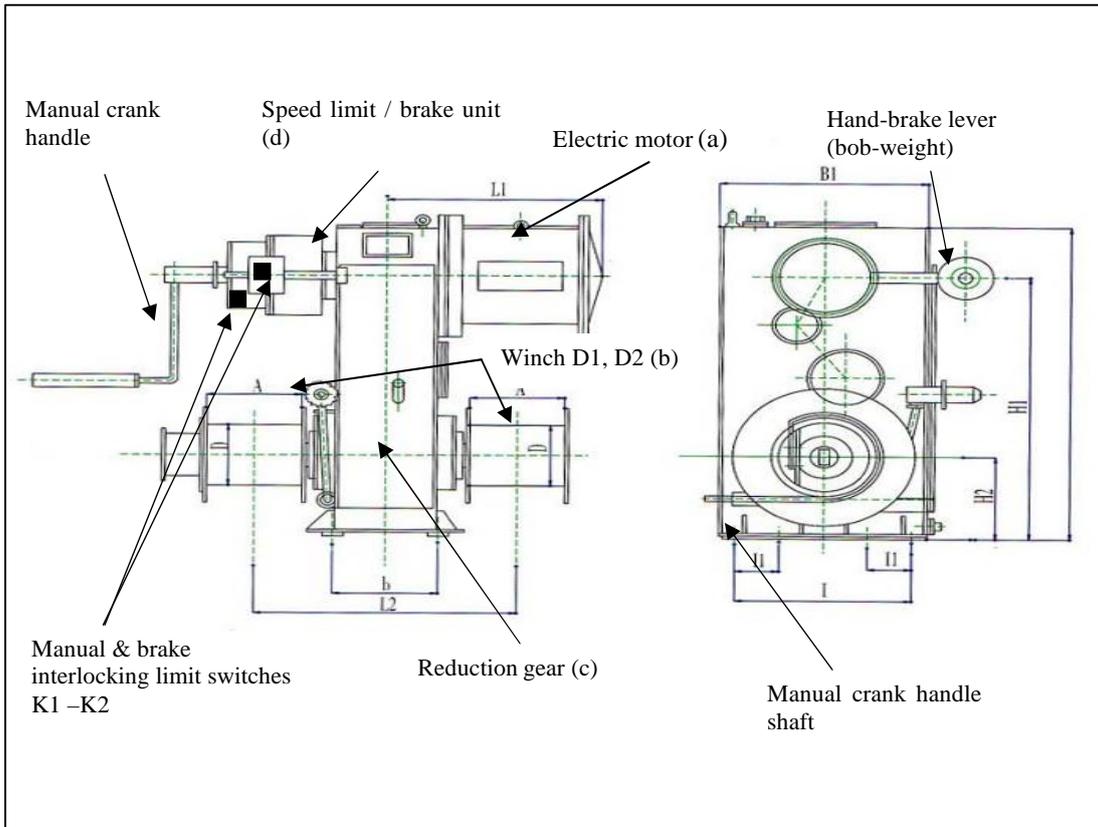
Figure 2: Starboard lifeboat winch assembly

- 3.5.5 The starboard lifeboat winch has the following main components (see figure 2):
- a. Built-in electric motor which drives a wire-drum for the hoisting and recovery of the lifeboat;

- b. Double winch drum (two drums D1-D2 on two sides of reduction gearbox);
 - c. Reduction gear unit fitted in a closed gear casing, incorporating a conventional gear train and an automatic centrifugal clutch (fitted between the electric motor and the high-speed shaft). The action clutch-in or clutch-out between the gear box and electric motor shall be joined together when the electric motor turns and separated away (shaft is automatically separated from the reduction gear) when the electric motor stops;

- d. Speed limit / brake unit, incorporating a centrifugal speed limiter for gravity lowering and a stop brake mechanism (of “dead-man” type) which engages through the operation of a hand brake lever (bob-weight).

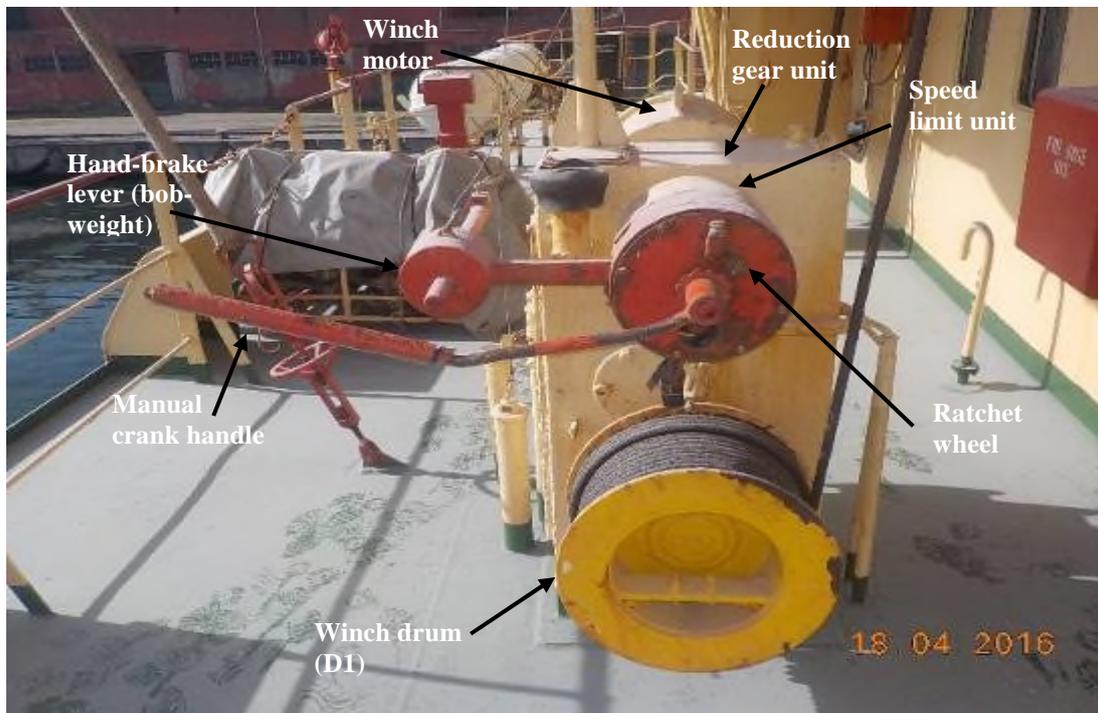
Figure 3: Winch controls

2.6.1 Lifeboat launching is independent of external power supply and is achieved by the release of the winch stop brake (lift-up of the hand-brake lever (bob-weight)). The release of the stop brake can be operated, depending on the operational circumstances, either locally by manual lifting of the hand-brake lever (clockwise turn) or remotely from inside the lifeboat by drawing a remote handle, hung in the boat, attached through wire rope and a series of pulleys to the hand brake lever⁶ (see figure 3).

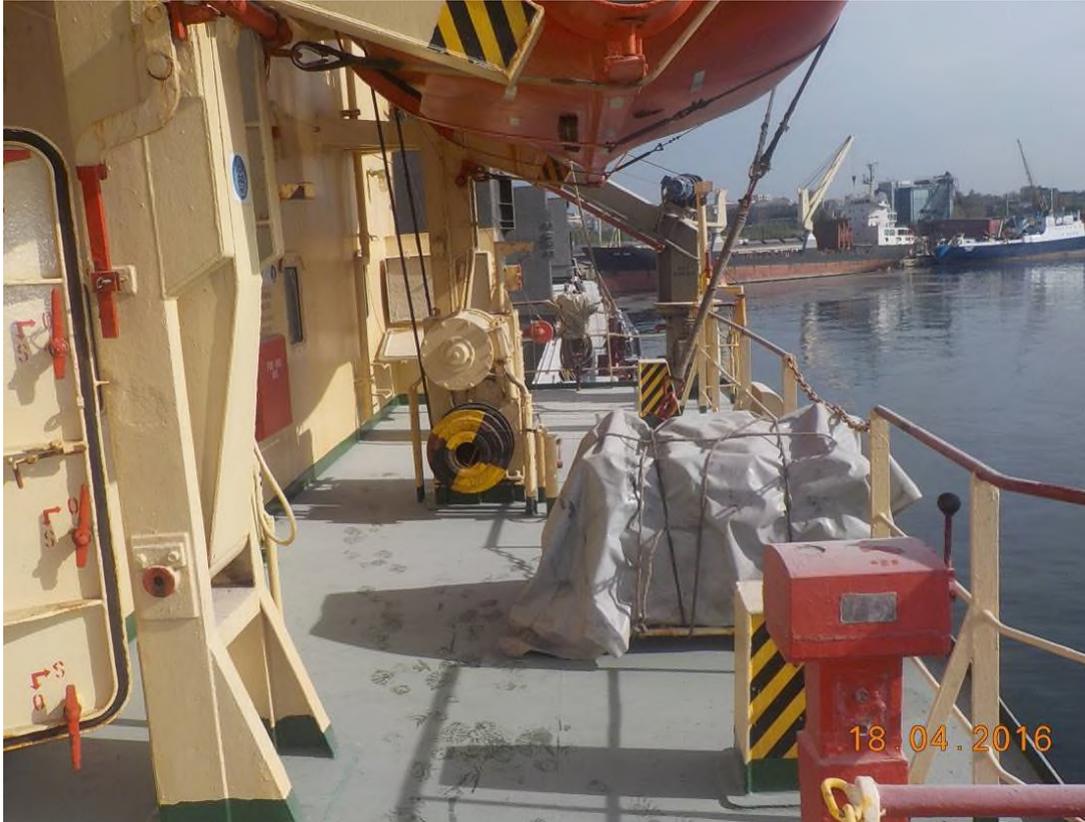
Figure 11: Starboard side boat deck in way of lifeboat No.1 davit from aft

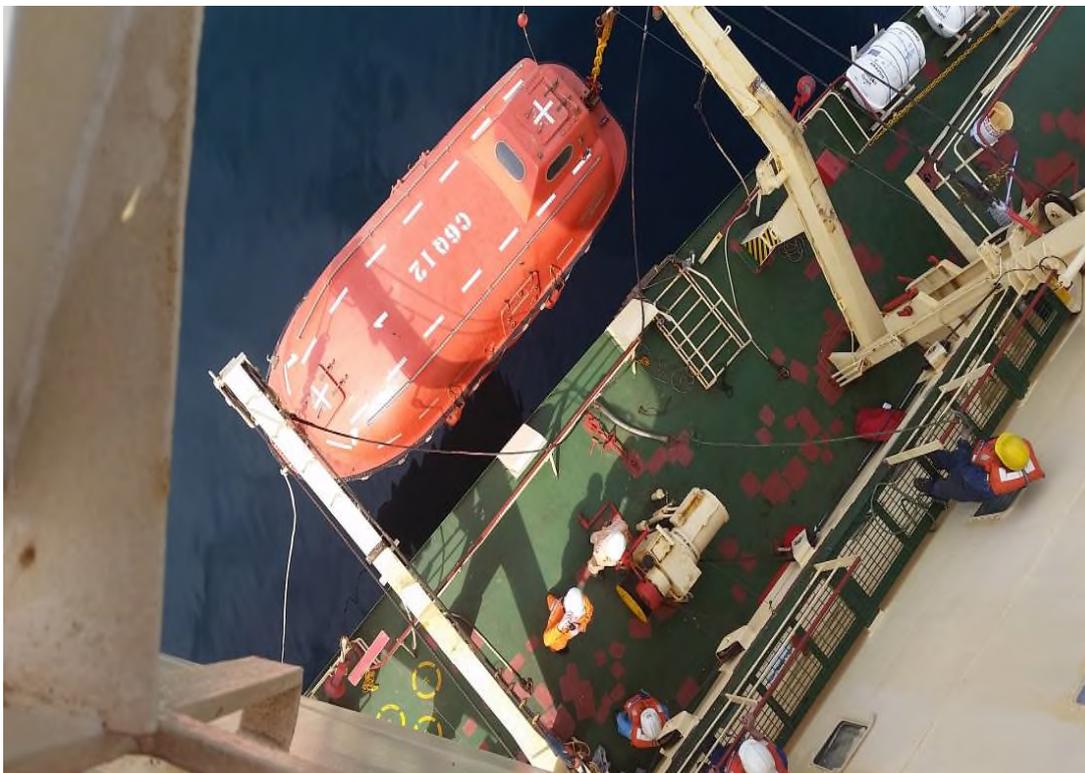
Figure 12: Starboard side boat deck during lowering of lifeboat No.1, taken from bridge wing

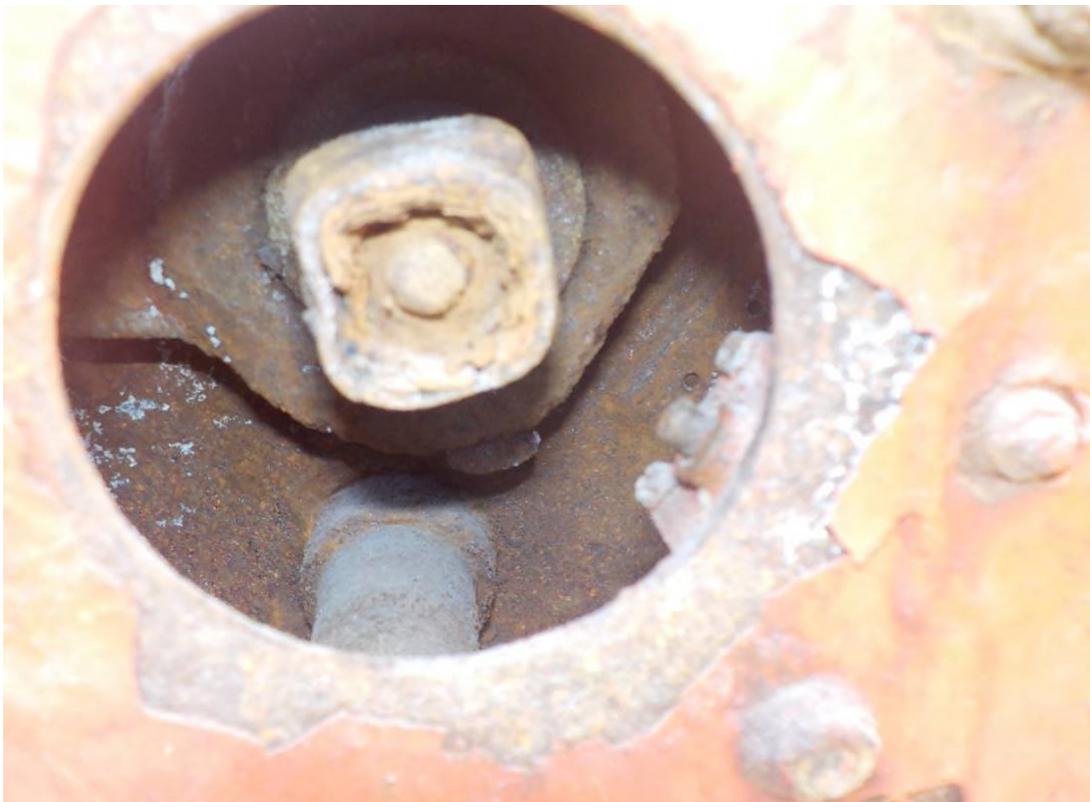
- 3.6.6 In the event of a power failure or malfunction of the electrical system, hoisting can also be done manually by using a manual crank-handle inserted into a designated rotating shaft installed concentric to the hand-

Figure 14: Manual crank-handle insert shaft

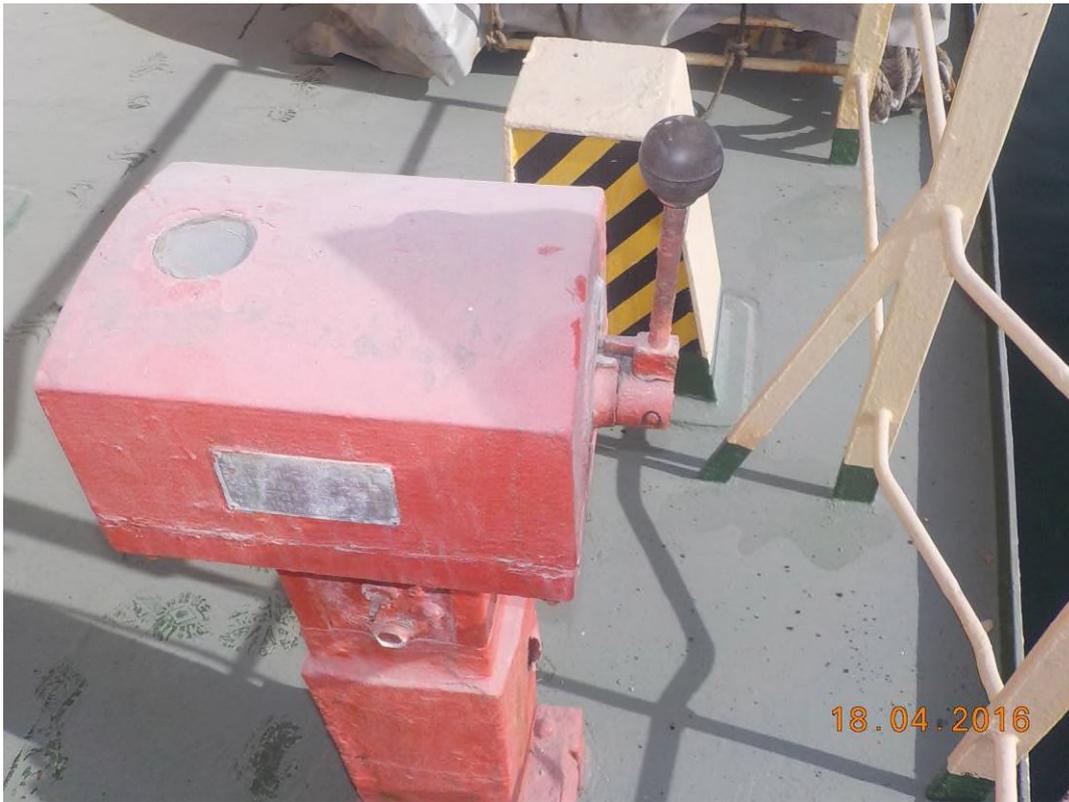
Figure 15: Master controller with two step speed change lever

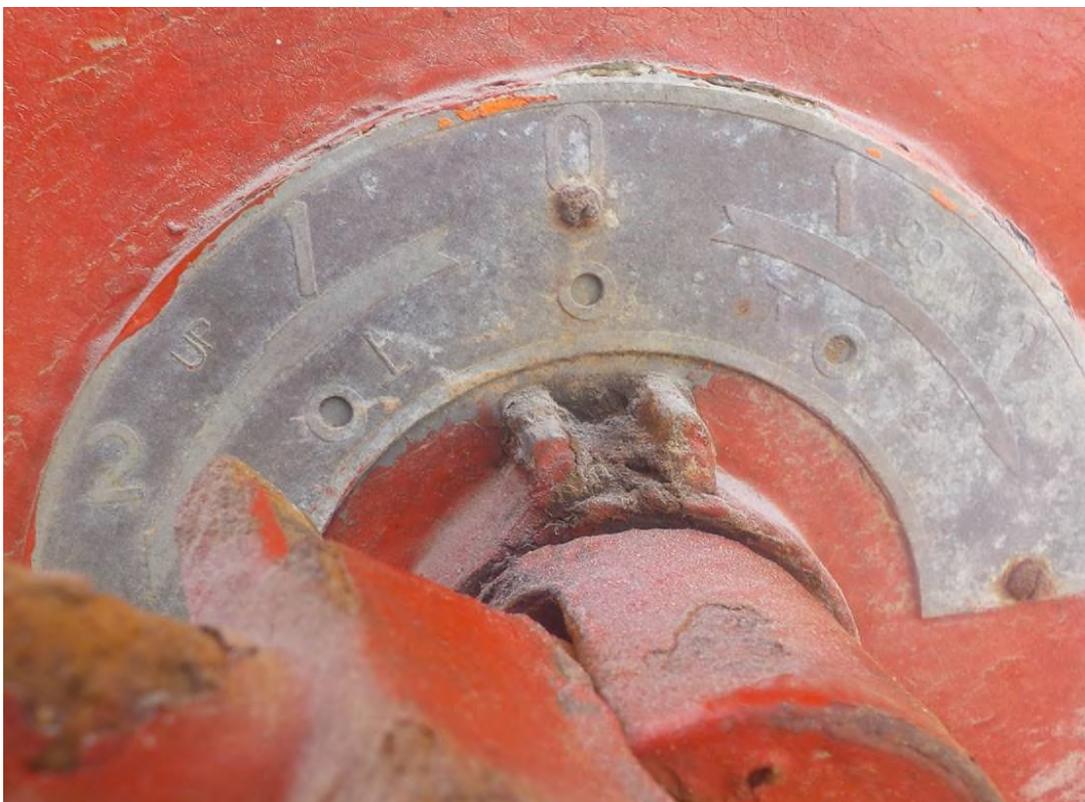
Figure 16: Speed change lever speed control and neutral location
