**GRYF**

**IMO Number: 8818300**

**Report of the marine safety investigation into a  
fatality of a crew member on a roll-on, roll-off  
passenger ferry  
on 04<sup>th</sup> May 2019**

## GRYF – Marine Safety Investigation Report

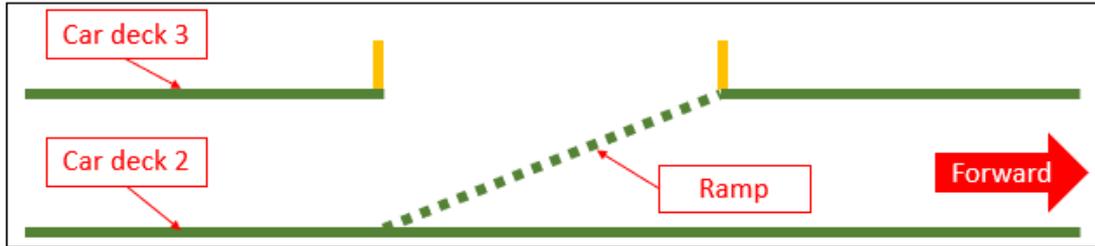
Figure 8: Position of the ramp<sup>8</sup> at the port of Trelleborg, Sweden

The ramp's position was changed at each port for the movement of vehicles between the two decks for the loading/discharging operation. At the port of Trelleborg, Sweden, the ramp was positioned to connect forward of car deck 3 to the car deck 2 (figure 8) and at the port of Swinoujscie, Poland, it was positioned to connect aft of car deck 3 to car deck 2 (figure 9).

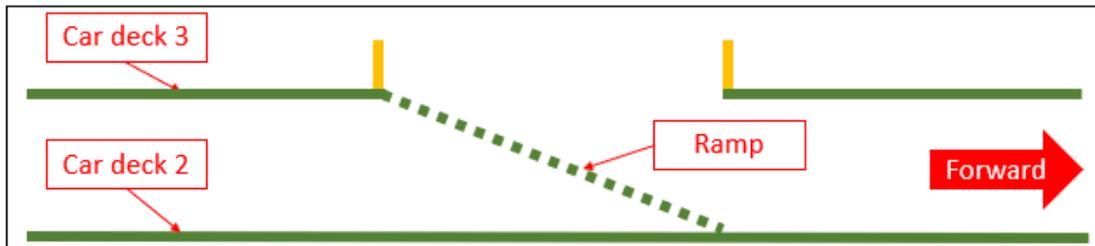
Figure 9: Position of the ramp<sup>9</sup> at the port of Swinoujscie, Poland

On the day of the incident, the vessel was at Swinoujscie, Poland and the ramp was positioned to connect aft of car deck 3 to car deck 2 (figure 9).

After the incident, the securing barrier on car deck 3 was found broken as the forklift fell from car deck 3 on to the ramp on car deck 2. The barriers were made of steel tubes and were not designed to take any heavy load or impact of the moving vehicles.
