**Majesty of the Seas**

**IMO Number 8819512**

**Report of the investigation into a crew member  
fatality on a passenger vessel  
on 5 April 2017**

Date of Issue: 02 January 2020  
The Bahamas Maritime Authority  
120 Old Broad Street  
LONDON  
EC2N 1AR  
United Kingdom

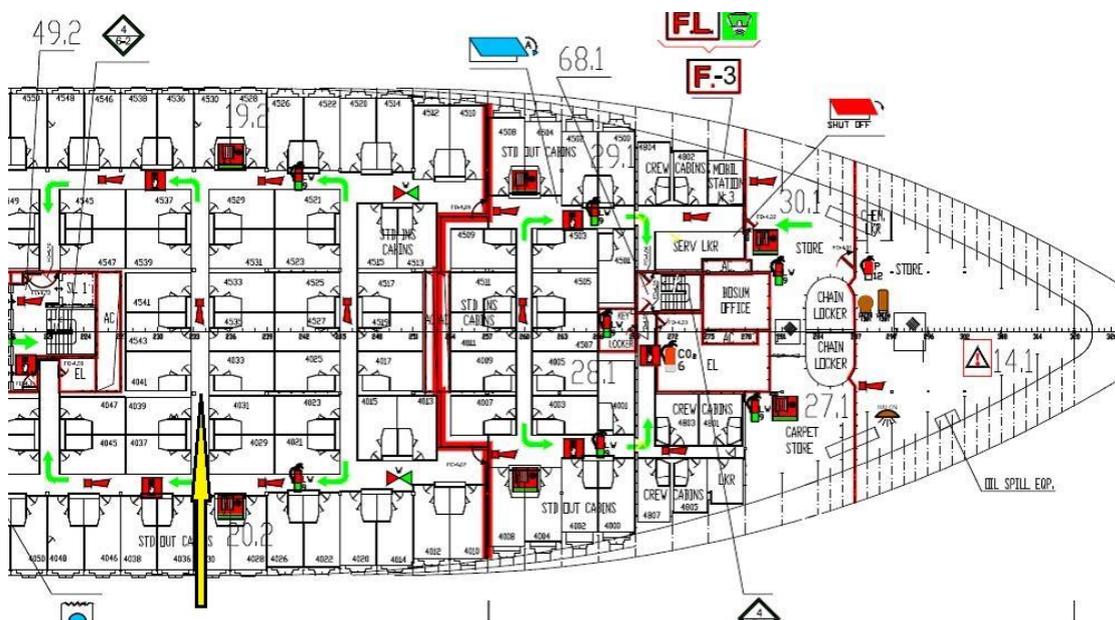
Figure 3: Crew member work location indicated by the yellow arrow:

On 5<sup>th</sup> April 2017, the team member was working in the passenger's accommodation area with five other RCMT members. With two team members per deck and displaced over decks 2, 3 and 4, the team members were replacing black water piping in corridors outside cabins 2019, 3023 and 4033.

Cabins 2019, 3023 and 4033 are aligned vertically above each other towards the forward of the vessel. The black water piping is common over the three decks outside cabins 2019, 3023 and 4033.

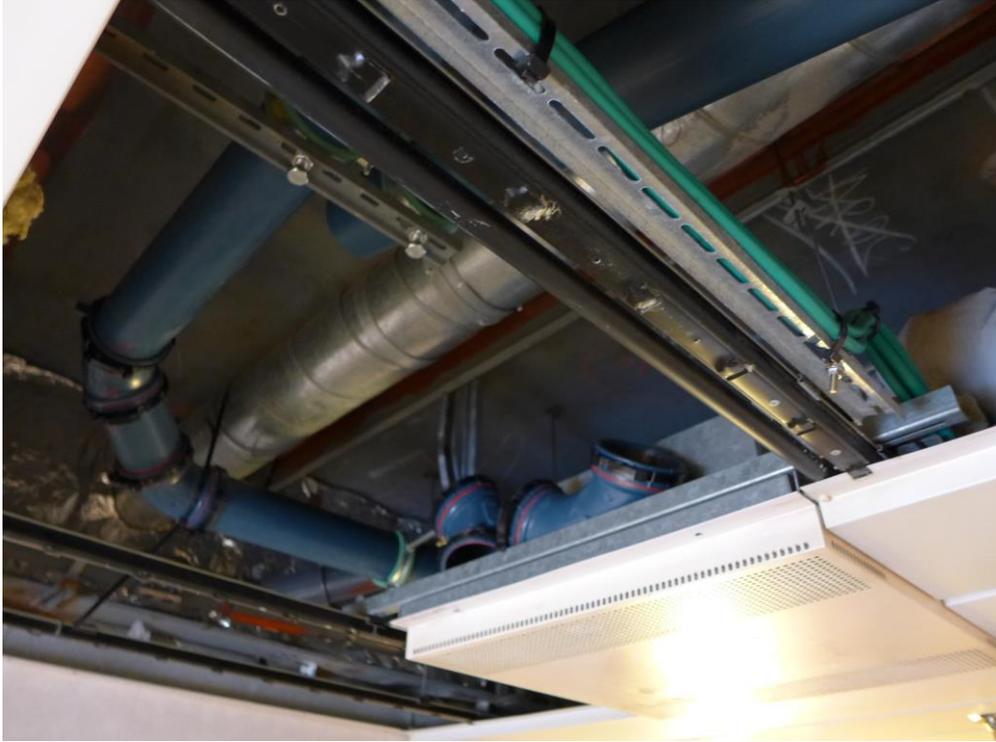
**Figure 4: Similar worksite photographed on 10<sup>th</sup> April to show pipe replacement work**

At 0900 hours the vacuum system to the branch line involved was isolated and cutting of the pipe commenced. Once the isolated line was exposed, the plastic piping was cut

and removed from the position, new piping was cut to fit and existing clamps were used where possible.
