**The Bahamas
Maritime Authority**

M.v. Platinum Explorer

**Report of the marine safety investigation into
the fatal accident of the Trainee Driller on 25th February
2016 at Labuan Anchorage, Malaysia**

Date of Issue: 26 March 2018

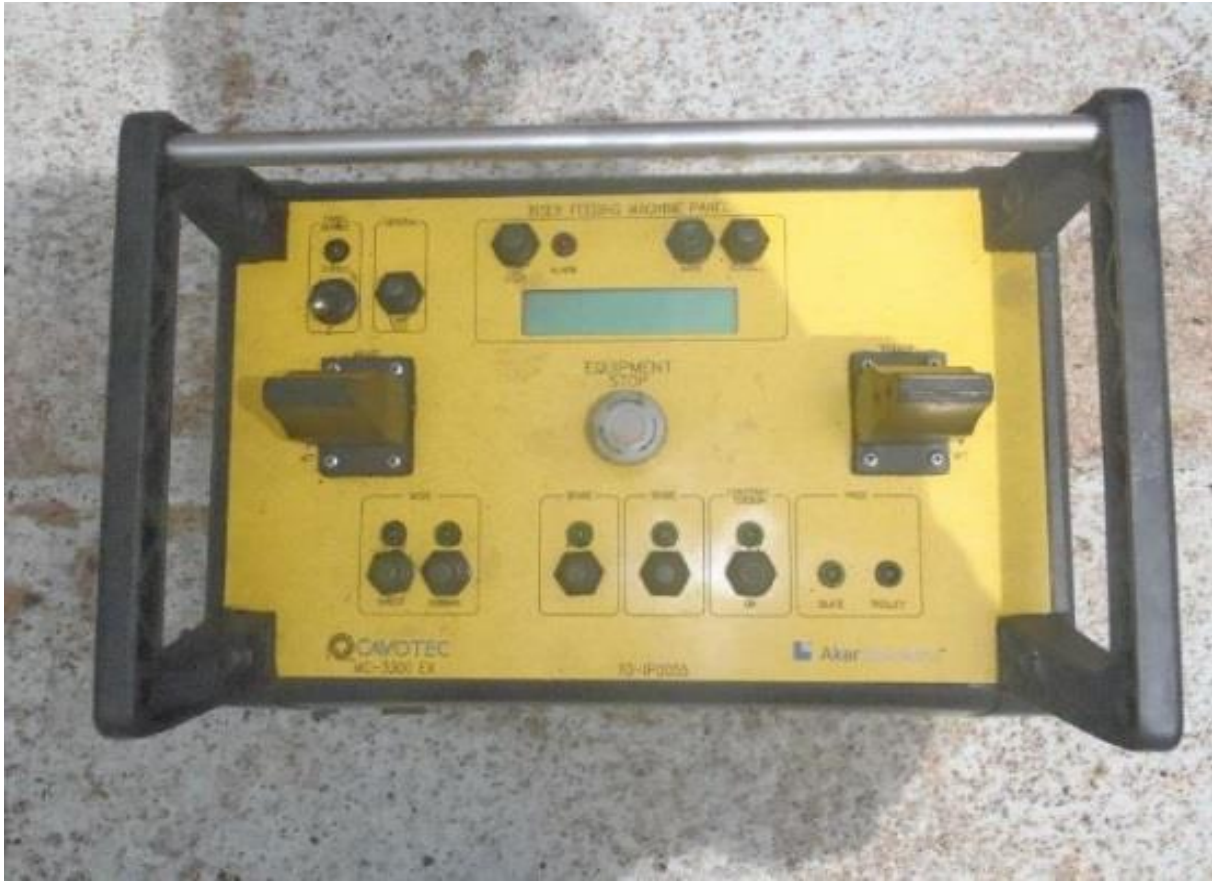
Figure 8: Remote Control Panel (RCP) for operating the RFM

- 3.6.3 The machine is hydraulically powered through the rigs hydraulic ring-line system. Once the system is powered-on the RFM can only be operated remotely by the Remote Control Panel (RCP, figures 8 & 9).
- 3.6.4 The enable switch must be switched-on (up) and the status yellow light will indicate that the RCP is enabled. Then normal or direct mode is selected which will be indicated by the green light. After which the skate and or trolley can be moved forward (towards the rig floor) or aft (away from the rig floor) by the respective toggle.

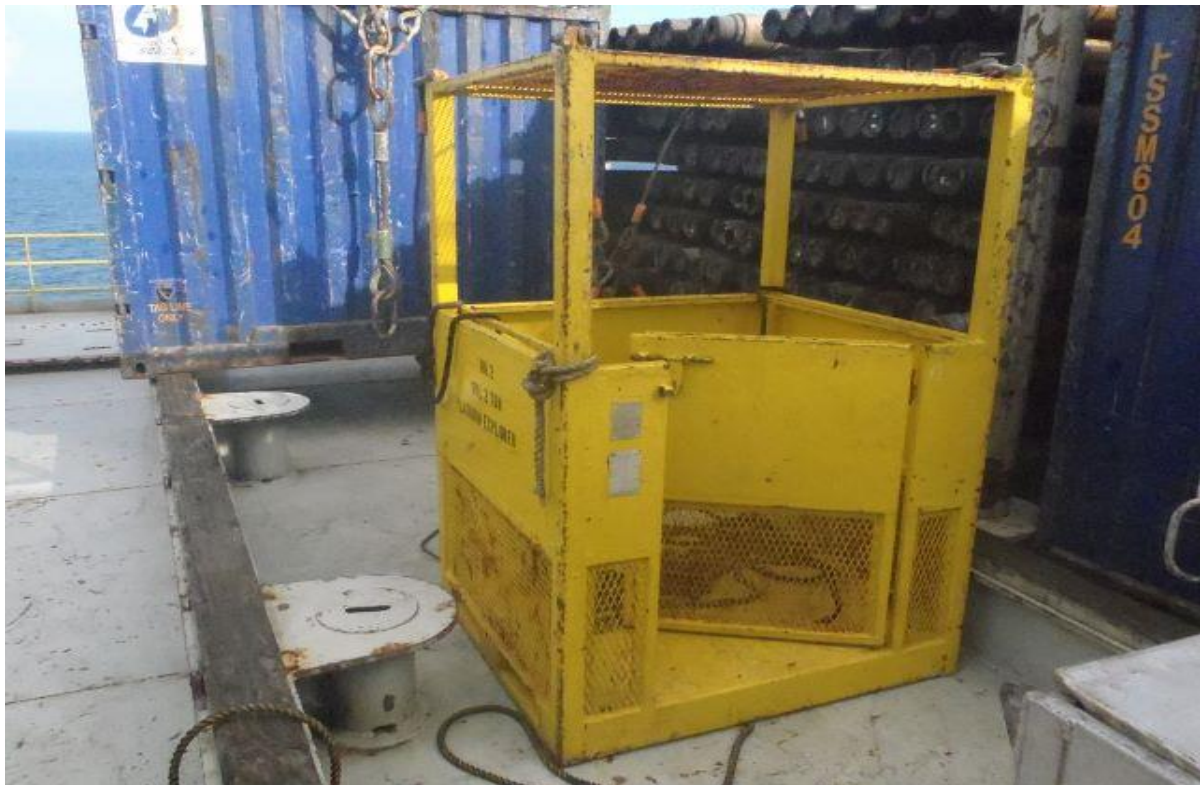
Figure 15: Work basket

- 4.1.19 The Medivac boat 'Mermaid 11' (figure 16) arrived alongside the vessel at 1605, the Trainee Driller was transported by wheelchair from the medical centre to the main deck. As the Trainee Driller could not be laid down it was decided that they would transfer the Trainee Driller from the main deck to the boat using the work basket (figure 15). The Trainee Driller had to be taken from the medical centre, down a level to the accommodation deck using the elevator and then out to the main deck. The Trainee Driller was lifted into the work basket accompanied by the Medic, it was then lifted by the crane over the side of the ship and down to the boat where the Senior Toolpusher and Chief Officer were waiting in order to safely land the basket and assist in getting the Trainee Driller out.

Trainee Driller. It would have then been known that the stretcher and wheelchair could not fit into the work basket without removing the handles. Furthermore, it could have been identified that the wheelchair would not be able to fit below the deck of the Mermaid 11 whilst carrying a casualty.

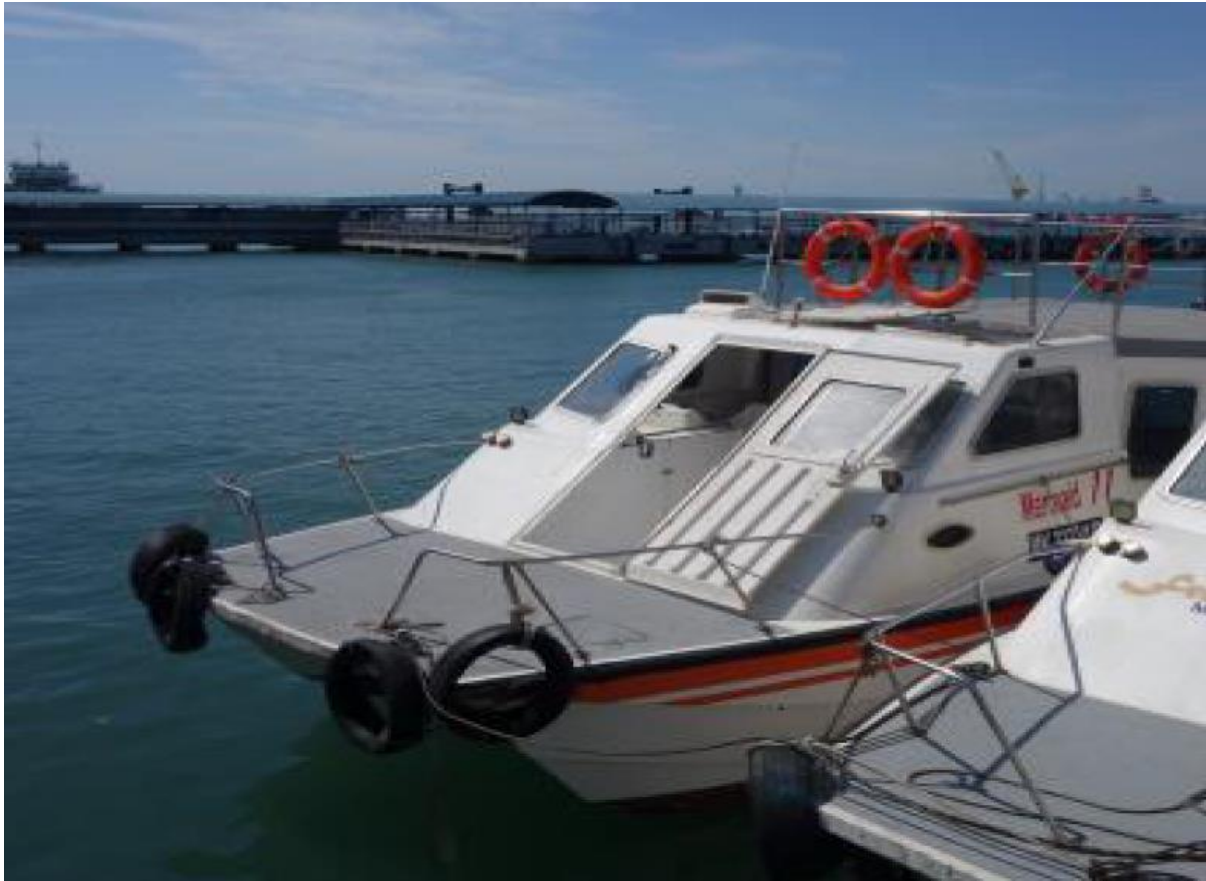
Figure 16: Medivac Boat 'Mermaid 11'

- 4.1.20 Once safely onto the boat the Trainee Driller was removed from the work basket by the Chief Officer and Senior Toolpusher. The 'Mermaid 11' is a crew boat and has a flat top deck surrounded by stainless steel handrails with narrow spiral stairs to an internal cabin area. Due to the narrow stairwell the wheelchair was not able to fit down the spiral staircase to the boat's cabin. It was decided to secure the wheelchair with the Trainee Driller still sat in the wheelchair to the front rail on the flat top deck with Senior Toolpusher and Medic beside.

- 4.1.21 The 'Mermaid 11' departed the ship at 1632 and once away from the ship's lee, the boat encountered rough seas which then started to cause the rail the wheelchair was secured to to break. The Senior Toolpusher then shouted to the boat driver to go back to the vessel as it was clear it was not safe to stay on the top deck. Approximately 2 minutes later the boat arrived back at the vessel. The Chief Officer along with the 3rd Engineer boarded the boat and decided the only option was to get the Trainee Driller safely downstairs to the seating area. The Trainee Driller was then assisted to the cabin below by the Chief Officer, Senior Toolpusher and the 3rd Engineer. The Master told the SDPO to inform the SOMC that he would be going ashore with the boat to assist. The Trainee Driller was seated on the front seat with the Medic beside him and the Senior Toolpusher the other side. The Medic requested for more O2 bottles (figure 17). O2 bottles were lowered but the Medic requested for a bigger bottle which was also supplied from the onboard medical centre. The Chief Officer and 3rd Engineer left the boat and the SOMC embarked on the boat to accompany them ashore.

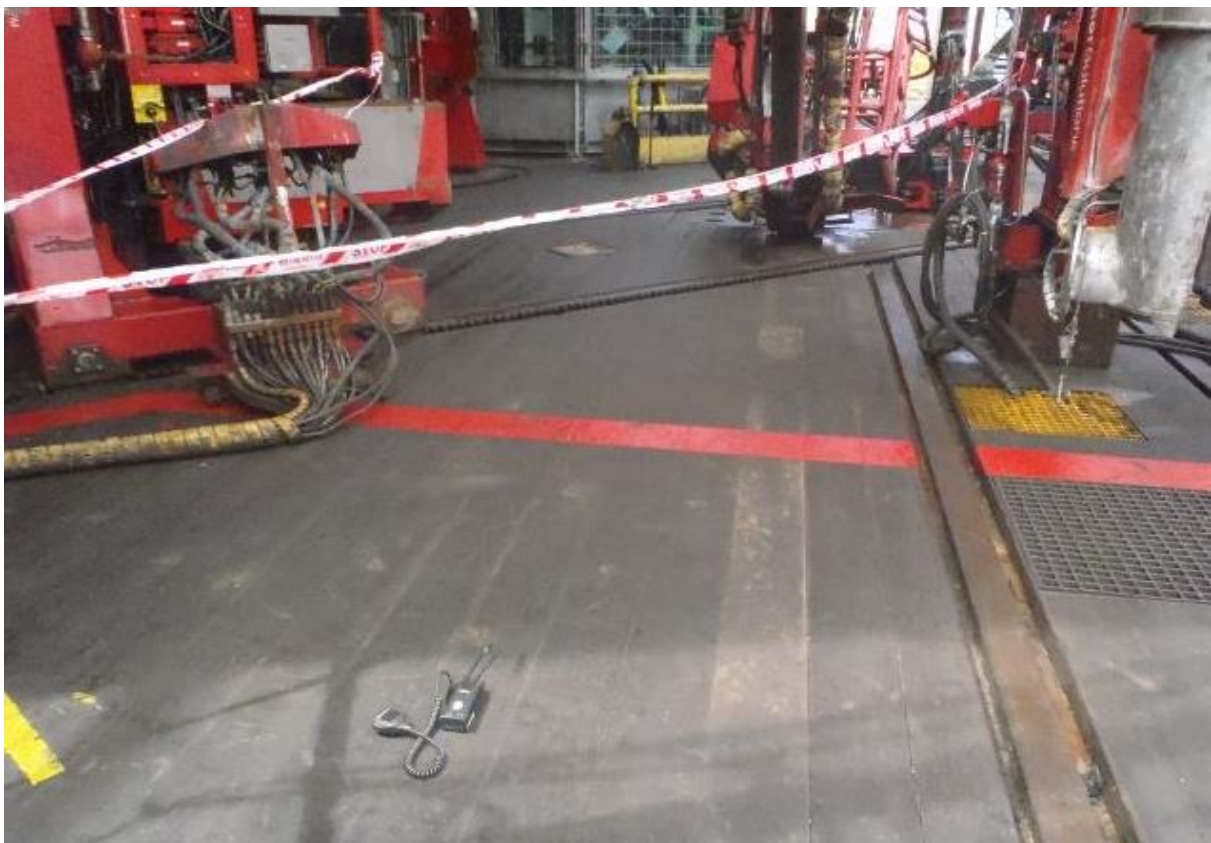
Figure 19: UHF on drill floor

- 5.7.7 The normal means of communication between individuals on board but not in sight of one another was via individual's personal hand-held UHF radio. After the accident, the Trainee Driller's UHF unit was located almost equidistance between the RFM and the drill house (figure 19), indicating that enroute to the drill house he abandoned the UHF unit. During the course of the investigation, the UHF unit was not tested to confirm whether it was working.

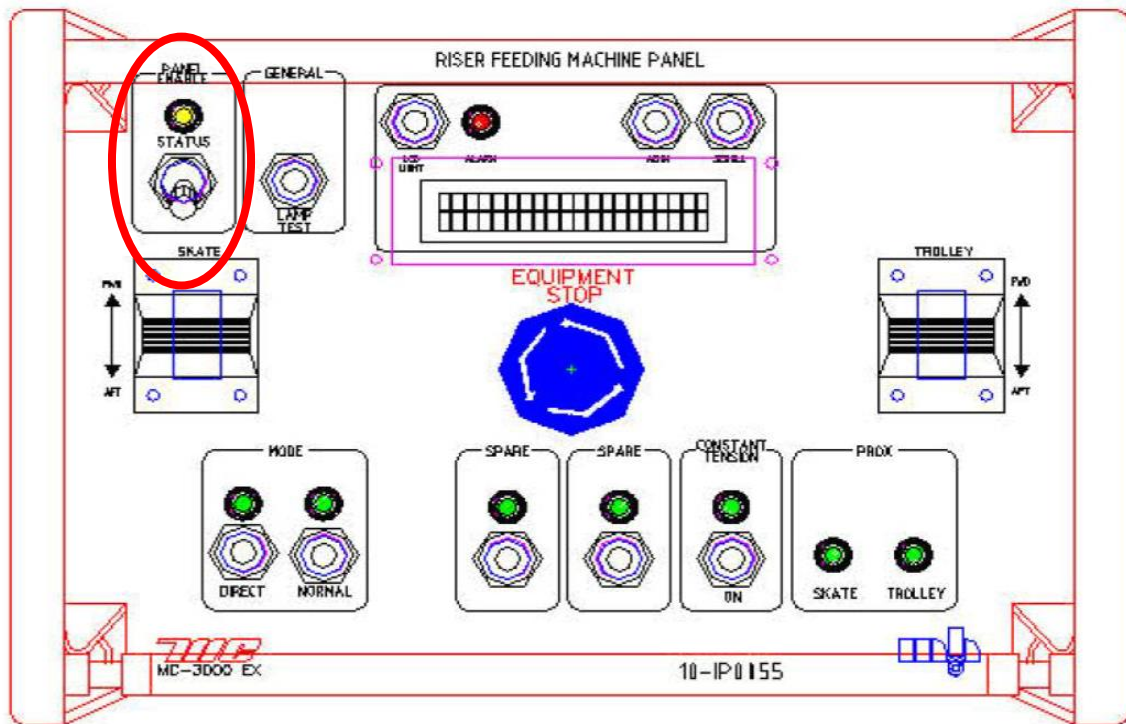
- 5.6.1 The RFM is operated by a Remote Control Panel (RCP). The panel is designed to be operated by one person only in vicinity of the RFM. The unit is designed to be held by the operator supporting the weight of the unit with both hands. Once the RCP is set in the active position, the RFM will operate with the functioning of the controls by the operator.

Figure 26: Remote Control Panel schematic (status button and yellow light indicated in red circle)

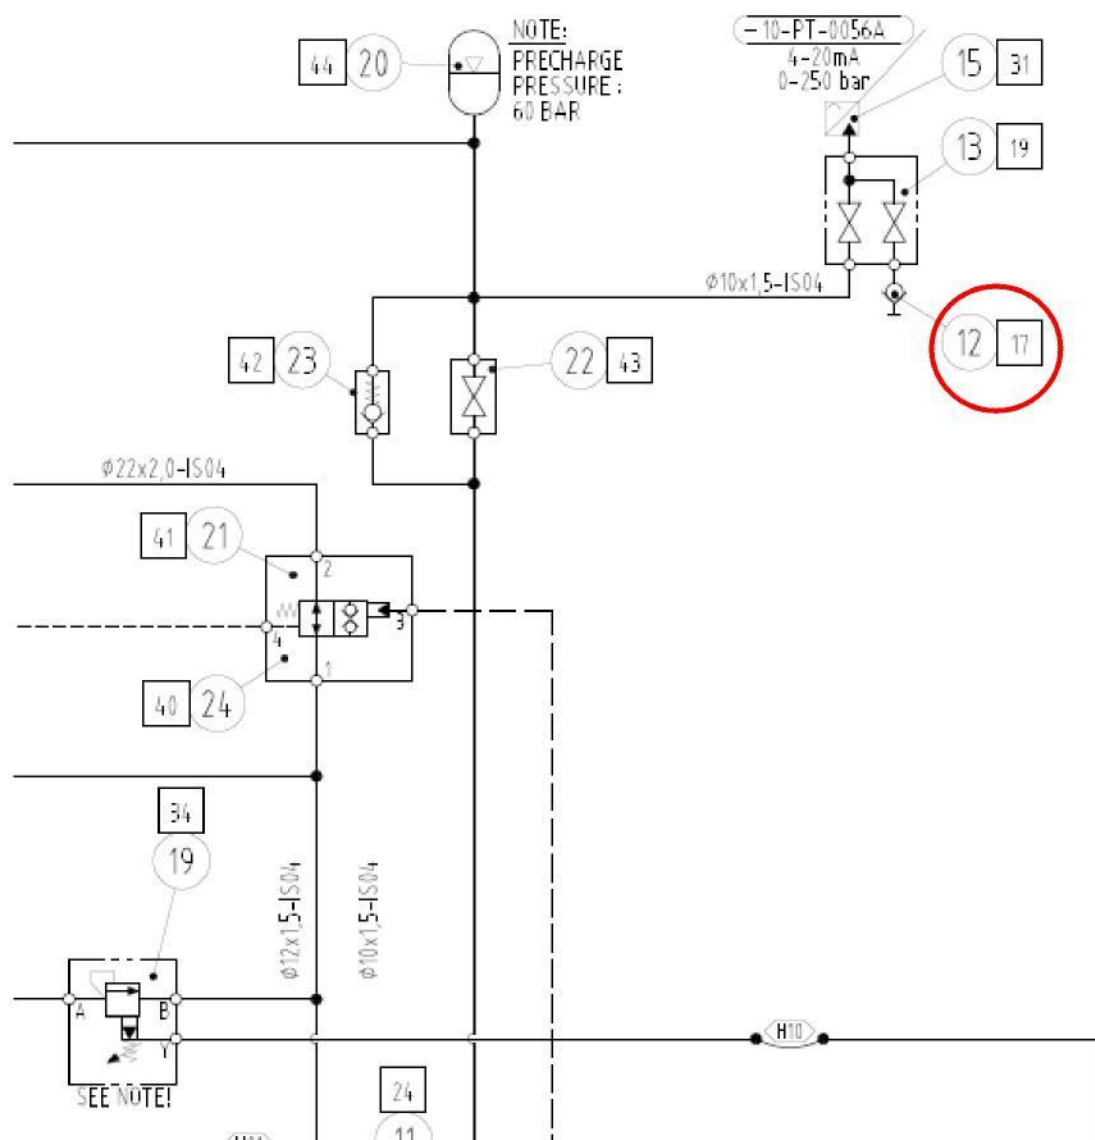
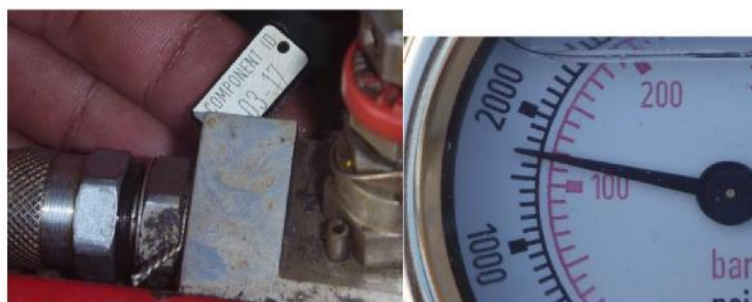
- Checked and verified all plumbing on the Riser Feeding Machine in accordance to these drawings.
- Function test Riser Feeding Machine, verifying pressure settings as per drawings.
- Test brake release pressure at constant tension mode from port ID 03-17. Pressure reading 125 bar. Refer to drawing 3285263.

Pressure reading 125 bar, from port ID 03-17. Refer to drawing 3285263.
