M.V. Tropical Star

**Report of the marine safety investigation into a
crew fatality on a refrigerated cargo vessel
on 15 June 2019**

M.V. Tropical Star – Marine Safety Investigation Report

Date of Issue: 19 November 2019

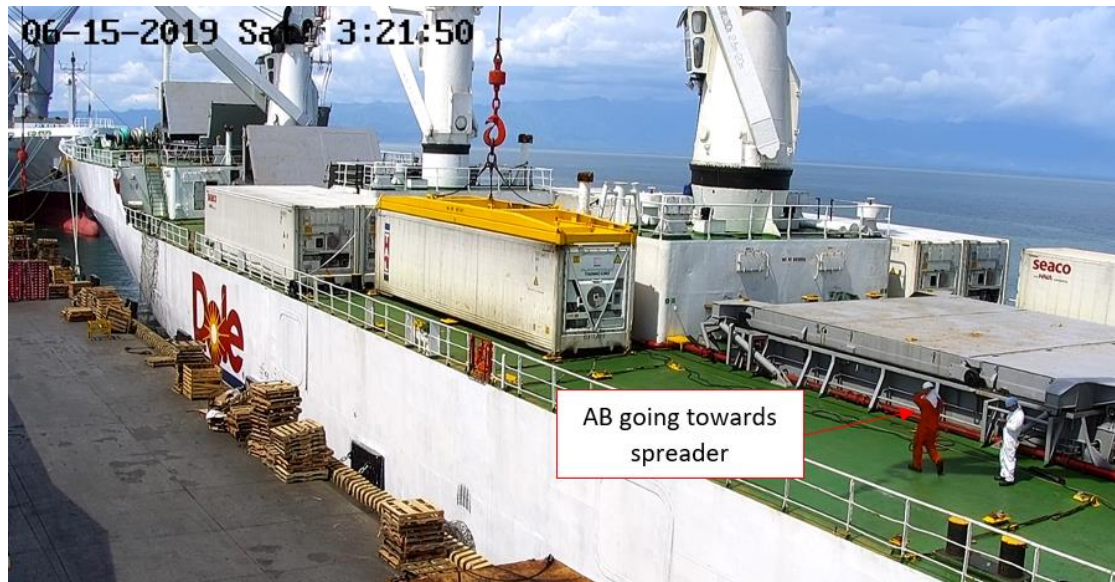
Figure 6: CCTV footage screenshot of AB going towards the spreader

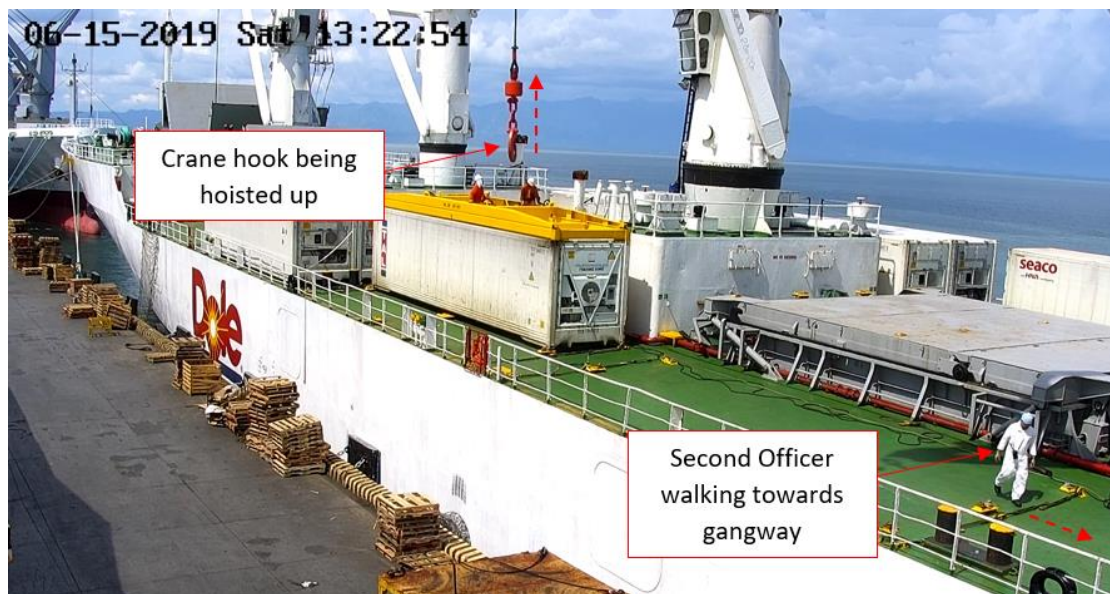
- 4.11 The crane was unhooked from the container and the hook was hoisted up to test the proximity switch of the crane. The Second Officer left the vicinity and went towards the gangway.

Figure 10: CCTV footage screenshot of Second Officer leaving the vicinity and going towards the gangway

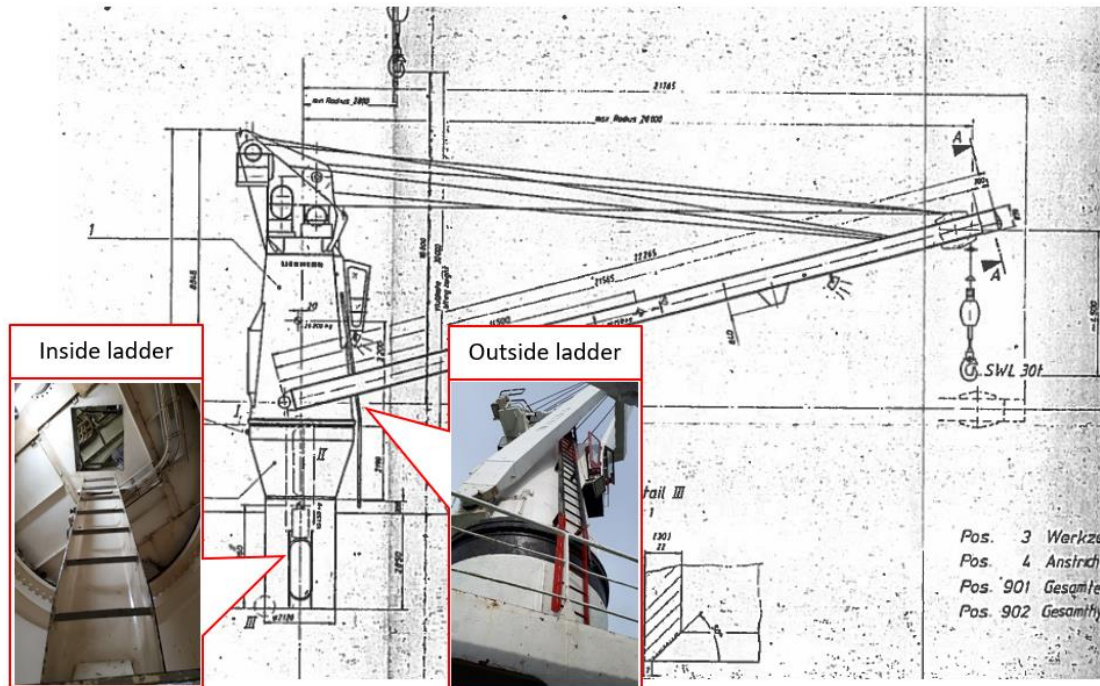
Figure 14: Location of the inside and outside crane access

- 5.1.2 The inside crane access was divided into three platforms with vertical ladders connecting each platform and providing access from ship's deck to the crane cabin.
- 5.1.3 The outside vertical ladder provided access from the crane mast housetop to the crane cabin while the mast house had another vertical ladder providing access from crane mast housetop to the ship's deck.

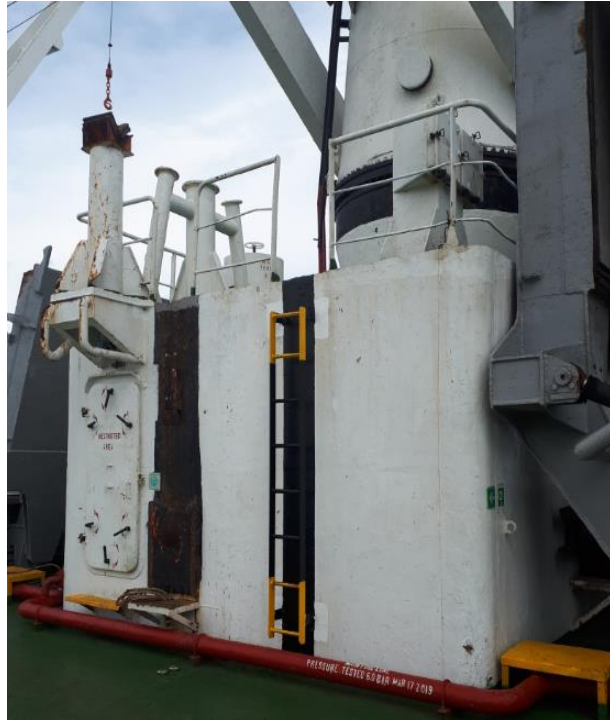
Figure 15: Crane no. 3's mast house vertical ladder

- 5.2.5 The OS and AB were exposed to the fall hazard at various instances while climbing on the container top and on the crane mast house ladder without any fall prevention safety measures in place. However, these hazards were not identified and mitigated by the crew members or the Second Officer on deck.

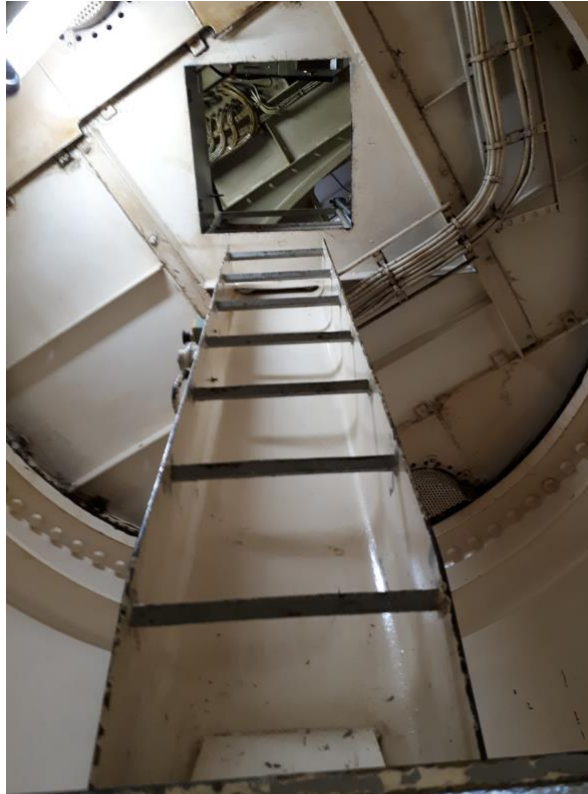
Figure 17: Inside ladder access to crane cabin
