M.v. SEADREAM I

**Report of the investigation into an engine room fire
on 01st September 2016 approximately 43nm off the
South West Italian coast.**

M.v. SEADREAM I - Marine Safety Investigation Report

Date of Issue: 07 July 2018
Bahamas Maritime Authority
120 Old Broad Street
LONDON
EC2N 1AR
United Kingdom

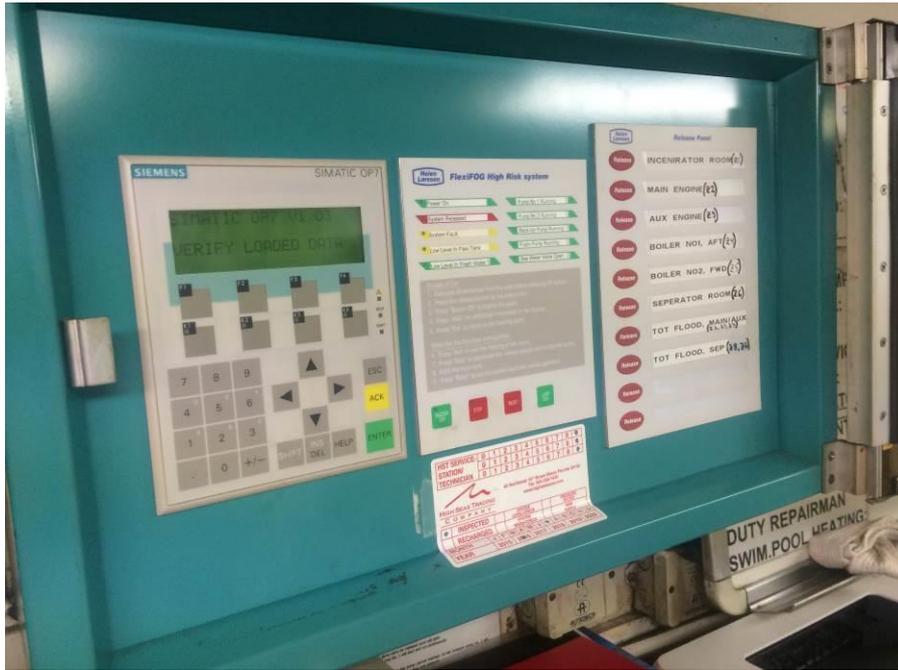
Figure 12: Flexifog system in ECR

- 4.17 The 2-person fire team proceeded to the main engine room door aft and assessed the temperature of the door. They assessed that the temperature of the door was too hot and retreated back to the fire station. The Chief Engineer then ordered them to be on standby and instructed them not to enter the engine room without his permission.
- 4.18 The Chief Engineer donned a BA set and proceeded to the ECR to check if the sprinkler system (figure 11) had been activated. He observed that although the power supply indication was on, there was no power to the screen showing the zones.

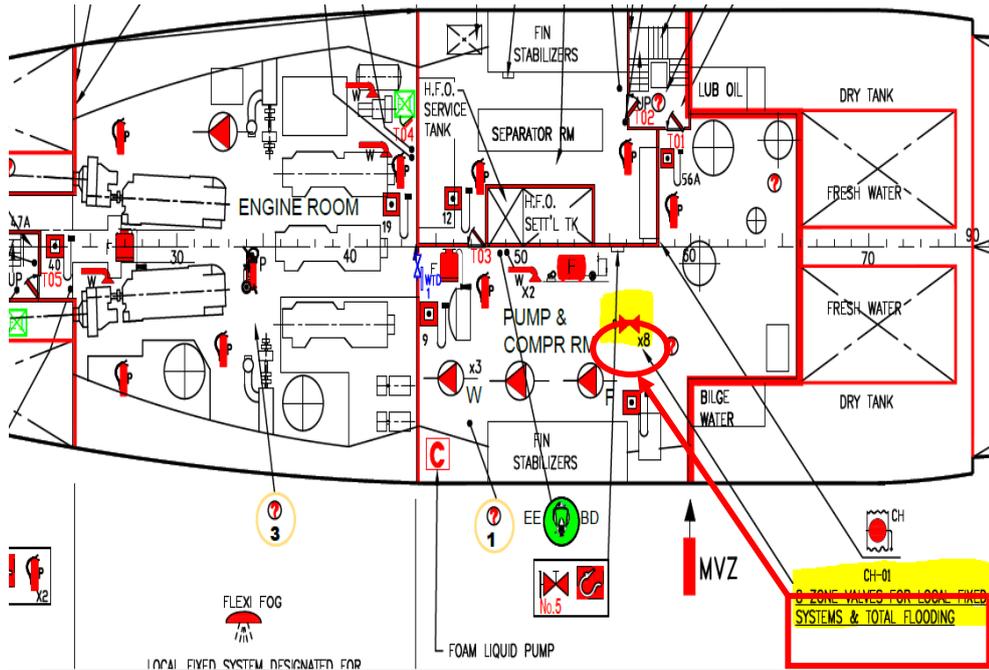
Figure 13: Position of sprinkler system valves in pump room on the tank top

4.21 On reaching the pump room the Chief Engineer found that all 4 sprinkler system supply pumps (figure 13) were running and the manifold pressure was at a pressure of between 17 – 19 bars, however, the manifolds for the release zones were showing a zero-bar pressure. The lack of pressure on the zone manifolds indicated that none of the sprinklers for the zones had been activated.

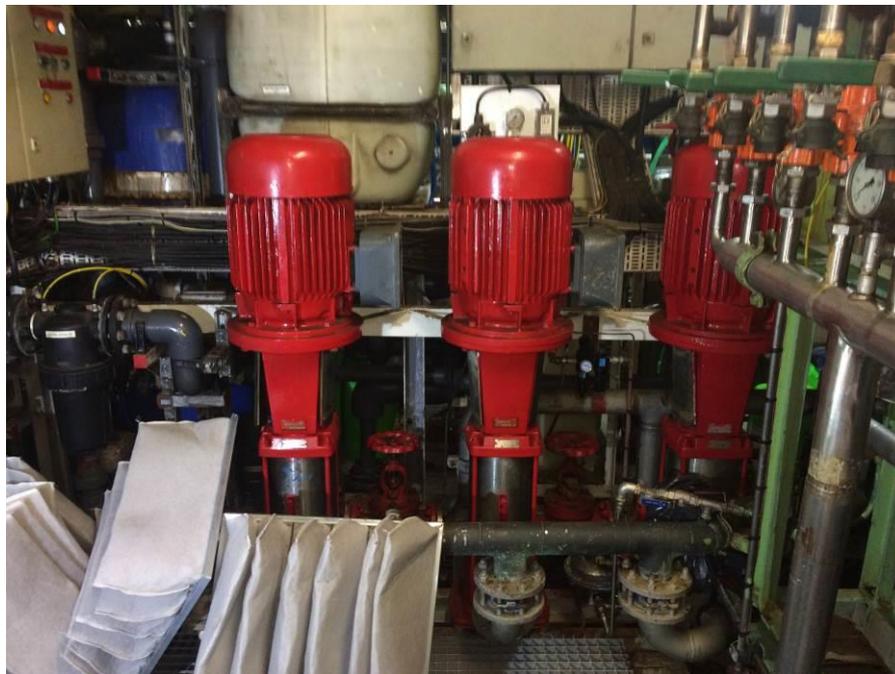
Figure 14: Water mist supply pumps in the pump room

4.22 On realising that there was currently no extinguishing median entering the spaces on fire, the Chief Engineer manually operated the release solenoid

valves (figure14) for the main engine 1, main engine 2, boilers and generators. One of the solenoid valves was not staying in the open position, so the Chief Engineer kept it open with the assistance of a G-clamp (figure15).

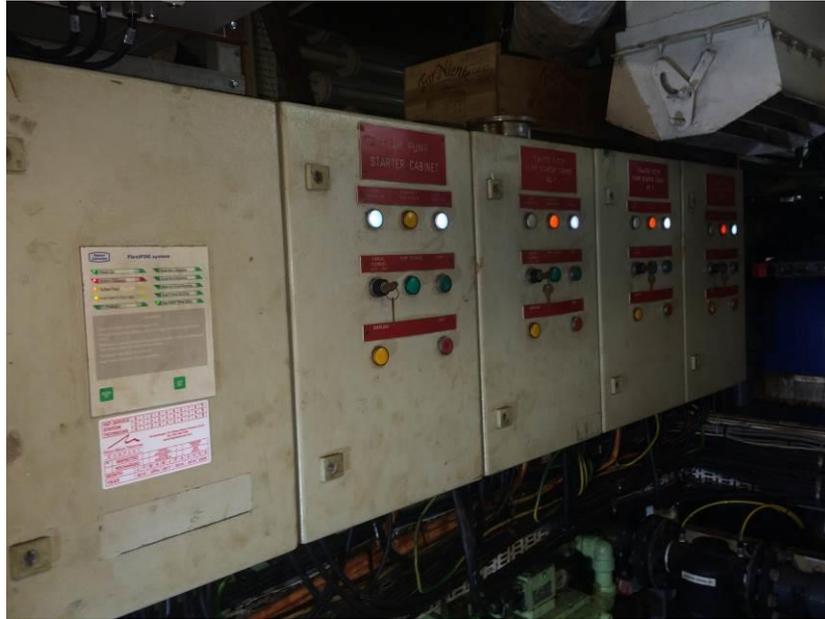
Figure 19: Sprinkler pump starters in the pump room

- 4.26 Due to the emergency generator stopping, the sprinkler pumps had cut out and the Chief Engineer had to go back to the pump room and restart (figure 19) them in order to continue the fire-fighting efforts.
- 4.27 The pumps continued running for approximately 10 more minutes until the Chief Engineer observed a reduction in temperature on the surrounding bulkheads.

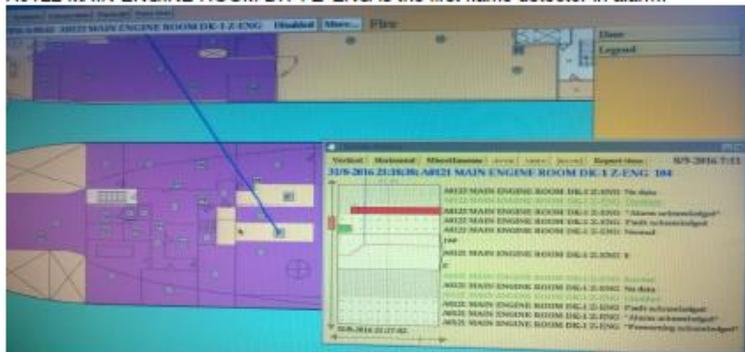
Picture form Autromaster

A0122 MAIN ENGINE ROOM DK-1 Z-ENG is the first flame detector in alarm.

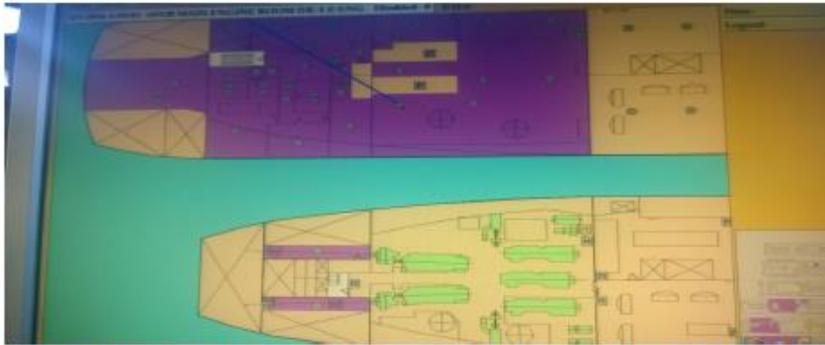
After this alarm many smoke detectors go direct in alarm All the 15 first detectors are displayed and give alarm on the BS-100 central and on the Autromaster 5000 graphical computer on the bridge. During the first 2 minutes was all detectors in the engine areas and detector no. A0279 FUNNEL DK-2 Z-2 in the casing on Deck 02 in alarm.

We also see that the system get 3 faults on the BS-100 panel: Earth fault and Short Circuited with in the 2 min. after the fire start. This indicate that the loop cabel was melted becuse of the heat in the engine room.
