**The Bahamas  
Maritime Authority**

### **FOUR C'S ADVENTURES 37ft Aluminium Catamaran 'Unnamed'**

**Report of the marine safety investigation into an explosion resulting in loss of life and multiple serious injuries on board a 37ft charter boat at Exuma, Bahamas on 30 June 2018**

Date of Issue: 01 October 2018  
Bahamas Maritime Authority  
120 Old Broad Street  
LONDON  
EC2N 1AR  
United Kingdom

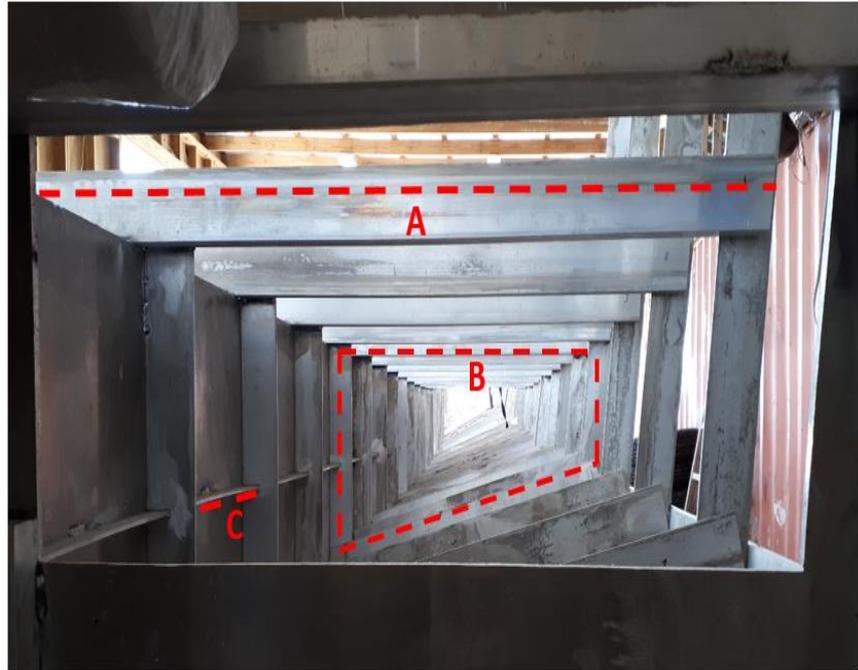
**Figure 4: Internal starboard pontoon structure of 60ft catamaran under construction, looking forward from the transom**

- 3.2.1 The photograph within figure 4 was taken by the marine safety investigator of the 60ft catamaran under construction at the Owners registered business address. It was confirmed by the Owner that this boat and the subject boat of this investigation are constructed using identical techniques.

- 3.2.2 The hull is constructed entirely of aluminium. The aluminium plates used in the construction process are of three thicknesses, namely; 3/16” plates for the side plating and cockpit deck, 1/4” bottom plating and 1/2” plates for the transom. The plates are Tungsten Inert Gas (TIG) welded to a transverse frame (B) constructed out of 2” and 1” angle bars. Each pontoon was framed using a ‘D’ frame configuration with each transverse frame spaced approximately two feet apart. A longitudinal stiffener (C) is used to provide longitudinal strength. Multiple transverse beams (A) of 4”x2” are used across the entire width of the boat joining the port and starboard transverse frames in which the cockpit deck is welded to. The centre hull section of the boat is constructed out of 1/4” aluminium plates and welded to the inner most transverse frame and the underside of the transverse beam.

A - Transverse beam  
B - Transverse frame ('D' frame)  
C - Longitudinal stiffener

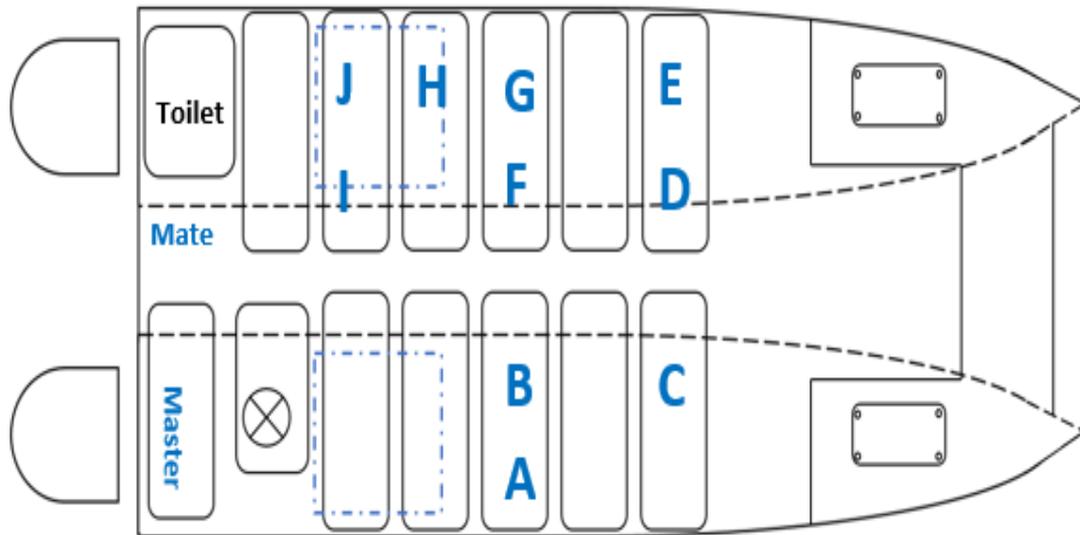
**Figure 10: The seating location of the 10 passengers and two crew at the point of the explosion**

- 4.10 The testimony provided by those who witnessed the explosion from onboard, recalled the explosion was followed by flames across the deck of the boat and large quantities of debris consisting of aluminium deck plates, bench seats and the canopy structure either displaced or missing.

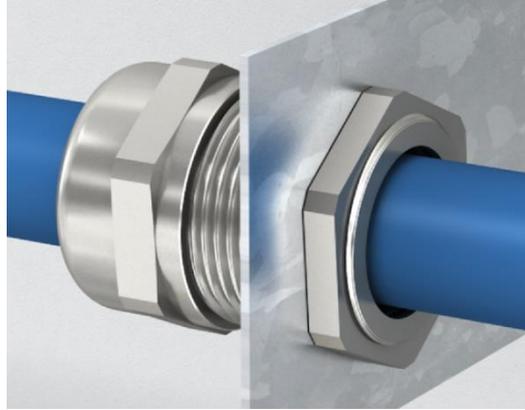
**Figure 15: An example of electrical cable gland fitted in an aluminium bulkhead**

5.3.4 As there was no inspection conducted, it cannot be confirmed if the electrical cables that passed through the transverse beam were properly protected to ensure the insulation material surrounding the electrical cable (conductor) was protected. If the electrical cable is not protected by a cable gland<sup>7</sup> or equivalent method (see figure 15), chaffing of the insulation material surrounding the

conductor can occur, this will compromise the integrity of the insulation and expose the conductor within.

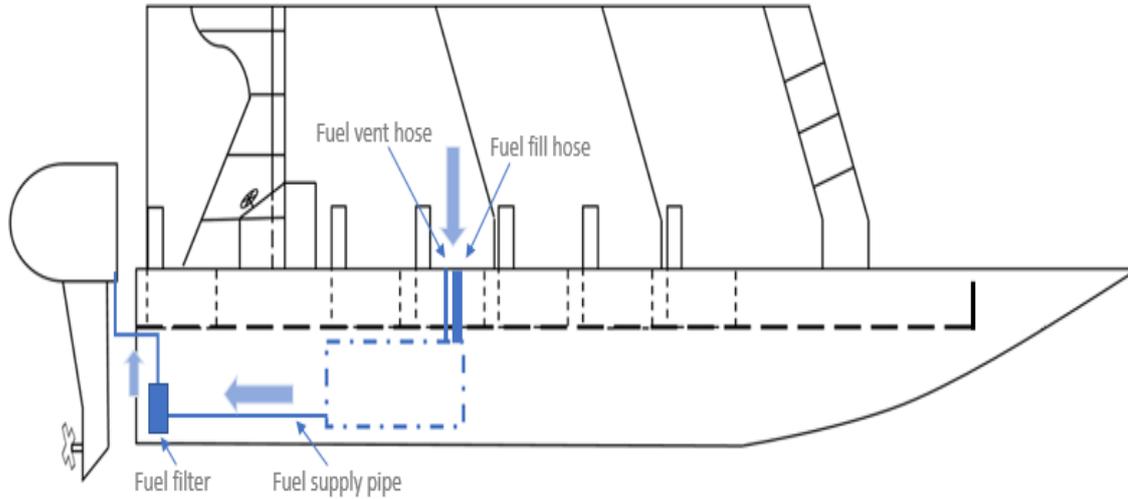
Figure 17: Schematic of fuel system on board

5.4.1 The fuel system on board consisted of an aluminium tank located within each pontoon approximately 2m in front of the transom. The tank was welded and suspended from the underside of the transverse beam and supported on each side within the transverse frame. Each tank had a fuel fill hose, a fuel vent hose and a fuel supply pipe. The filling and vent hoses were located on top of the tank in the forward, outboard corner and secured in place by two hose clips.

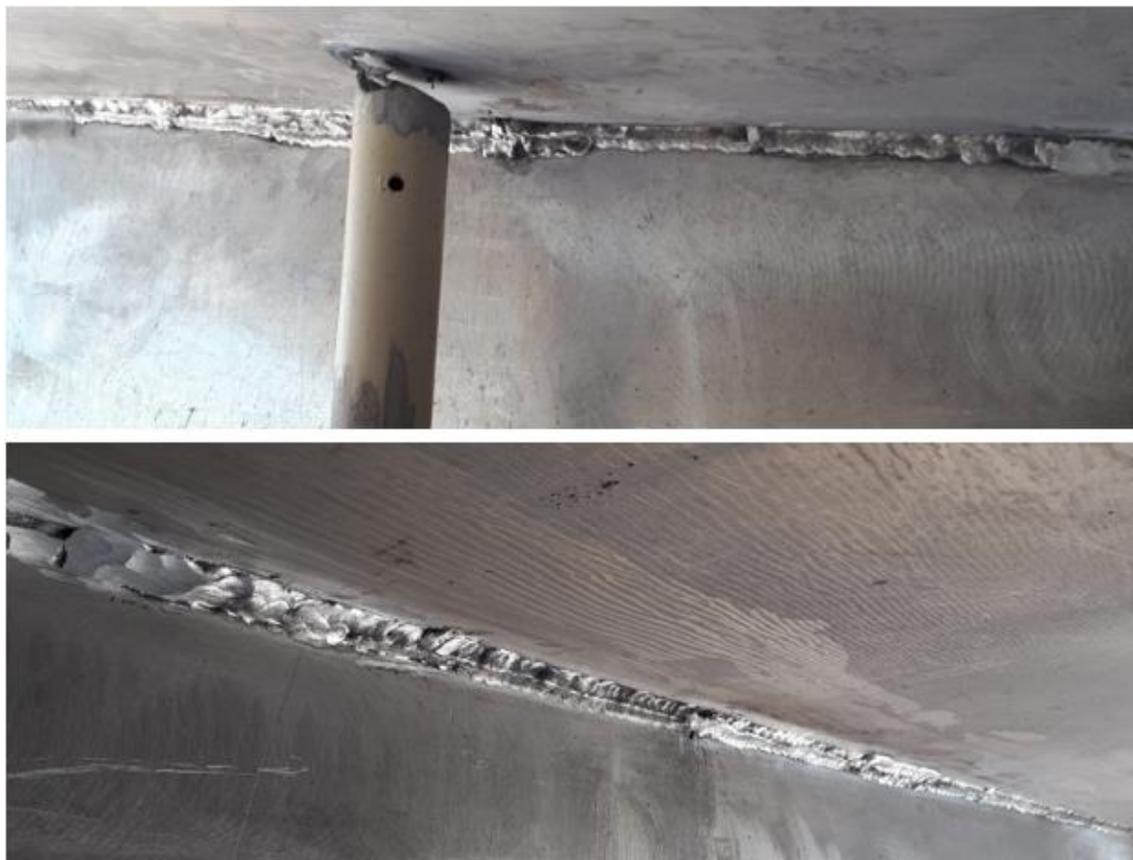
**Figure 21: Internal TIG welds used in the construction of the 60ft aluminium catamaran**

- 5.5.3 The Surveyor provided one recommendation to the Owner within the report, which states: *“While interior seams and joints were extremely well welded, the exterior welds were poorly done and would need continuous monitoring.”* CBA Engineering Ltd. was approached during the course of this investigation in order to validate this statement, which, based on the facts outlined in paragraph 5.5.2, the Surveyor’s recommendation must be based on an assumption rather than fact. Unfortunately, CBA Engineering Ltd. declined to provide any assistance or provide an explanation as to how this recommendation was ascertained.

- 5.5.4 Two pictures were taken of internal welds used in the construction of the 60ft boat located at the Owner’s premises (as seen in figure 21). It is known that the 60ft boat is being constructed using the same techniques as the 37ft Boat. The pictures taken were provided to two independent marine welding specialists associated with two independent Classification Societies<sup>9</sup>. The following opinions<sup>10</sup> were provided: *“the welds shown in the pictures are not of sufficient quality. The welds show large amounts of lack of fusion and I would doubt that they have sufficient penetration in order to give the joints enough strength”* and *“the example does not look adequate”*.

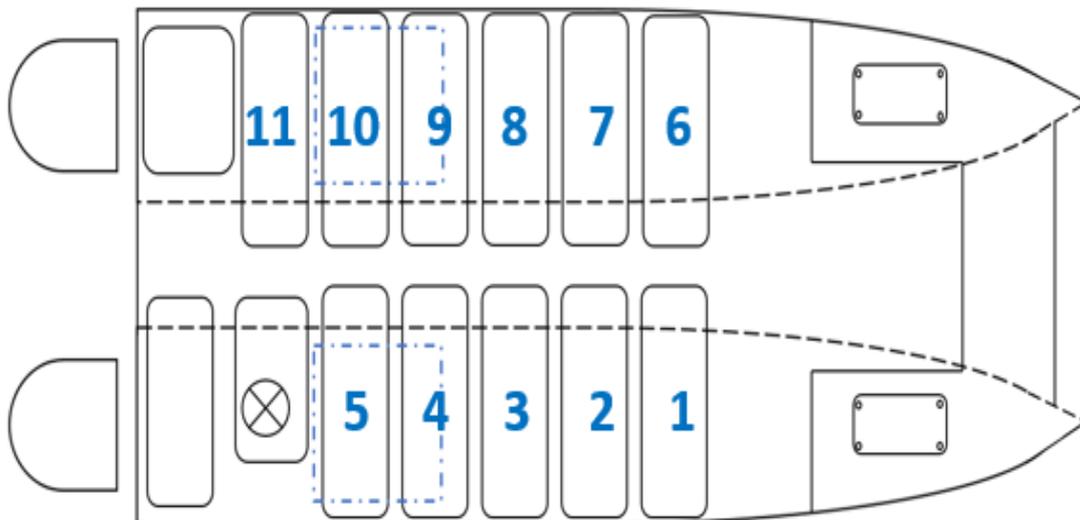
**Figure 25: Seating arrangement as numbered 1 - 11**

5.7.6 Based on the significant structural damage in the forward section of the starboard pontoon, the most likely scenario is that the explosion of gas and vapours of combustible liquid occurred in front of the starboard fuel tank. The explosion of a combustible atmosphere generated by gas and vapours in this section of the boat would result in the initial over pressure resulting in a blast wave dispersing forward, filling the void within the pontoon to a point where the structural integrity of the hull could no longer contain the over-pressurisation. The explosive pressure contained within the starboard pontoon, sought to find the path of least resistance. As indicated by the witness testimony, the analysis of the concentration of injuries and based on analysis of the debris found at the scene, it is determined that the explosive path was beneath the deck in the proximity of seats 1, 2 and 3 (see figures 24 and 25).
