The Bahamas Maritime Authority

“HARBOUR KRYSTAL”
IMO Number 9330020
Official Number 8001246

**Report of the investigation into the explosion
and fatality on the 6th March 2013**

Date of Issue: 30th August 2013

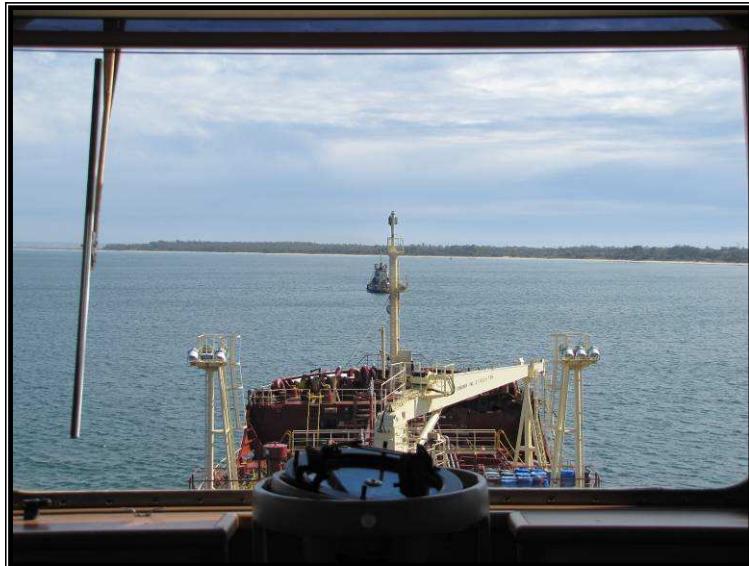
- 3.35 At 09.12 hrs a loud explosion was heard followed by vibration and an impact on the bridge.
- 3.36 The exact location of the explosion could not be seen due to hose crane stowage position although smoke was seen emanating from the forward part of the vessel.

HARBOUR KRYSTAL view from bridge window

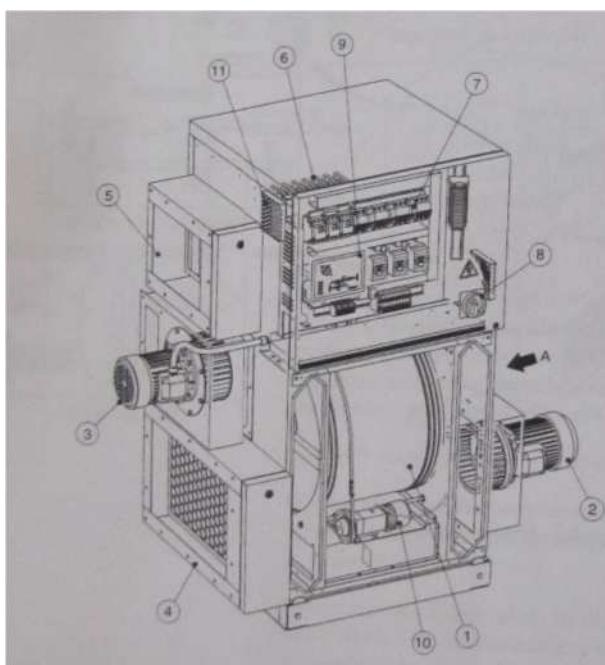
1. Rotor
2. Process air fan and motor
3. Reactivation air fan/motor
4. Process air filter
5. Reactivation air filter
6. Reactivation heater
7. Electric control panel
8. Mains power isolator
9. Switch panel ad temp. display
10. Rotor drive motor
11. Cooling fan

- 5.15 The system is designed to deliver dry air into and air pump which pressurises the line leading to deck.
- 5.16 The unit is connected in line with a fan manufactured by a Norwegian company, NYBORG AS.
- 5.17 While the fan was seen to be built to an explosion proof type, the de-humidifier was not seen to be Ex proof type

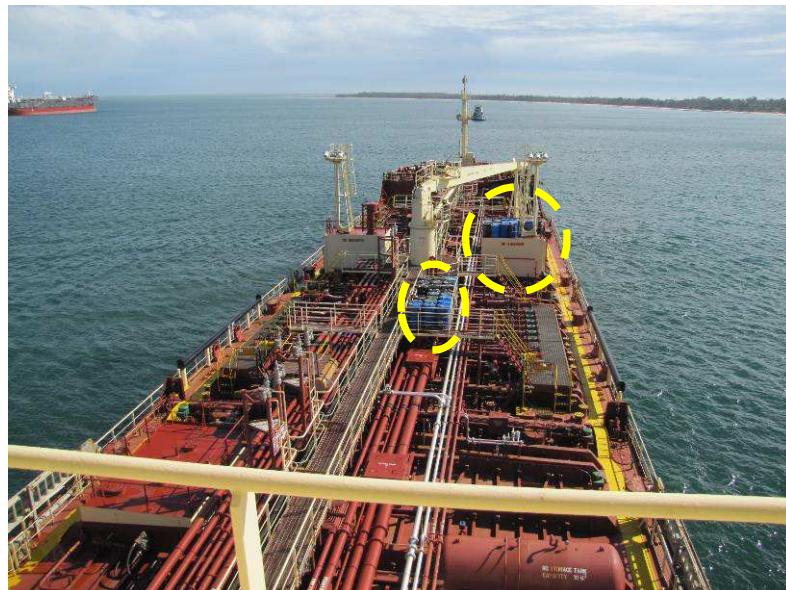
5.37 There were no indications that the bosun store and any area of the forecastle area were being used to stow chemicals or paints. All chemicals seen onboard were stowed midships on deck in blue plastic barrels.

Location of chemicals onboard

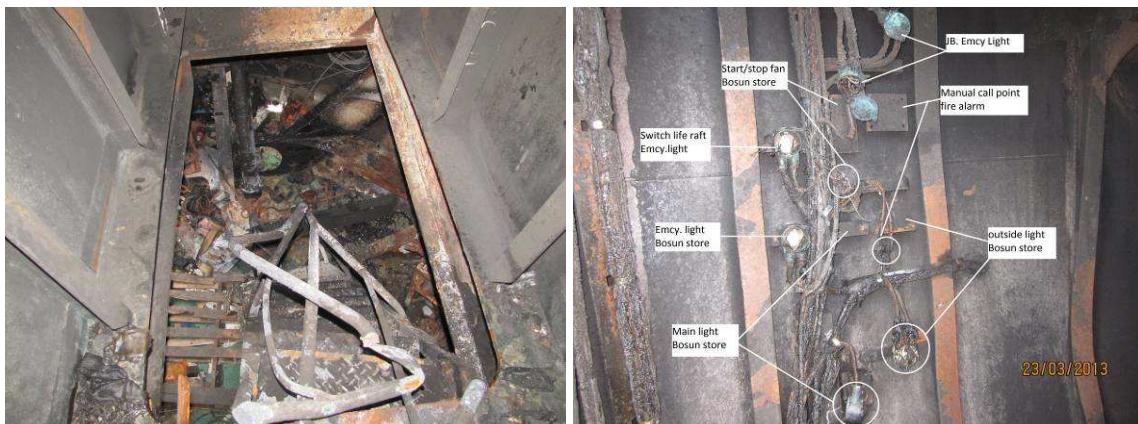
5.38 It is likely that the Bosun went to the forecastle, opened the door and found the forecastle lights on, which were confirmed to be always switched on. He stepped in and closed the door behind him. Immediately after closing the door he switched on ventilation since it is assumed that he would have noted a strong smell inside.

Entrance to forecastle as viewed from upper deck

View of switches easily reachable from inner side of entrance

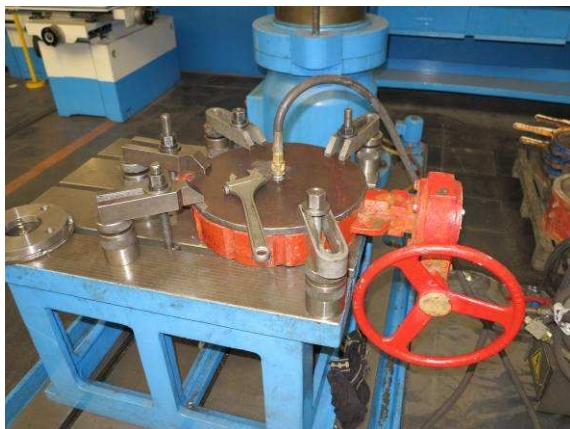
Isolating valve under testing

- 6.2 Although all tank lines were said to be closed, valve tests revealed that a number of those tanks were leaking and their condition was fair. Valves were confirmed by the workshop as not closing properly without excessive force.

- 6.5 None of the valves were included in the maintenance system. Hydraulic tests on valves revealed that they were all partially seized due to lack of maintenance and that valves from 1 Port, 1 Stbd, 2 Port, 3 Stbd, 5 Stbd, main isolation valve and non-return valve were leaking.
