**The Bahamas
Maritime Authority**

IMO Number: 9116876

**Report of the marine safety investigation into a
fall from height overboard on 5th September 2019 in
Livorno, Italy**

Date of Issue: 04 December 2019
Bahamas Maritime Authority
120 Old Broad Street
LONDON
EC2N 1AR
United Kingdom

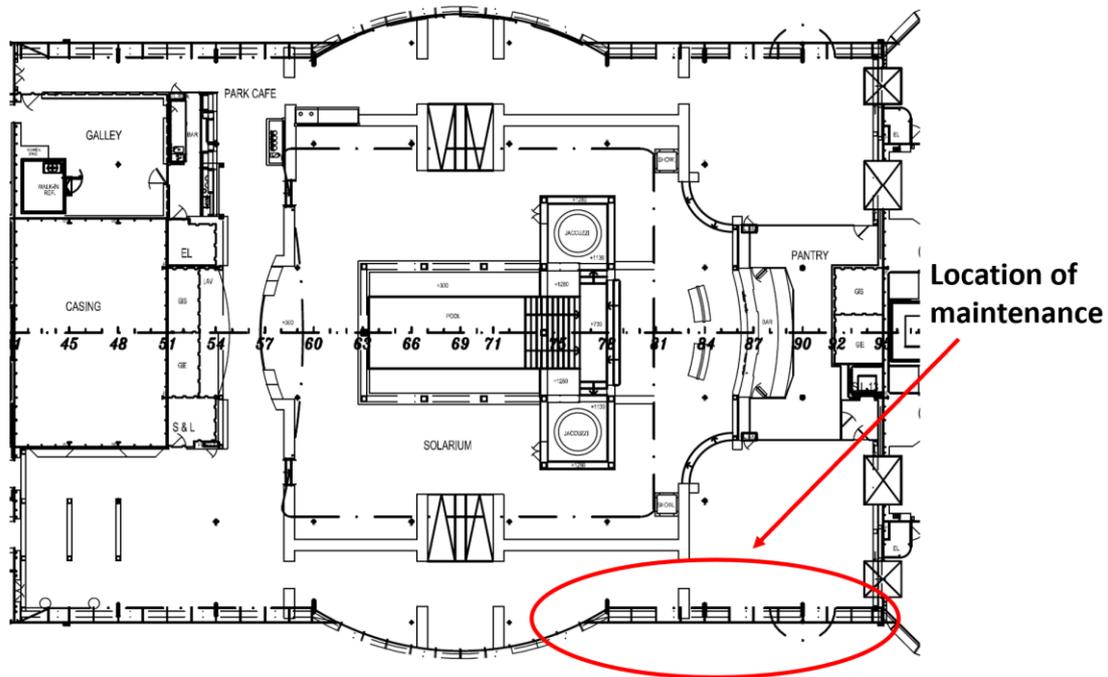
Figure 3: General arrangement plan of Solarium, location of incident circled

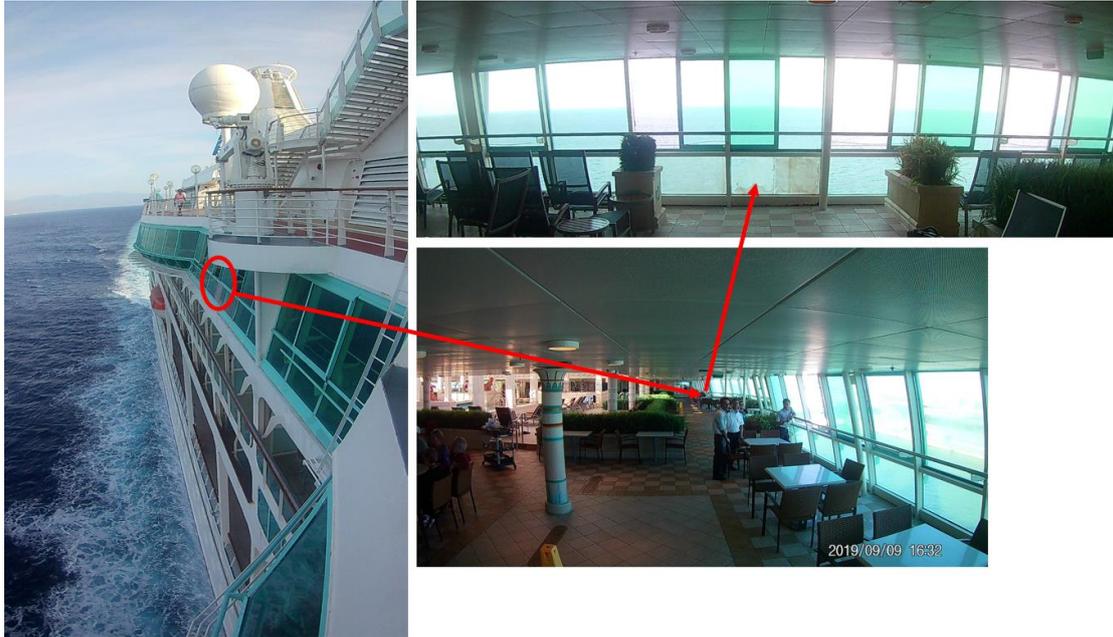
Figure 4: Internal and external view of the Solarium windows in the location of the maintenance work from the perspective of the internal CCTV camera (bottom right picture)

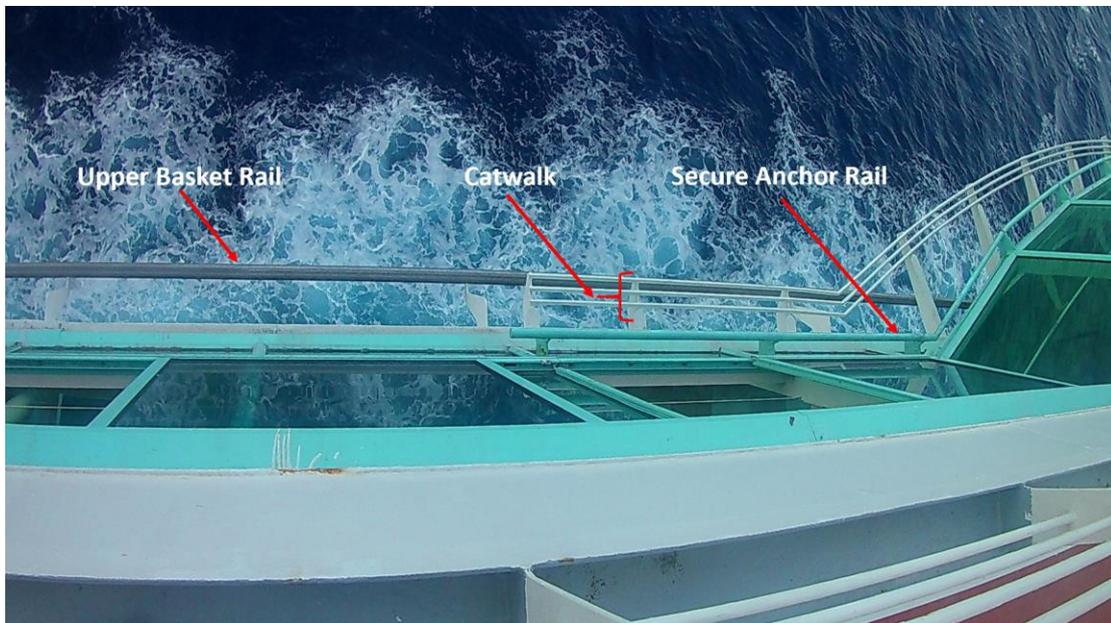
Figure 5: External view of Solarium windows (starboard side), picture taken from deck 10 looking down

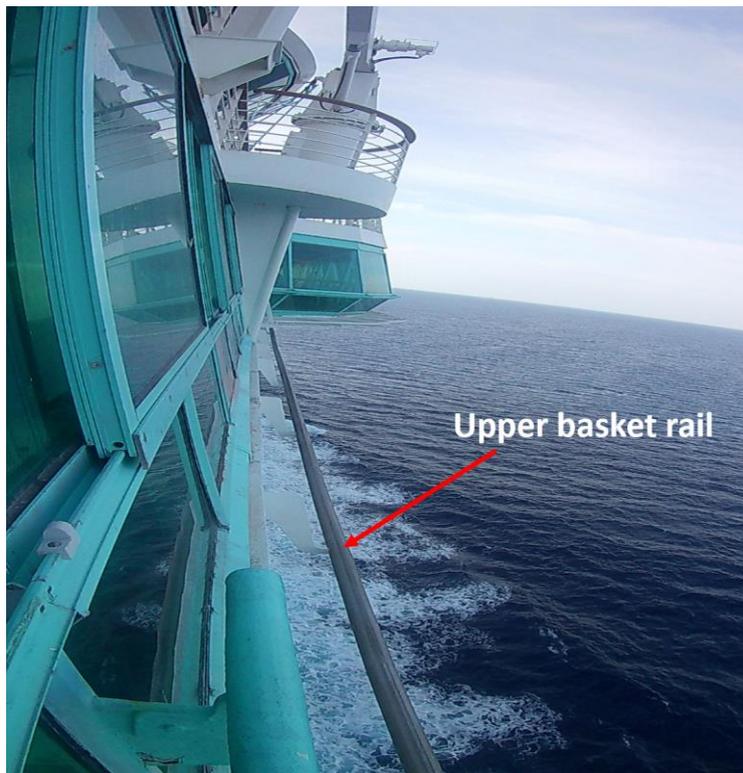
The two Ordinary Seamen donned their harnesses and stepped outboard of the vessel. In order to undertake the maintenance forward of the catwalk the two Ordinary Seamen, led by OS(1) connected their lanyards to the inboard handrail via a strop. Their feet at this point were positioned on top of the upper basket rail which is designed to support and carry the weight of the basket⁴.

Figure 6: External view of Solarium window (starboard side) looking forward

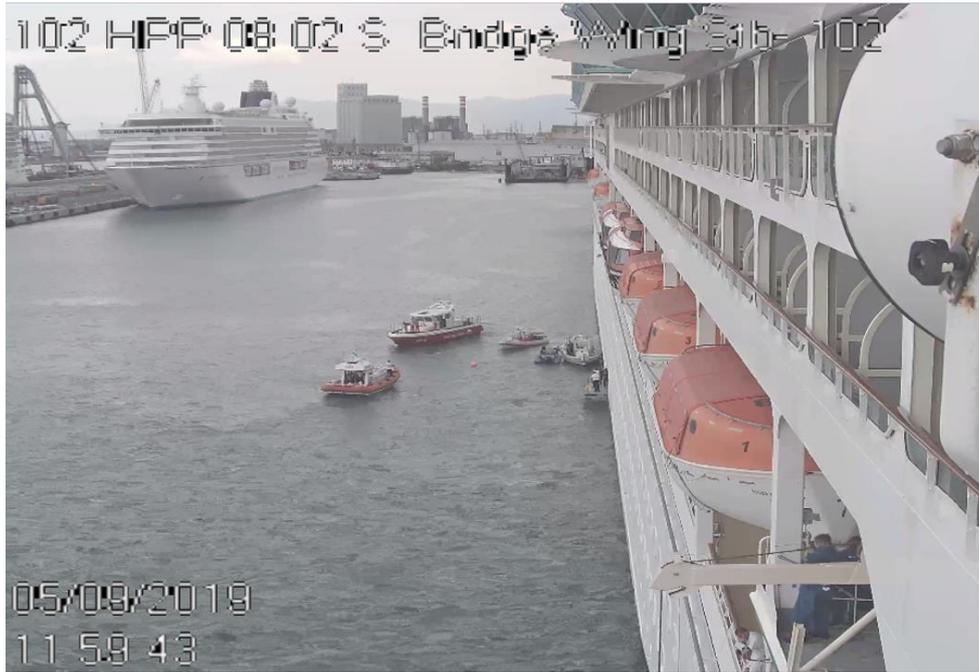
Figure 7: CCTV imagery of rescue vessels attending the scene searching for the OS(2)

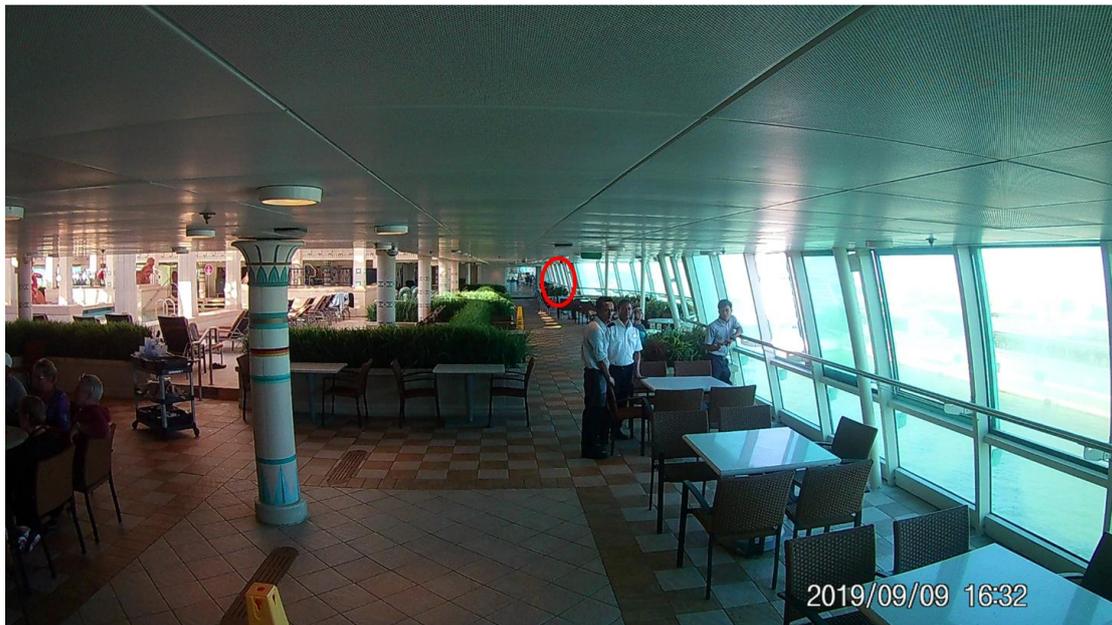
The evidence obtained during the course of the investigation was provided by witness testimony and CCTV imagery. There were two cameras located internally within the Solarium. One camera was obscured by a statue located between the camera and the work location. The second camera provided the optimum view of the work location, circled within figure 8.

Figure 8: Picture taken from the perspective of the internal CCTV camera located aft of the Solarium (the area circled is the location of the maintenance work)

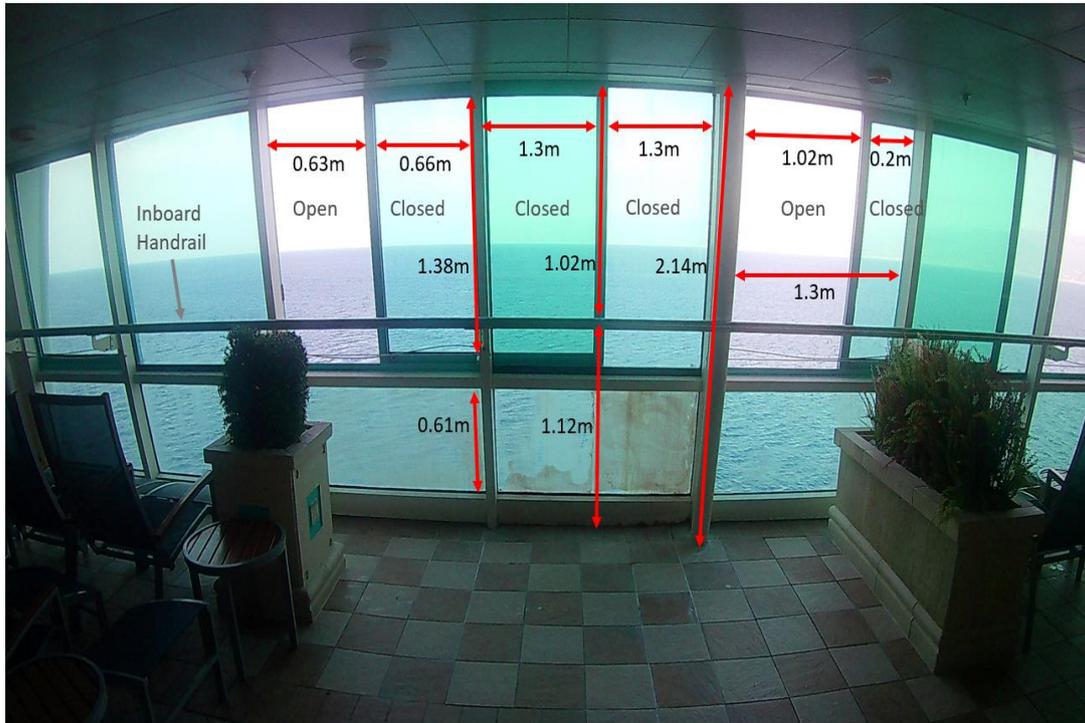
Figure 9: Dimensions of the starboard side windows of the Solarium where the maintenance and fall occurred

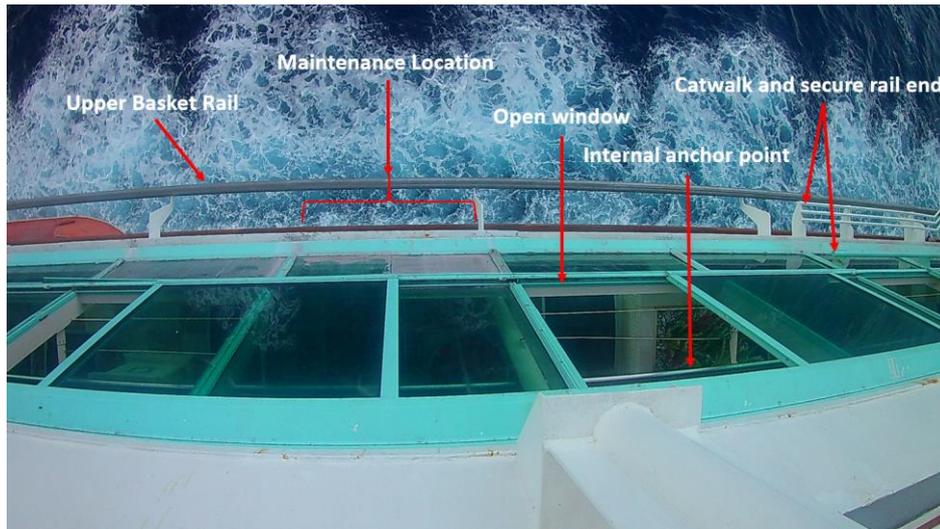
Figure 10: External view and description of safety apparatus of the starboard side Solarium windows in the location of the maintenance work and where the fall occurred

At this point, the maintenance of external windows cannot be easily achieved and is described within SQM 4.02 as inaccessible by virtue of there not being a platform/basket or shoreside equipment available. It recommends that the use of ladders, stages, bosuns chairs should be *“used with caution. The use of such equipment should be limited and considered only when an area is inaccessible.”* The investigation determined that the use of ladders, stages or a bosuns chair was not used nor was it considered by the Authorizing Officer, despite reservations raised as to how to safely navigate the external 15m section which was void of a catwalk or external securing mechanism.

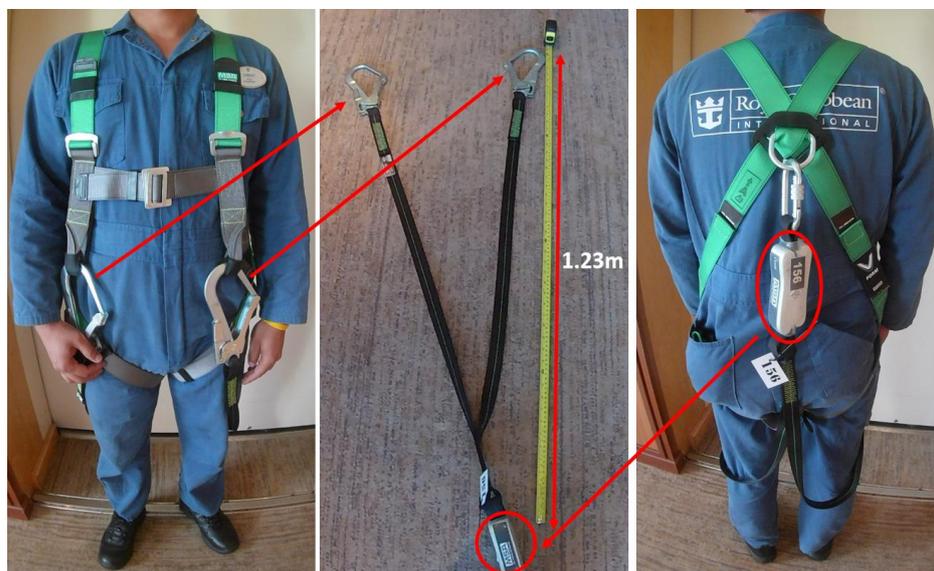
Figure 14: Full body harness as worn by the OS(1) and OS(2) with 2 energy absorbing lanyards with hooks attached

¹⁶ Full body harness manufactured by MSA, model V-Form No. C10180137 constructed from polyester. Date of construction 01/2018, date first used on board 08/2019, expiration date of harness 01/2028. The policy on board requires the Harnesses to be discarded 10 years after manufacture or 5 years from when first put in use, whichever is shortest.

It is known that the point at which the crew member fell, neither lanyard was attached to an anchor point. The Italian Coastguard conducted an inspection of the harness, lanyard and hook and found no defects. It is understood but cannot be categorically determined as no CCTV captured the precise location of the fall, that the OS(2) may have been adjusting the length of one lanyard by using a strop which was known to be wrapped¹⁷ around the handrail prior to the fall. It was acknowledged by the Deck department personnel that using a strop in this method was forbidden.

Although the personal protective equipment worn by the OS(2) did not fail, the harness did not undergo a two person check immediately after donning and prior to commencing the work and therefore its condition could not be known or verified prior to the fall.

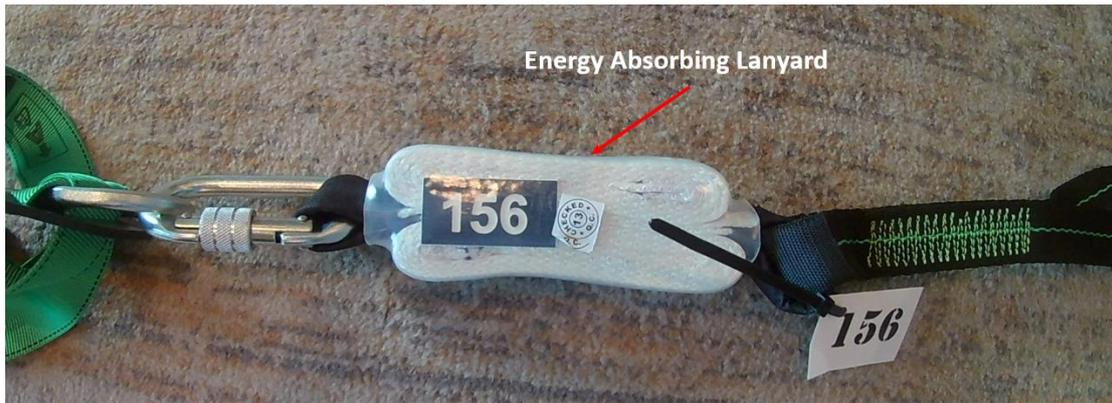
Figure 15: Energy absorbing lanyard connected to the harness with a locking carabiner

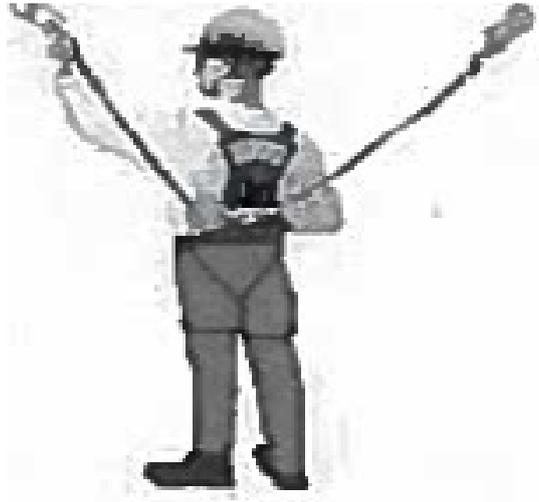
This restricted the free movement of each crew member as the hooks could not run unobstructed along the length of the Solarium. The window structure, by design, required the OS(2) to connect and disconnect more frequently in order to reach the glass that required maintenance either side of the window frame. The SQM 4.02 (working aloft and overboard) states: *'lanyards and lifelines are to be attached to an anchor point at all times during work. When moving from point to point, a two-lanyard method is to be employed'* as described within figure 17.

Figure 17: Diagram obtained from SQM 4.02 describing 2-lanyard method of connecting to two secure anchor points

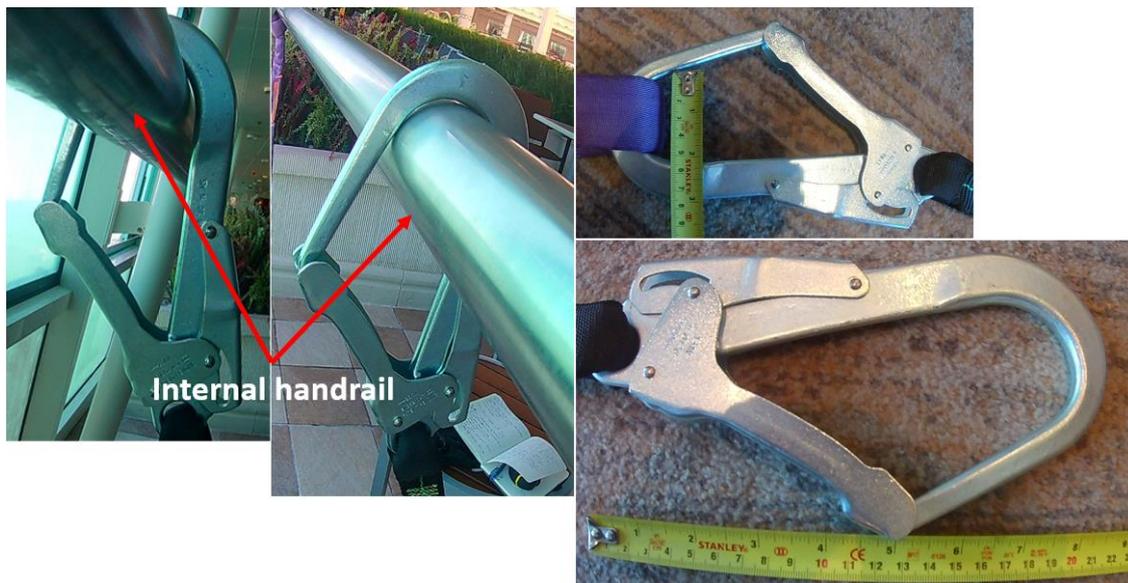
The strop used was not a designated safety critical piece of equipment for the purpose of securing a lanyard to a securing point and is not covered directly by a safety policy or instruction. As can be seen within figure 19, the hook provided with the lanyard and attached to the harness will connect directly to the internal handrail without the need for a strop. The strop was determined by the maintenance team to be a necessity in order to extend the reach of the OS(2) in between the open window frames so the OS(2) could conduct maintenance furthest from the securing point. Additional risk was therefore introduced by this adhoc securing method which was in violation of the SQM procedure which requires the lanyard and lifelines to be attached to a secure anchor point at all times.

Figure 19: Demonstration of lanyard hook connected to internal handrail and dimensions

The lack of adequate external securing anchors in the proximity of the Solarium windows, resulted in the OS(2) having to connect to a secure anchor point inside the frame of the window. This shortened the available reach and as such a temporary solution was determined necessary in order to conduct the maintenance required. The temporary solution complicated the securing method by introducing another failure mechanism in the form of a strop. The strop therefore had to be looped inside itself to provide an anchor point increasing the risk of confusing the secure end of the strop with the loose end.
