Report on the investigation of
the fire and explosion on board

Yeoman Bontrup

Glensanda Quarry, Loch Linnhe, Western Scotland

Report No 5/2011
May 2011

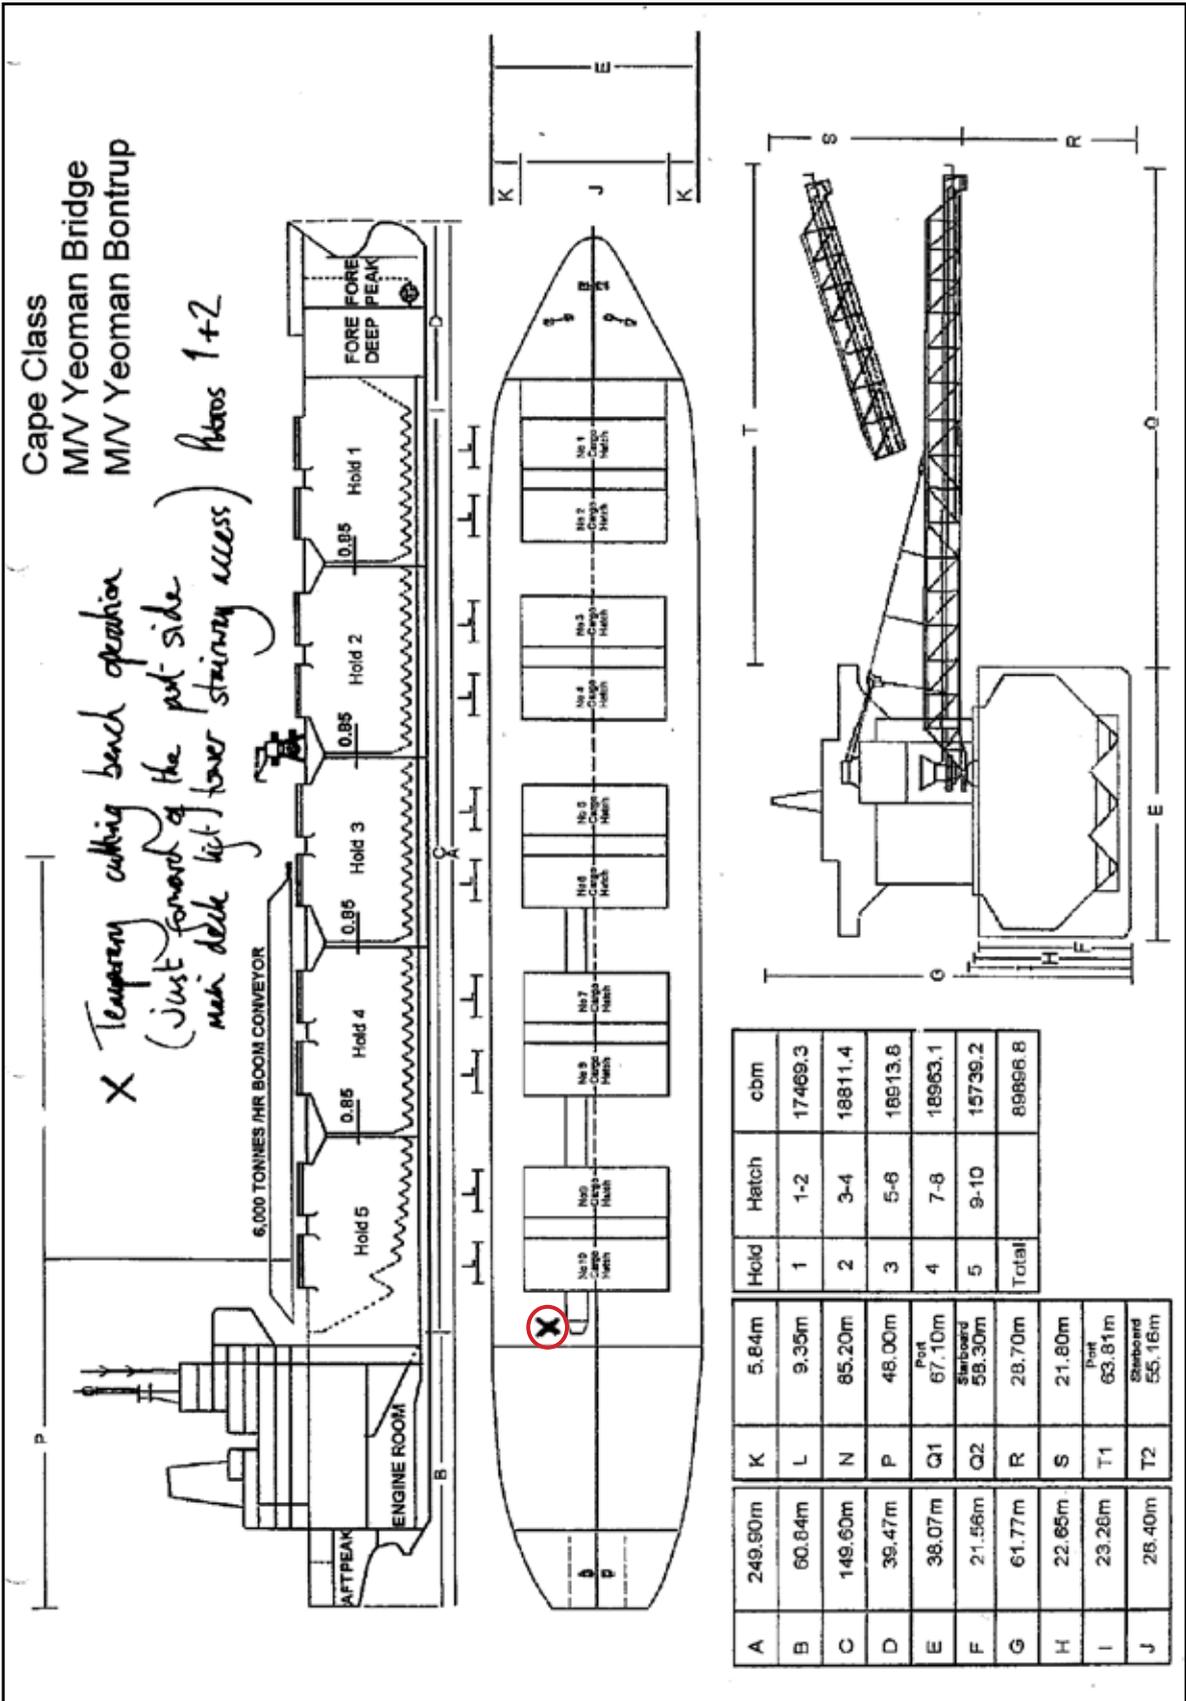
Figure 3

As a limited number of "Hardox" and ceramic tiles were available on board to effect the repairs, it was decided to use a number of "Hardox" plates to cover the larger holes. The plates were cut to shape using oxy-acetylene equipment at a temporary work bench located on the main deck at the port side of the vertical conveyor tower (**Figure 3**).

Position of temporary workbench used for hotwork

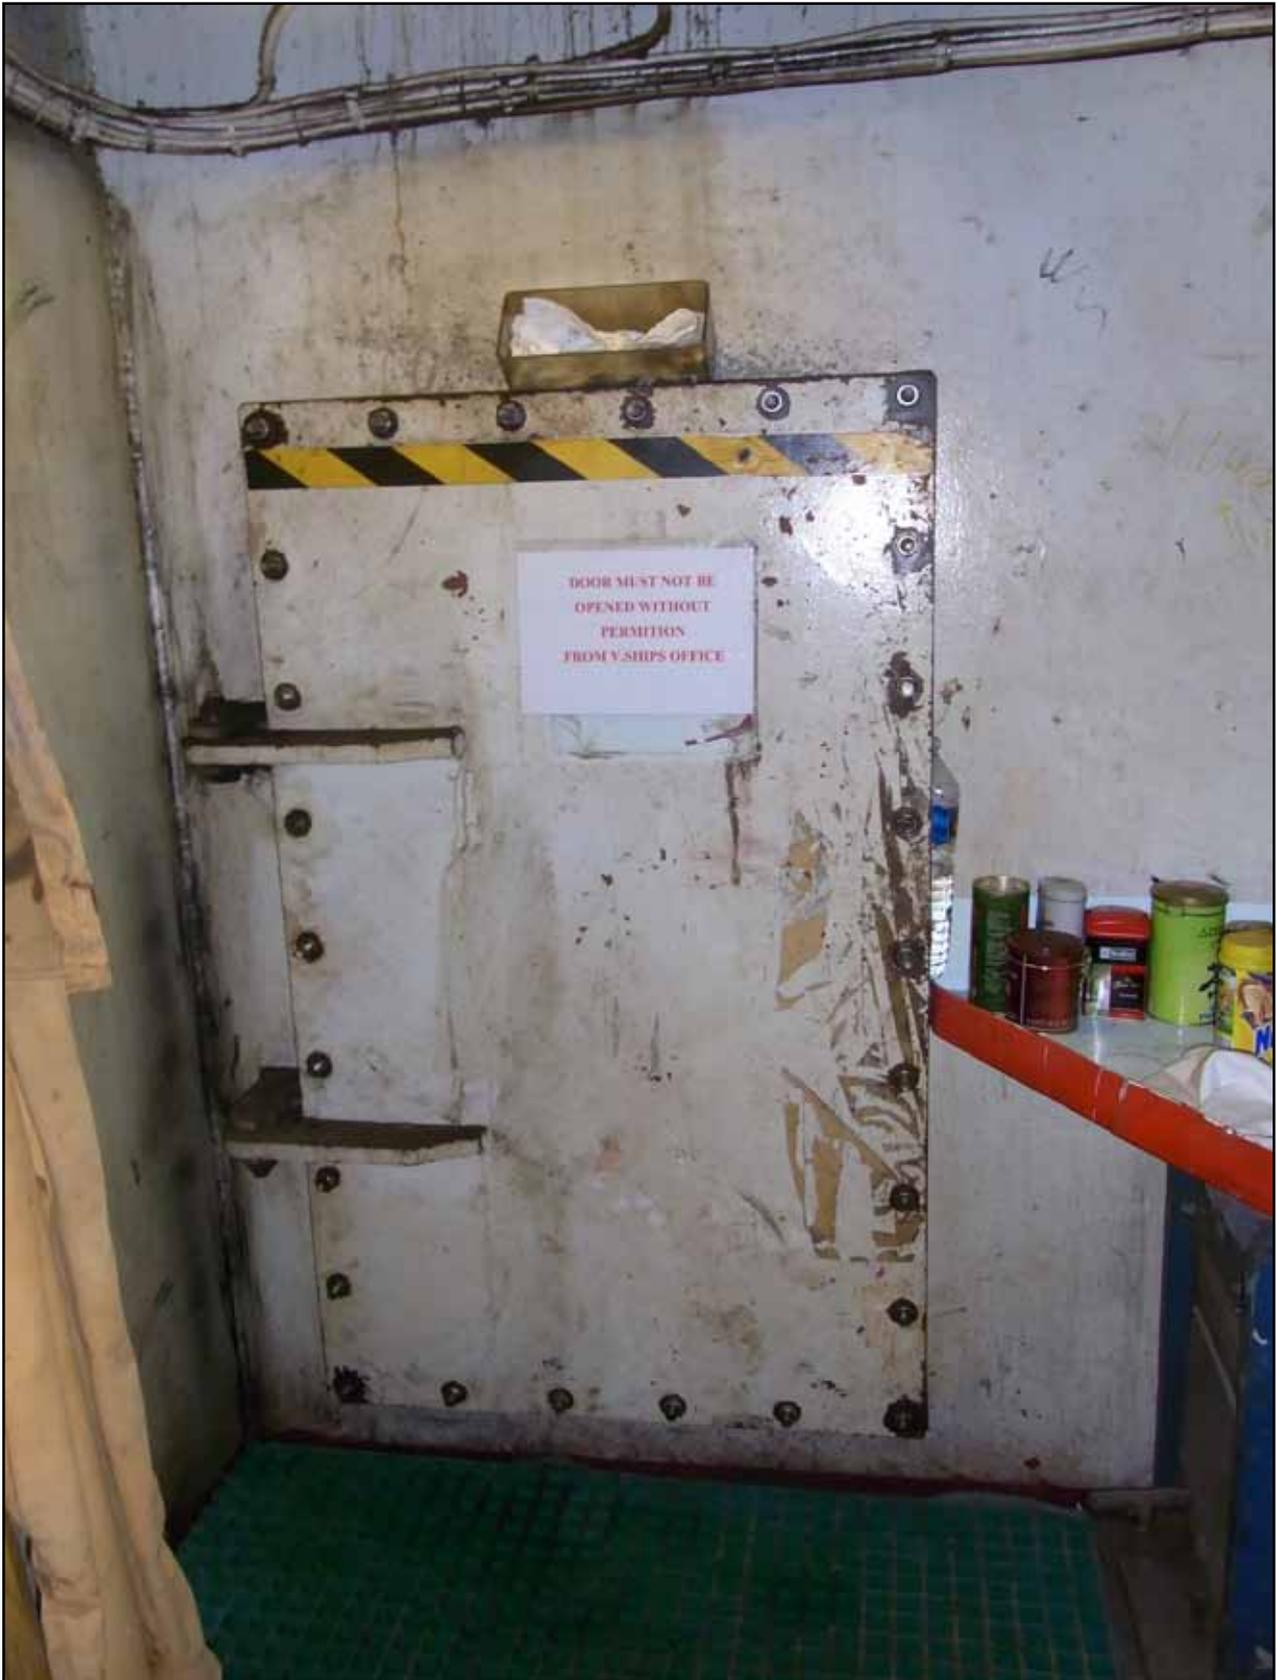
Figure 4

Yeoman Bontrup arrived at Glensanda Quarry at 2135 on 1 July. Soon afterwards the bolted, hinged door¹ in the engine room workshop's forward bulkhead was opened into the SUS hydraulic pump space (**Figure 4**). This was normal practice in harbour and provided easy access between the tower and hold tunnels, and the workshop.

Door between the engine room workshop and the SUS hydraulic pump space

The chief engineer and his team felt that they were achieving some success in dealing with the fire. However, they were not aware that by that time the SUS hydraulic pump space was engulfed in fire, and that the fire had spread into the engine room workshop through the open door. Despite the chief engineer's optimism, at about 1550 part of the conveyor belt collapsed. He reported this to the master, who was in discussion with the quarry's PPO manager. The quarry staff then noticed the portable oxy-acetylene bottle stowage that was used in support of the hopper repair work. Worried about the hoses which were led to the tower, and their close proximity to the fire, they moved the stowage away from the immediate danger, having confirmed that the bottle valves were closed³. In doing so, one of them suffered the effects of smoke inhalation and had to be escorted off the vessel to await medical attention.

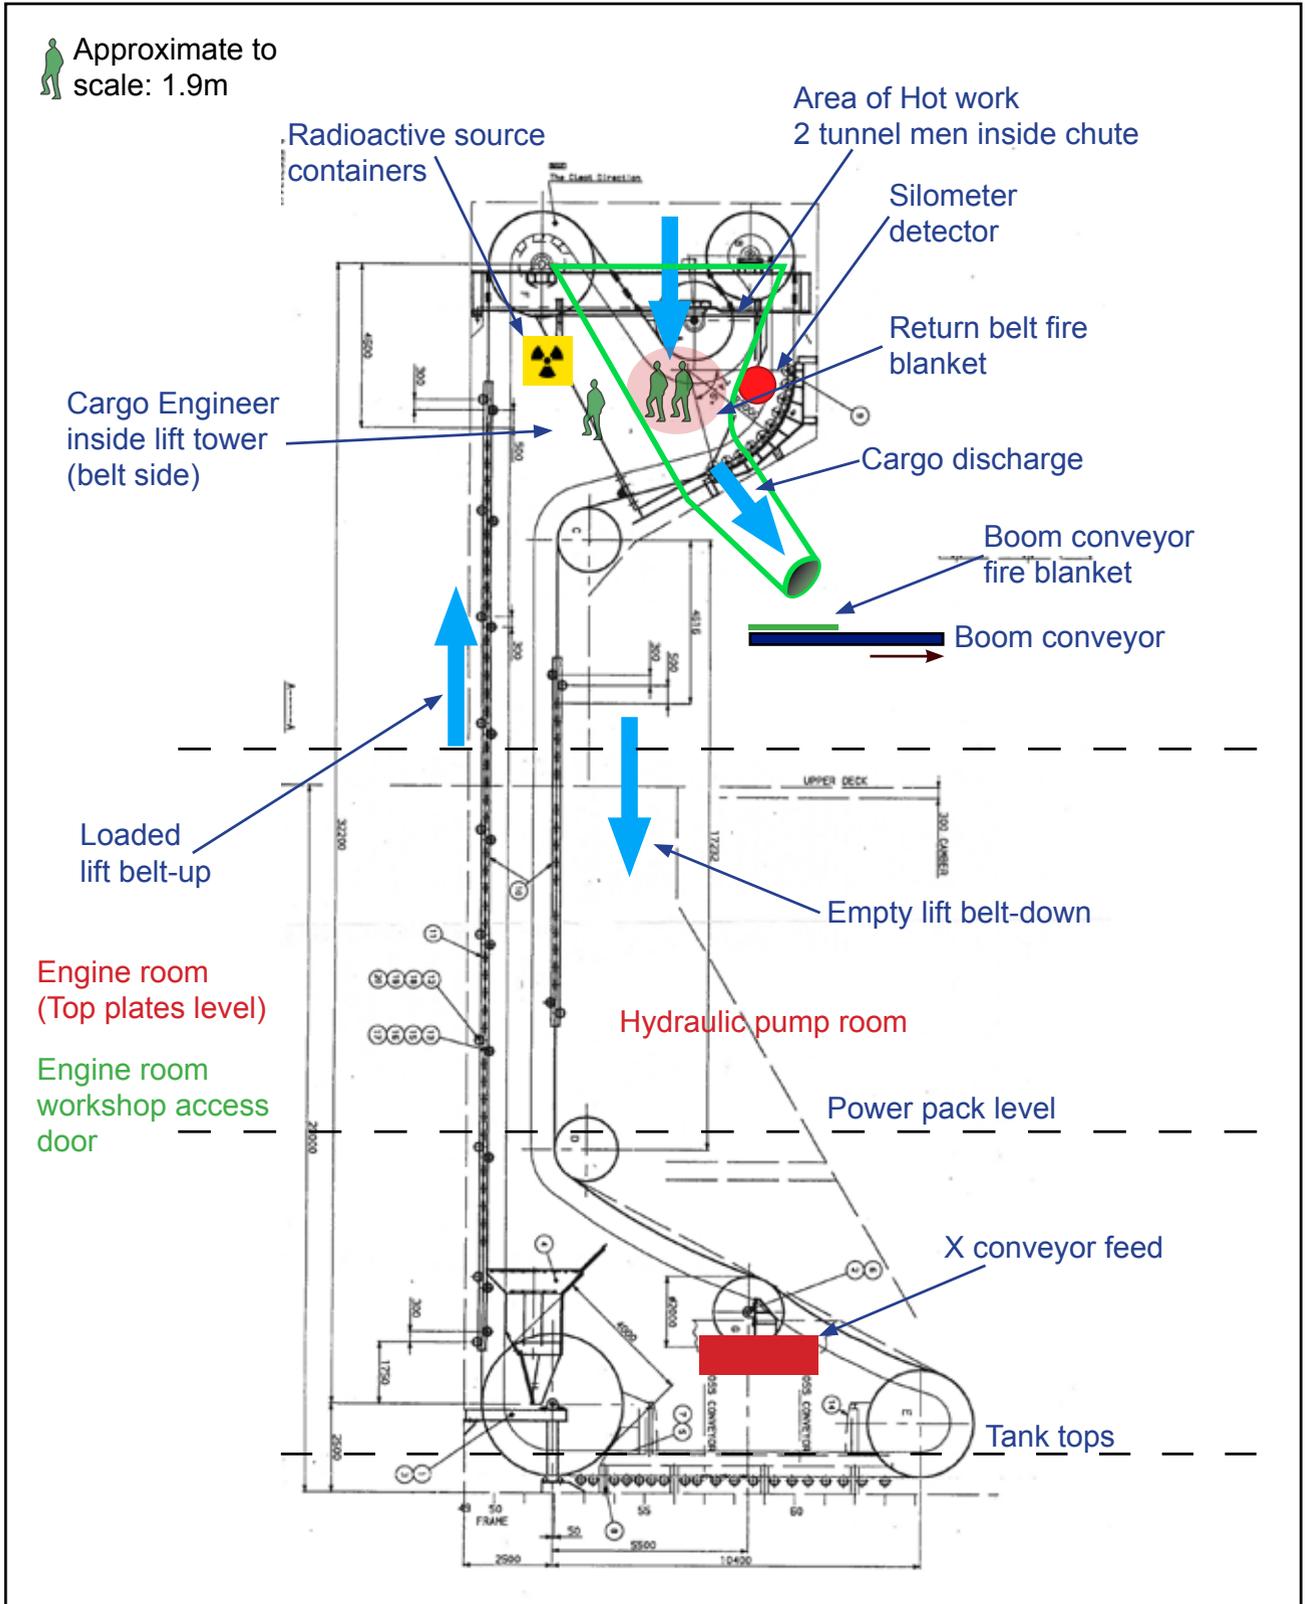
Figure 5

At 0700, the chief engineer carried out a "tool-box talk" with the cargo engineer and the two tunnel men who were to carry out the hopper repairs. The repair team rigged a fire hose from the pressurised fire main to deal with any potential fires resulting from the intended hotwork. Protective fire blankets were laid on the boom conveyor belt and on a plywood sheet covering the return section of the vertical conveyor belt which passed between the hopper legs. Electric arc welding leads were led from the welding machine, located in the starboard deck workshop, into the hopper chute. Oxy-acetylene hoses were run to the chute area from a portable bottle trolley positioned on the main deck to the starboard side of the conveyor tower, and an oxy-acetylene cutting attachment was also taken into the chute. A schematic of the area of the hopper work is at **Figure 5**.

Schematic of the area of the hopper work

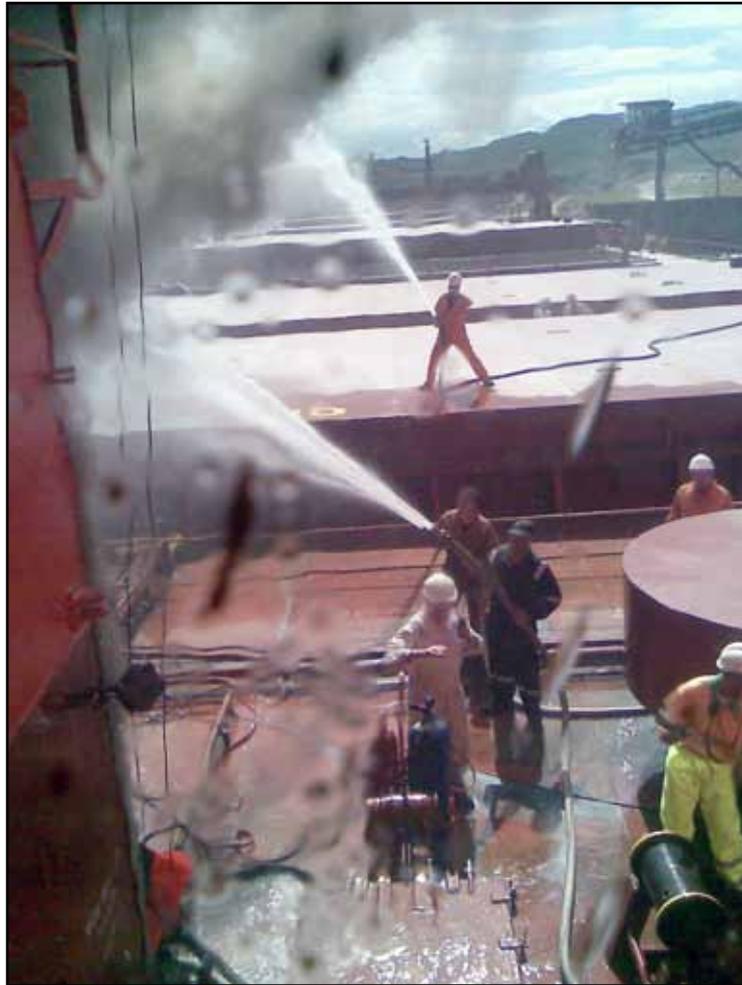
Figure 7

On the upper deck, the cargo engineer was relieved by a crew member who continued to direct the fire hose into the tower. Immediately afterwards, at 1524, a number of additional hoses were directed at the tower (**Figure 7**). The cargo engineer activated the tower wash-down sprays from inside the SUS hydraulic pump space in an attempt to help douse the fire. He then went to the base of the tower, where he rigged a fire-fighting hose and directed it at the fire.

Fire-fighting on the tower

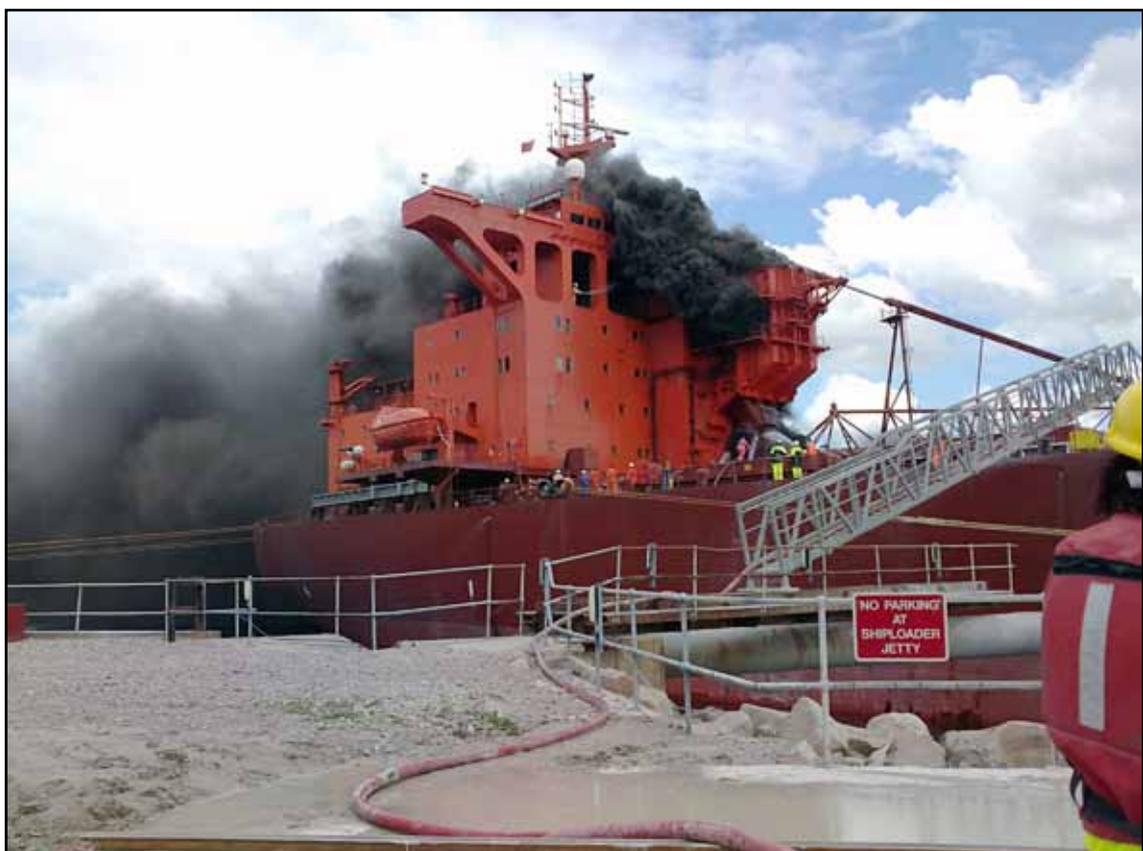
Figure 8

At 1533, the Glensanda Quarry fire team arrived with its tender under the direction of the Primary Production Operations (PPO) manager, who was also the senior site manager. The team connected its fire hoses to the shore-side hydrants and supported the boundary cooling effort around the tower (**Figure 8**).

Additional fire support from Glensanda Quarry's fire team

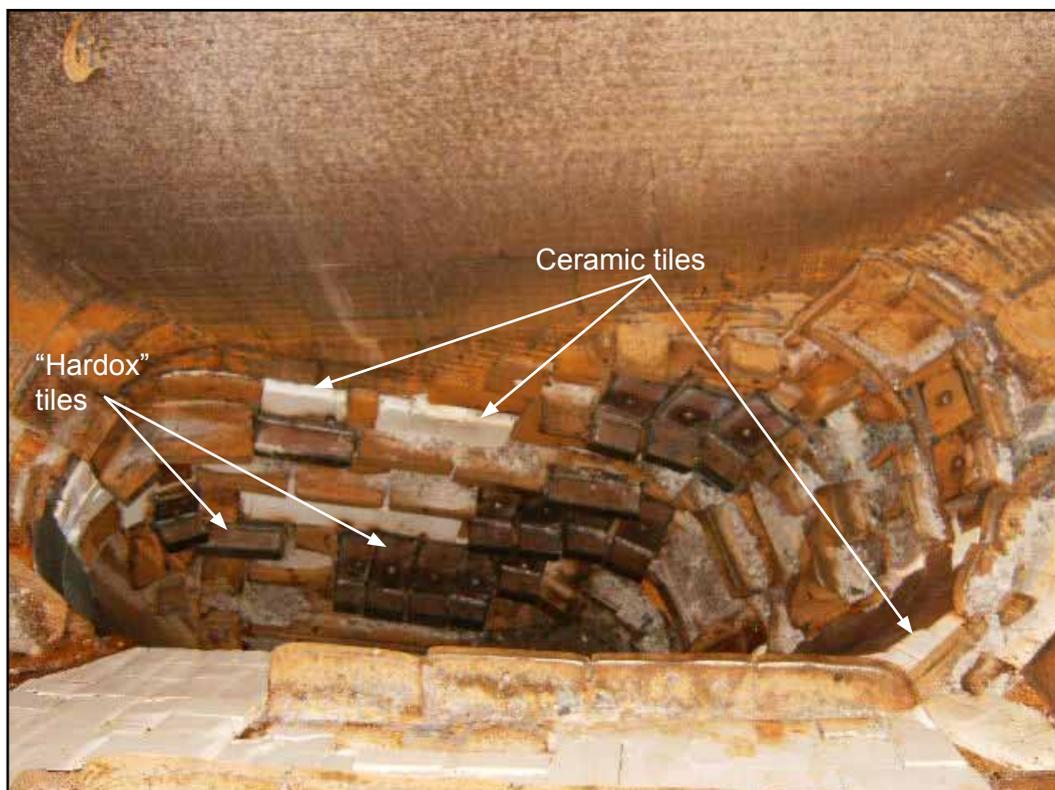
Figure 20

The internal surfaces of the hopper were protected by a combination of sacrificial “Hardox” and ceramic tiles. The ceramic tiles were secured to the hopper carcass using a special adhesive while the “Hardox” tiles were secured using a nut and bolt arrangement. Both tile types (**Figure 20**) required frequent replacement. In the case of the “Hardox” tiles, this involved flame-cutting hotwork to trim the tiles and tack welding to secure the new tiles to adjacent tiles. The internal apex created by the legs was protected by right-angled “Hardox” tiles. The angle formed filled with cargo and provided a flush face to assist the cargo discharge. The system was designed for discharge rates of up to 6000 tonnes/hour. Each cargo type had an optimum discharge rate, greater or lesser rates of discharge resulted in stones impacting on the more vulnerable side of the hopper, which then required more maintenance.

Internal view of the hopper “trouser leg” showing sacrificial “Hardox” and ceramic tiles

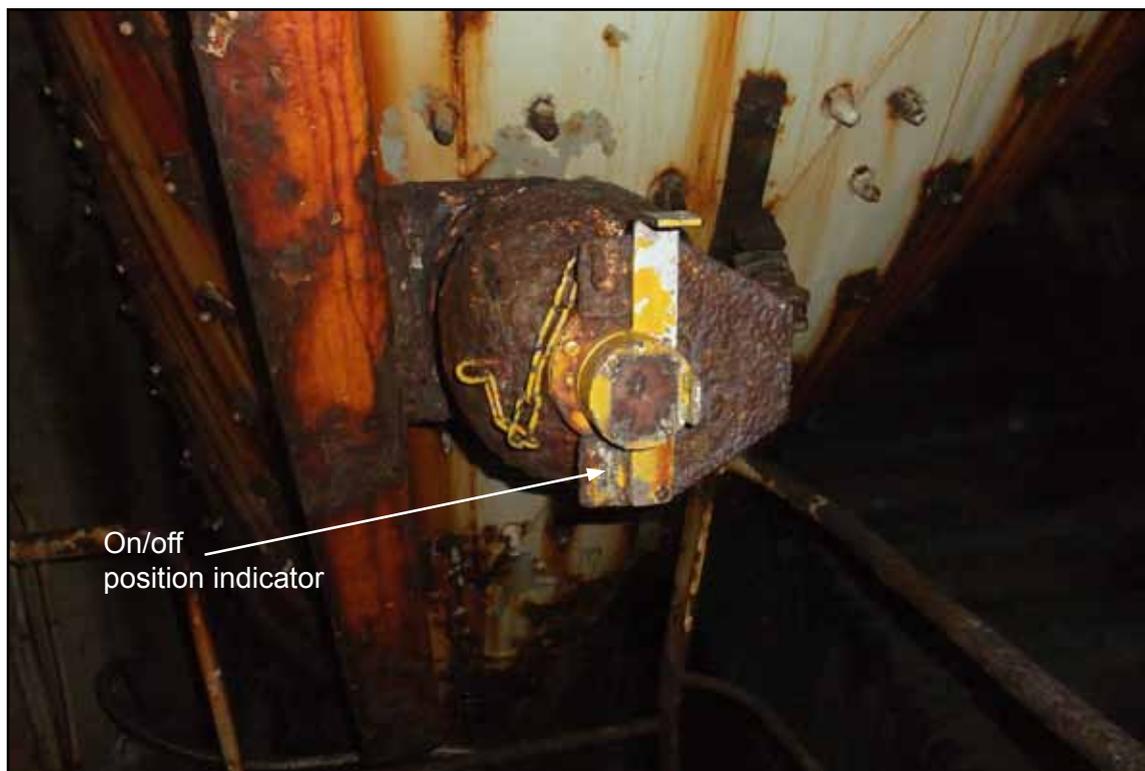
Cargo in the hopper of both *Yeoman Bontrup* and *Yeoman Bridge* was originally monitored by two radioactive silometers. They were designed to identify cargo blockages in the hopper and stop the SUS in a controlled manner to prevent damage. The silometers comprised a radiation source, a detector (**Figure 5**), and an electronic process controller. While the system had not been in operation for the past 10 years, the silometers had remained on board.

Yeoman Bridge - port silometer source container

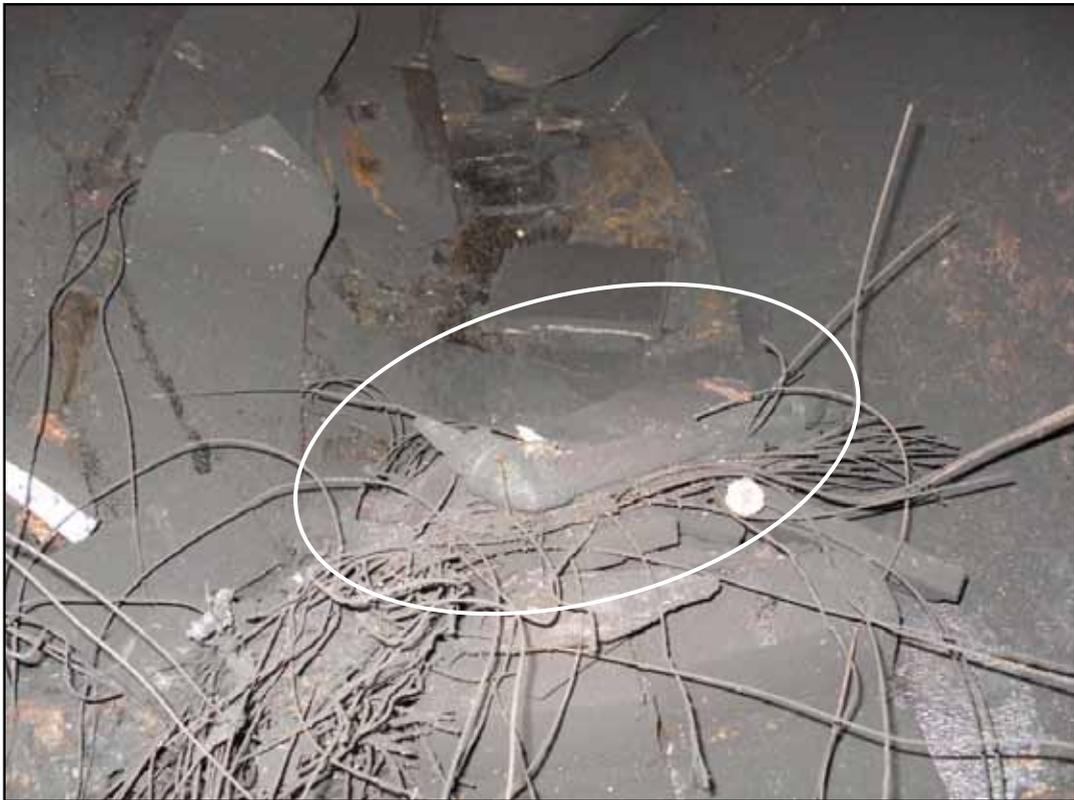
Figure 26

The cutting attachment of an oxy-acetylene torch was found resting on the “Hardox” tiles inside the hopper at about 2.5m from the chute opening, and the shank was found with hose connections still attached⁵ at the tail end of the boom conveyor (**Figures 26 and 27**).

Oxy-acetylene torch cutting attachment

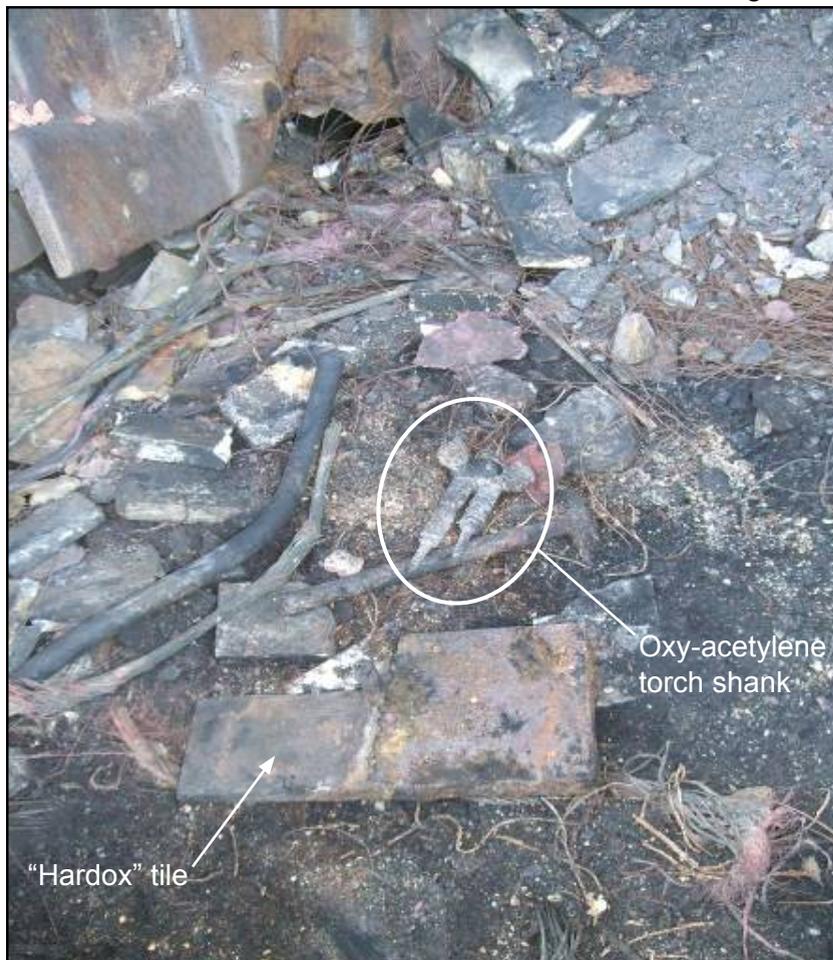
Figure 27

Oxy-acetylene torch shank

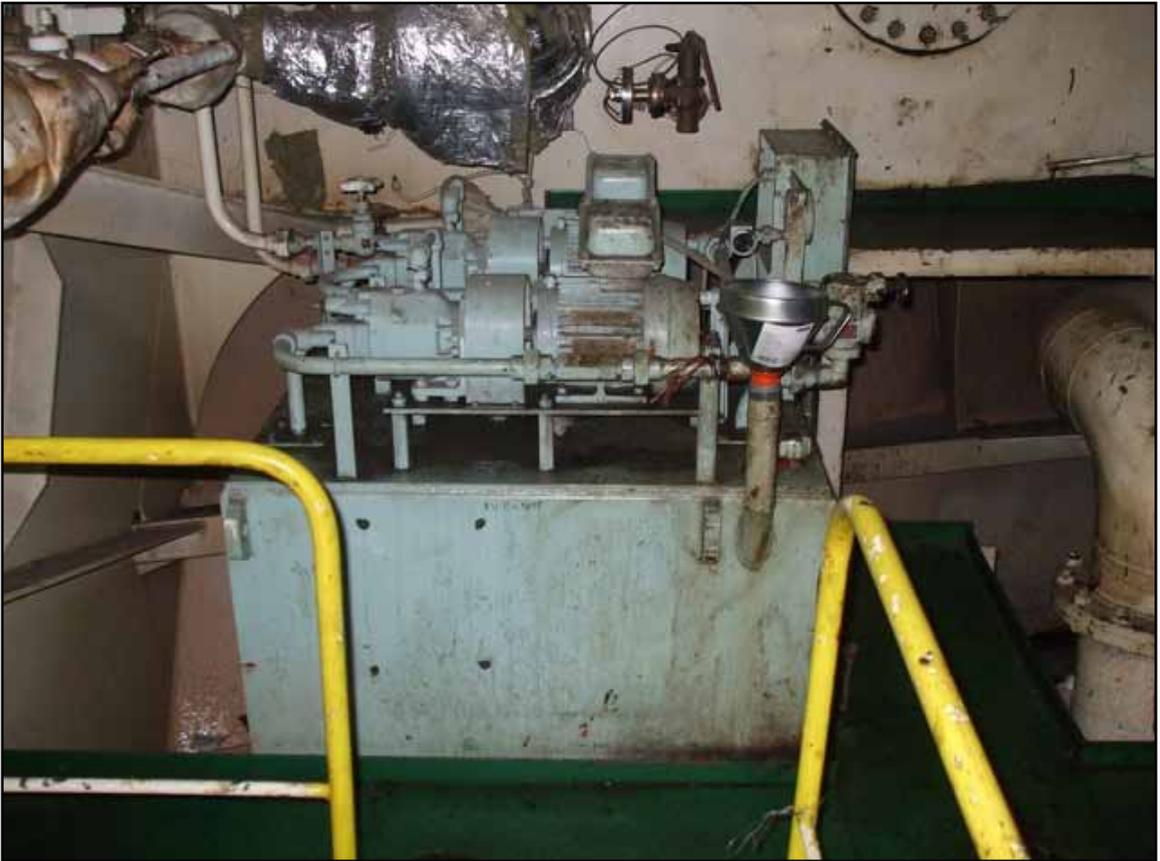
Figure 28

A number of water ballast butterfly valves were hydraulically-operated and remotely-controlled from the CCR. The associated self-contained hydraulic system power pack was located on the starboard side, adjacent to the forward bulkhead of the engine room (**Figure 28**).

Water ballast tank valves - hydraulic power pack

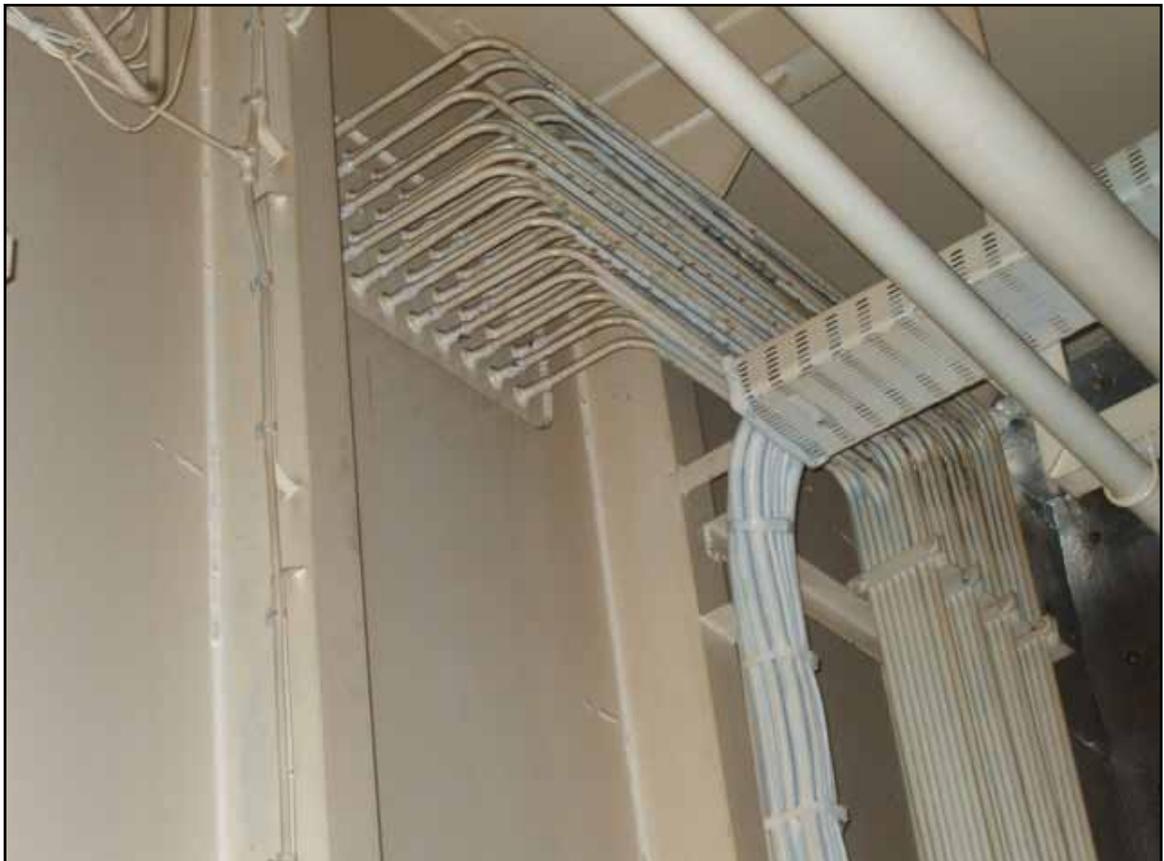
Figure 29

The hydraulic oil was delivered to the ballast valves through 20mm diameter copper pipes which were located in the general vicinity of the fire. The sections of pipes were connected by brazed cup and cone couplings (**Figure 29**). The system was pressurised at the time of the fire.

Water ballast tank valves - hydraulic distribution lines

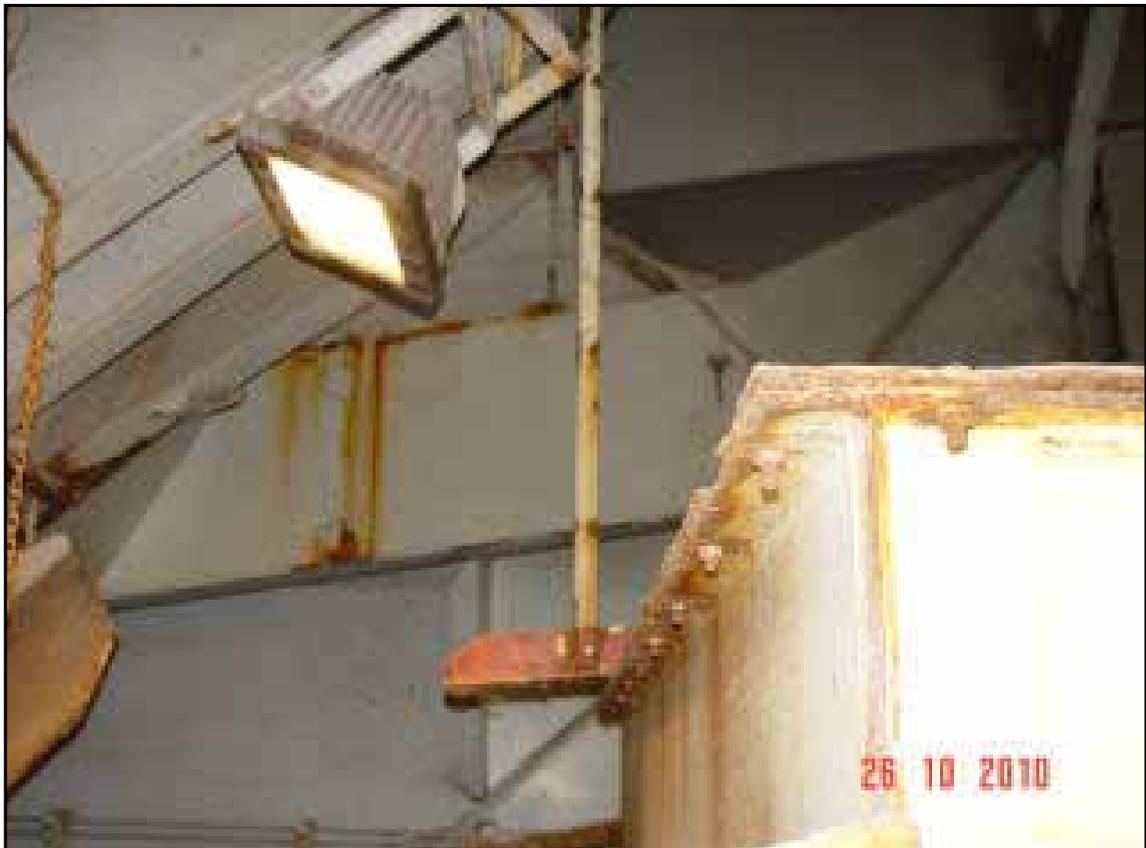
Figure 30

The surface temperature of the 500W tungsten halogen light lenses (**Figure 30**) was 135°C with the body of the light measuring 41°C. The temperatures measured at 100mm and 500mm from the halogen lights, in the direction of the vertical conveyor belt, were 40°C and 26°C respectively. The halogen lights were positioned approximately 1.3m from the vertical belt and about 2.9m from the pressured hydraulic system operating the ballast tank valves (Section 1.11.4)⁹.

500W halogen lamp fitted to *Yeoman Bridge*

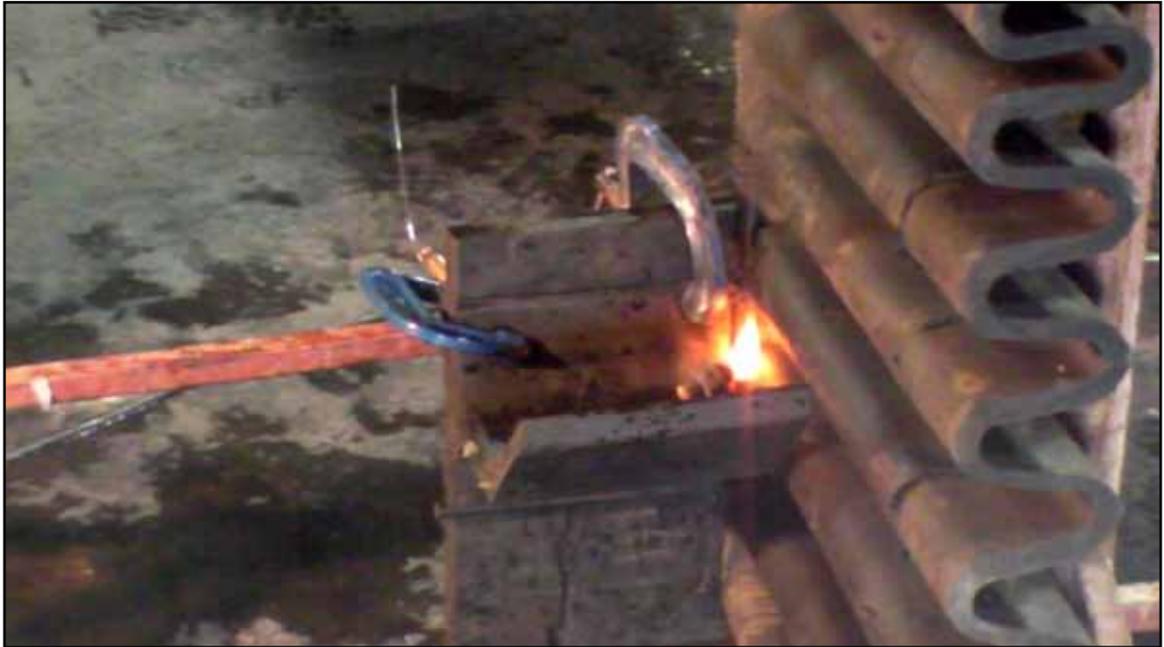
Figure 32

During the second series of tests, the stud and nut were heated to just below their melting point of 1370°C, about the temperature that would have been reached had oxy-acetylene equipment been used. Following a 3-second delay to take into account cooling during a 21m fall¹¹, the hot stud and nut were placed centrally in the cleat, in the cleat and against the side curtain, and in the side curtain corrugation. The three separate tests were carried out in 0 m/s and 0.4 m/s wind speeds to simulate airflows in the SUS tower. On each occasion, the cleat ignited, smouldered and then self-extinguished. However, when the stud and nut were in contact with the side curtain, the latter readily ignited (**Figures 32 and 33**).

Fire Tests - stud and nut placed in cleat adjacent to the side curtain

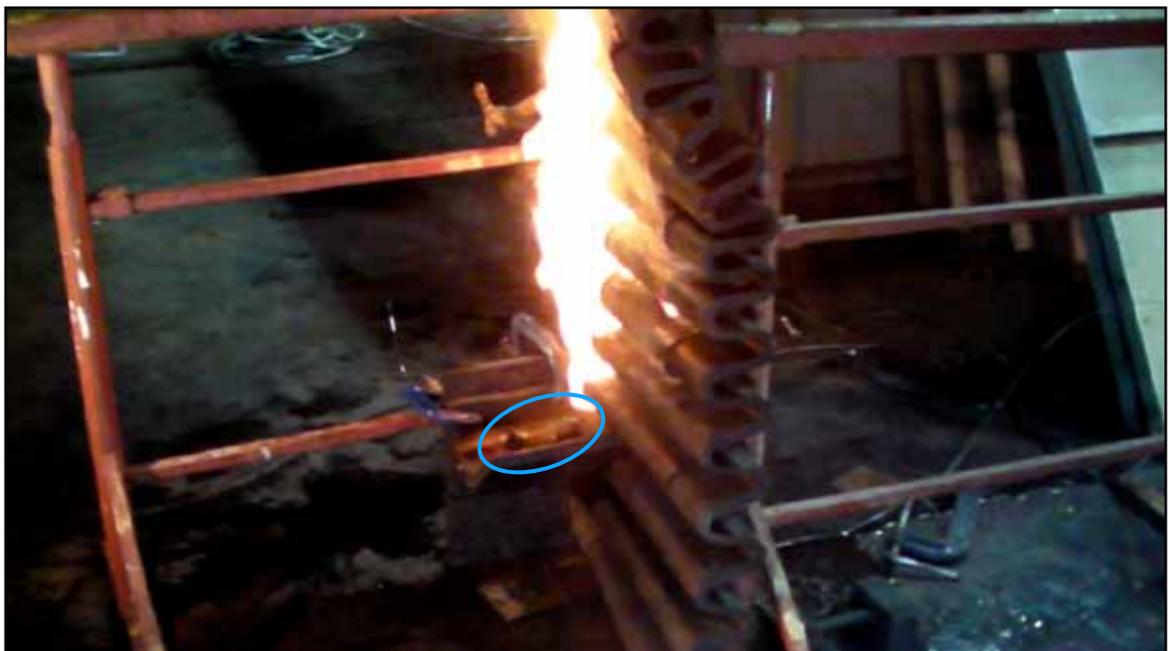
Figure 33

Fire Tests - stud and nut placed in cleat adjacent to the side curtain after 10 minutes
