**The Bahamas
Maritime Authority**

**“M.v. Black Watch”
IMO Number 7108930
Official Number 8000293**

**Report of the investigation into the Auxiliary Engine
Room fire on the 01st July 2016 approximately 260nm
off the coast of Funchal, Madeira**

Date of Issue: 19th January 2017
Bahamas Maritime Authority
120 Old Broad Street
LONDON
EC2N 1AR
United Kingdom

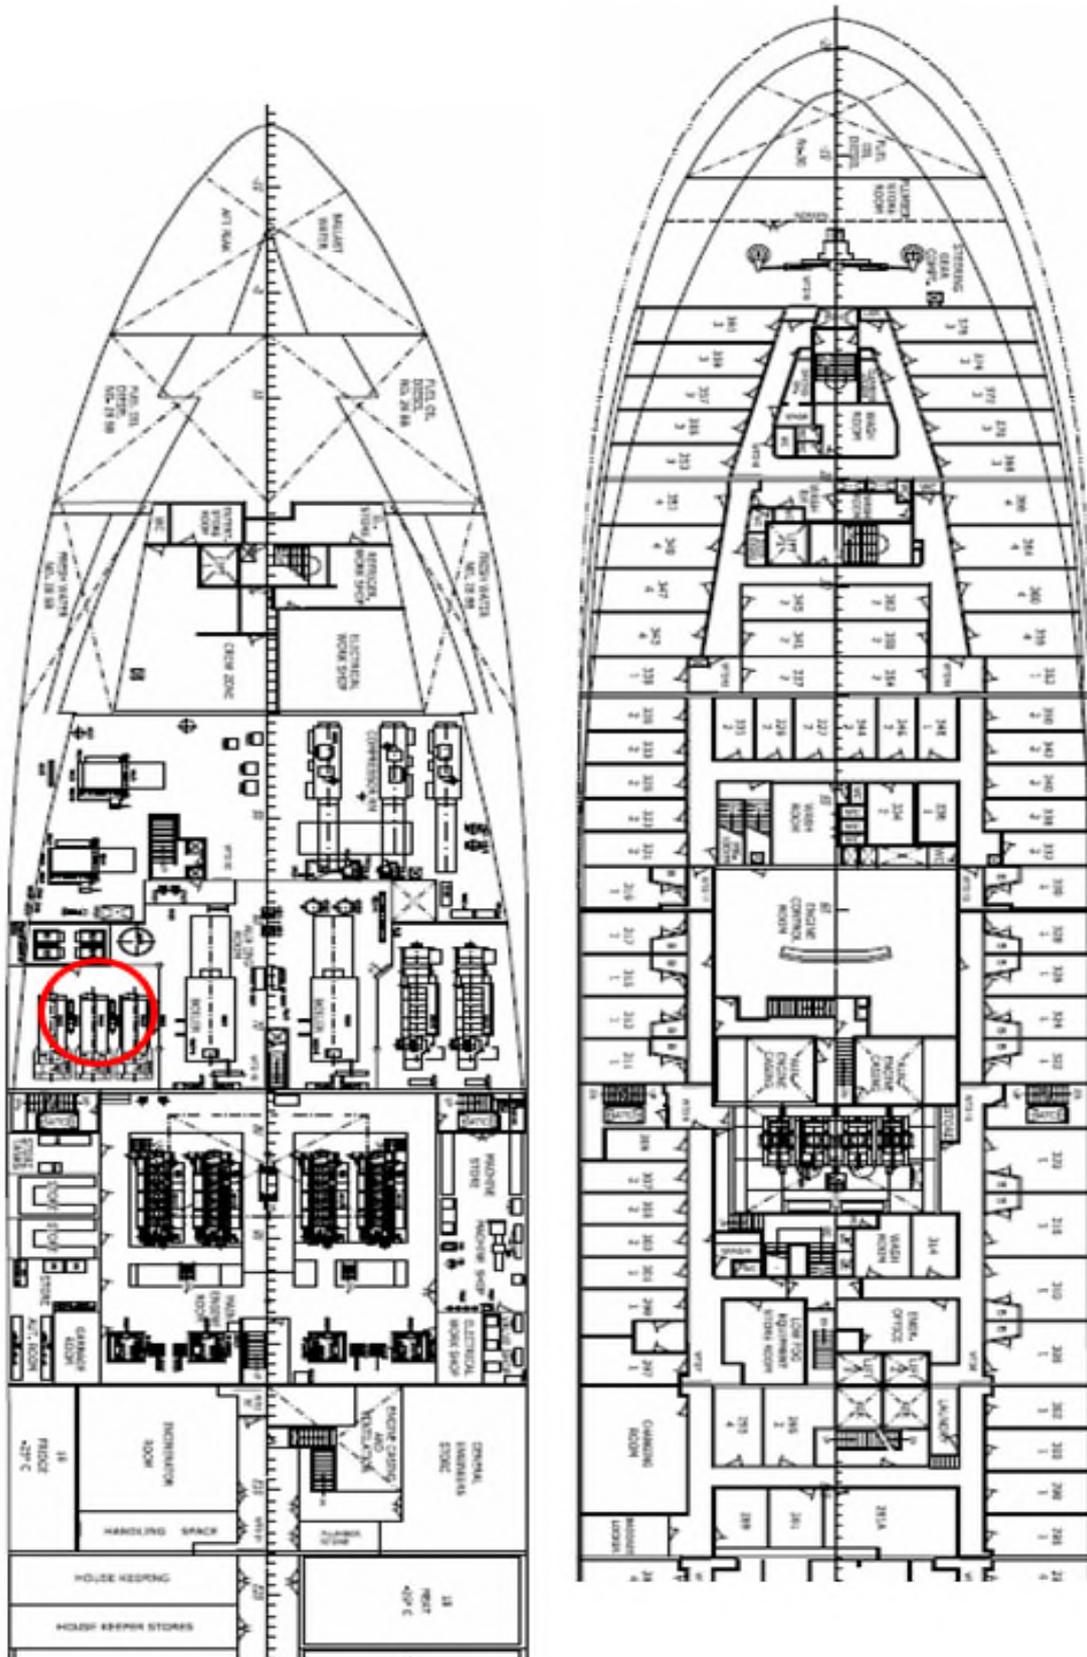
Figure 1: General Arrangement Plan indicating decks A (left) and B (right) (location of fire circled in red)

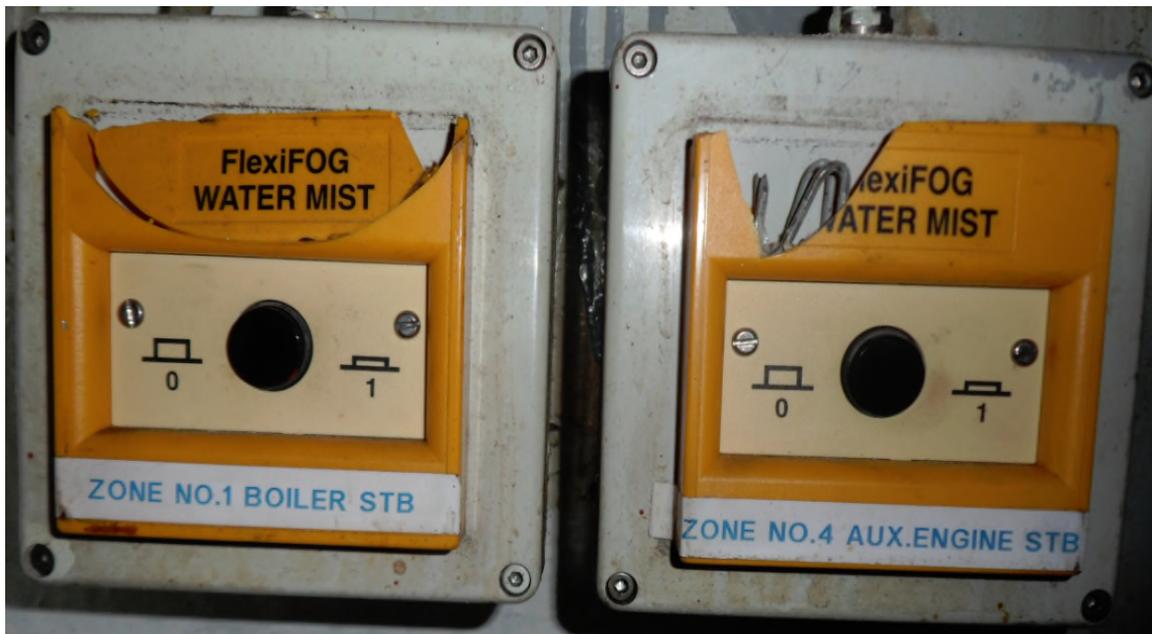
- 4.8 At 0844 the first report from the scene was provided to the Master and Chief Officer located on the bridge by the 3rd Officer who was a witness to the fire while working in the Main Engine room. The Oiler also confirmed that he managed to activate the flexi-fog for zones 1 and 4 from the local release buttons located adjacent to WTD 19. At 0851 the two contractors from Wilhelmsen Ship Services arrived on the bridge to brief the Master. They confirmed the fire started at the aft end of AE2, spreading vertically and bouncing off the deck head above the generator. They also confirmed that prior to exiting the compartment through WTD 19 they managed to discharge one 12kg powder extinguisher on top of the generator. On exiting the compartment they met with the Oiler who was holding open WTD 19.

Figure 4: Flexi-Fog local release adjacent to WTD 19

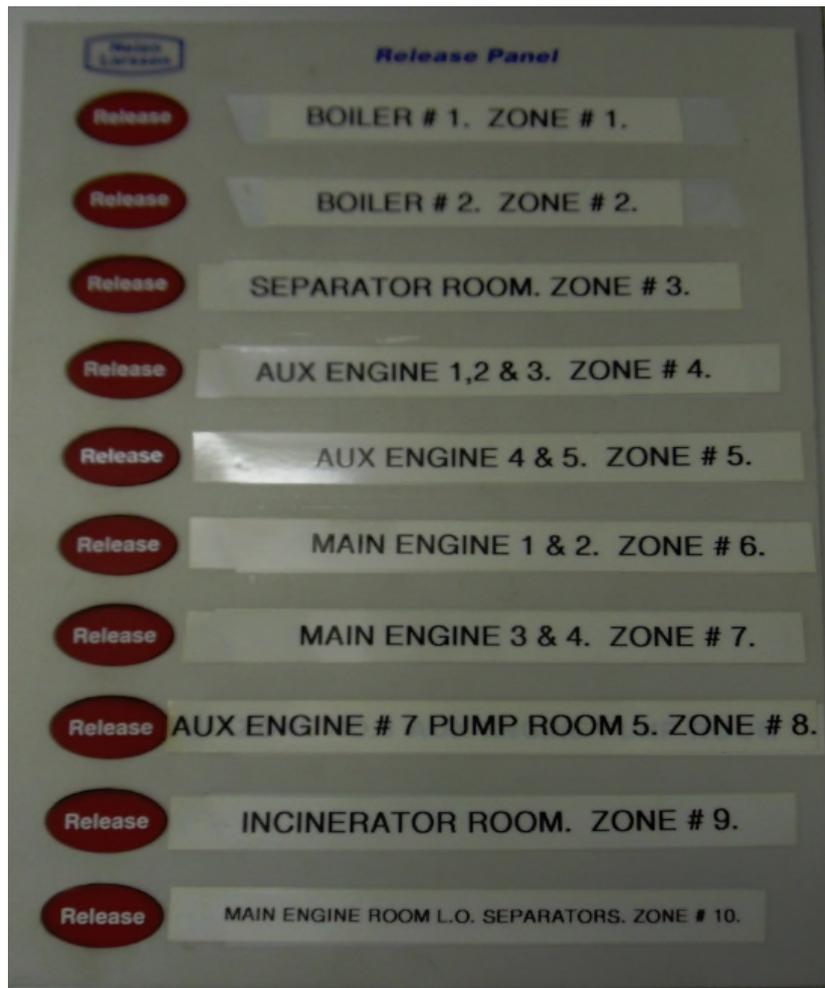
Figure 5: Flexi-Fog control panel within Engine Control Room

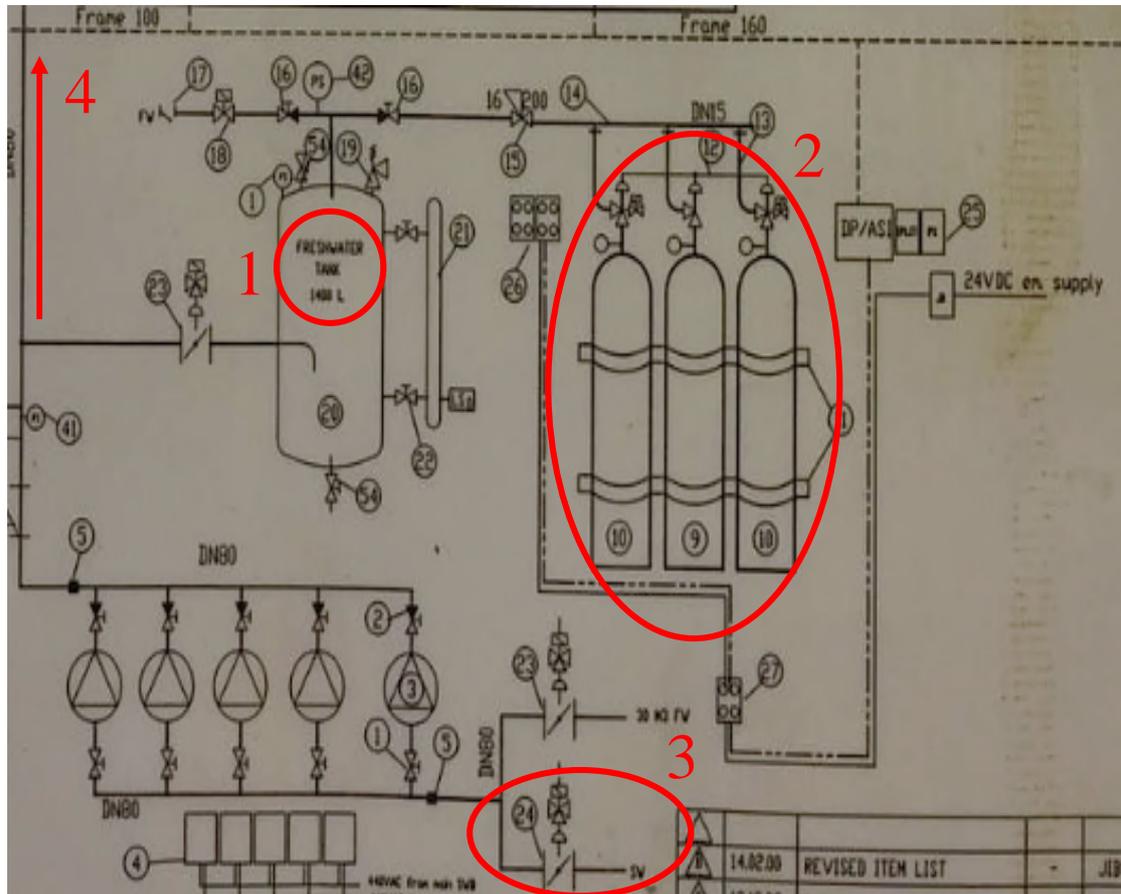
- 5.3.4 The supply and operation of the flexi-fog system was not fully understood by senior technical leadership on board. The system is a dry pipe, low-pressure system, which uses freshwater, stored within a feeder tank, pressurized by nitrogen in order to deliver water through the respective nozzles. It was determined through the course of an interview that one senior Officer was under the impression that it was a freshwater system and once the freshwater is depleted, the system stops operating. The flexi-fog system is freshwater up

to the point where the water level within the feed tank reaches a particular level, at which point the seawater pumps start and provide a ready supply of seawater.

Figure 18: Flexi-fog fire extinguishing system plan highlighting freshwater tank (1), nitrogen cylinders (2) and seawater intake and valve (3) and route of water to zones (4)

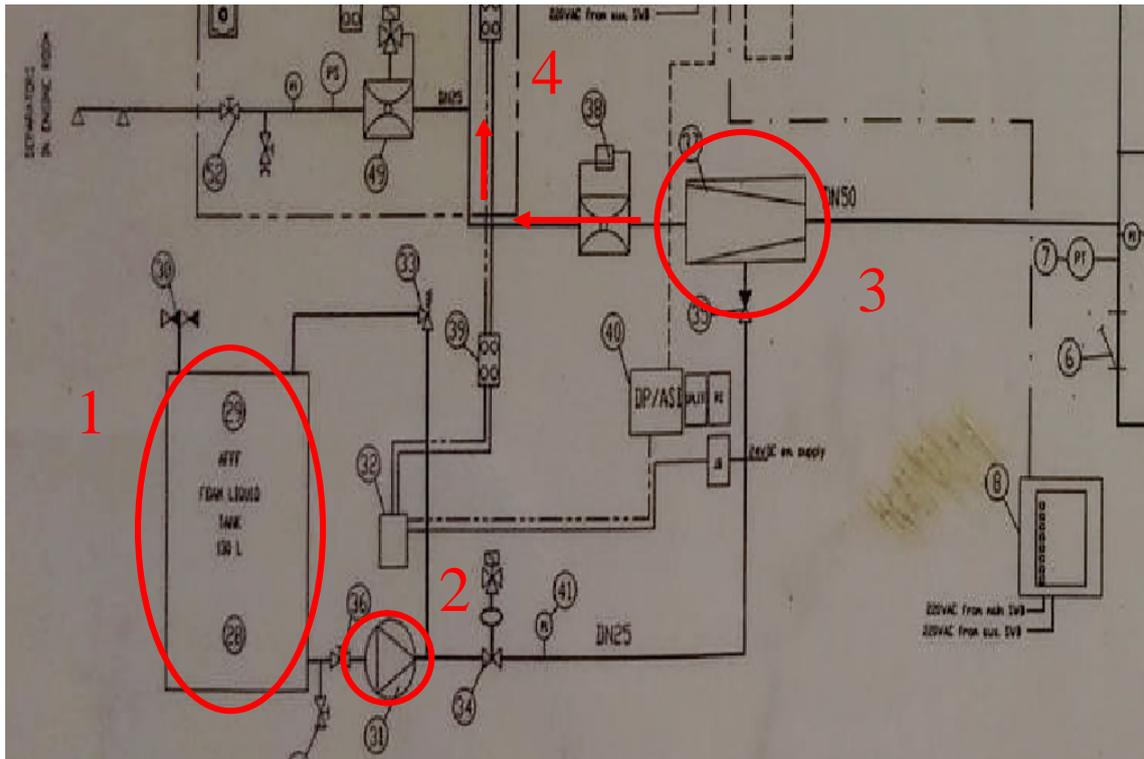
5.3.5 It was also determined that the technical leadership did not fully understand the operation of the fixed foam application available on board. It was determined that portable eductors were available in each engine space but fixed foam application was not. As can be seen in figure 19, local fixed foam application was available within the machinery spaces. During an interview with the Oiler, a concern was raised regarding the quantity of oil and flammable liquid located within the bilge underneath auxiliary engines 1, 2 and 3, although this cannot be verified, had foam been used, even as a precautionary measure its fire suppression capabilities may have potentially been enough to reduce the ferocity of the fire or as a minimum aid the firefighting effort.

Figure 19: Flexi-fog fixed foam application system highlighting AFFF foam tank (1), centrifugal foam pump (2), automatic foam proportioner (3) and the route (4) of foam distribution to zones

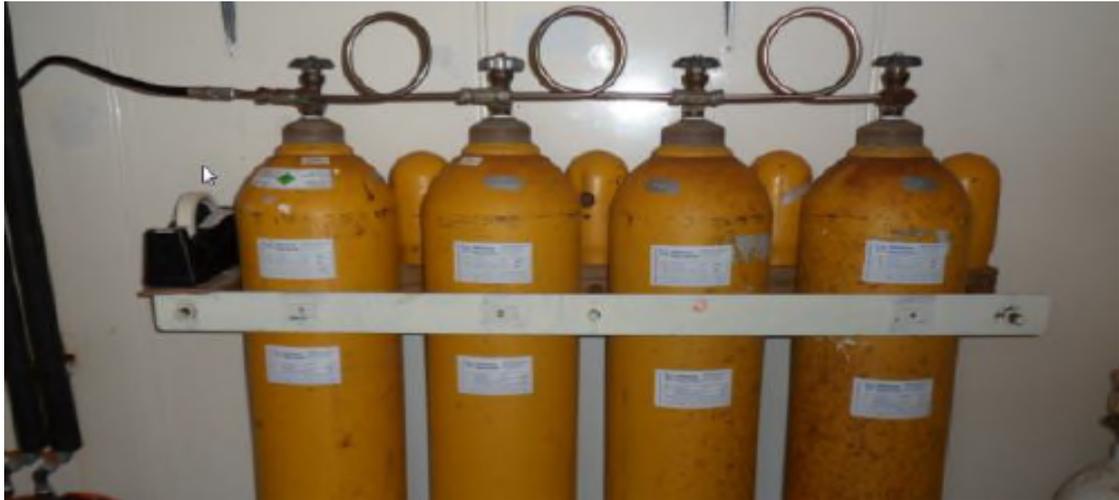
Figure 21: BA compressor cascade system and below 6-litre BA bottles

- 5.3.9 The bottles are capable of being recharged on board by means of an air compressor located on deck 8. Attached to the compressor the option exists to recharge via 4 x 50 litre stored pressure bottles in parallel known as a cascade system. To recharge one bottle with the air compressor would take approximately 15 minutes whereas by the cascade system would take approximately 13 minutes. Therefore in order to partially recharge one fire team by the cascade system would take 39 minutes. However, the Cascade bottles are charged to 200 bar, the same pressure required within the 6-litre cylinders. In order to achieve 200 bar each cylinder decanted from the Cascade system will need to be topped up by the air compressor in order to achieve 200 bar. The Cascade system must be used in conjunction with the air compressor to achieve a fully charged BA bottle.

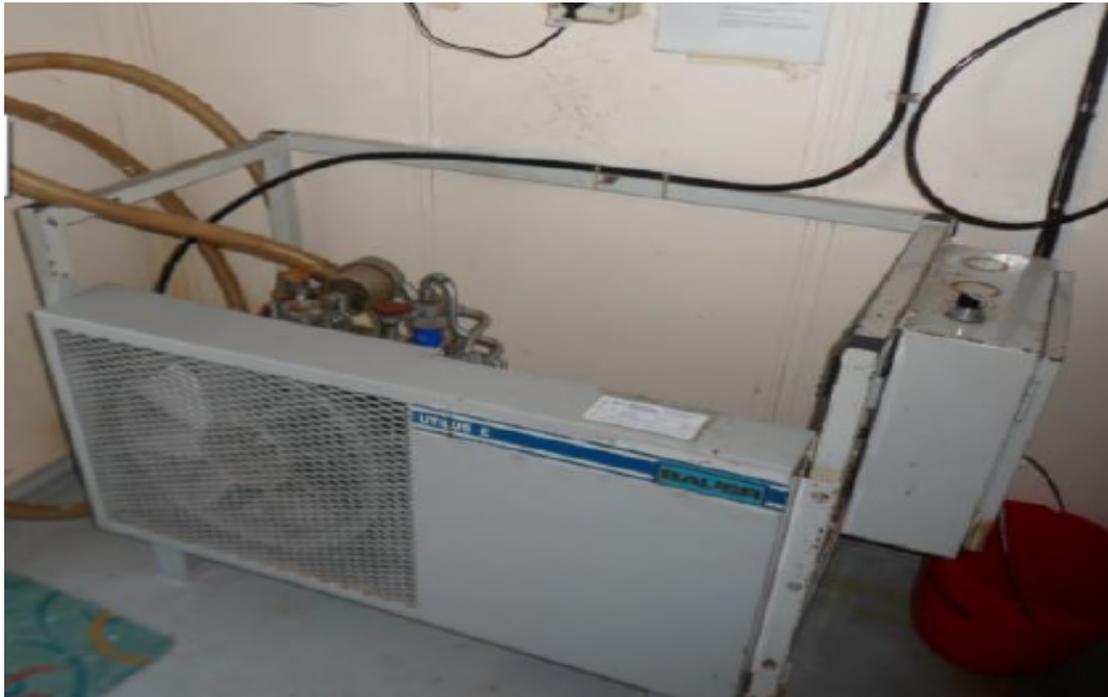
Figure 22: BA air compressor located on deck 8

- 5.3.10 At 1143 all BA bottles had been used. With no electrical power to operate the BA compressor and the cascade bottles empty, the fire teams were unable to fight the fire wearing breathing apparatus. At the commencement of the firefighting effort, each team member had sufficient air to make 1 entry and 2 re-entries before expending the three available charged bottles. Based on a 20-minute consumption rate each team had the total capacity to remain on air for 220 minutes before expending all charged bottles onboard. The first on air time was recorded at 0843, 3 hours (180 minutes) before the BA was depleted without using the 10 spare bottles located in the compressor room. Based on these figures alone it could be considered that all fire teams went on air at approximately the same time and remained on air for the next 3 hours, without recharging any bottles by either method.

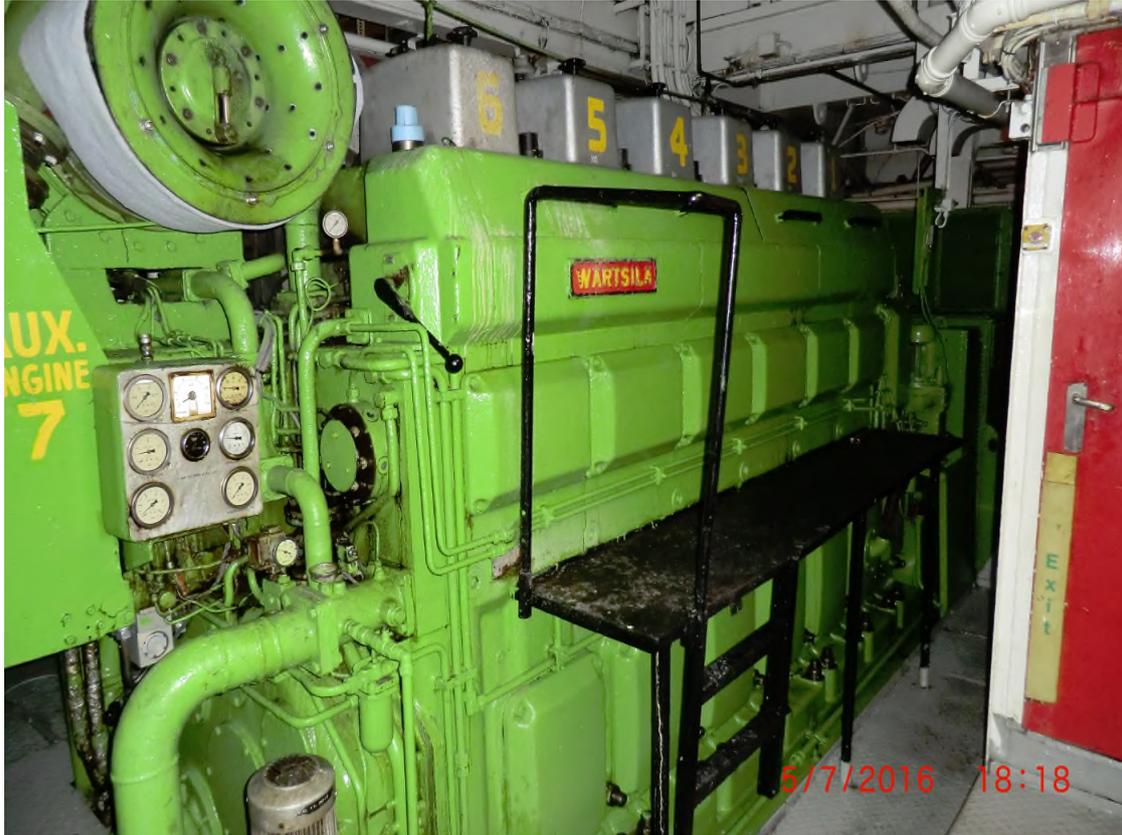
- 5.6.2 It was not possible to start auxiliary engines 4, 5 and 7 as neither generator was connected to the emergency switchboard. In order to start an alternative engine from the emergency switchboard, supplied by the emergency generator, fabrication of a hard wire connection was required. This was achieved by the Chief Electrician who had to don BA to enter the main

engine room where a connection could be made to the booster pump and cooling pump of AG7.

Figure 29: Auxiliary generator 7

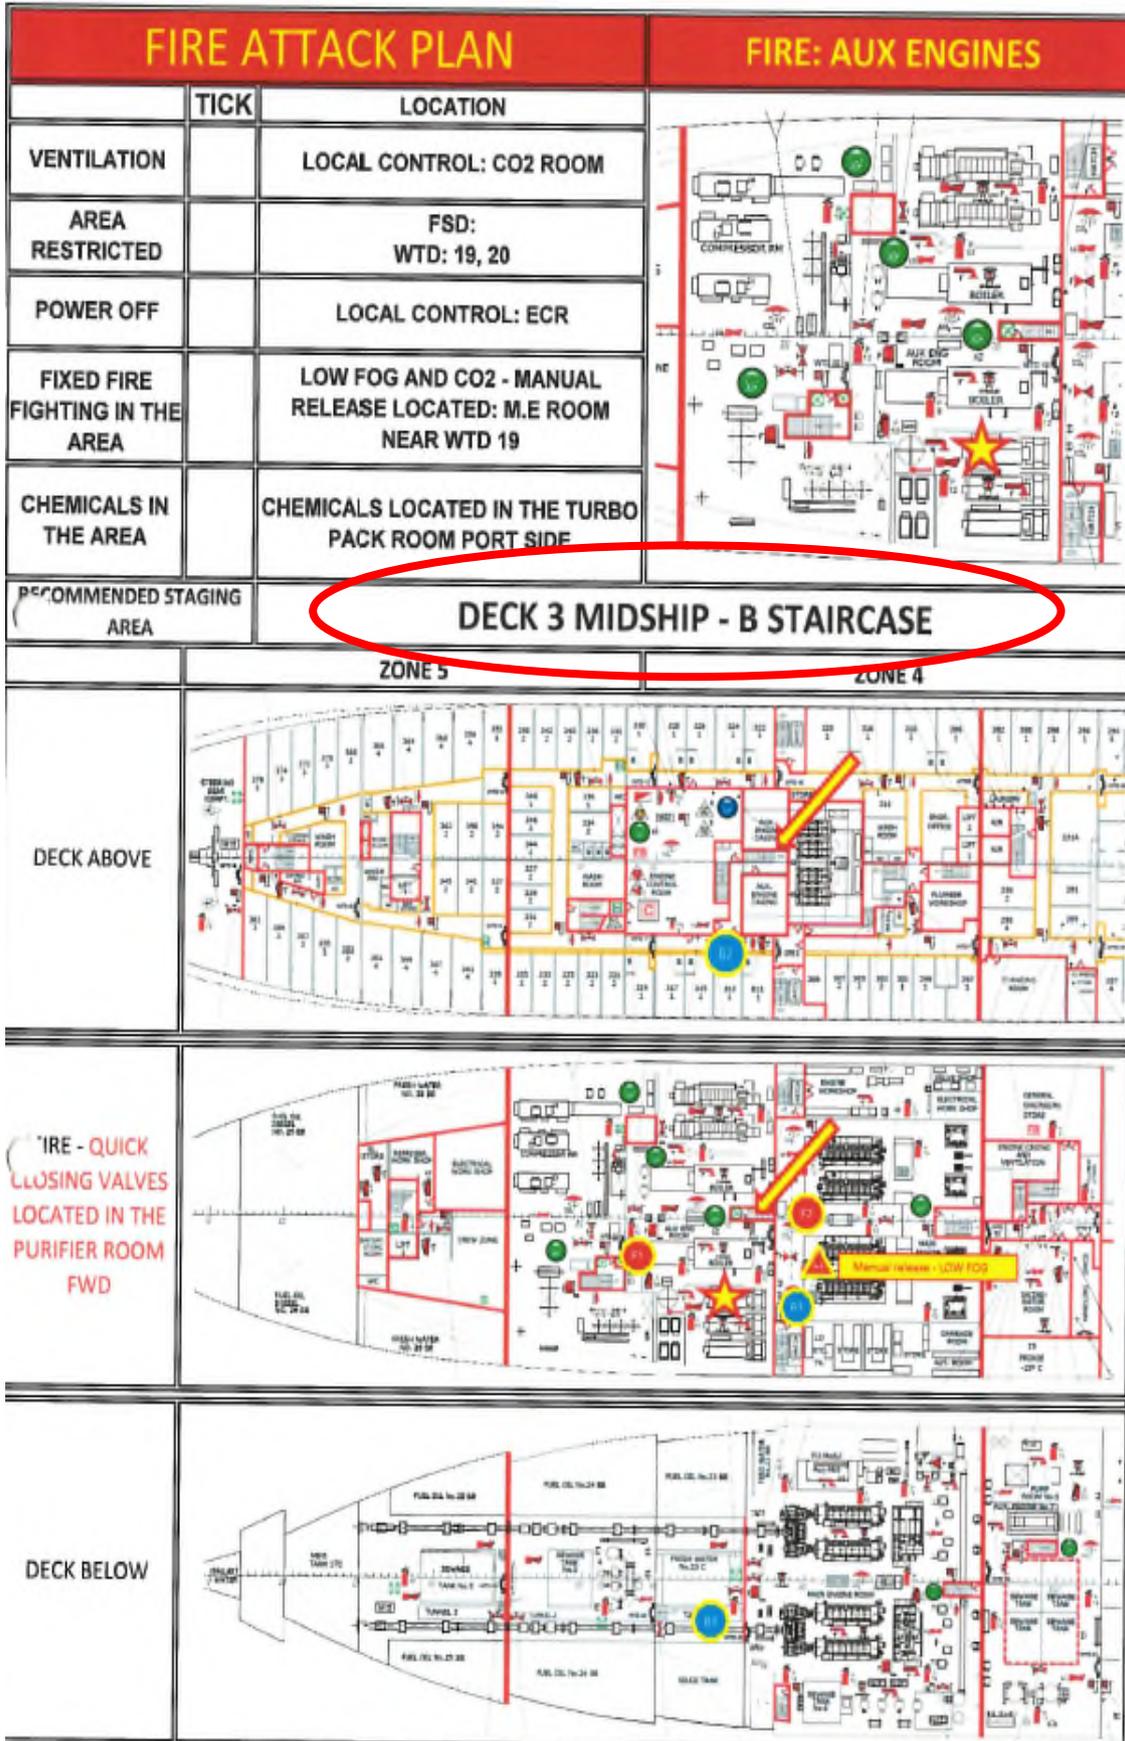
- 5.7.2 The establishment of the staging area outside cabin 320 was not in accordance with the pre-planned response for a fire within the auxiliary engine room (see figure 30, fire attack plan). Once the ECR was evacuated and WTD 10 was allowed to remain open, there was no physical boundary between a smoke filled compartment and an area deemed, at the time to be suitable for controlling and coordinating fire teams entry and exit. In drills the crew train to incorporate a two-door separation between a smoke filled compartment and fresh air however this is not a Company policy. This was not achieved in practice and instead of re-establishing the staging area to a location further forward in fresh air, the staging area remained outside cabin 320 subjecting the staging team to smoke which had migrated from the ECR through the open WTD 10. Further, a smoke boundary could not be maintained due to the movement of personnel to and from the smoke filled staging area; this allowed smoke to migrate freely.

Figure 30: Fire Attack Plan and highlighted (circled) recommended staging area
