**The Bahamas
Maritime Authority**

**M.v. BOUDICCA
IMO Number 7218395
Official Number 8001101**

**Report of the investigation into an
Auxiliary Engine Room Fire on the
25th January 2015**

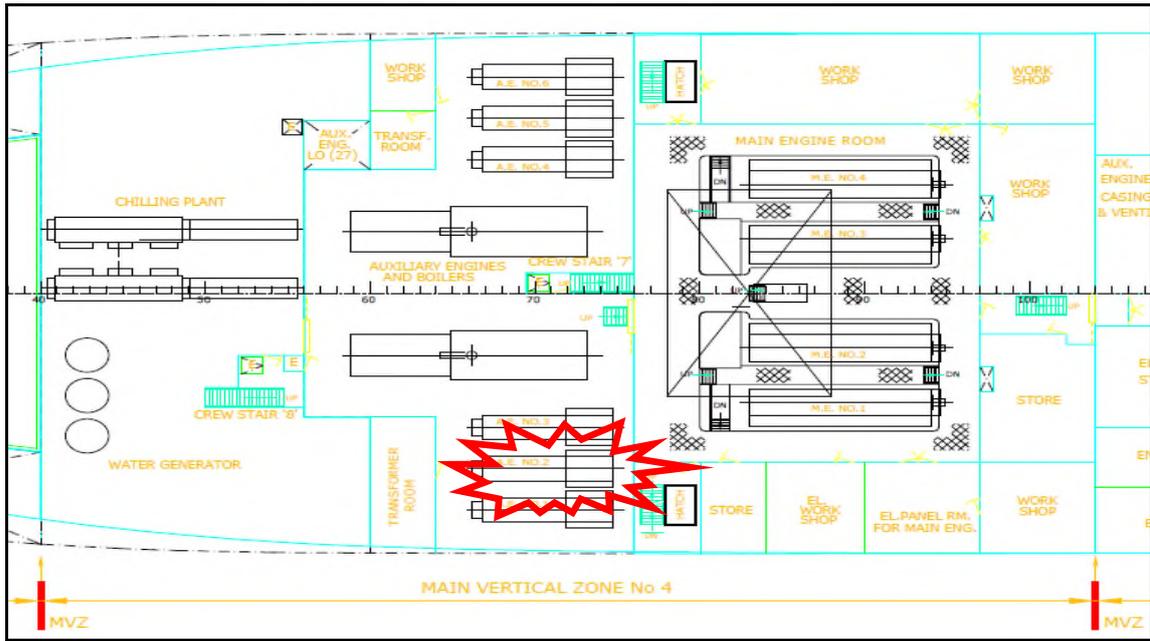
- 3.3.4 The Oiler reported “when I arrived in the main engine room I see a lot of smoke in boiler room” (auxiliary engine room). This was confirmed by the closed circuit television circuit (CCTV) monitor, displayed in the ECR and witnessed by the 4/E.
- 3.3.5 On the bridge, the 3/O on watch, hearing the fire alarm, acknowledged the alarm and confirmed the location. Conversations overheard on the UHF radio by the 3/O, between the 4/E, Oiler and Motorman also alerted the bridge to the fire. This was quickly followed with a phone call from the 4/E in the ECR to the bridge, advising “he had a fire in the engine room, boiler room auxiliary engine No.1” (AE1). The 4/E then proceeded to shut down the AE1, which is located on the starboard side of the auxiliary engine room.

Figure 5: Location of Fire (AE1 - Deck 1, Fire Zone 4)

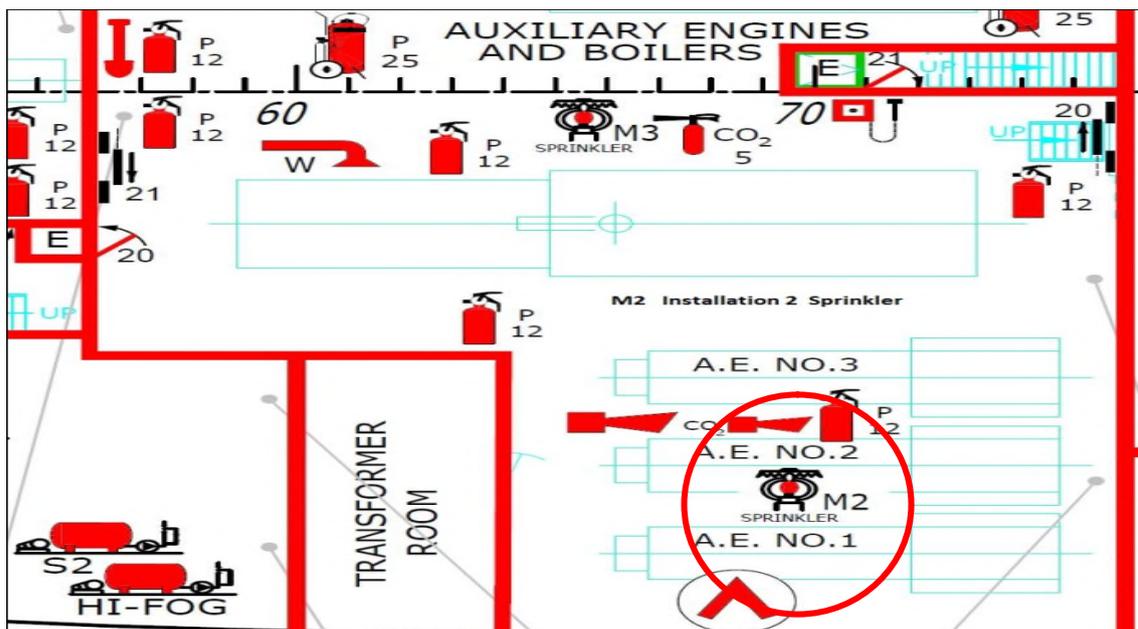
- 3.3.6 During this short period of time the Oiler and the 4/E were communicating on the UHF radio in Tagalog and not in the common language of the ship - English. As the 3/O did not speak Tagalog he was unable to understand what was being communicated and therefore unable to monitor the situation or any progress achieved by the actions of the initial responders.
- 3.3.7 Once the 4/E was satisfied the fire in the auxiliary engine room was confirmed by the Oiler, he manually activated the Marioff Hi-fog system for the affected area covering generators No.1, 2 and 3, via the sprinkler head No.M2 (see figure 6) by utilizing the Hi-Fog control panel (see figure 7).

Figure 6: Location of Hi-fog sprinkler – M2 (circled in red) adjacent AE1 and AE2 generators.

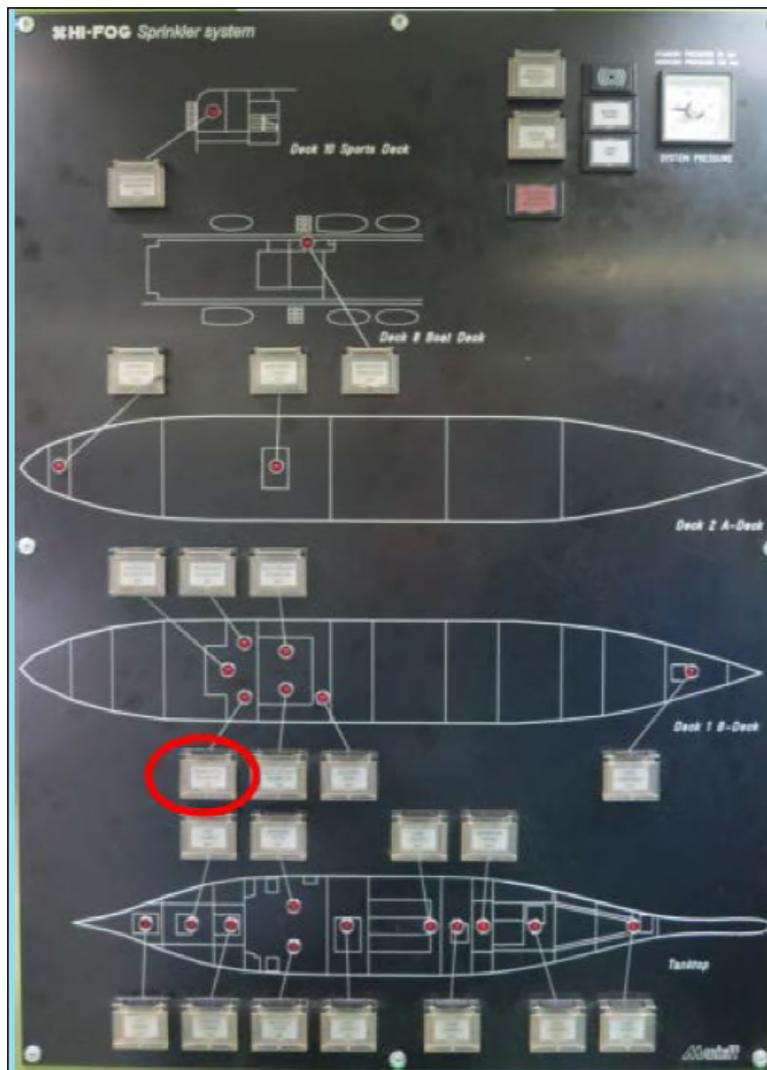
Figure 7: Hi Fog Control Panel

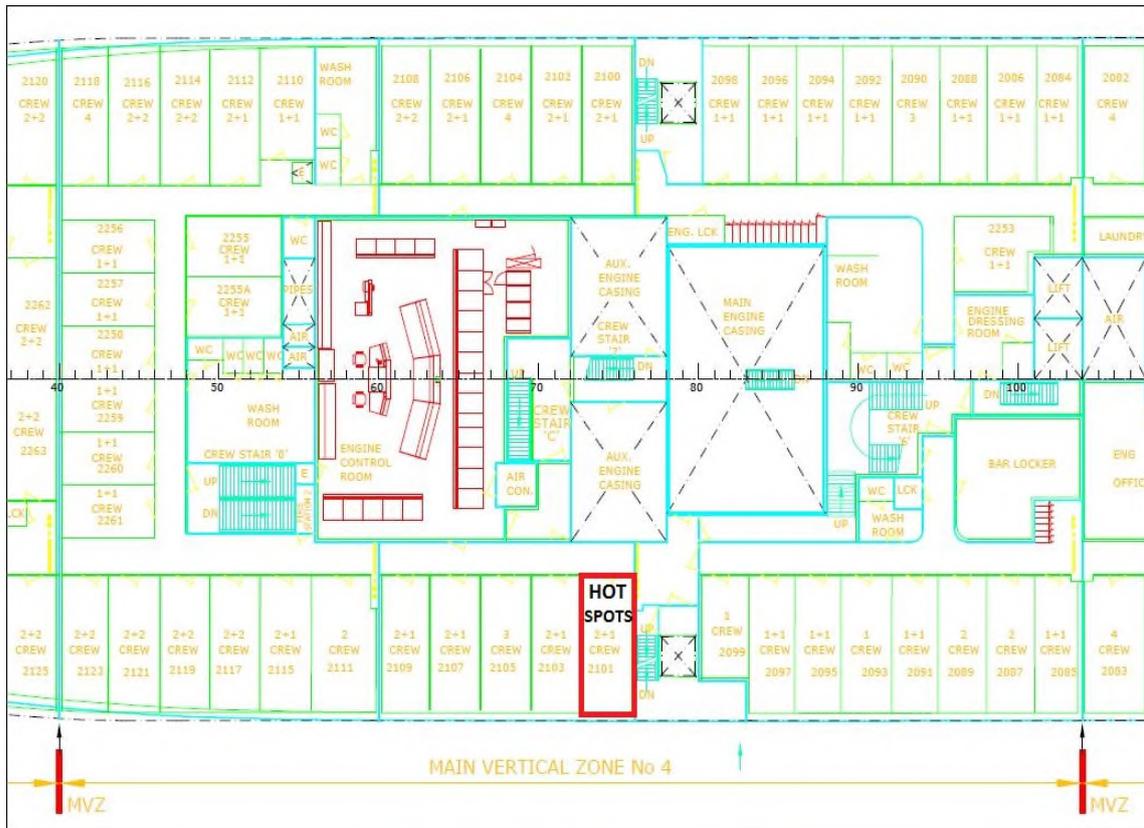
- 3.6.1 At 0358 hotspots were found on deck 2 in cabin 2101 (see figures 10 and 11), the location of which was immediately above the source of the fire in the auxiliary engine room. The rapid response team conducted boundary cooling containing the situation and preventing the vertical spread of the fire.

Figure 9: Location on Deck 2 of fire damage in Cabin 2101

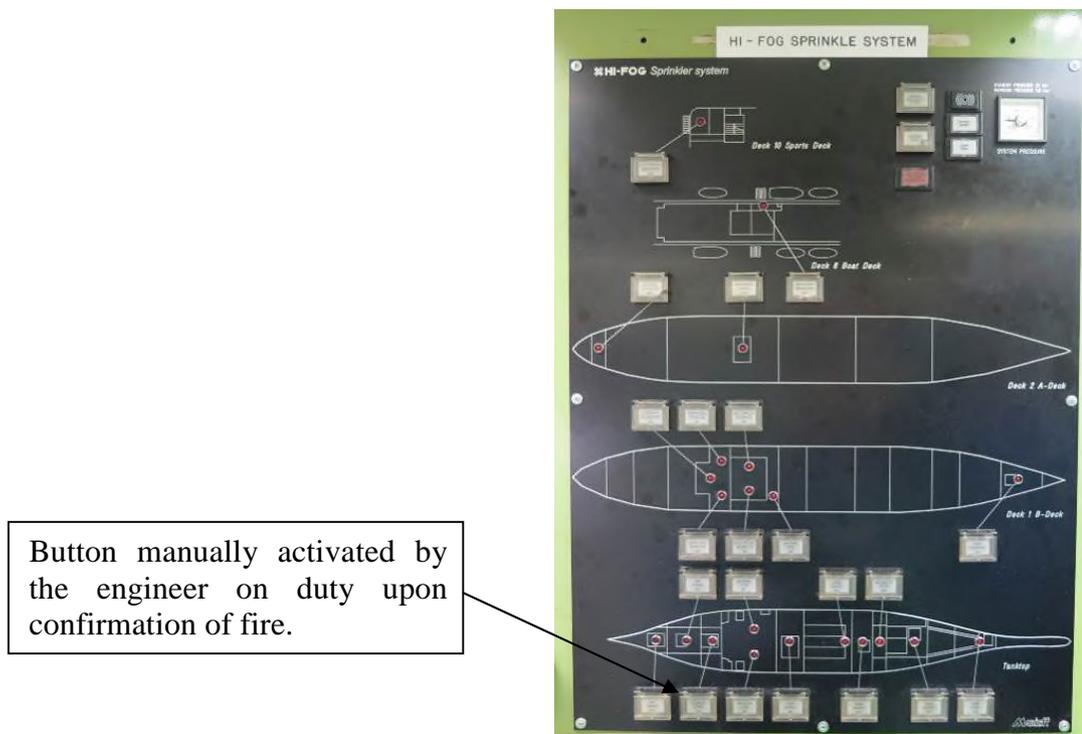
Figure 20: HI Fog Sprinkler System Panel

- 4.3.5 Due to the developing list, which was the first indication the vessel had not restored all systems, it was determined that the Hi-Fog system had continued to operate for 1 hour 14 minutes after the point at which it was assumed it had been stopped. The estimated water discharged into the space during the course of the systems operation was in the region of 80m³, which was collected in the bilge of the chilling plant and water generation room, aft of the auxiliary engine room that subsequently drained into the tunnel room (tank top).

- 4.3.6 A Marioff technician, instructed to determine the cause of the system not operating as required, found that at some point during the incident the manual emergency start button had been activated on the bridge panel which starts all high pressure pumps, feed water pumps and overrides the pump units technical tanks high level switch. This resulted in the technical tanks to overflow despite

- 4.3.7 It may have been apparent to the operator on the bridge if the lamp, indicating the switch was activated had not been faulty, resulting in a delay in switching off the breakers to the system to stop the Hi-Fog system from operating.
- 4.3.8 Once acknowledged as being the root cause of the 5^o list to port, the remaining water was pumped from the bilge restoring the upright condition of the vessel via the onboard emergency bilge pumps.

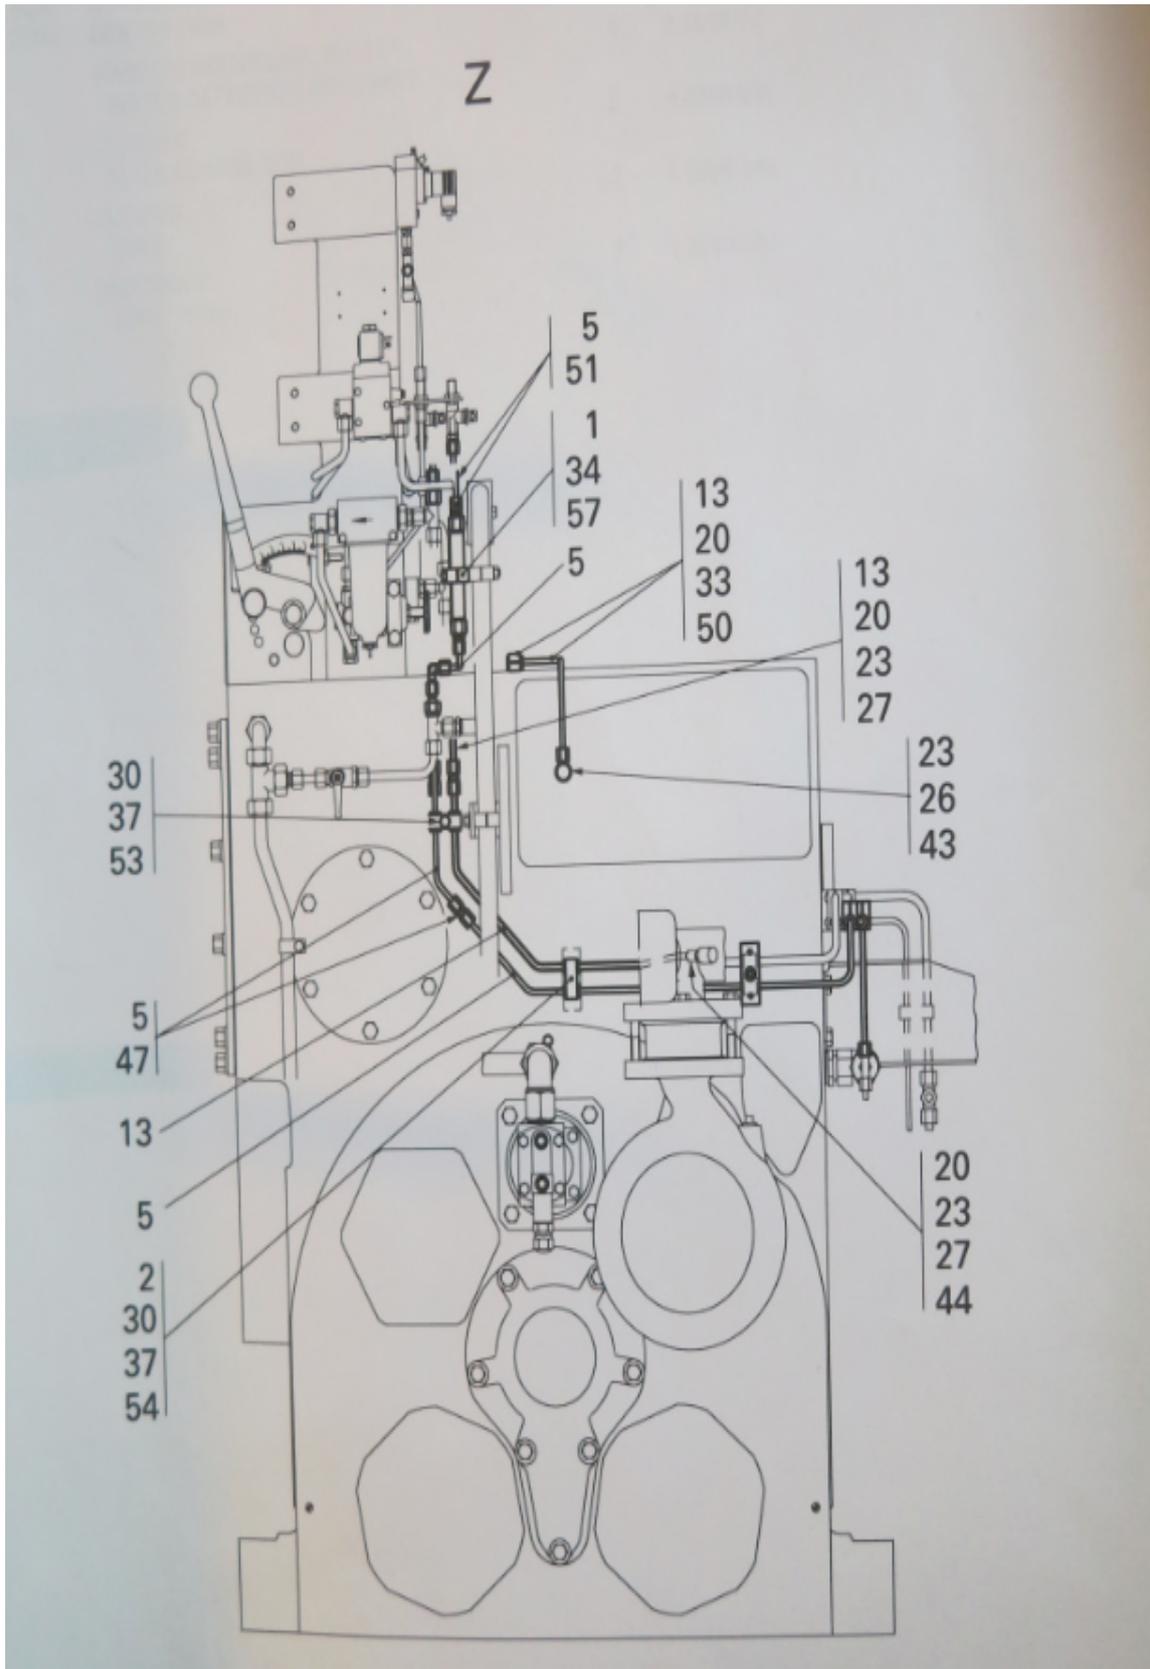
- 4.2.2 The fuel supply line is situated on the forward end of AE1 behind the panel holding the manometer pressure gauges. The fuel oil pressure gauge supply line measures the fuel oil supply to the generator by feeding the manometer gauge, the approximate pressure of the fuel within the line is 5 bar. The steel line is inverted 'Z' shape, 6mm wide and 120mm in length, situated (see figure 13) approximately 500mm below the top of the engine and 800mm beneath the turbo charger. At the point of the fracture the pressurized fuel, occupied the atmosphere surrounding the engine. The exact source of ignition cannot be determined, however, there are various components that have a surface temperature sufficient to auto-ignite hot fuel in vapour and liquid form within the immediate vicinity of the fracture. Due to the proximity of the turbo charger to the fuel oil supply line at the front of the engine, it can be concluded with a high degree of probability that the source of ignition was provided by the turbo charger.

Figure 24: Front End MaK 6M20 Auxiliary Engine
