**Report of the investigation into
the engine room fire
onboard the *MV. Laurentian*
at sea on
11 October 2001**

Date of Issue : 23 April 2002

Bahamas Maritime Authority
Latham House
16 Minories
LONDON
EC3N 1EH
United Kingdom

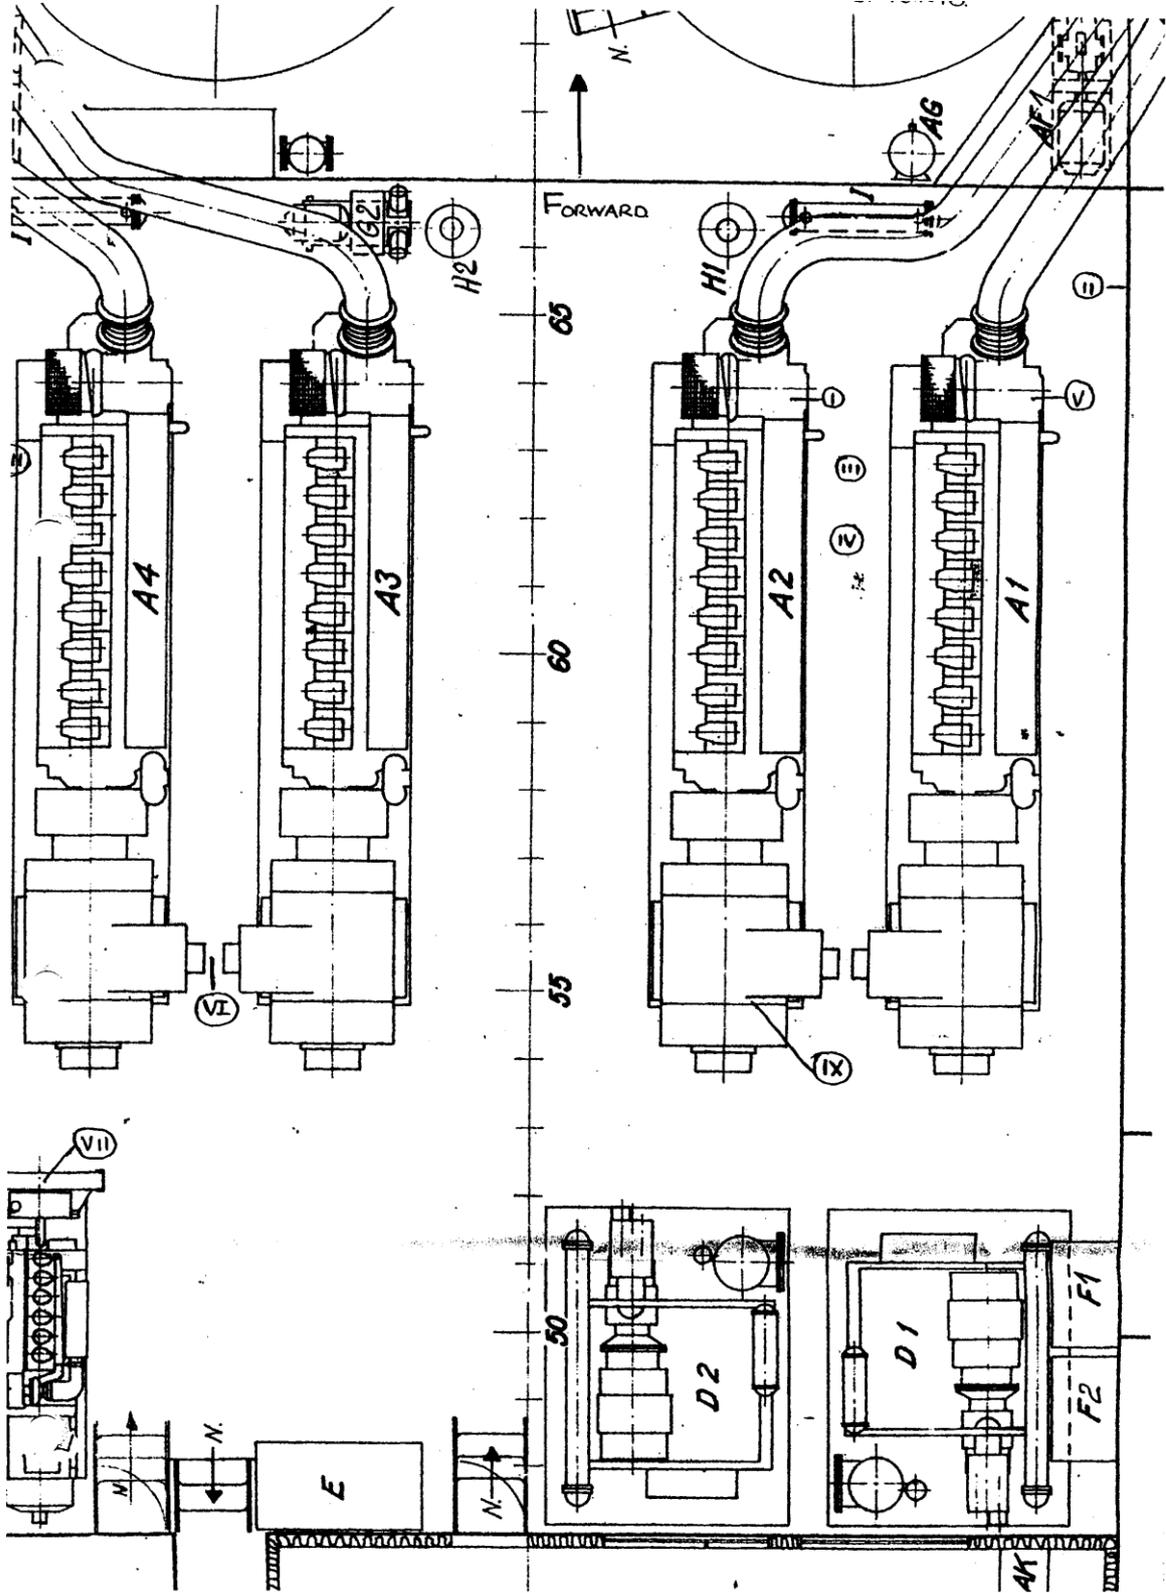
ANNEX 1

- 5.5 The fuel system fitted to the vessel is a conventional fuel booster system with one pump supplying four engines. In the case of a diesel electric system such as this, stopping the fuel booster pumps to isolate a fuel leak will result in the loss of all power supplies.
