**The Bahamas
Maritime Authority**

TAI SHAN

IMO Number 8513560

**Report of the investigation into
Fire damage to
Tai Shan
on
2nd July, 2014**

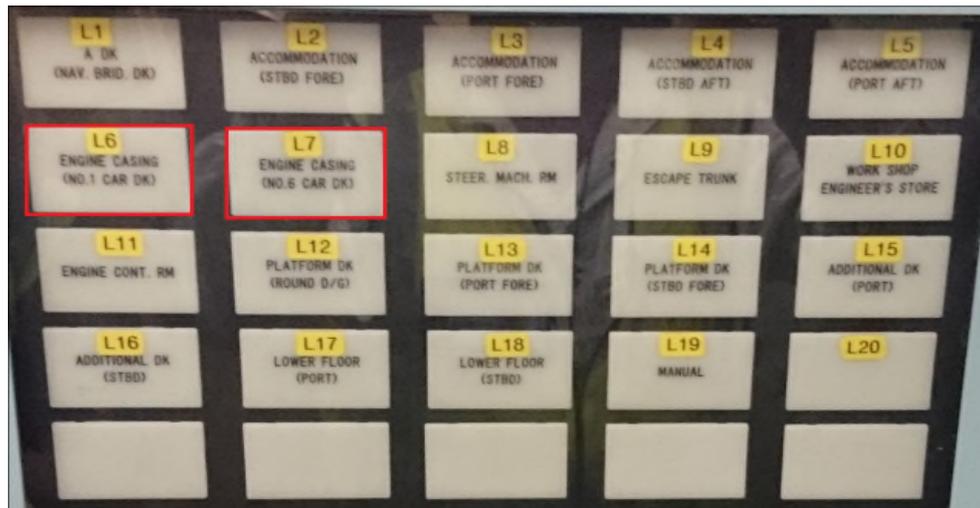
Fig.13 ECR – Fire Alarm Panel

3.24 At 09:12 hours, the fire alarm sounded, being identified within zone – Engine Casing (Car Deck No: 1 L6). The Master, who was on the bridge within a minute of the fire alarm sounding, announced over the intercom that there was a fire in the funnel and that it was not a drill. On looking aft, the Master sighted from the starboard wings, “*clouds of thick black smoke from and around the funnel*”. The Engine Log Book recorded the events, one hour earlier than the bridge log book. The statements issued by engine staff all stated the same times as the bridge log book, indicating incorrect times in the engine log book.

3.25 A second fire alarm activated in less than 2 minutes - Engine Casing (Car Deck No. 6 - Alarm L7). At 09:14 hours, the C/E, who was in the Engine Control Room, advised the Bridge officer of the watch, that there was a fire in the Auxiliary Boiler area and requested that the main engine was stopped from the bridge control. The vessel altered course to keep the wind from the port side.

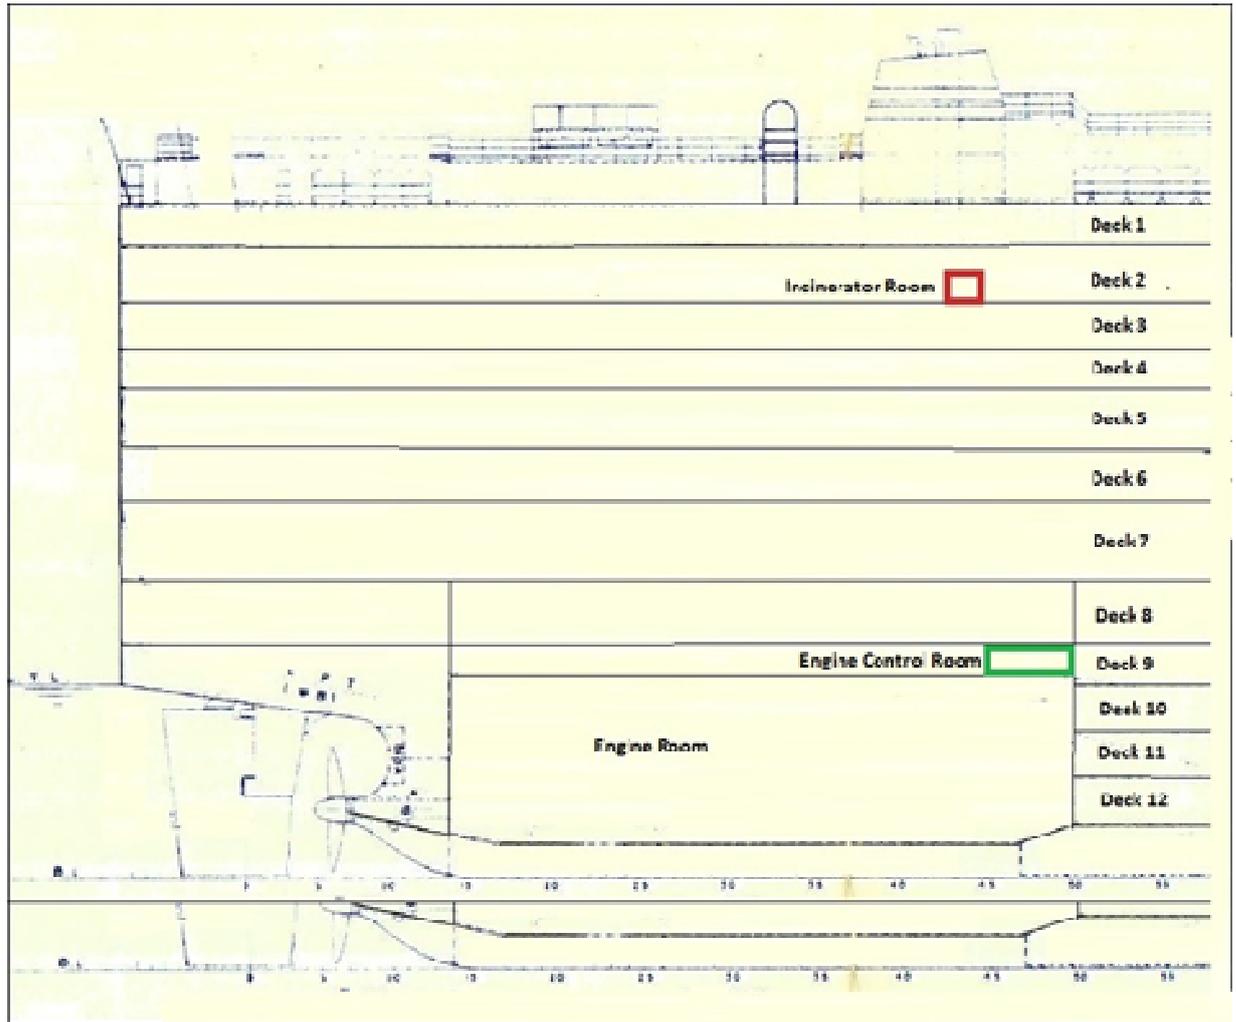
- 3.20 The primary source of the fire was found to be centred in the incinerator room, which was fed by the pilot burner and diesel fuel tank, the content leaking fuel from the burnt pipes and melted alloy fuel filters under the incinerator. The diesel tank and the waste oil tank were both found empty.
- 3.21 Prior to the fire the diesel tank was stated to have been “*about half full*”, which would indicate that it had contained approximately 300 litres of diesel.
- 3.22 A large amount of insulation in the stairwell had allowed a secondary fire to develop, which spread to No. 2 Car Deck. The spread of the fire was caused by the opened Incinerator room door. The insulation had been removed in places, down to the bare metal. Where insulation did remain, it was evident that the cladding had been coated with paint.

Area where initial fire was reported - debris had fallen from incinerator above.

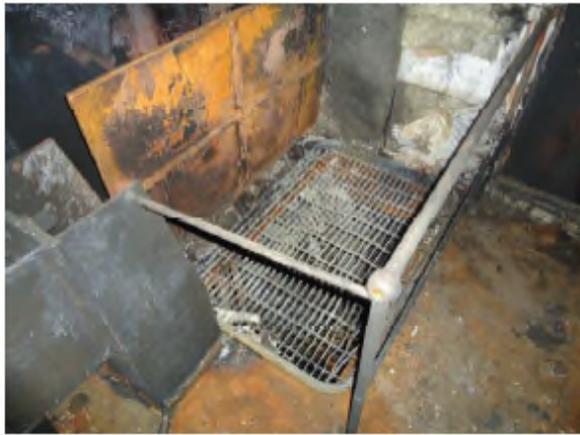
Fire flap (one of two) in the funnel space, above the incinerator room. The deck shown, was the same level as the upper deck outside.

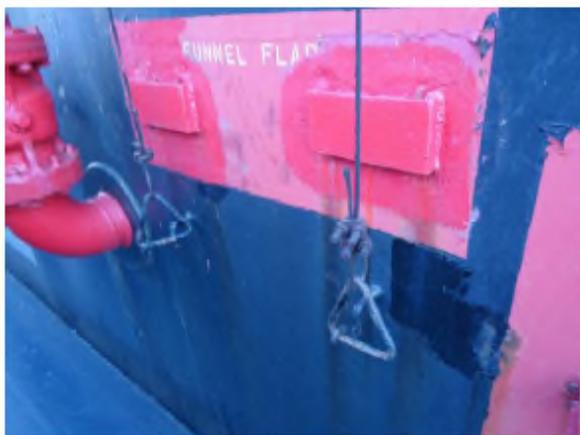
The two pull wires to release the funnel flaps mentioned above. These were positioned on the inboard side of the funnel casing (which was situated on the stbd side).

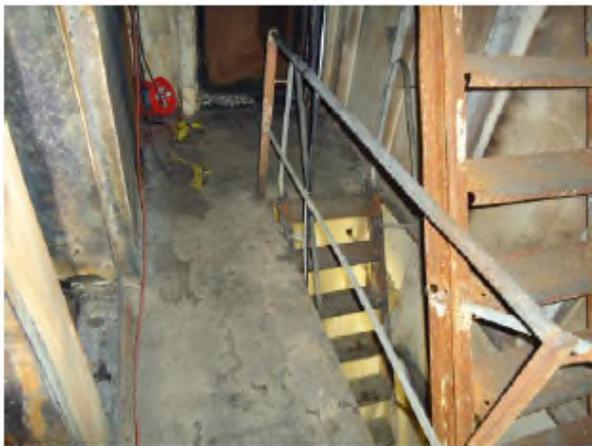
Staircase at car deck 2, looking in a port direction, with the car deck entrance door in the background and the incinerator room door on the left.

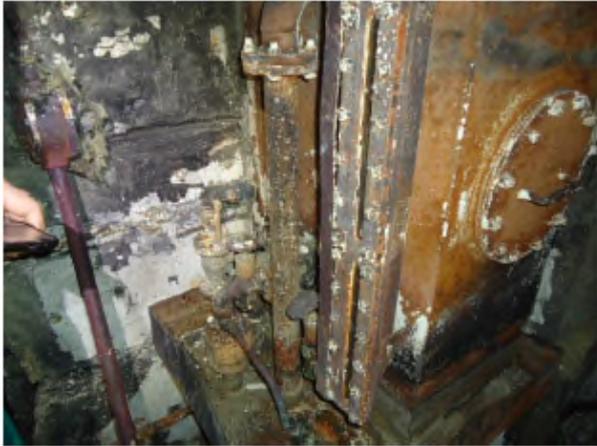
- 3.43 During investigations, the diesel tank and the waste oil tank were both found empty. Prior to the diesel tank was stated to have been "about half full", which would indicate that it had contained approximately 300 litres of diesel.

Diesel tank in the incinerator room, for the incinerator pilot burner and for burner assistance when incinerating poor quality waste oil.

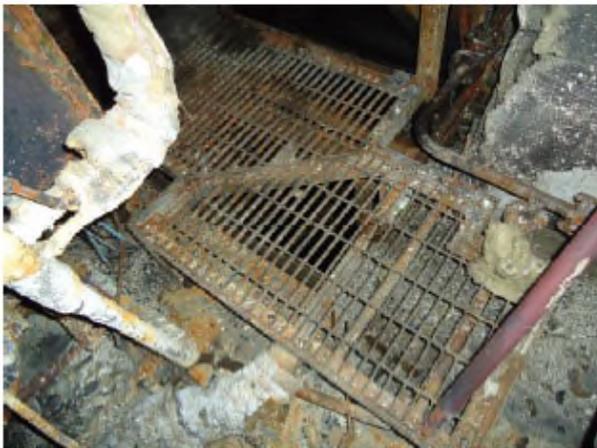
Gratings in the incinerator room deck, covering the openings to the engine room below.

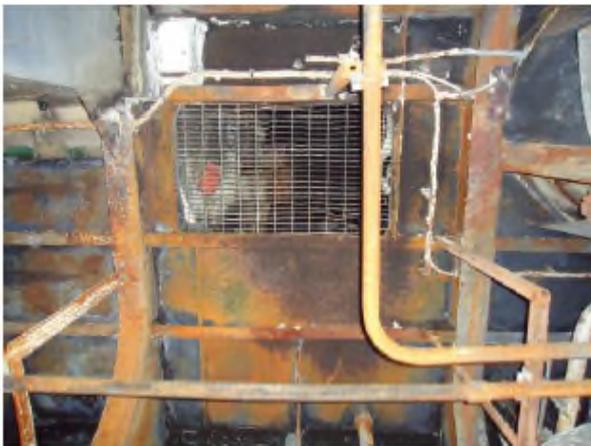
The deckhead above the incinerator with the opening (one of two) fitted with a spring loaded, (to close), flap, operable from open deck.

The incinerator room was two decks high. (No plate deck, level with cargo deck No. 1)

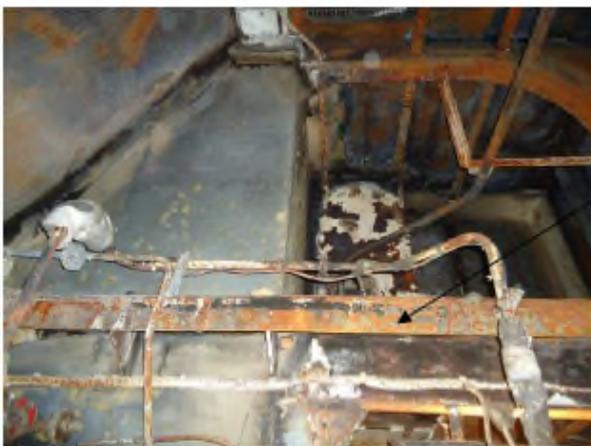
Incinerator room, looking upwards and slightly forward. As per the previous photograph, the space was two decks high, with car deck No. 1 level, only with a small thwartships stringer plate at the forward part.

The fire flap in the deckhead, to the funnel space, mentioned in the previous photograph, can be seen at the top of this photograph.

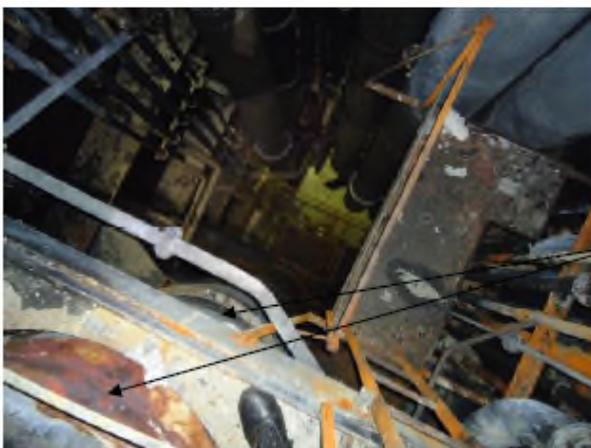
At the aft end of the No. 2 Deck platform on which the incinerator was fitted, the deck was open, down to Deck 5, where the exhaust gas economiser was fitted.
