M.V CELTICA HAV

**Report of the marine safety investigation into a grounding
in the approaches to the River Neath, Wales on 27 March
2018**

Grounding of general cargo vessel *Celtica Hav* in the approaches to the River Neath, Wales 27 March 2018

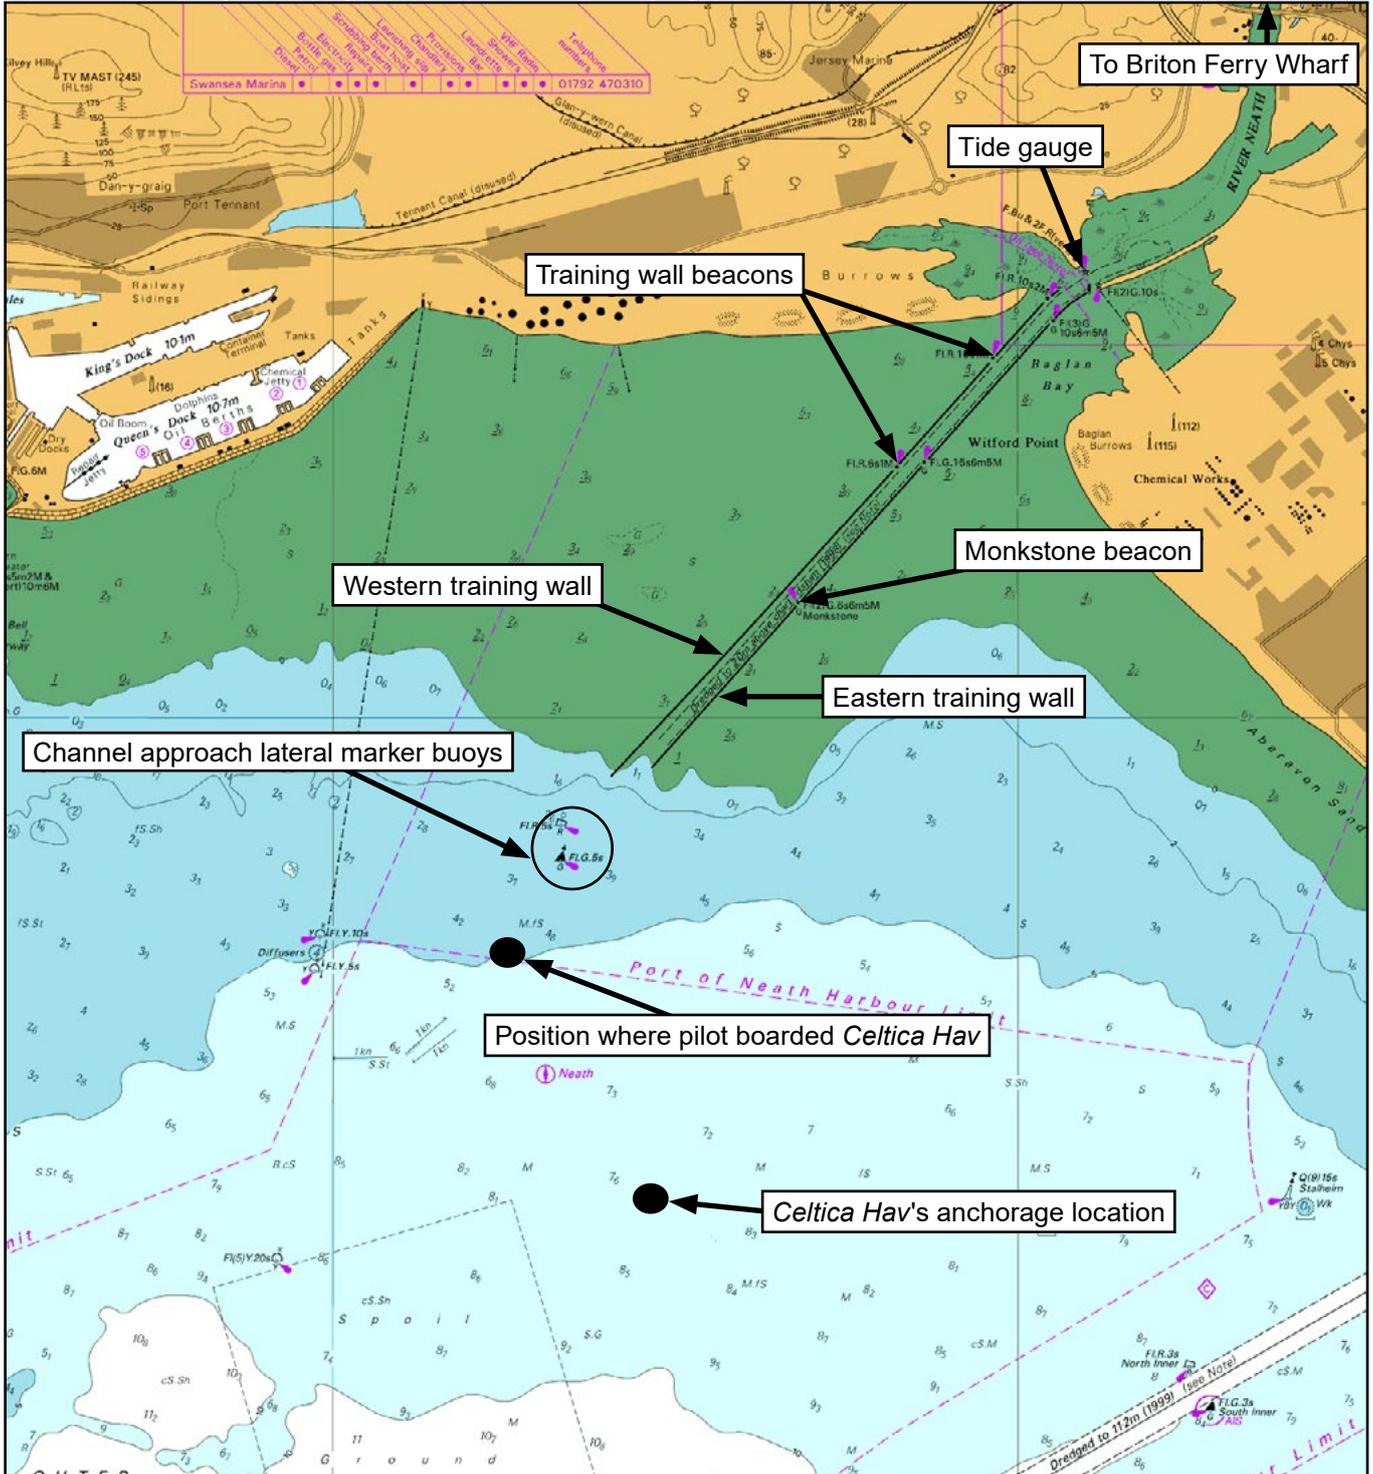
Figure 1: Chart extract showing key locations

On 19 March 2018, *Celtica Hav* sailed from Liepaja in Latvia, carrying 2070t of Anthracite, bound for Briton Ferry wharf on the River Neath, Wales. During the passage the ship's agent advised *Celtica Hav*'s master of the draught restrictions at the discharge berth and instructed him to be ready to take a pilot and enter the River Neath during the afternoon flood tide on 27 March. *Celtica Hav* arrived in Swansea Bay at 1700 on 26 March and anchored 1 mile south of the River Neath approach channel (**Figure 1**).
