**The Bahamas
Maritime Authority**

**Report of the investigation into
the grounding of
*M/V Mona Lisa***

at the Irbe Strait, Latvia

**on
04th May 2008**

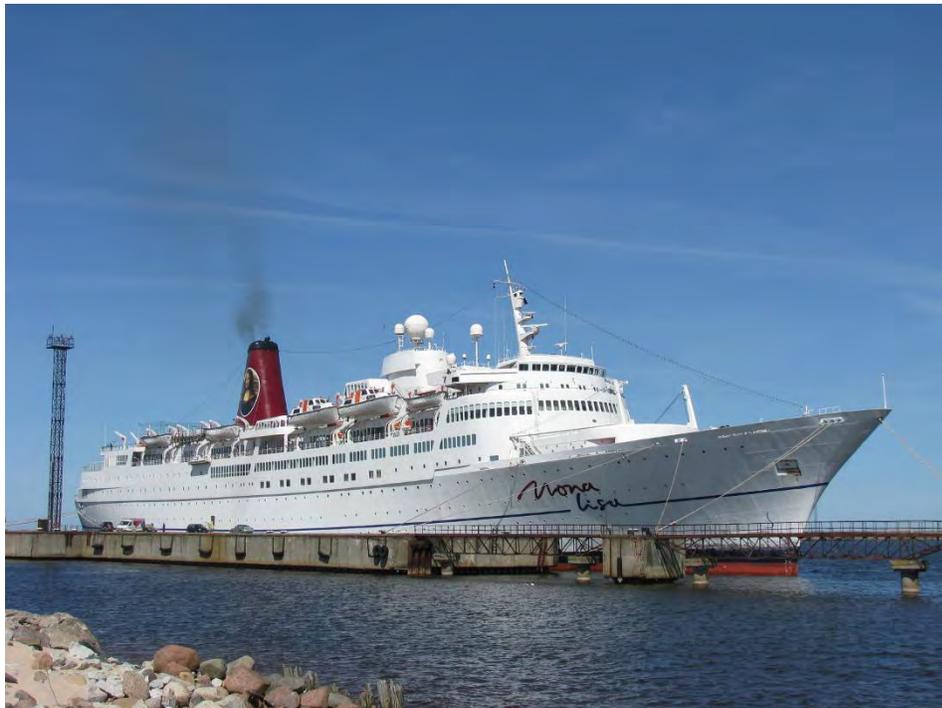
M/V MONA LISA berthed at Ventspils. Photo taken on 8th May 2008

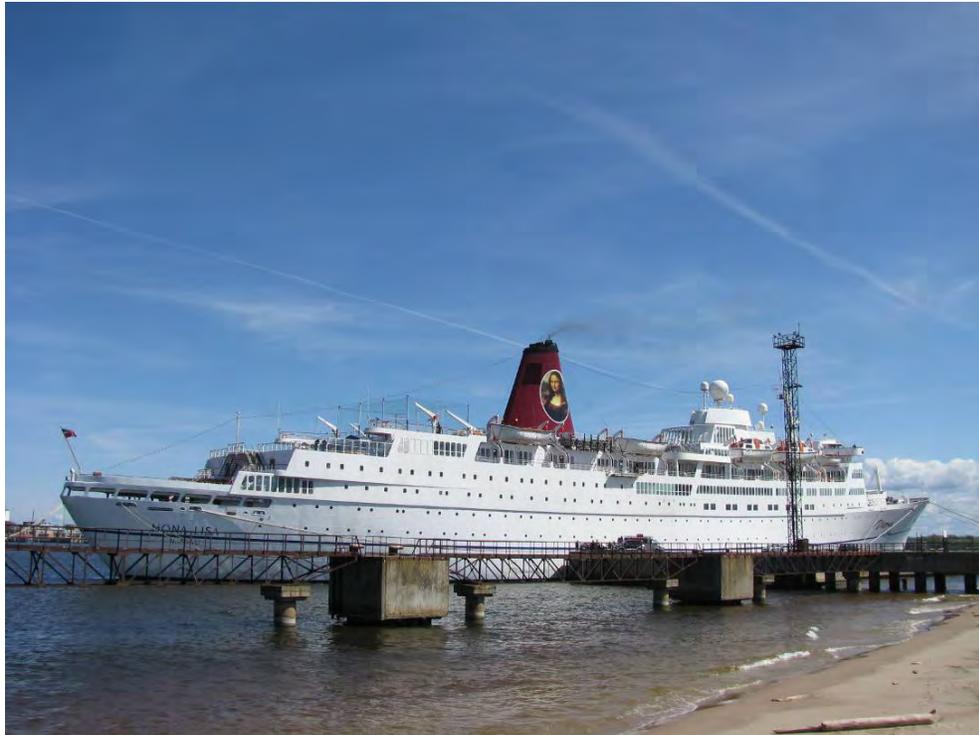
M/V MONA LISA berthed at Ventspils. Photo taken on 8th May 2008

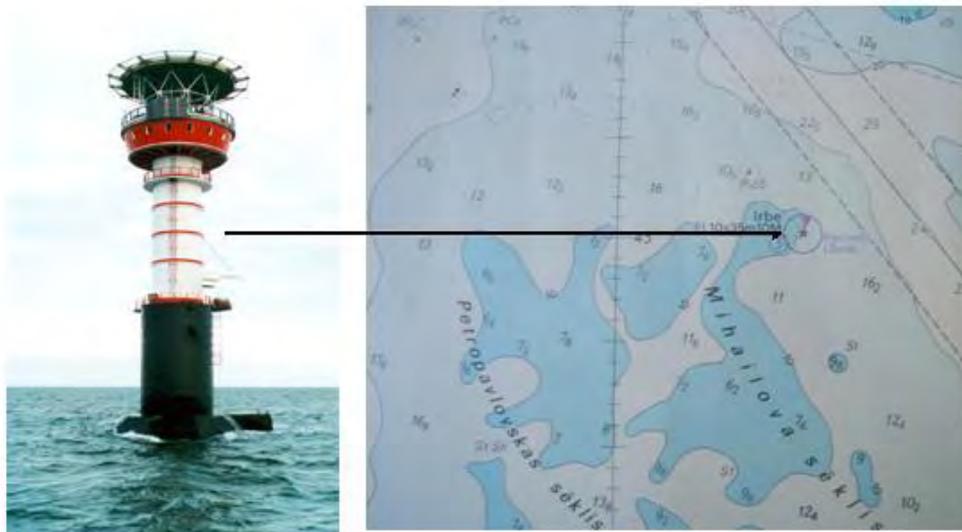
Irbe Lighthouse and Location

- 3.4.1 The Irbe Strait is the main entrance to the Gulf of Riga, partially obstructed by numerous shoal patches through which three fairways exist – Main Fairway, West Fairway and Inshore Fairway. The Main Fairway having a depth in excess of 10 metres.
- 3.4.2 The passage plan directed the “MONA LISA” into the Main Fairway, the intended track being to the east of the Irbe Lighthouse. This lighthouse protects shipping from the eastern side of the Mihailova Shoal, having a least depth of 5 metres over it.
- 3.4.3 The Irbe Lighthouse (LAT 57°45.04N LONG 21°43.38E) having an overall height of 35 metres and being a round black and white concrete tower with red bands and a helicopter platform was easily visible in the prevailing conditions at the time of the grounding.

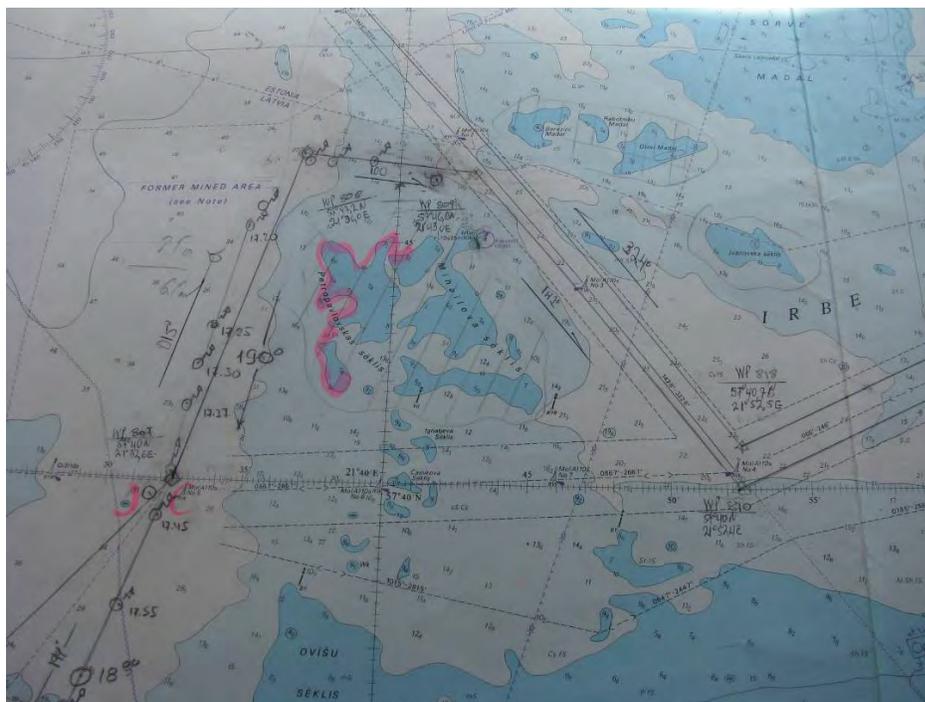
- 4.3.1** The navigation chart used during the grounding incident was BA Chart 2226, Entrance to the Gulf of Riga (1:100 000), Edition 2005, corrected up to NTM 14/2008. Chart datum was WGS 84, i.e. GPS positions could be plotted directly on this chart.
