**The Bahamas  
Maritime Authority**

**ANTHEM OF THE SEAS**

**Report of the marine safety investigation into a heavy  
weather incident on 7<sup>th</sup> & 8<sup>th</sup> February 2016**

## Anthem of the Seas – Marine Safety Investigation Report

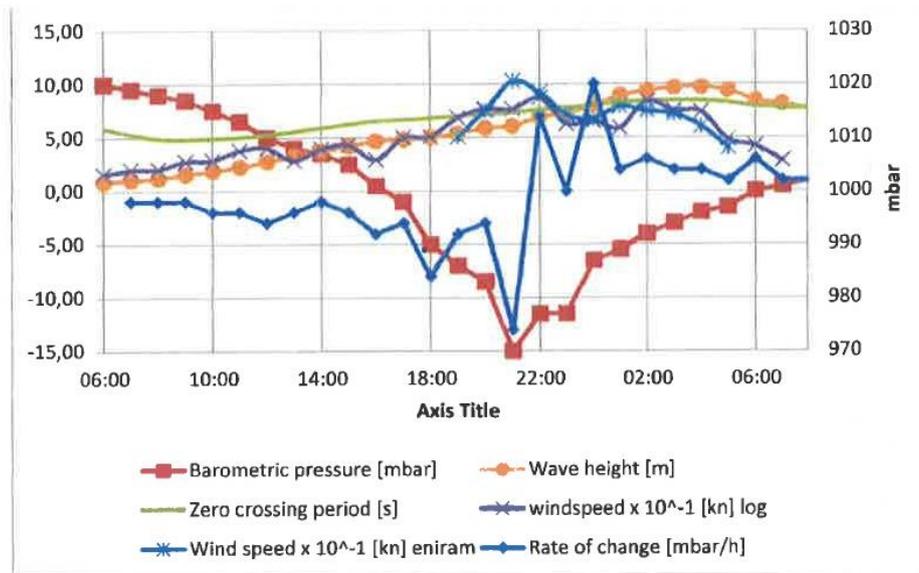
The VDR wind data (port side anemometer) indicated the maximum true wind speed experienced by the vessel was 146 knots at 18:06:35 on 7<sup>th</sup> February. For safe navigation of the vessel and considering the comfort of the passengers and crew, 40-45 knots of wind speed was considered safe by the Master.

The barometric pressure dropped at an almost steady rate until 2000 hours. After 2000 hours, the rate of change dropped to  $-13 \text{ mbar/h}$  and the pressure dropped to a minimum of 970 mbar. After 2100 hours the barometric pressure started rising again. Wind speeds also peaked at the same time. The wave height peaked between 0300 - 0400 hours to a height of 9-10 meters.

Figure 8: Weather Data (Source: AN Propulsion study by ABB, DNV-GL, Elomatic, Meyer Werft, RCCL, VTT)
