Report of the investigation into the loss of the Bahamian registered tanker "Prestige" off the northwest coast of Spain on 19th November 2002

Bahamas Maritime Authority Latham House 16 Minories London EC3N 1EH +44 (020) 7264 2550

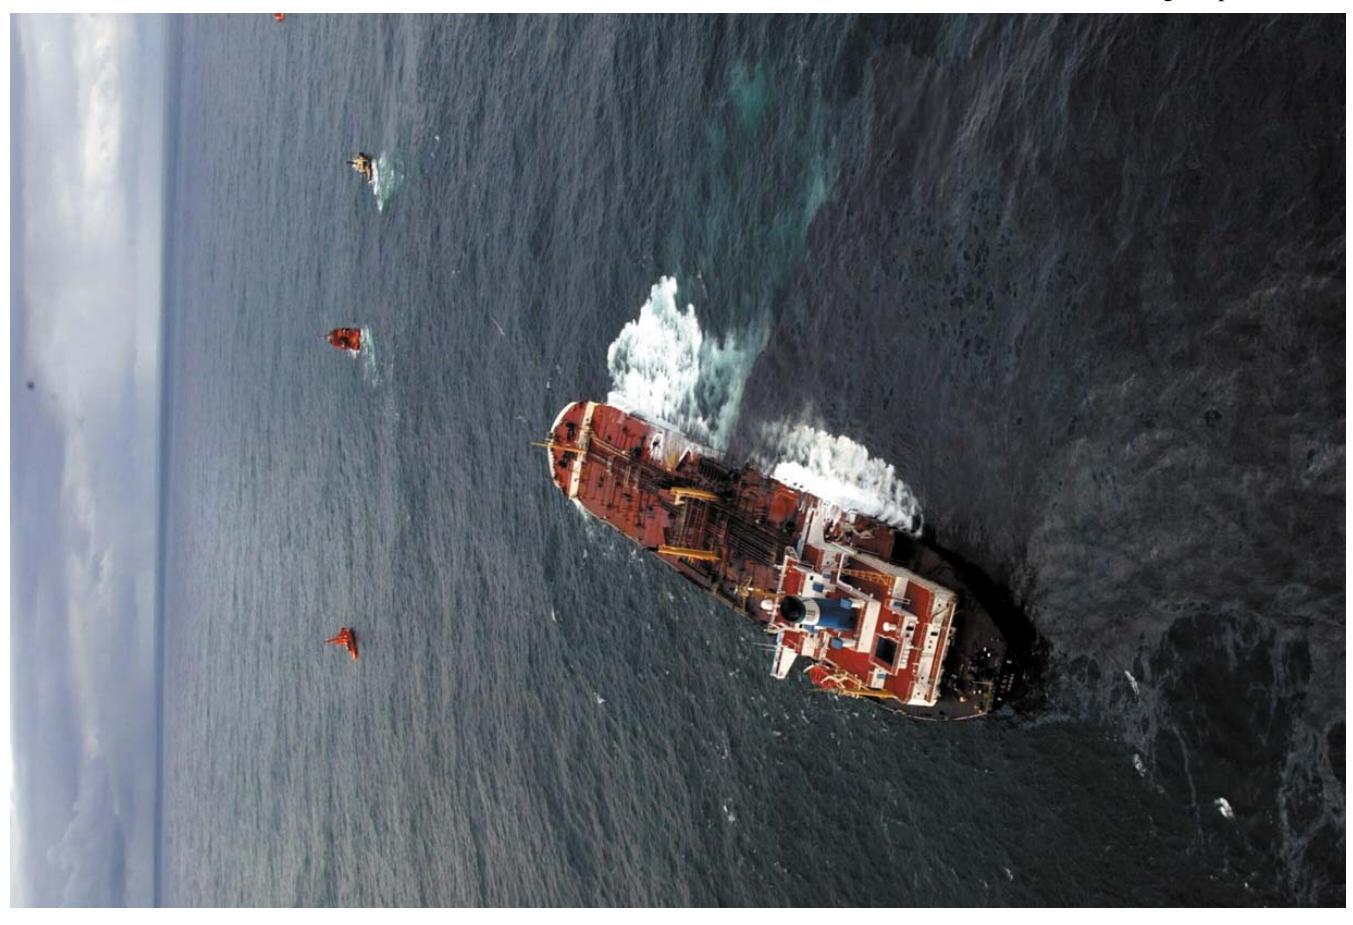
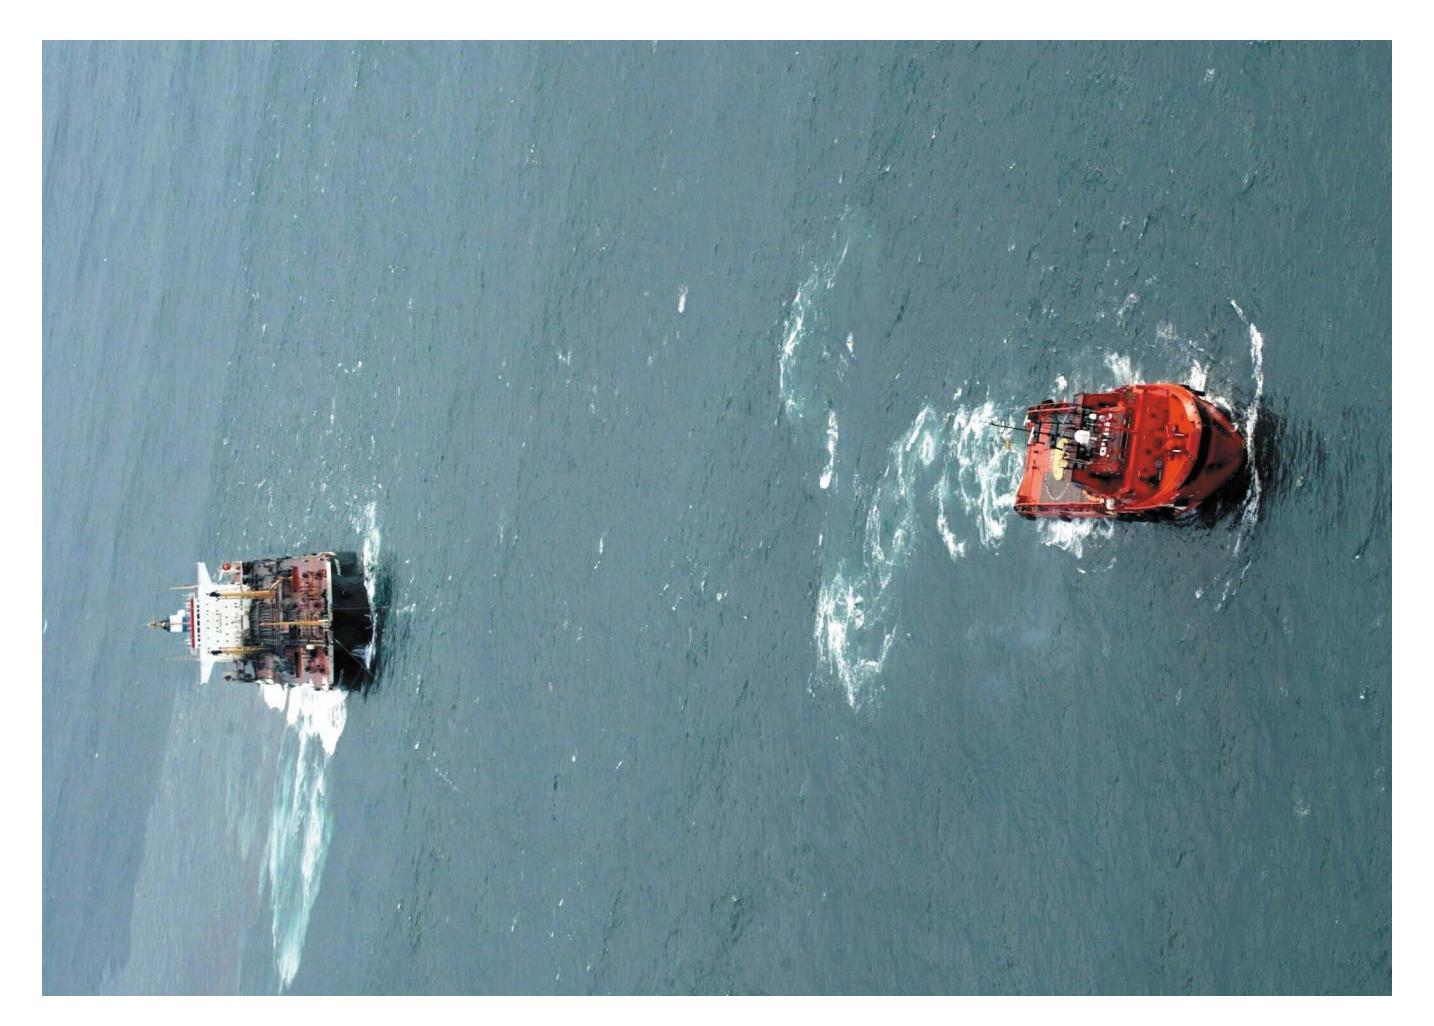
Under tow Figure 6 Narrative
2.7 Oil pollution

2.6.17 Ria de Vigo began shortening her towline at 1035 on 18 November and remained in attendance after disconnecting. At about the same time, the Spanish authorities advised the owners of the Ria de Vigo that Ria de Vigo should be released immediately. The Salvage Master advised that Ria de Vigo was required on site and could not be released. It was agreed by SASEMAR at 1120 that Ria de Vigo could remain in attendance. Sertosa 32 and Alonso de Chaves were released and returned to port. Deda resumed towing the Prestige stern first at around 1800 in a SW'ly direction at a speed of about 3 knots. The position of the Prestige at 1904 on 18 November was reported by Ria de Vigo to be latitude 42° 26'N longitude 11° 28.7'W.(Figure 6 shows tht Prestige under tow)
