**The Bahamas
Maritime Authority**

“MONARCH of the SEAS”

**Report of the investigation into
hazardous material release during
pipe work renewal.**

2nd September 2005

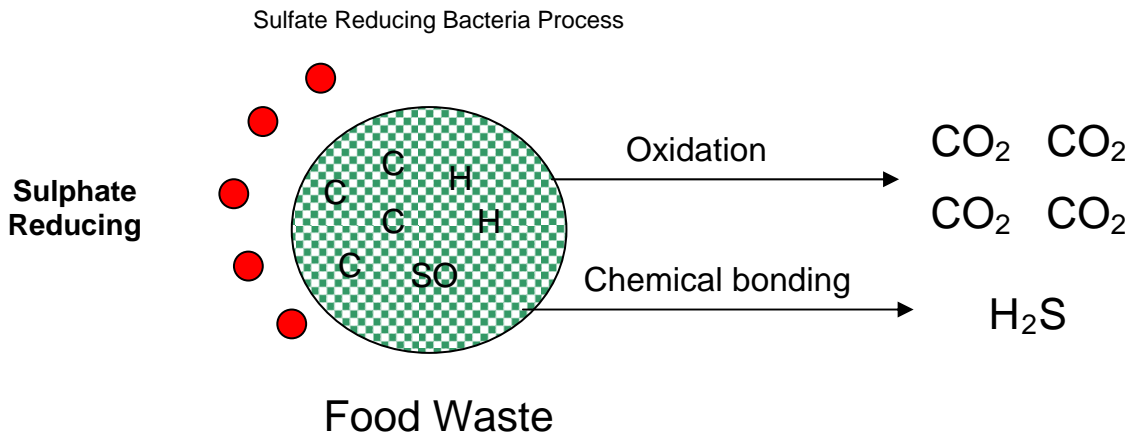
- 4.32 The production of hydrogen sulphide gas in this environment is both biological and chemical. In an anaerobic environment, sulphate reducing bacteria will consume food waste that contains carbon and sulphates (SO₄). The carbon provides food for the bacteria and the sulphate has four Oxygen atoms that are oxidized as the bacteria digest the carbon. Once the Oxygen atoms are split from the sulphate, the remaining sulphide ion is very unstable and looks to bond with available hydrogen atoms. The bonding of sulphide atoms with hydrogen atoms creates hydrogen sulphide (H₂S) see Figure below)

4.33 Most Sulfur Reducing Bacteria (SRB) requires an anaerobic environment to survive. This oxygen deficient atmosphere was provided within T7017 Permanent Ballast Tank 11 because the vents to this tank were blocked and oxygen content was reduced therefore allowing the SRB to actively produce the enzymes necessary to reduce sulfate. (*See Appendix IV SRB Memo from Nova Tech Consultants*) When the pipeline was opened by the crew, the liquid level of the tank was at or below the level of the pipeline penetration. By opening the pipe, the crew created a path for the gas to escape from the tank. Readings taken after the accident by the Los Angeles Fire Department indicated H₂S levels over 300ppm (the maximum reading of the gauge).

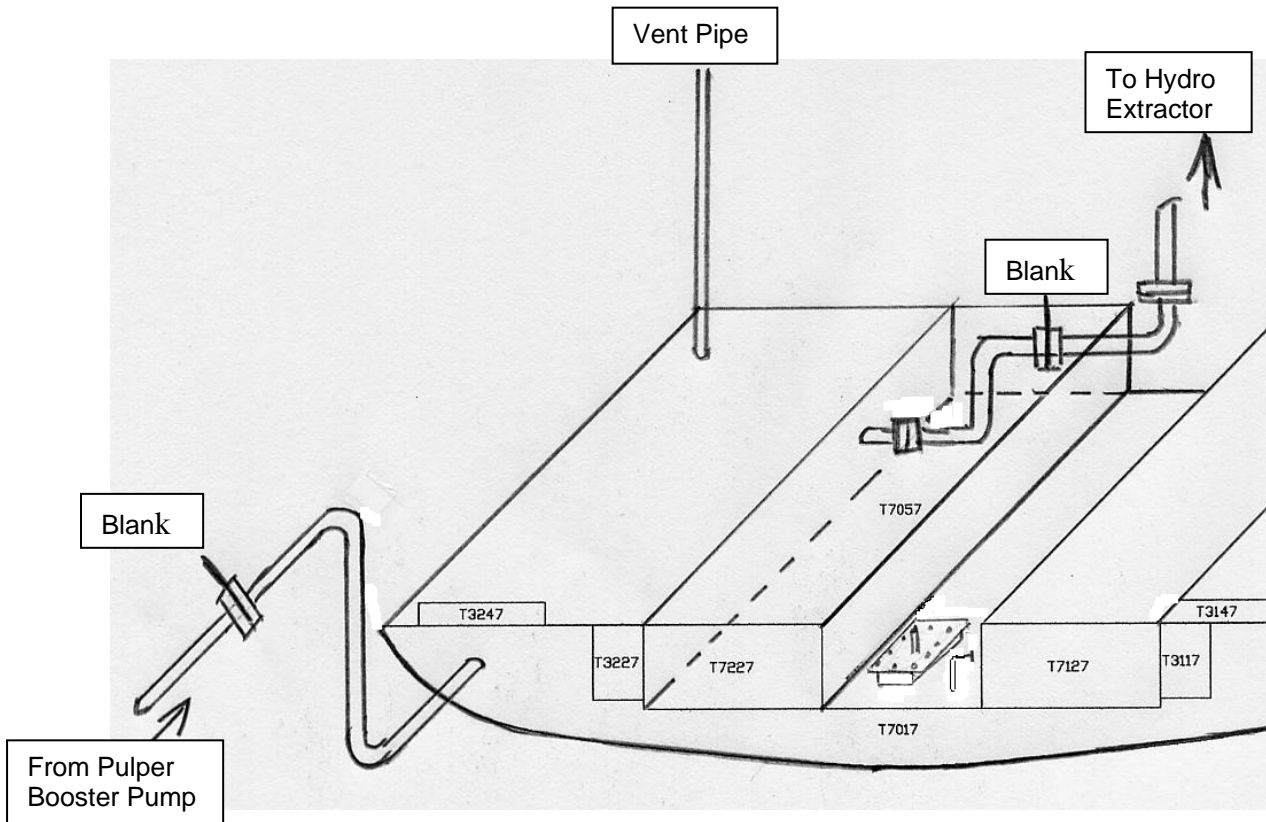
Sketch representing pipe and tank layout

- 1.8 The pulper pipe passed through an adjacent fresh water ballast tank (T7017 Dry Tank 11), sections of this pipe line were later discovered to be holed and this had allowed large quantities of food waste to accumulate in the tank. The resulting chemical reaction had caused Hydrogen Sulphide, (H₂S) gas to be generated which released during the incident.

- 3.18 The pulper pipes which passed through the water ballast tank (T7017 Dry Tank 11) were suspected of leaking due to dirty smelly water having leaked from the tank vents at no 1 deck. This had happened on several occasions and in an effort to keep the area clean these vents had been connected by hoses to drains which led to the starboard shaft tunnel bilge. During the managers investigation these vents/hoses were found to have been blocked at the time of the incident.
