Bahamas Maritime Authority

**Report of the Investigation into
The Premature Release of the
Port Lifeboat on *M.V. Pac Monarch*
at Vancouver, Canada,
on 26 October 2000.**

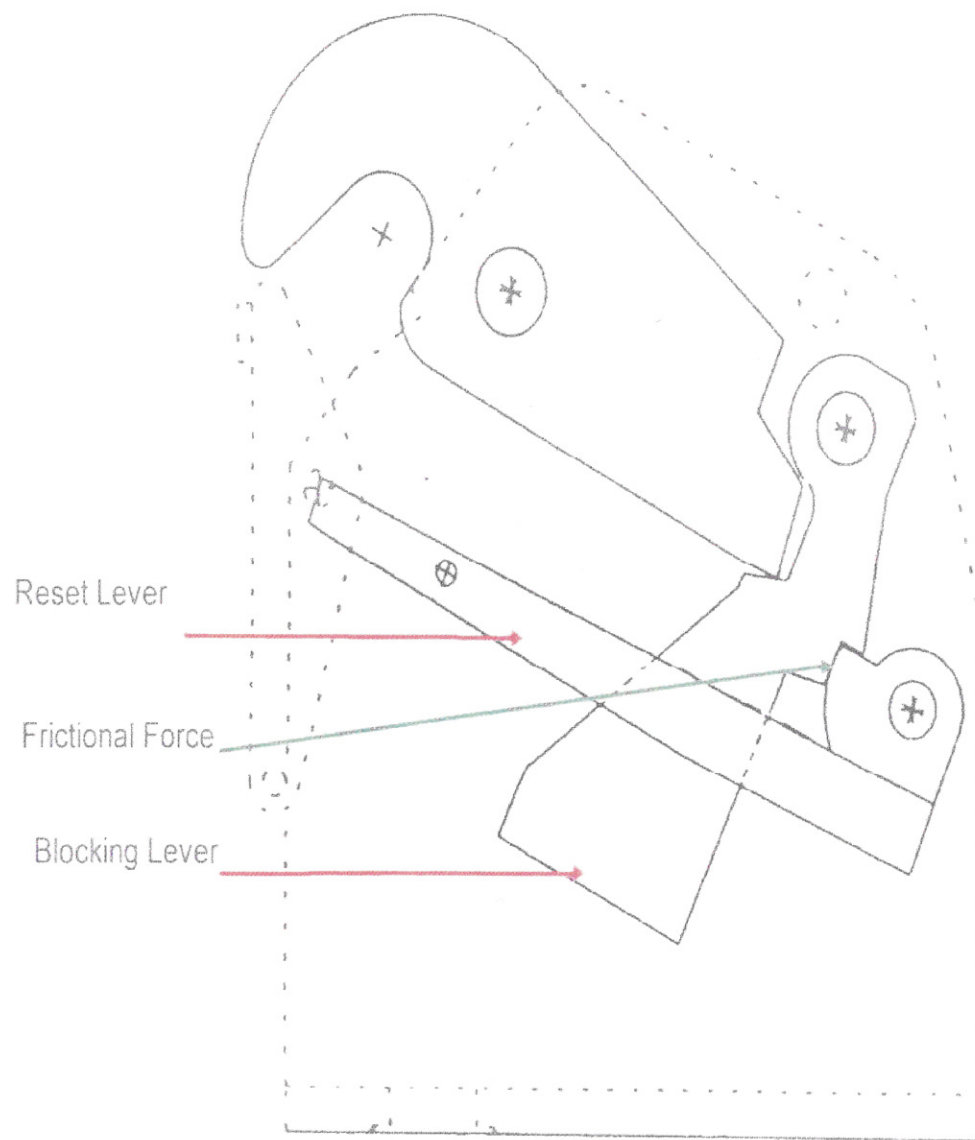
Figure 1. Hook Assembly

3.1 The lifting hooks and release mechanism fitted on the lifeboats were 'onload/off load' release hooks of type 'NS-Hook', manufactured by Nishi-Nippon FRP Ship Building Co. of Japan. (Annex II, Figs 1 & 2). (See also Makers Instruction Manual, Annex 3 for part numbers)

6.7 The wear on the contact surface of the hook, (fig.3, Annex 2 and Replacement Standard, Manufacturers Instruction Manual, Annex 3) determines the limiting dimension of 122mm. The vessel was only 6 months old at the time of the accident and the boat had apparently been launched only 4 or 5 times, but this dimension on one of the hooks was already found to be 121.7mm. - below the minimum allowed for the hook to remain in a safe condition.

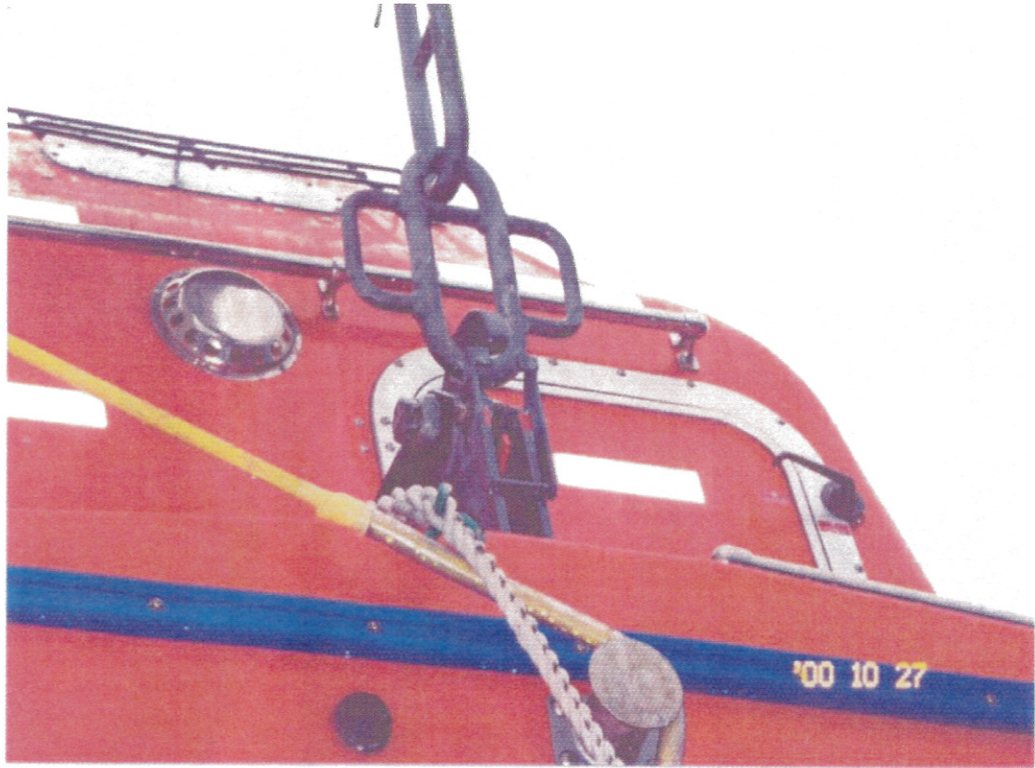
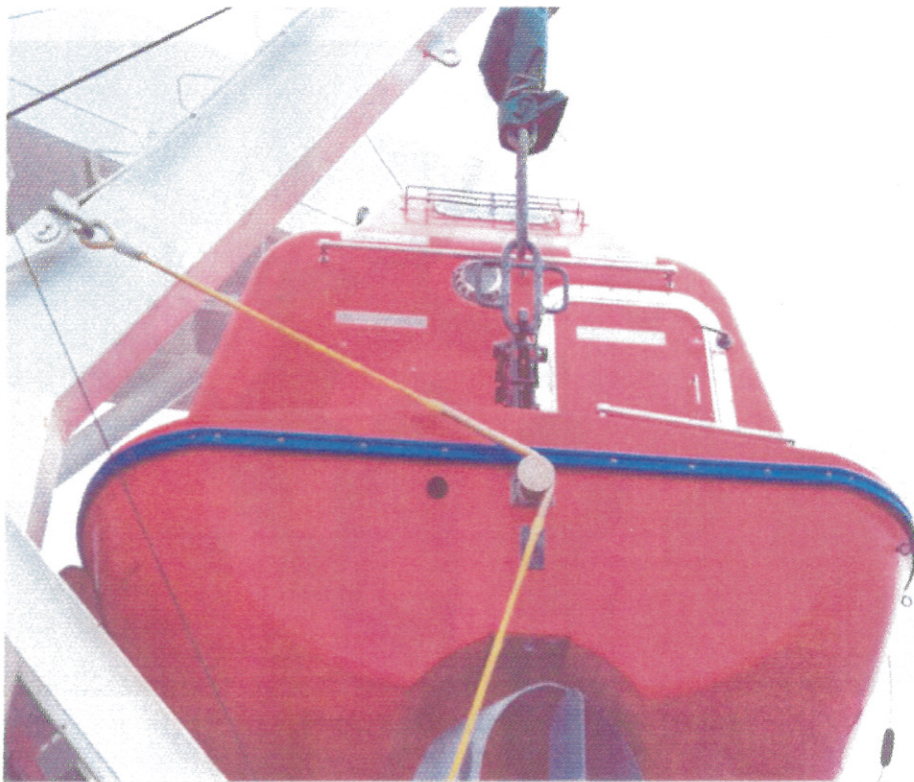
Photo. 5 & 6 Hook assembly

6.8 The red reference mark on the Cable Reset Lever does not line up with the 'red' alignment marks on the cheek plates on both the forward and aft hook assemblies. This applied to the 4 boats fitted on *M.V. Pac Monarch* and sister vessel *M.V. Pac Emperor* as well as the associated manufacturers' engineering drawings. With the passage of time and wear on the landing surfaces this situation may create an acceptance in the minds of those operating the boat that increasing misalignment is acceptable. (Photo. 1 & 2, Annex 2).

6.9 Resetting the hooks is a relatively complex three part, two handed process, the final stage of which is pushing up the Cable Reset Lever until its tip lines up with the 2 reference marks on the cheek plates of the hook assembly. Even when the hooks were correctly reset, the marks did not align correctly. On the aft hook assembly these marks face away from the operator which does not permit easy viewing or verification of the position of the Cable Reset Lever. Although an access window is provided on the lifeboat, it presents a difficult task for a person wearing a bulky life jacket and helmet, in the close proximity of a heavy steel fall to view and verify that the alignment of the Cable Reset Lever is correct with the 'red' marks on the cheeks of the hook assembly. (Photos. 5 & 6, Annex 2). However, it is recognized that the fall is orientated in the same direction as the forward fall in an attempt to increase the safety margin for 5 knot launching [IMO Res.MSC 48(66)].

- 8.3. consider providing a viewing port on the side cheek of the central release mechanism to allow a direct view that the interlock (10) is actually blocking the Cable Connection Arm (12) when the mechanism has been reset,
- 8.4. consider fitting the aft hook with the open end facing forward so that the 'red' alignment marks are easily viewed when being reset by the lifeboat crew,
- 8.5. verify the 'red' marks in 8.4 align correctly before delivery,
- 8.6. revise the design of the hook with a view to reducing the wear at its contact point with the Blocking Lever.

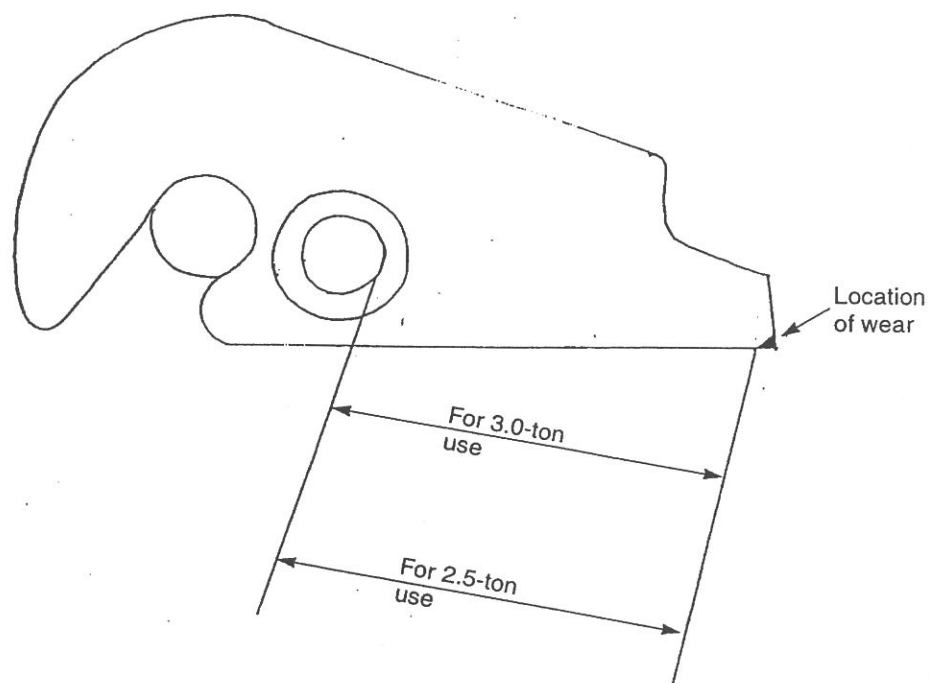
Replacement Standard

When the wear at the contact point between the release hook and the frame reaches:

156mm for 3-ton use or
122mm for 2.5-ton use,
the release hook, the frame and the lever should be replaced.
