**The Bahamas
Maritime Authority**

M.V. CMA CGM BERLIOZ

**Report of the marine safety investigation into the
disappearance of a person in the Red Sea on the
21st March 2017**

Date of Issue: 07th June 2017
Bahamas Maritime Authority
120 Old Broad Street
LONDON
EC2N 1AR
United Kingdom

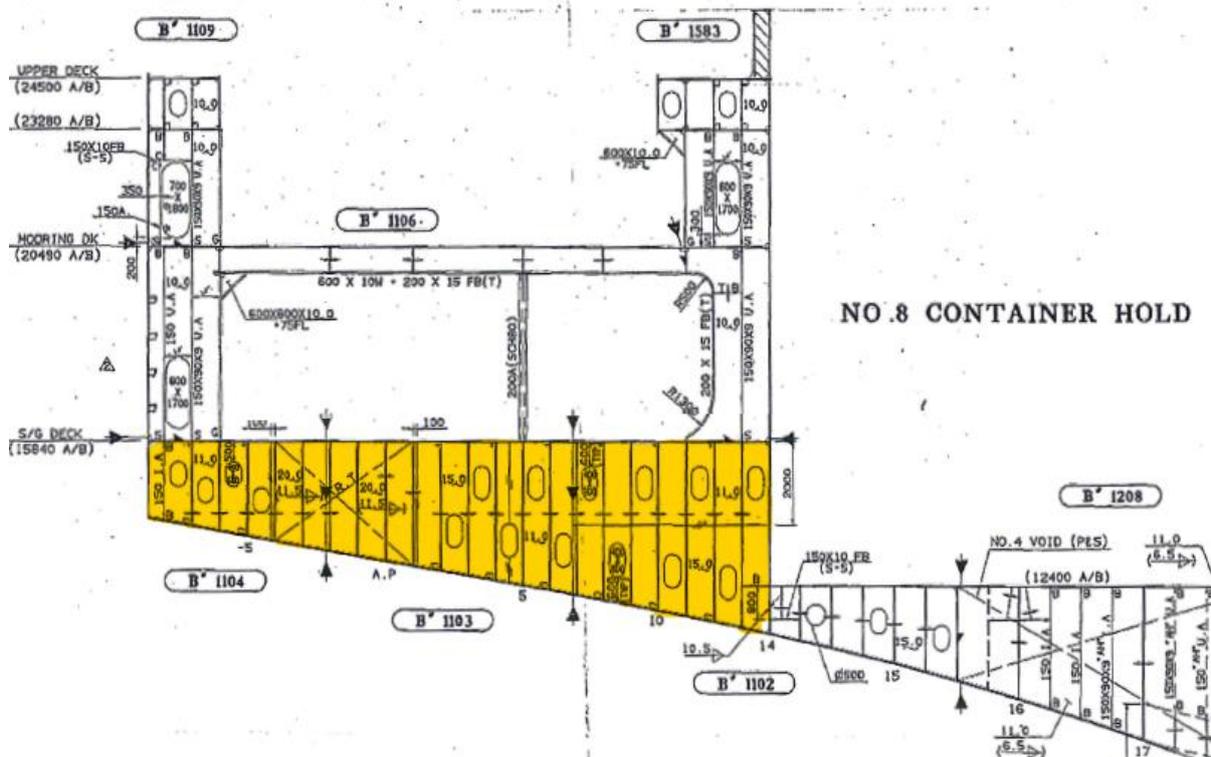
- 4.1.4 At its aft end the tank is approximately 2000mm in height extending to some 5000 mm in height at frame 14. See figure 1 below for details.

Figure 1: Structural cross section of vessel showing aft peak tank location highlighted in yellow

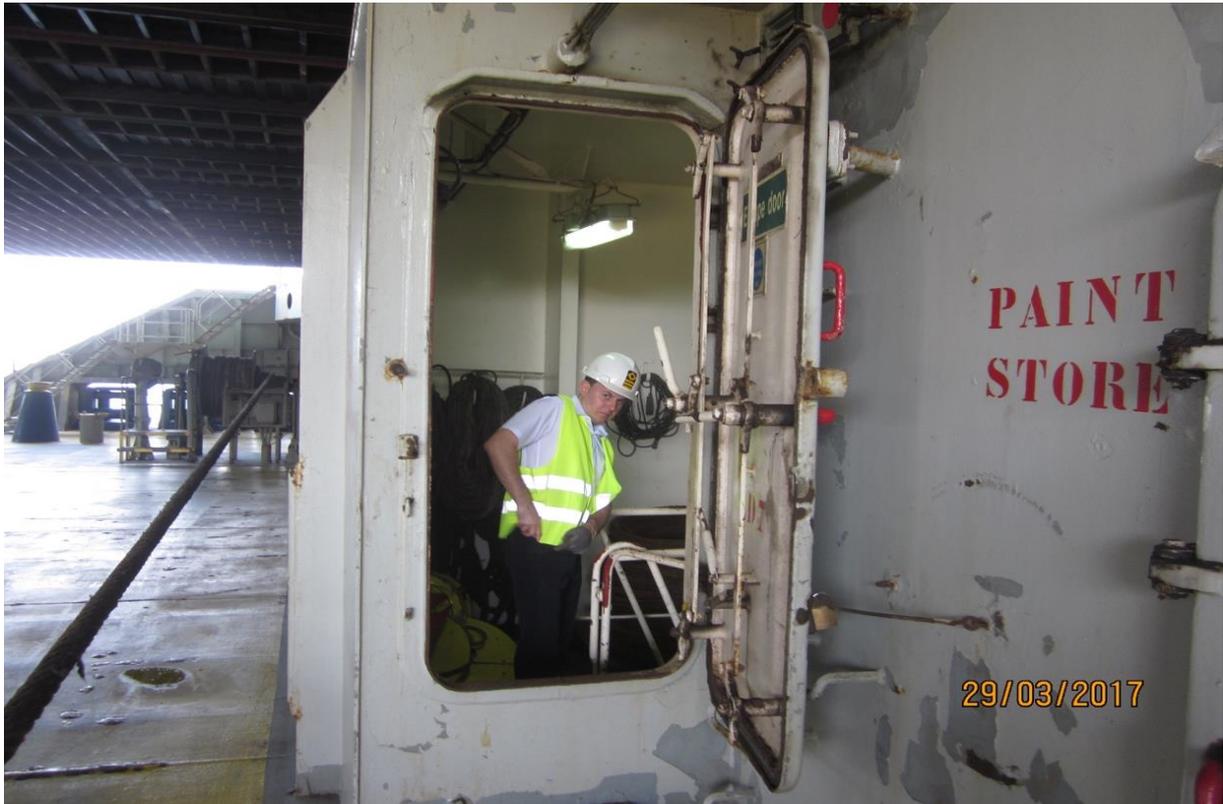
- 4.2.1 The primary access to the steering flat is via the stairwell located to starboard of the centreline. The stairwell links the mooring deck to the steering flat level. At the mooring deck level the stairwell is secured with a weathertight door. Two flights of steps go down to a lobby area off which the CO₂ room and the steering flat are accessed through steel doors to the starboard and port sides respectively.

Figure 2: Entrance door to steering flat from mooring deck

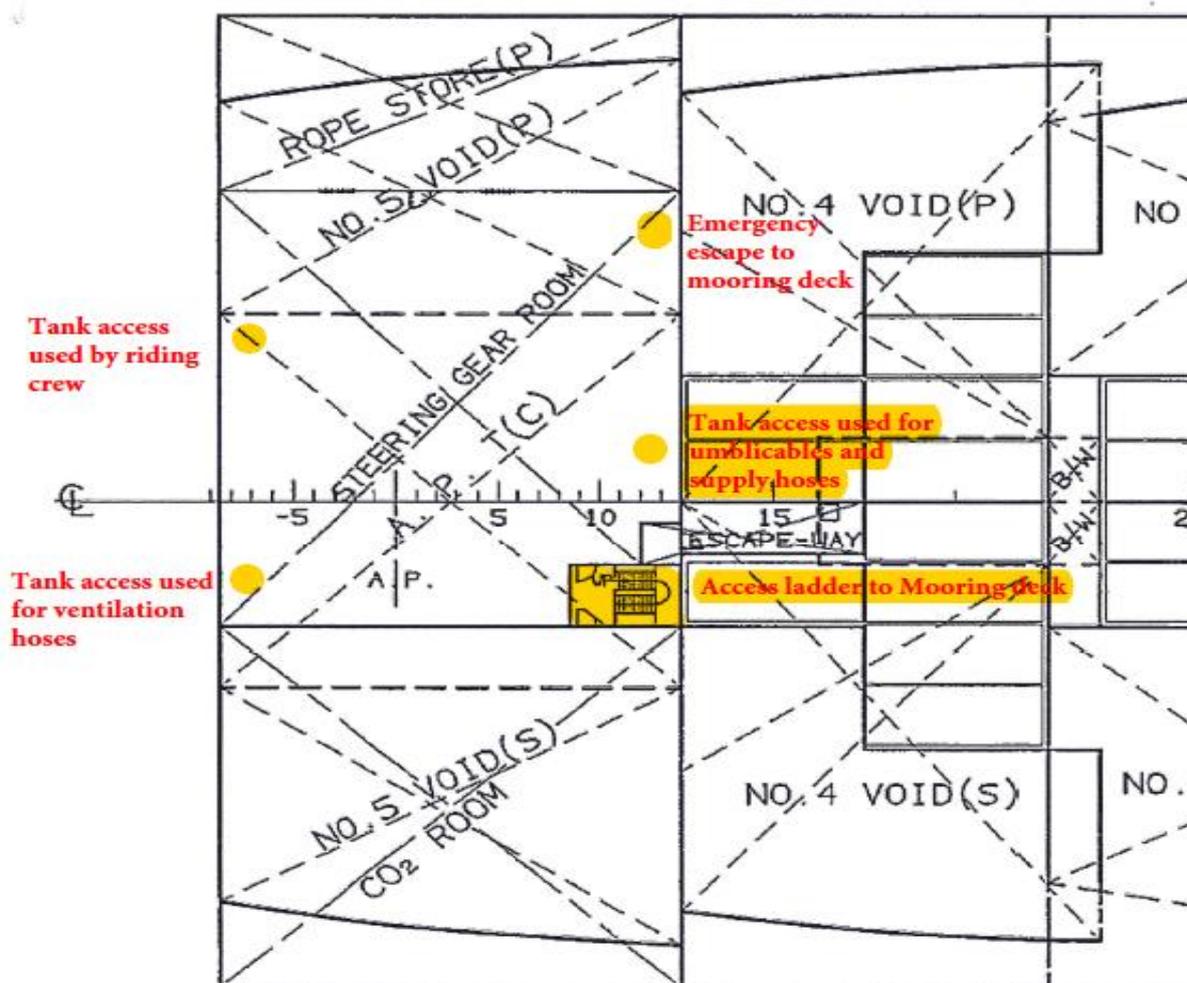
Figure 3: Plan view of steering gear room, aft peak tank, CO₂ room and access points

- 4.2.4 Although all four manholes were opened during the maintenance works. One was being used for personnel access. Two of the other openings provided conduits for ventilation, umbilicals and hoses. The tank lid located under the stairs in the main stairwell was barricaded off as it was located outside of the steering flat.
- 4.2.5 A supply of drinking water was kept outside the tank between the two after aft peak tank lids in the steering flat.
- 4.2.6 The riding gang foreman, who acted in the capacity of the external safety person, was situated on a chair for the duration of the works by the tank lid used for tank access. From this position, he had line of sight to all three tank lids within the steering flat and the emergency escape ladder.

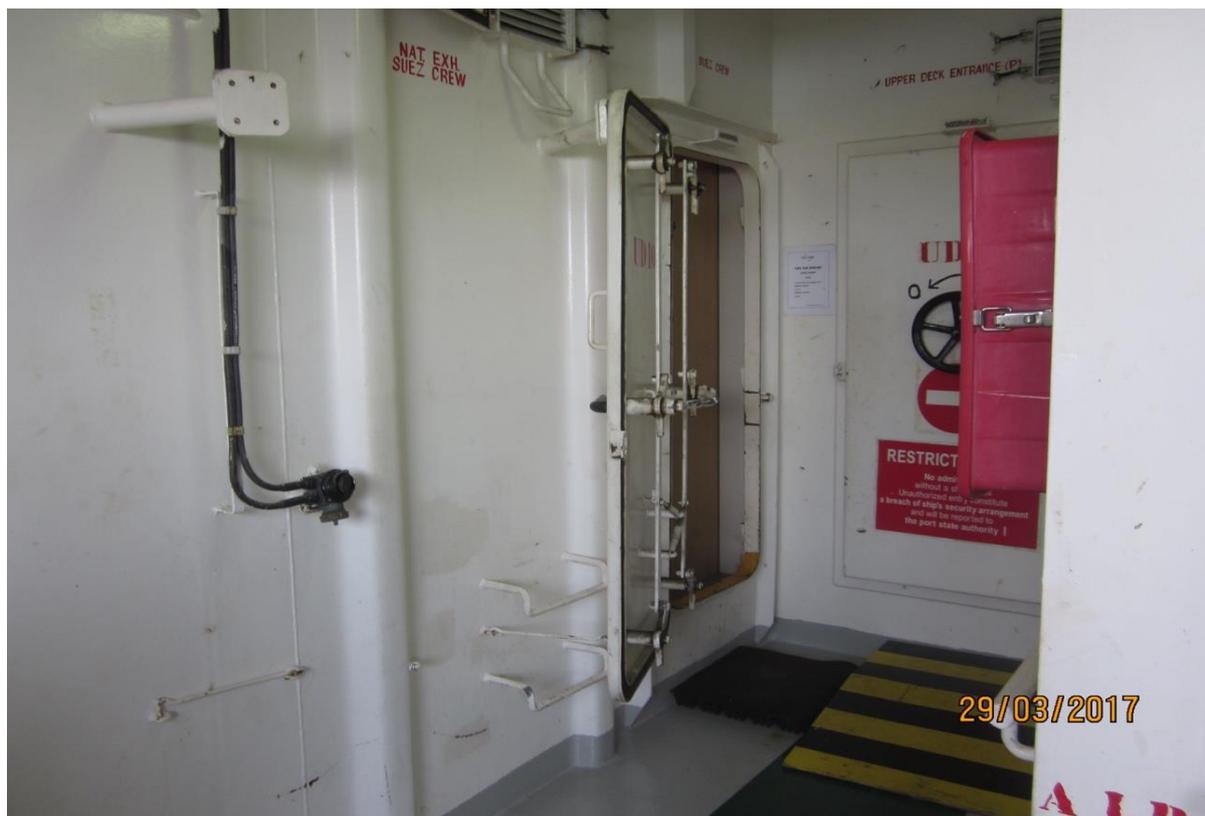
Figure 7: Entrance to the Suez cabin located on the upper deck

- 4.3.2 The Suez cabin has no direct access to the accommodation but is accessed through a lockable weathertight door leading directly on to the upper deck. The cabin contains three sets of bunk beds of which the riding gang utilised two sets.
- 4.3.3 The riding team took their meals in the crew mess room with the crew. They were reported as generally sitting together and talking between themselves. There was little interaction other than courtesy greetings between the riding team and the ship's crew due to a lack of a common language.
- 4.3.4 The riding team were employed to work 10 hours per day. Their working day was structured as follows:

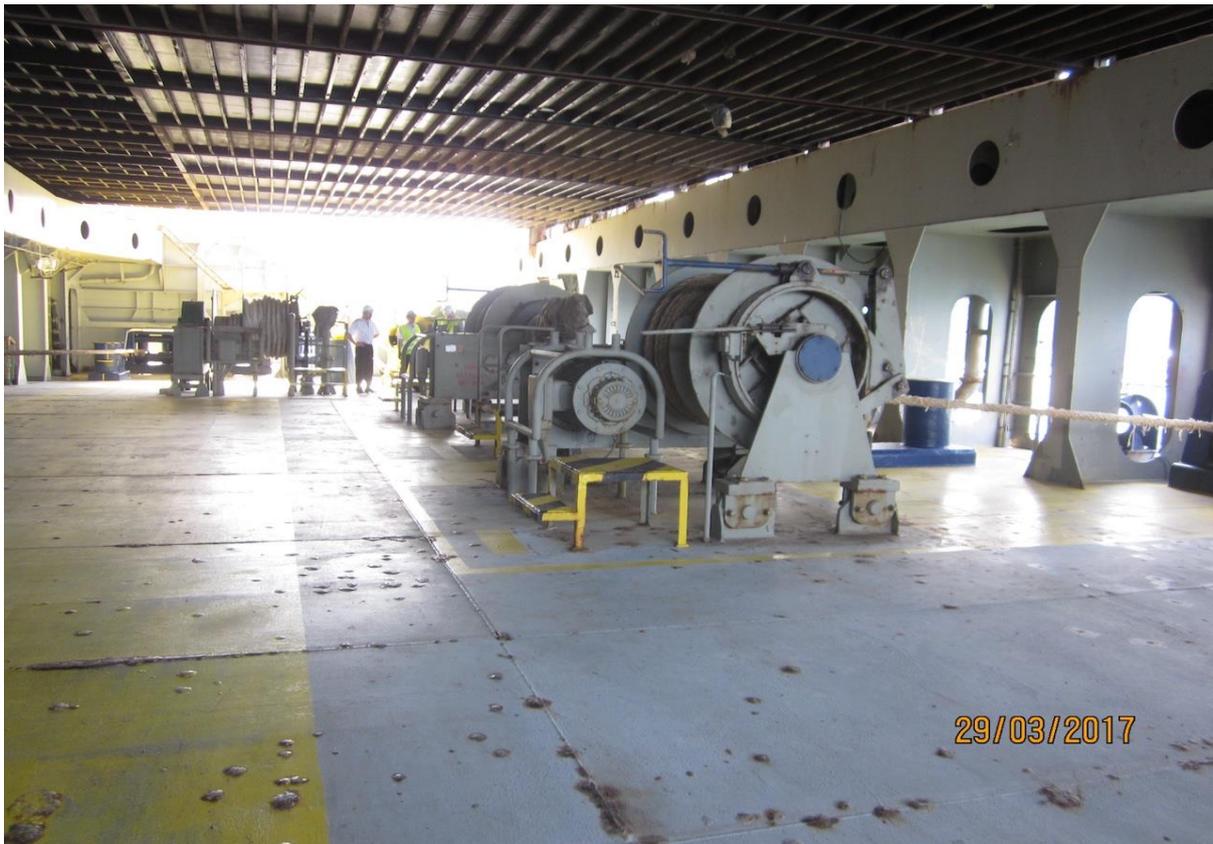
1. Mooring deck looking from port to starboard
