**The Bahamas
Maritime Authority**

“mv Sea Spirit”

**IMO Number 8802868
Official Number 730911**

**Report of the investigation into the capsizing of a zodiac craft and
passenger fatality at Fjortende, Juli-Bukta Norway on the
17th June 2013**

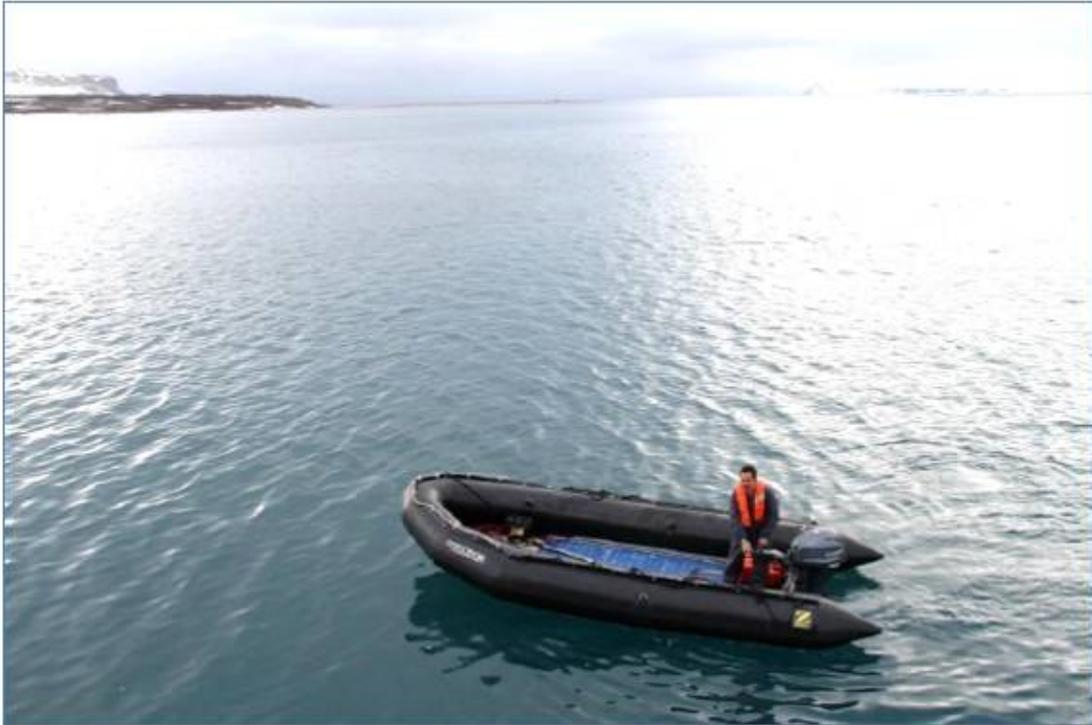
FIG 12: Zodiac «Poseidon» som havarerte i Fjortende Juli-bukta.

FIG 12: Zodiac «Poseidon» som havarete i Fjortende Juli-bukta.

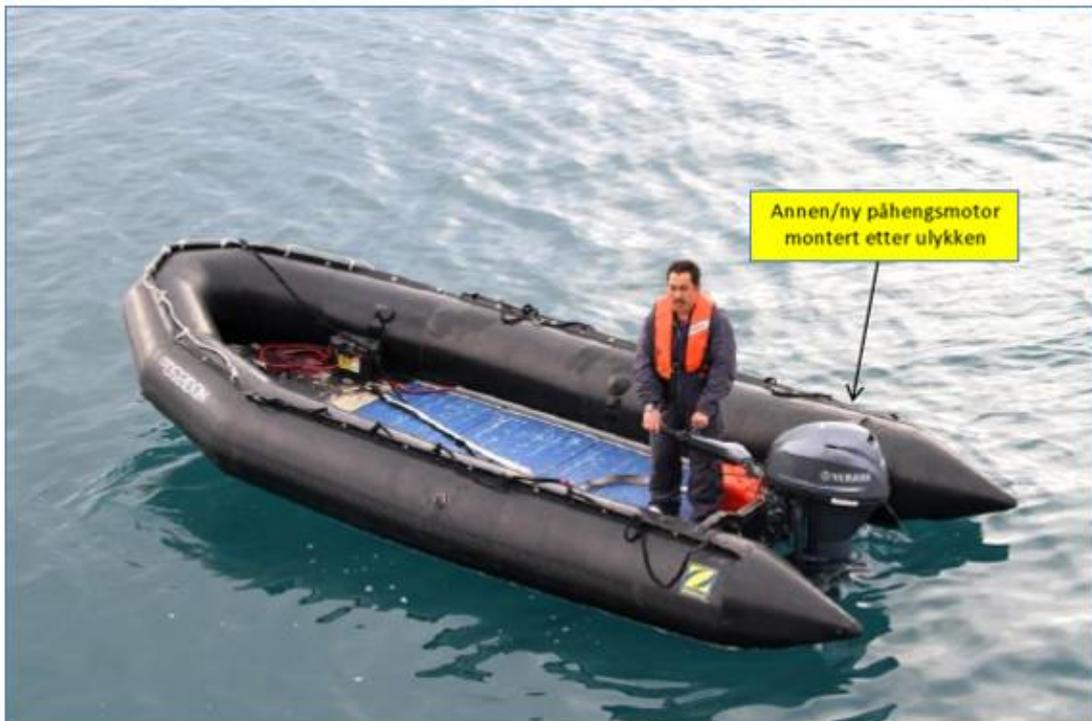
FIG 13: Zodiac «Poseidon» som havarerte i Fjortende Juli-bukta.

FIG 13: Zodiac «Poseidon» som havarete i Fjortende Juli-bukta.
