**The Bahamas
Maritime Authority**

GENTING DREAM

**Report of the marine safety investigation
into a 10-year-old passenger fatality
on 18th November 2019**

Genting Dream – Marine Safety Investigation Report

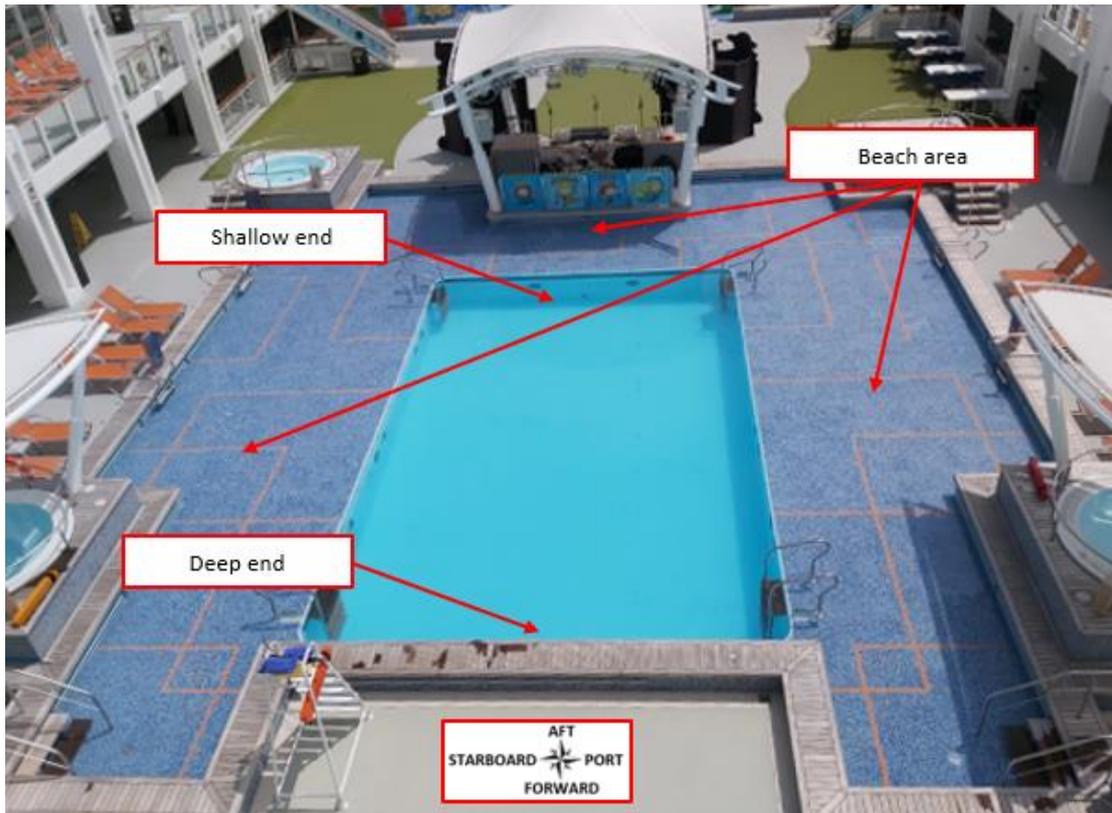
Figure 2: Main pool on deck 16

The main pool had a beach area covering three sides of the pool. The water level in the beach area was usually maintained at about 0.10-0.15 m. At the time of the investigation, the level was observed to be about 0.17-0.18 m due to heavy rainfall.

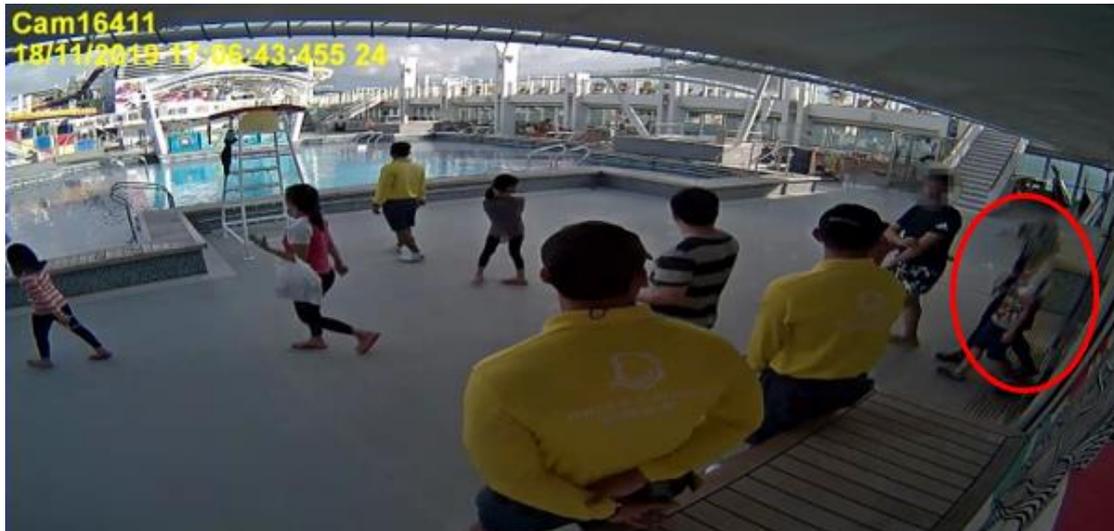
Figure 3: CCTV footage screenshot of the victim entering deck 16

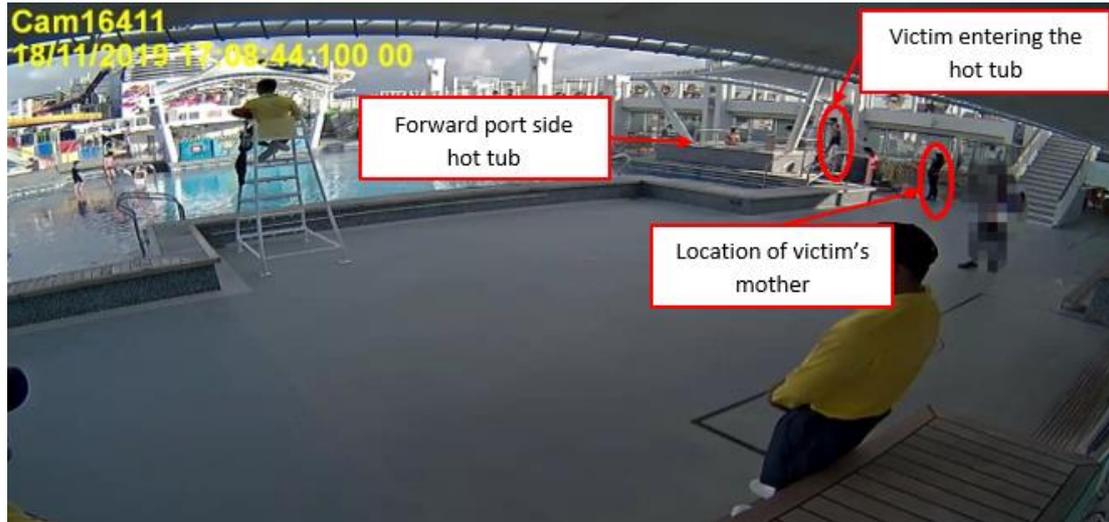
Figure 4: CCTV footage screenshot of the victim entering forward port side hot tub

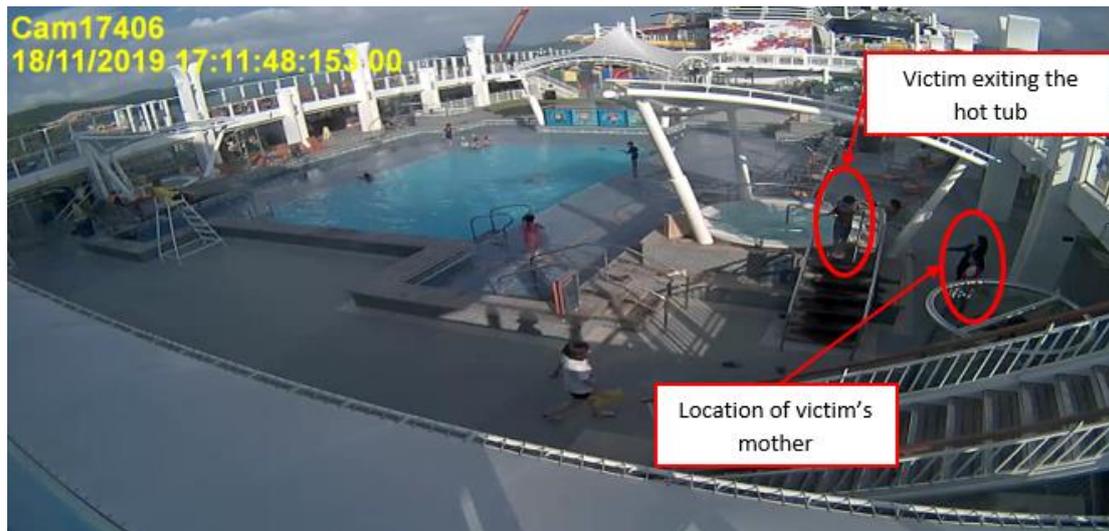
Figure 5: CCTV footage screenshot of the victim exiting the forward port side hot tub

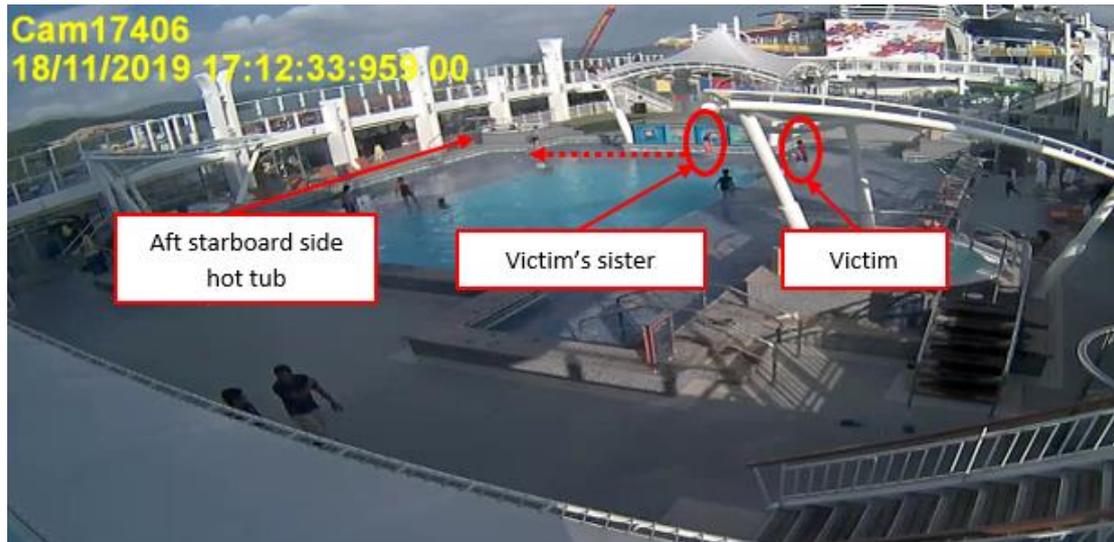
Figure 6: CCTV footage screenshot of the victim and his sister going towards the aft starboard side hot tub

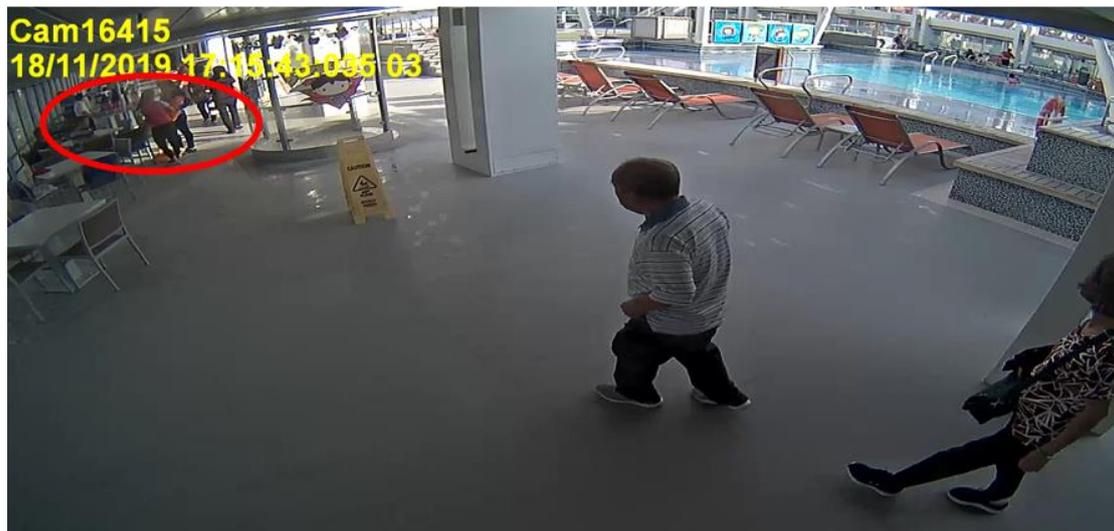
Figure 7: CCTV footage screenshot of the location of the victim's mother and her adult companions arriving at starboard side pool deck area

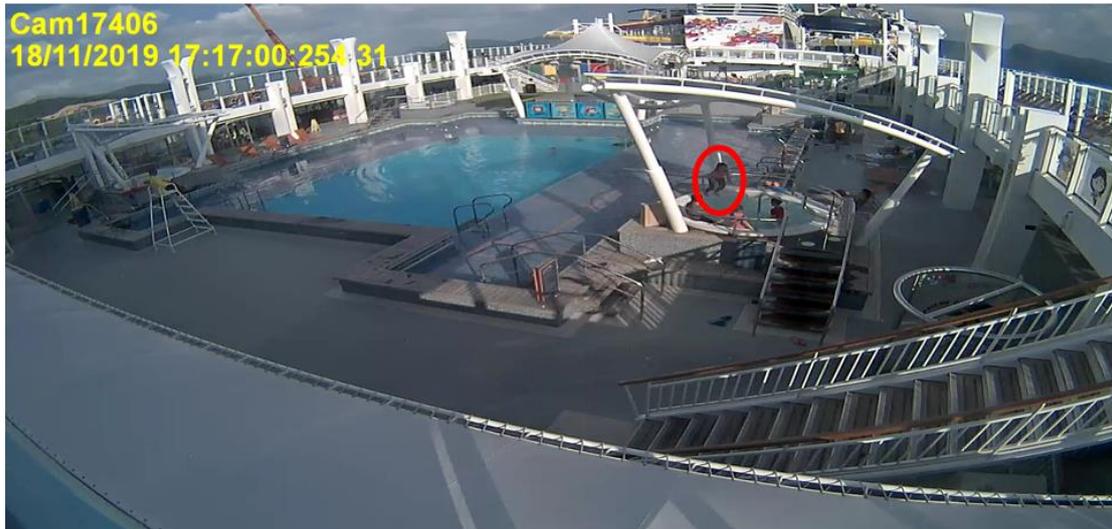
At 1716 hours, the victim and his sister, along with another child, entered the forward port side hot tub. A minute later, a child who was in the hot tub stood at the gutter of the hot tub and jumped into the hot tub. At this time, the Deck Steward on the highchair observed the child and blew his whistle to caution her.

Figure 8: CCTV footage screenshot of a child jumping into the hot tub

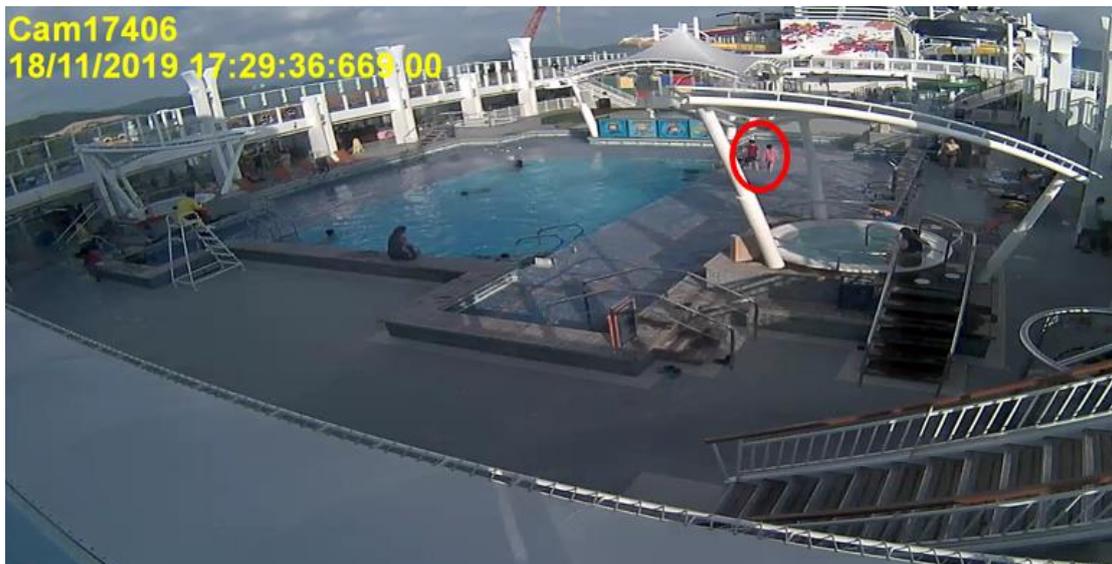
Figure 9: CCTV footage screenshot of the victim entering the main pool, port side aft.

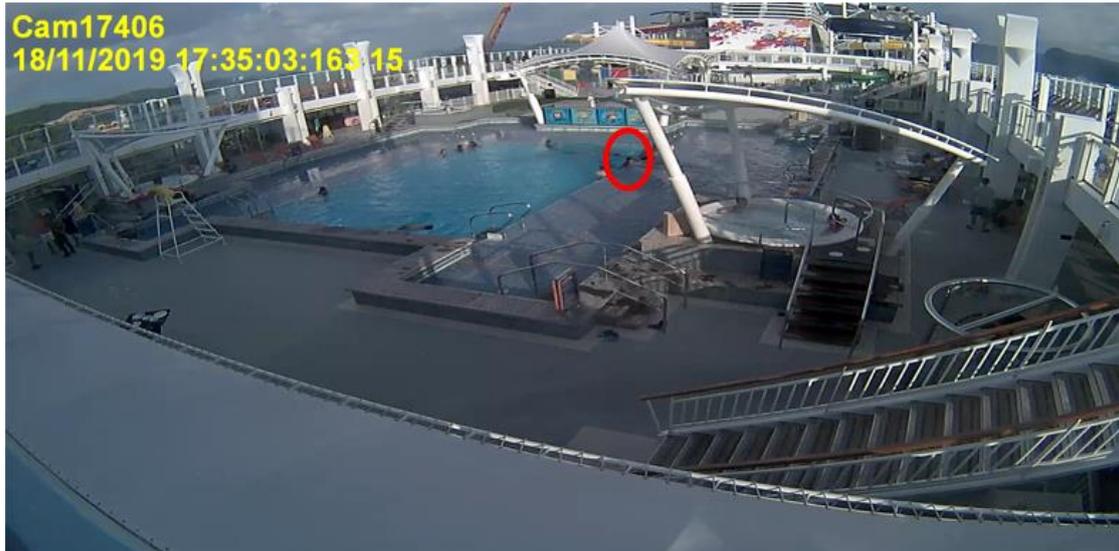
Figure 10: CCTV footage screenshot of the victim entering the main pool

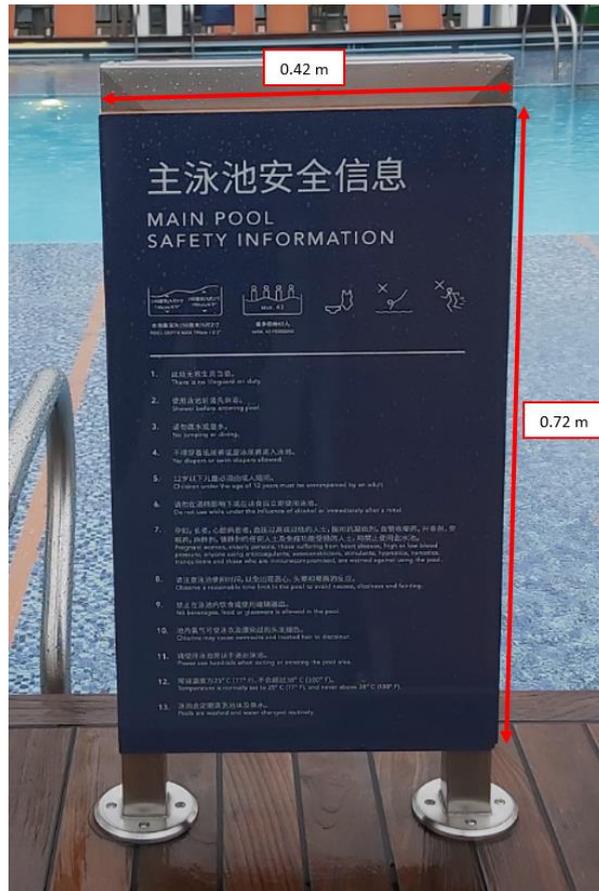
Figure 15: Dimensions of main pool safety information

The safety information board had a height of 0.72 m and a width of 0.42 m. The font size of the text is 5 mm (14 pt⁹).

Pool safety information was posted at four locations in the vicinity of the pool but did not accurately reflect the physical orientation of the pool. Due to the size of the text, the safety information could not be read a distance greater than one meter and the information was not available anywhere else on the vessel. The actual main pool depths were found to be inconsistent with the depth markings next to the pool and on the main pool safety information board.

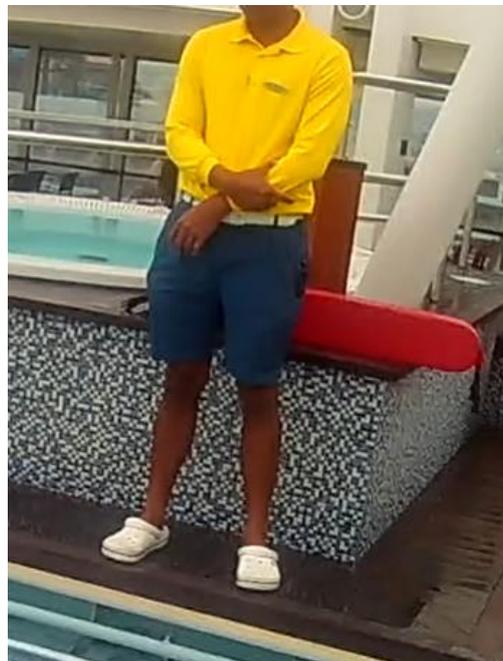
Figure 18: Deck Steward's uniform

The Deck Stewards wore a yellow t-shirt as part of their uniform with 'Dream Cruises' written on the back in English and Chinese. The yellow-coloured t-shirt distinguished them from the rest of the staff on the pool deck working in a restaurant or as cruise staff allocated at the water slides.

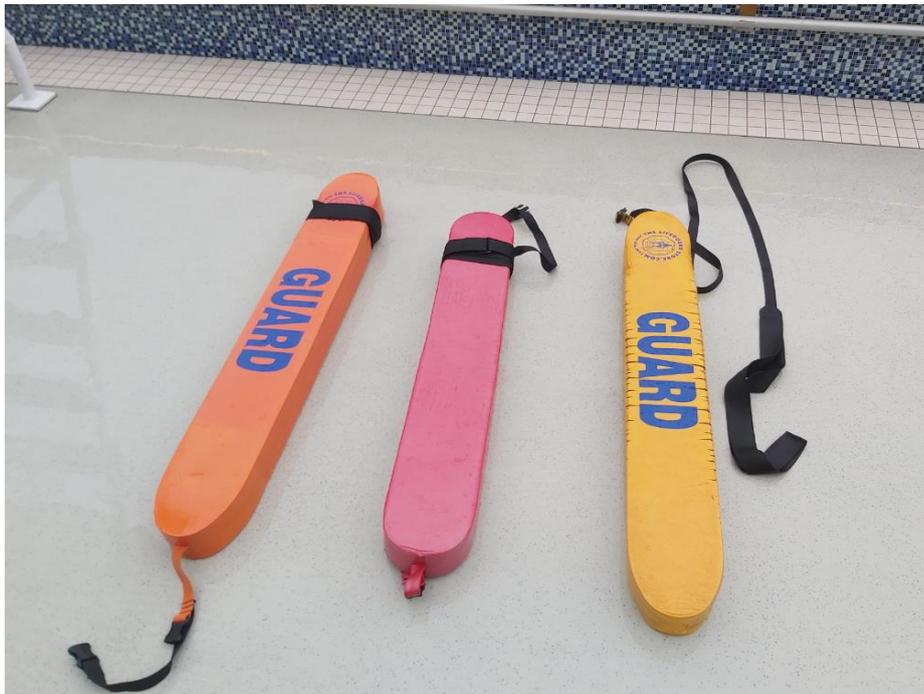
Figure 20: Rescue tubes available at the main pool

- Three rescue tubes - one usually placed on highchair and two in the vicinity of the duty Deck Steward.
- One shepherd's hook - located on the forward side of the main pool.
- Two lifebuoys - located on aft port side and forward starboard side of the main pool.
