Report on the investigation of
The machinery space fire on board

Oscar Wilde

In Falmouth Bay

Report No 3/2011
March 2011

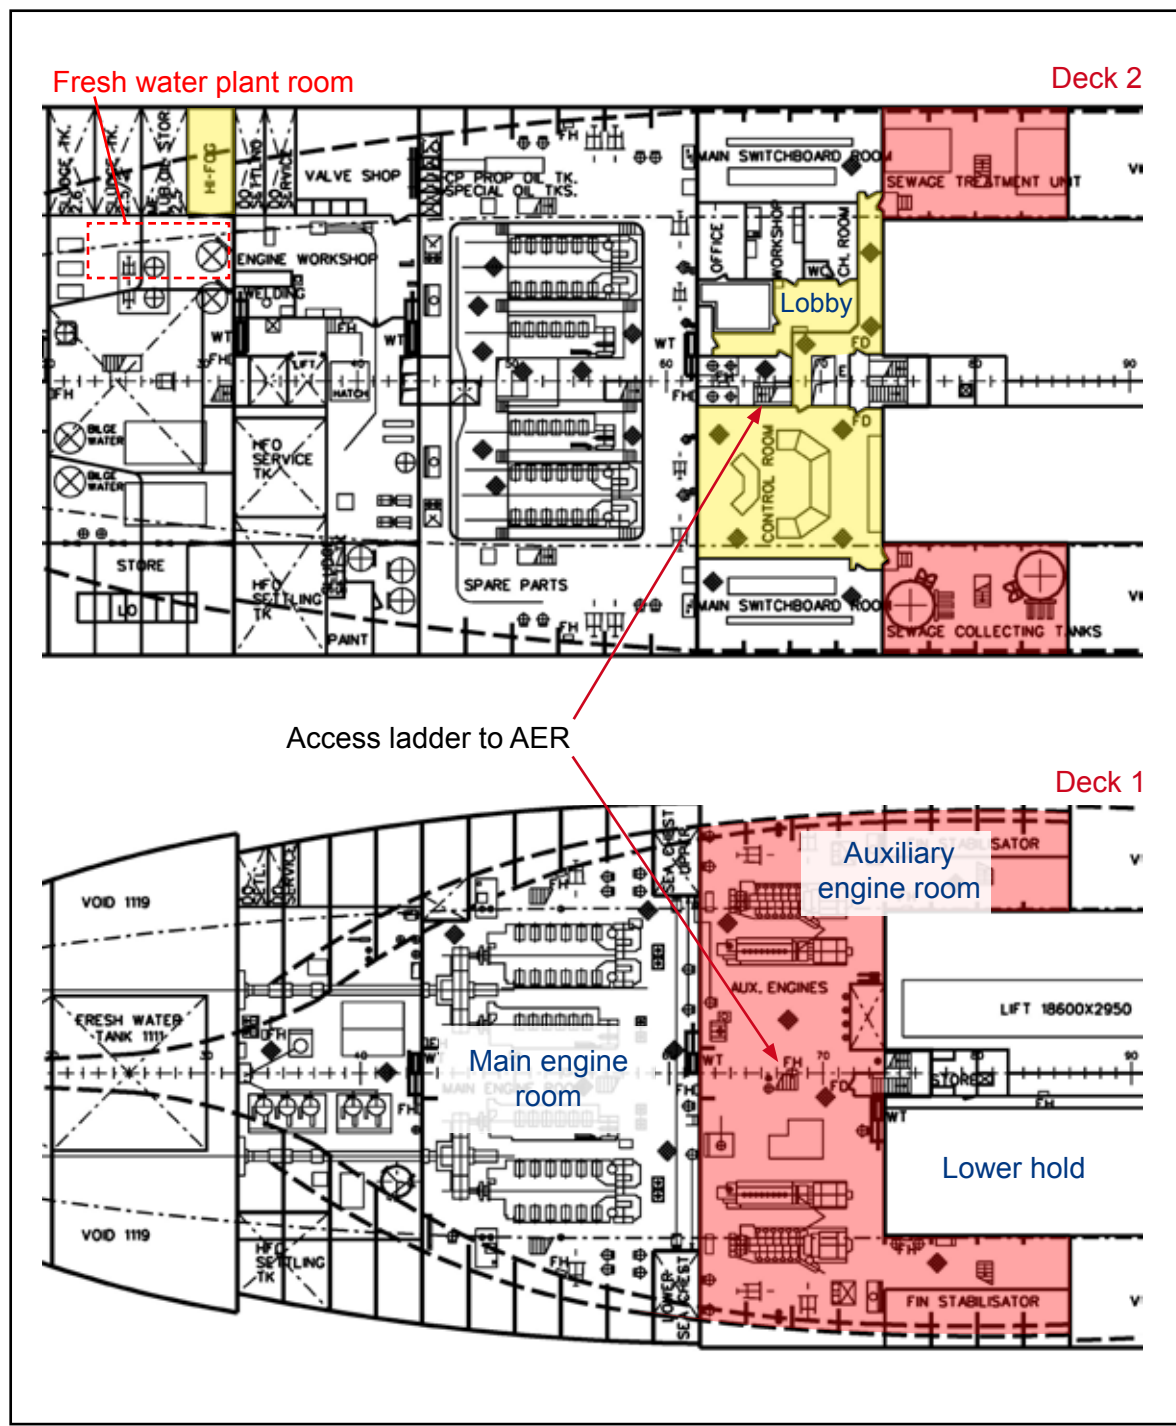
Figure 1

Machinery space layout

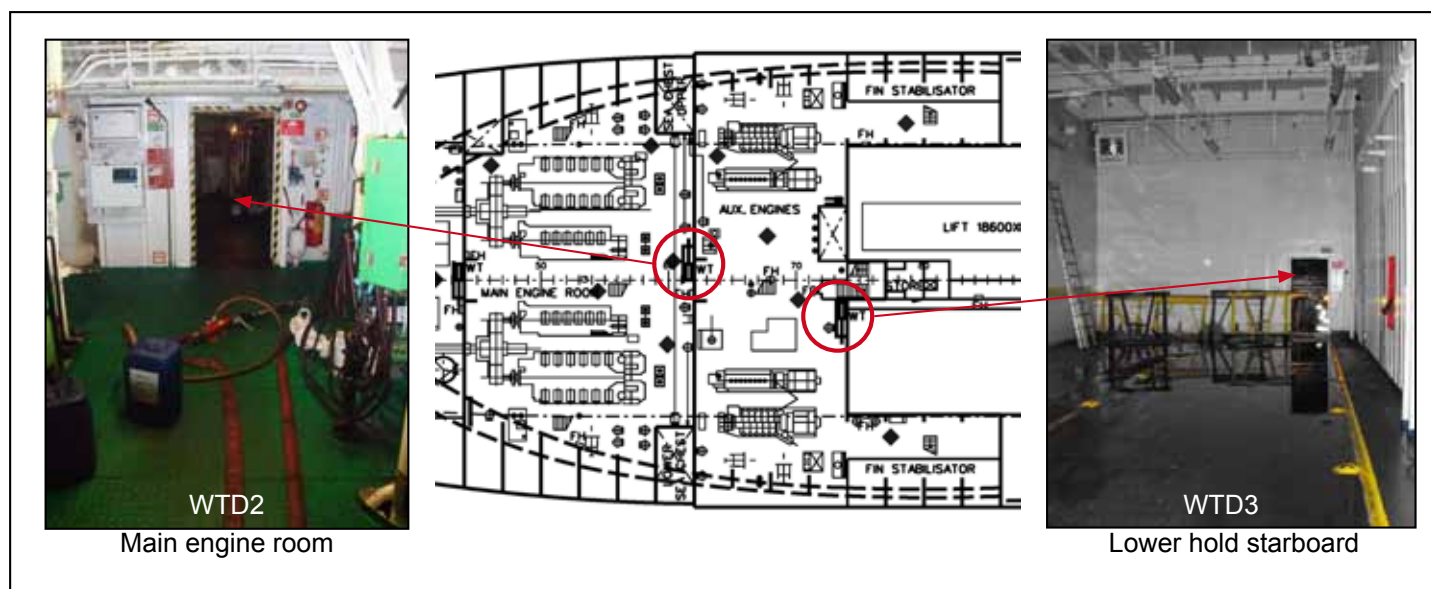
Figure 3

Meanwhile, contract cleaners opened hydraulic watertight door number two (WTD2) between the main and auxiliary engine rooms (**Figure 3**) and saw thick black smoke. They closed the door and alerted the second engineer (2/E), who was inspecting the main engines on the deck plates above. He rushed to the door, opened it slightly, saw the smoke and closed it again. The 2/E told the cleaners to leave the engine room, and rigged a fire hose and a foam branch pipe.

Number two and number three watertight doors

The extra 2/E joined the 2/E in the engine room and manually activated the *Hi-fog* section covering the port side of the AER using the remote switch located next to WTD2 (**Figure 3**). The extra 2/E and the 2/E then went to their emergency stations. On his way to his emergency station in the ECR, the extra 2/E saw water dripping down from the funnel casing, indicating that the *Hi-fog* was operating in that area.

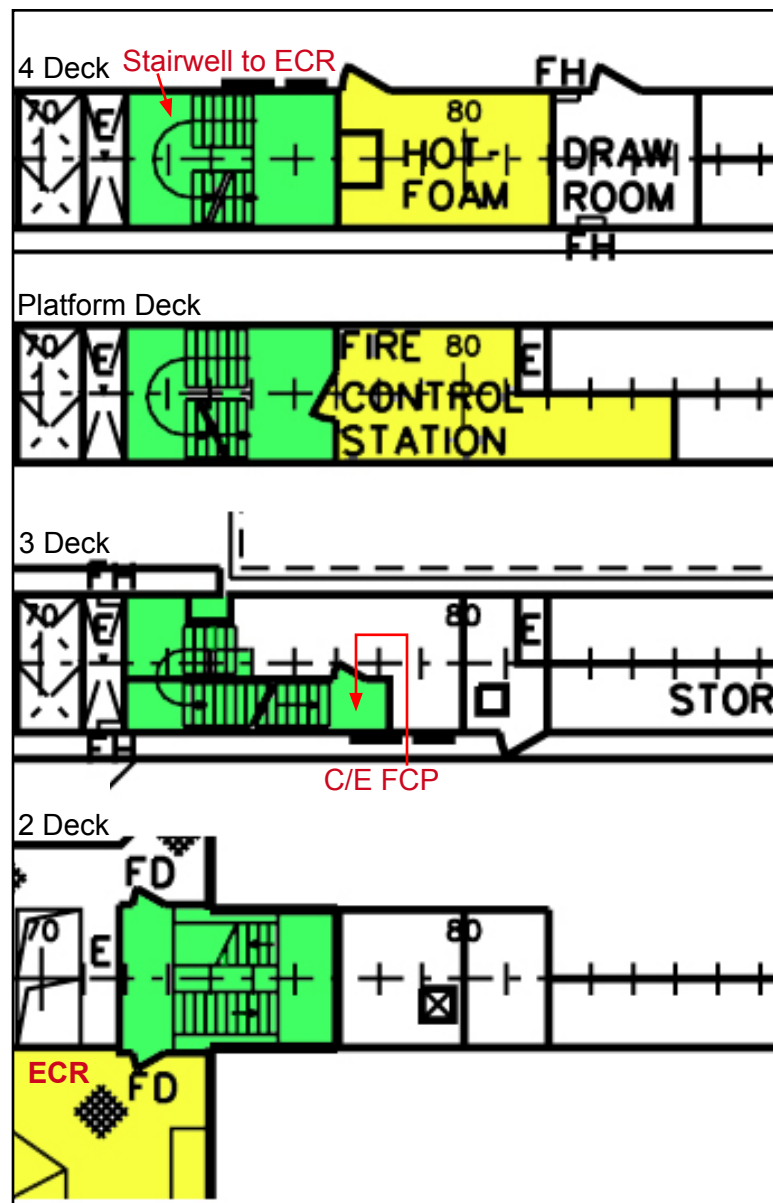
Figure 7

Fire control station and *Hotfoam* room

By 1930, the ECR, switchboard rooms and adjacent lobby area were smoke-logged. The ECR was evacuated; the EOOW went to the lower hold while the chief engineer, extra 2/E and duty ETO went to the fire control station where they tripped the fuel oil quick-closing valves. On instruction from the C/O, the chief engineer also opened the vehicle deck drencher valve for zones 3 and 4. Independently the 2/E decided to go to the *Hotfoam* room on deck 4 (**Figure 7**), where he attempted to activate the fixed high-expansion foam system.

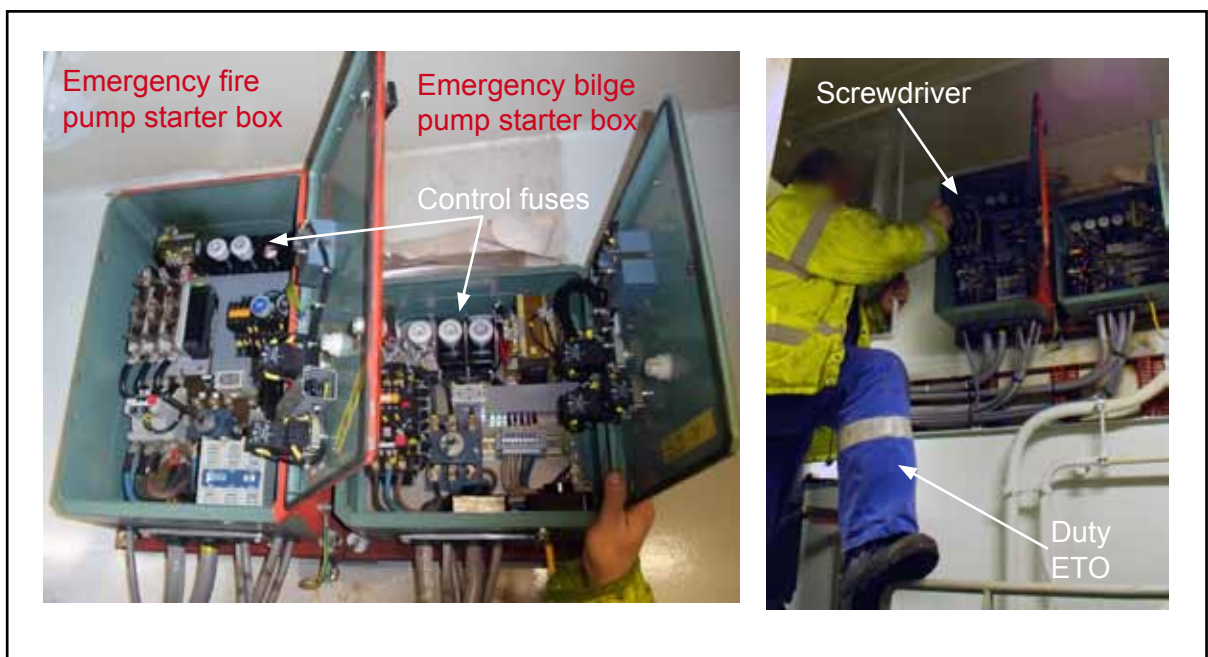
Figure 8

The emergency fire pump was not running. The 2/E opened its starter box and replaced a blown control fuse with a fuse taken from the adjacent emergency bilge pump starter box. This also blew when he attempted to restart the fire pump. The duty ETO climbed onto a set of guardrails next to the starter box, and used his screwdriver to push in the start control contactor (**Figure 8**). The pump started and fire main pressure was re-established. The EOOW was sent to close the engine room fire main isolation valve while the chief engineer went to the *Hotfoam* room, and the 2/E checked the *Hi-fog* system. The extra 2/E and the duty ETO remained in the bow thruster space.

Emergency fire pump starter box and actions of the duty ETO

In the bow thruster space, the duty ETO continued to hold in the emergency fire pump contactor which was sparking and generating smoke within the starter box. The extra 2/E advised the C/O that the pump might only last a further 5 minutes. A second ETO was dispatched to the bow thruster space with an emergency repair bag to assist his colleague.

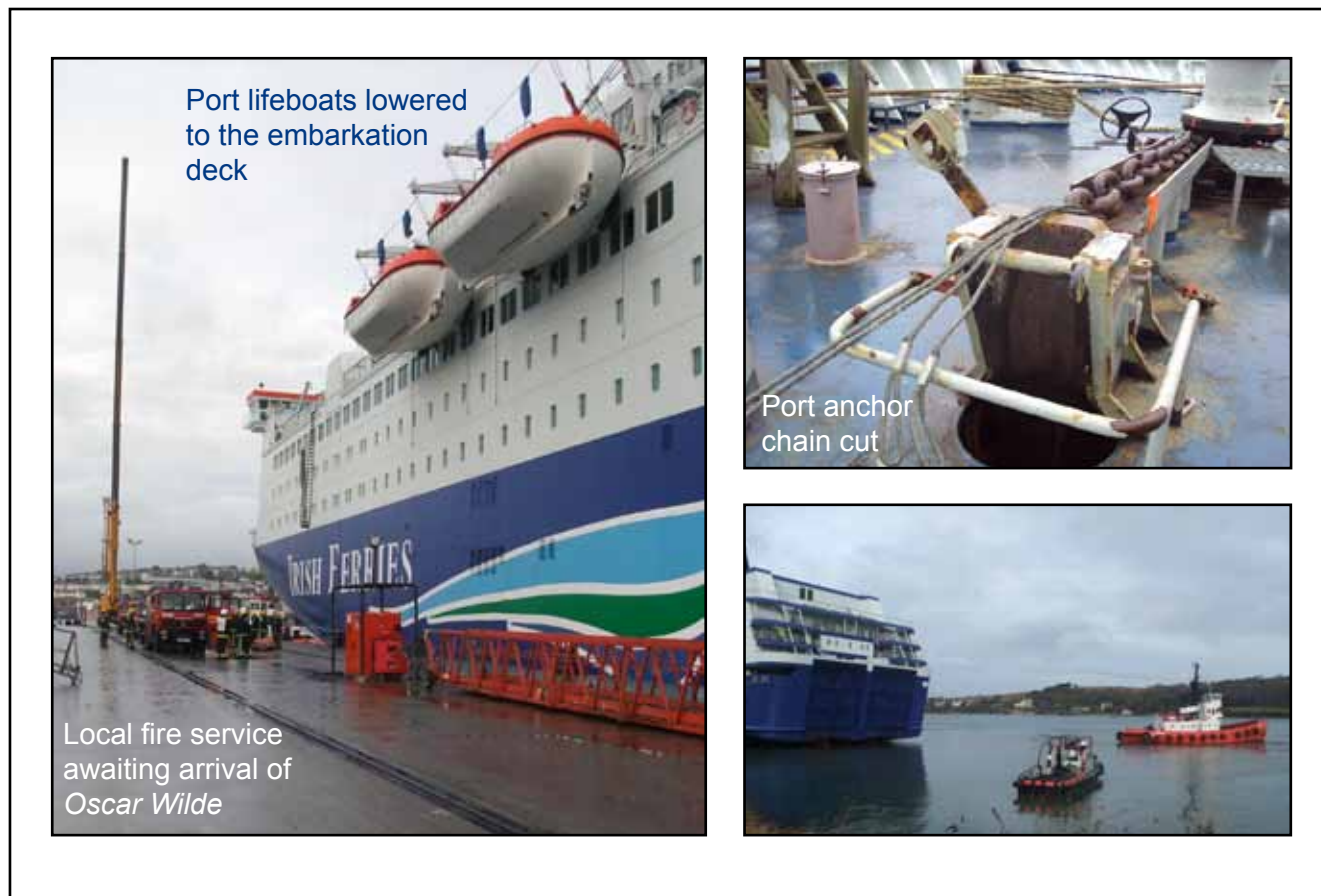
Figure 9

Due to the extent of the fire damage it was not possible to restore main electrical power to the vessel. Therefore, the anchor could not be recovered. At 0555 the following morning, the port anchor chain was cut to allow the vessel to be towed back to Falmouth (**Figure 9**).

Oscar Wilde towed back to the Falmouth ship repair yard

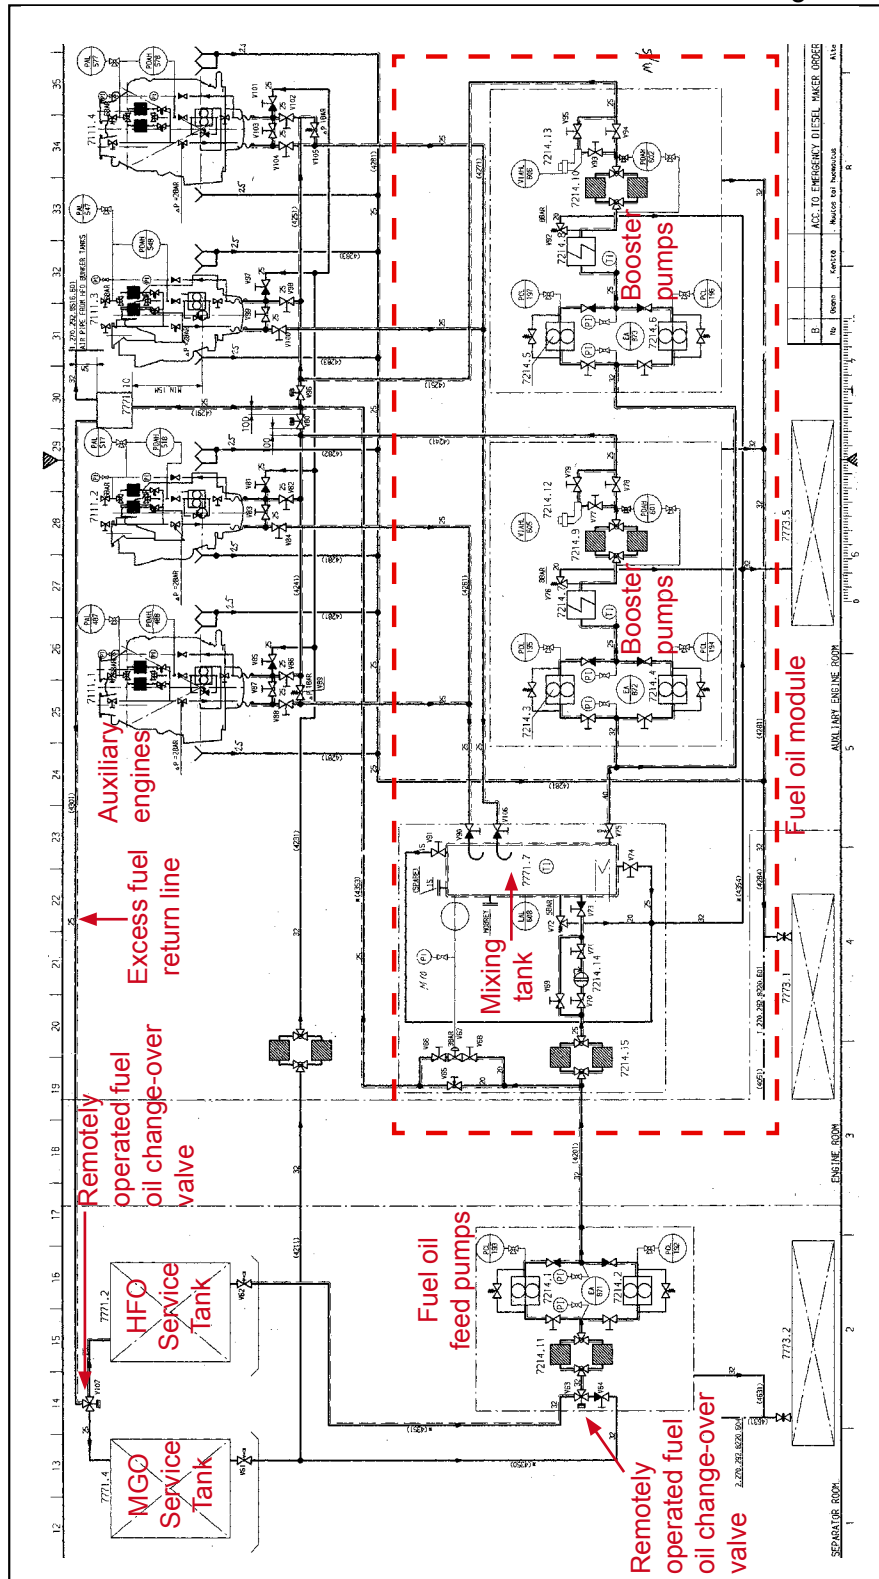
Figure 17

The fuel system was designed and manufactured by Wartsila at its Turku shipyard in Finland. It consisted of an HFO service tank, an MGO service tank, two feed pumps, a fuel module, and two remotely operated change-over valves (**Figure 17**). The module housed a 100 litre fuel oil mixing tank, a flow meter, an excess pressure regulating valve, four booster pumps, two pre-heaters, two viscometers and six filters. After the mixing tank, the system split into two sections; the port section served No.1 and No.2 auxiliary engines and the starboard section served No.3 and No.4 auxiliary engines.

Auxiliary engine fuel oil system

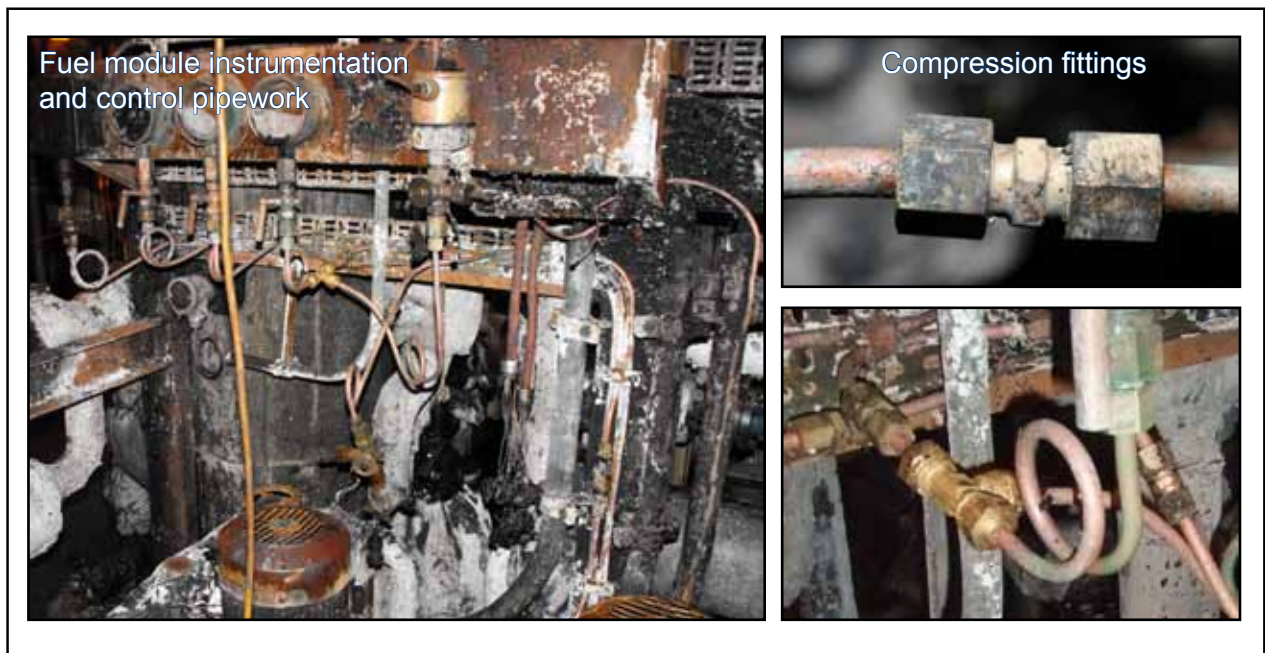
Figure 18

Copper pipework was used extensively on both the auxiliary engine and main engine fuel modules to connect the pressure gauges and sensors to the main fuel oil circuit (**Figure 18**). The copper pipes were interconnected by compression fittings and, although many of the fittings were found to be loose, none of the connections appeared to have failed and no breaks or fractures were identified.

Fuel module copper pipework and compression fittings

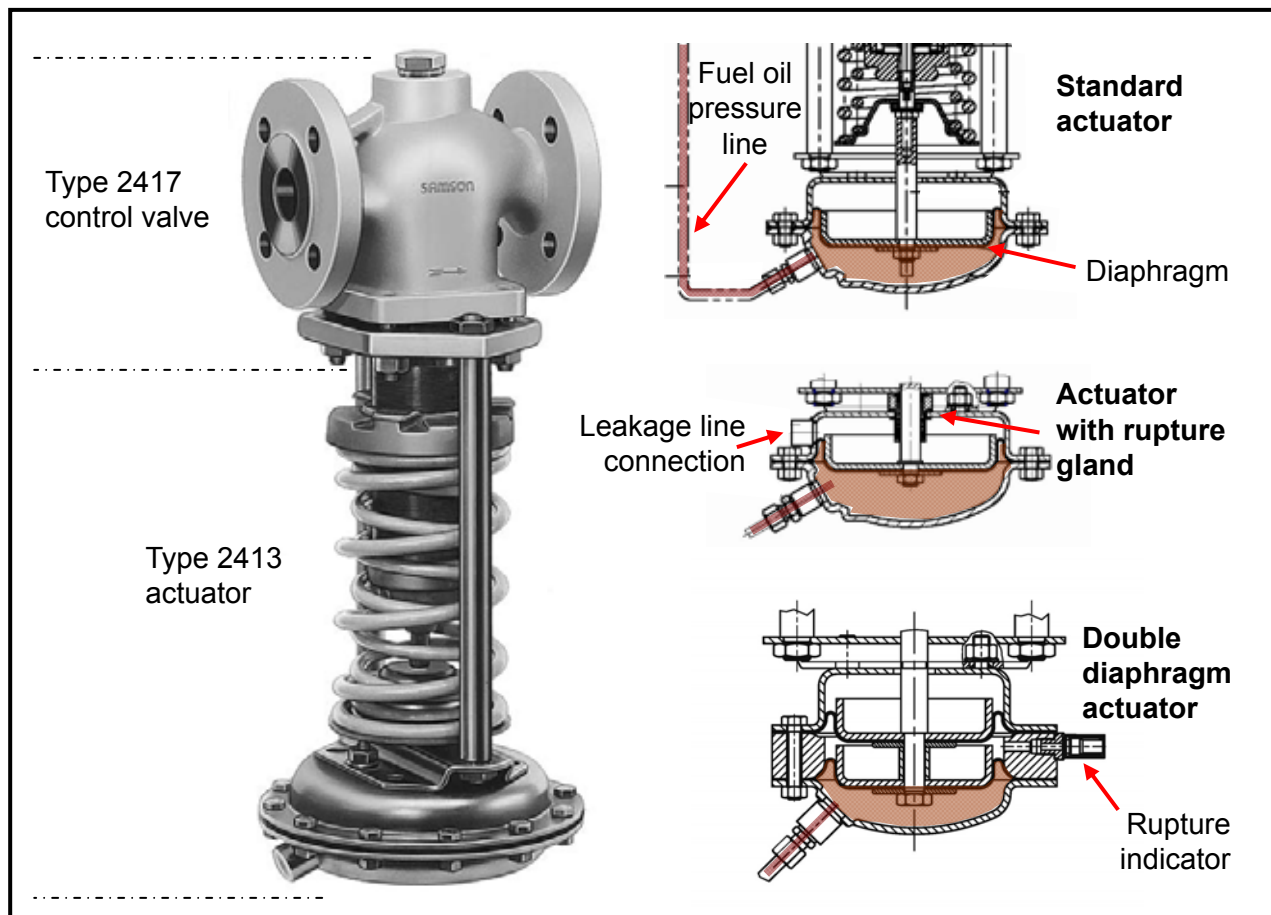
Figure 21

The excess pressure regulating valve fitted to the auxiliary engines' fuel module was a type 41-73 self-operated back pressure regulating valve manufactured by Samson Controls Ltd (**Annex A**). The regulating valve comprised two main components: a type 2417 control valve and a type 2413 actuator (**Figure 21**).

Samson Type 41-73 self-operated back pressure regulating valve

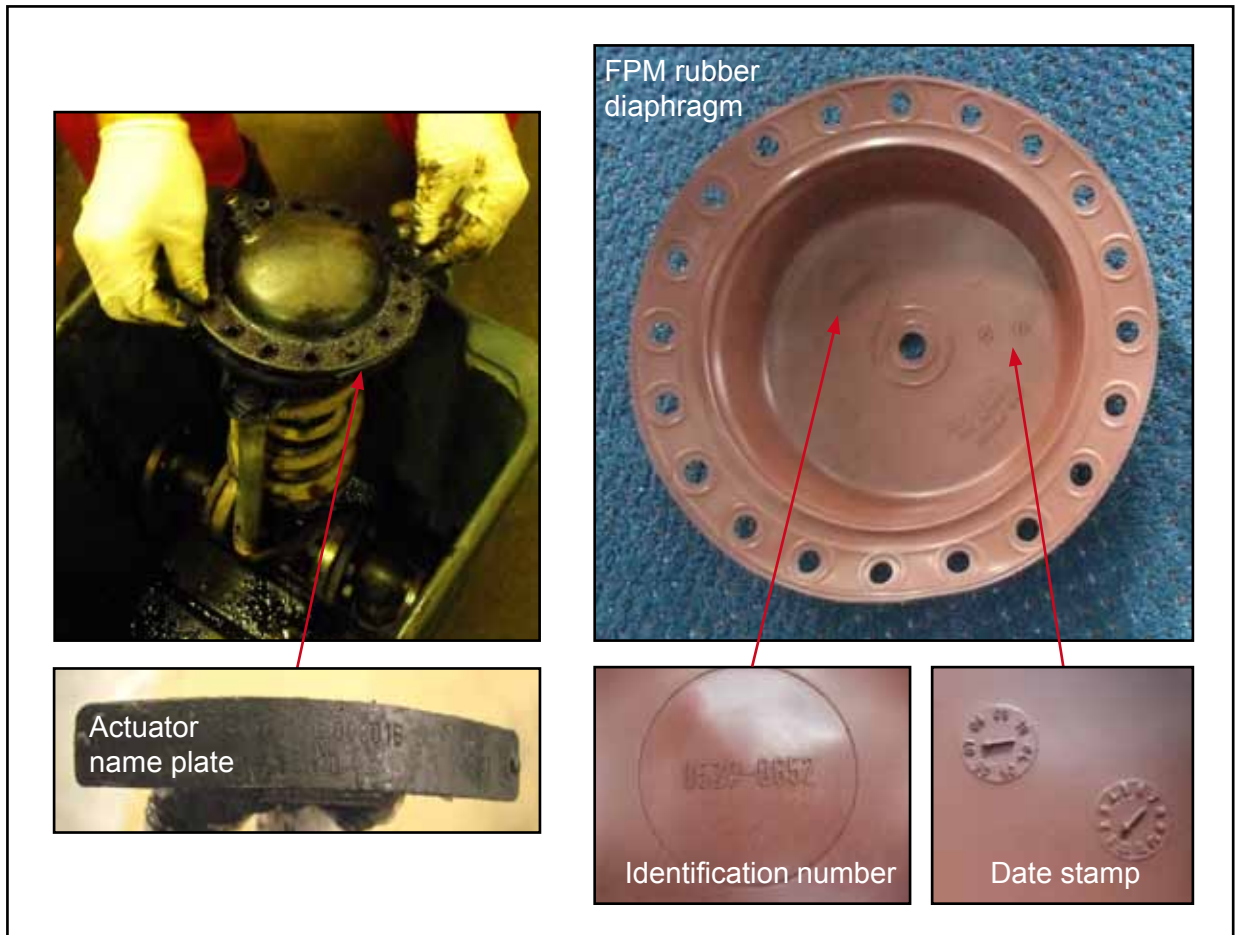
Actuator name plate and diaphragm markings

The test report on the diaphragm removed from the valve actuator identified deterioration of the rubber and a tear in its main flex region (**Annex B**). This damage was remote from the fire damage evident at its outer edge. The diaphragm was made from EPDM rubber and was therefore not suitable for use in fuel oil systems. The actuator had a diaphragm area reducing plate which increased the valves' operating pressure range to 4.5 to 10bar (**Figure 23**). The actuators fitted to the fuel modules on board *Oscar Wilde* were not fitted with any optional safety features.

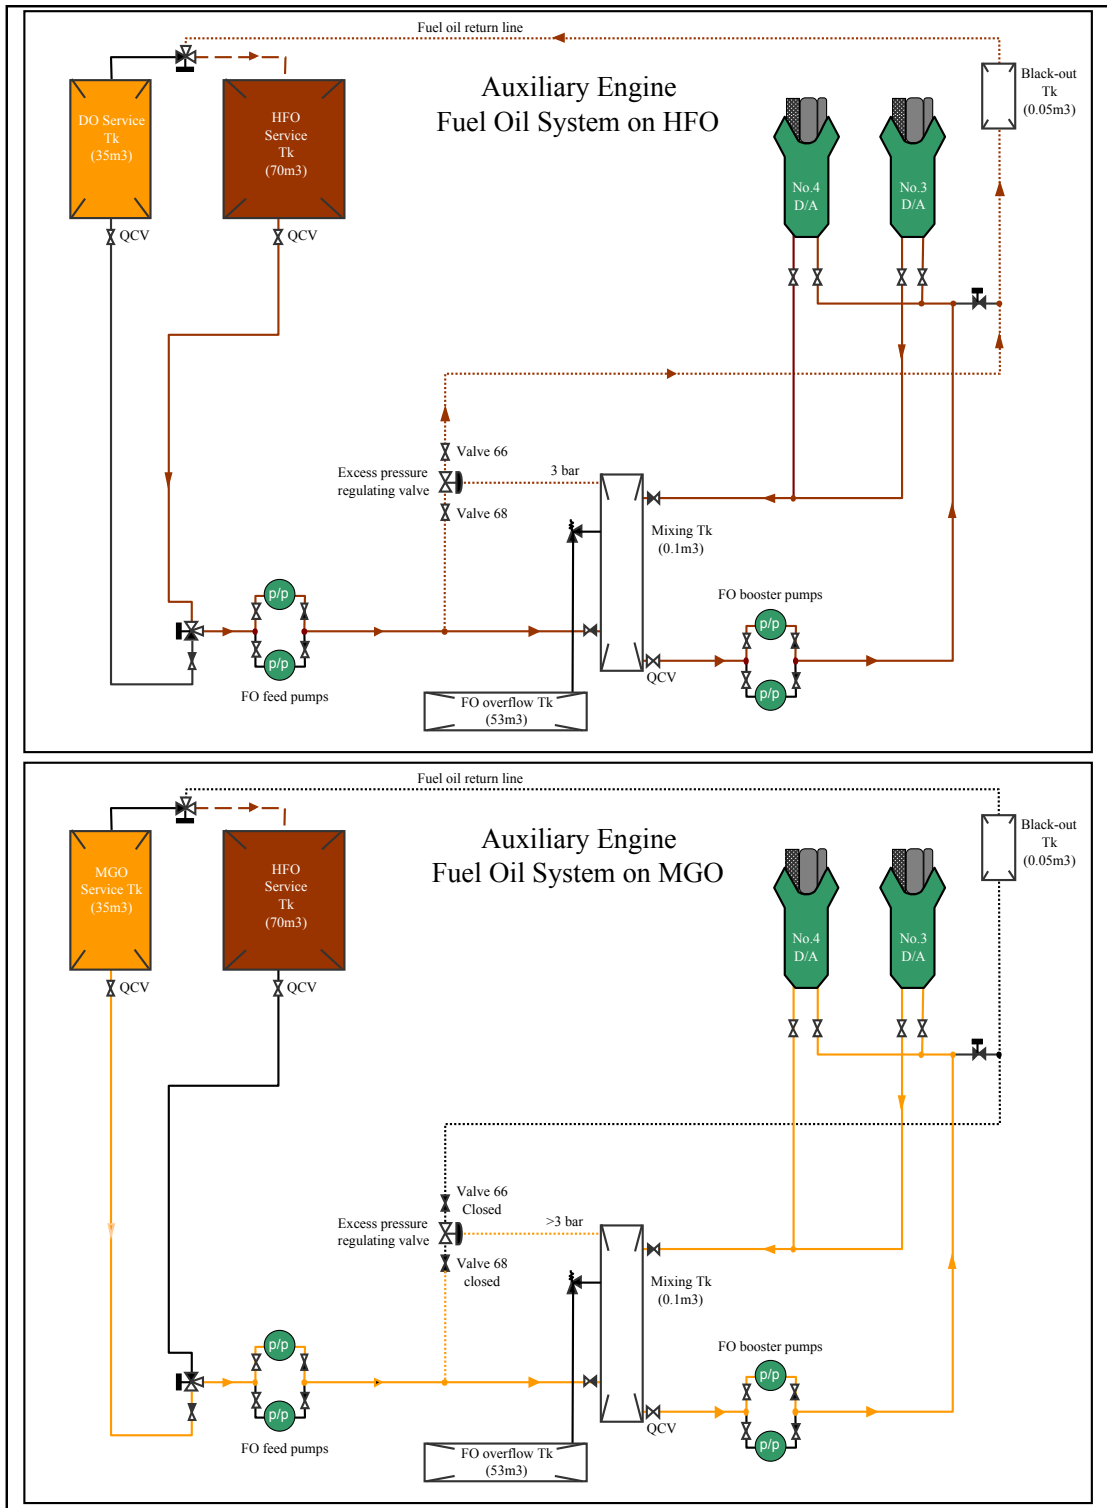
Figure 25

Simplified illustration of the auxiliary engines' fuel oil system

Throughout the day prior to sailing from Falmouth, the ship's engineers had experienced problems maintaining the required pressure in the auxiliary engine fuel system. The succession of low pressure alarms led the chief engineer to start the second fuel oil feed pump and instruct the EOOW to abort the initial attempt to change over to HFO as the vessel was manoeuvring out of Falmouth harbour. Once the master had ordered "full away on passage", the chief engineer changed over to HFO by operating the three-way supply and return valves remotely in the ECR; he was unaware that the EOOW had closed the manually-operated valves V66 and V68, and therefore did not open them in accordance with the vessel's operating procedure.

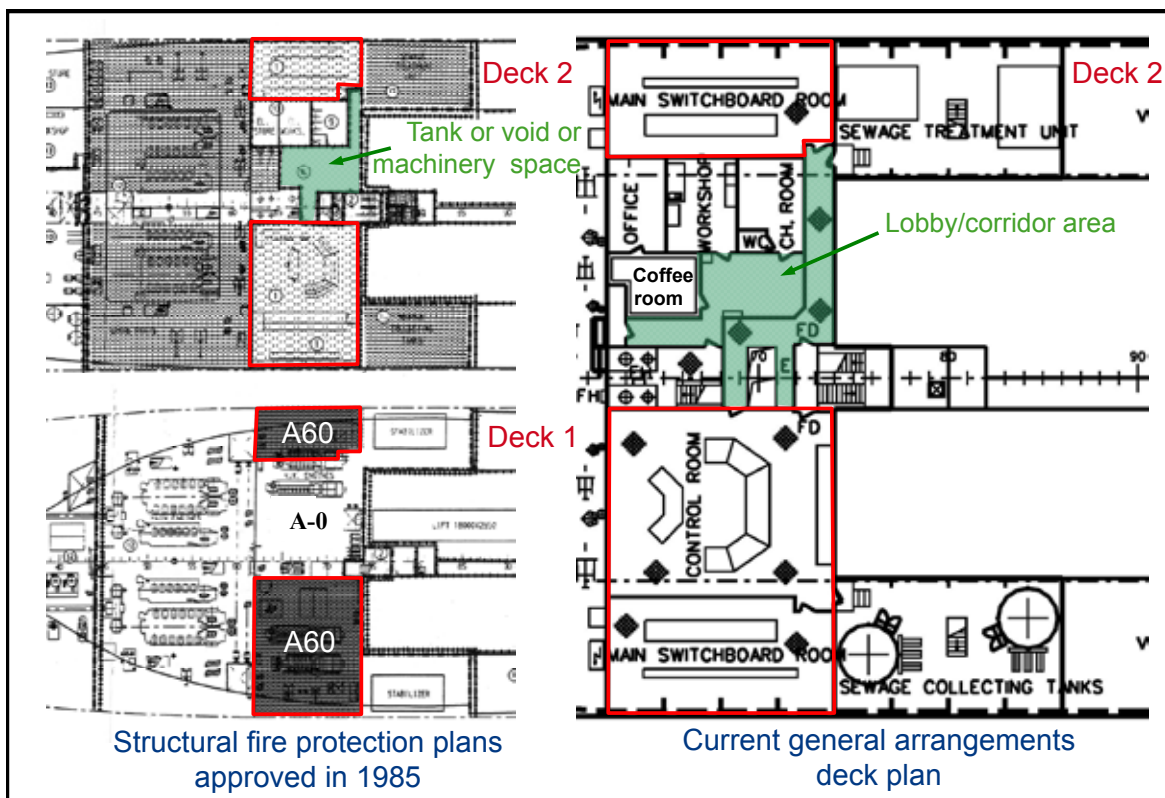
Structural fire protection plan

The lobby and corridor area on the port side of the ECR was classified as a *tank, void or auxiliary machinery space having little or no fire risk*. As such, the deck and bulkhead boundaries between it and the AER required A-0 structural fire protection. Therefore, no thermal insulation was provided. Some of the compartments had changed use over time; an electrical store had been converted to an office and a coffee room had been provided for the engineers (**Figure 29**). The deck between these areas and the AER also had no thermal insulation. Following the fire, and prior to *Oscar Wilde* returning into service, Irish Ferries fitted an additional section of A60 insulation to the deck between the AER and the corridor area next to the ECR (**Figure 30**). This additional insulation has subsequently been extended to cover the whole of the AER boundary.

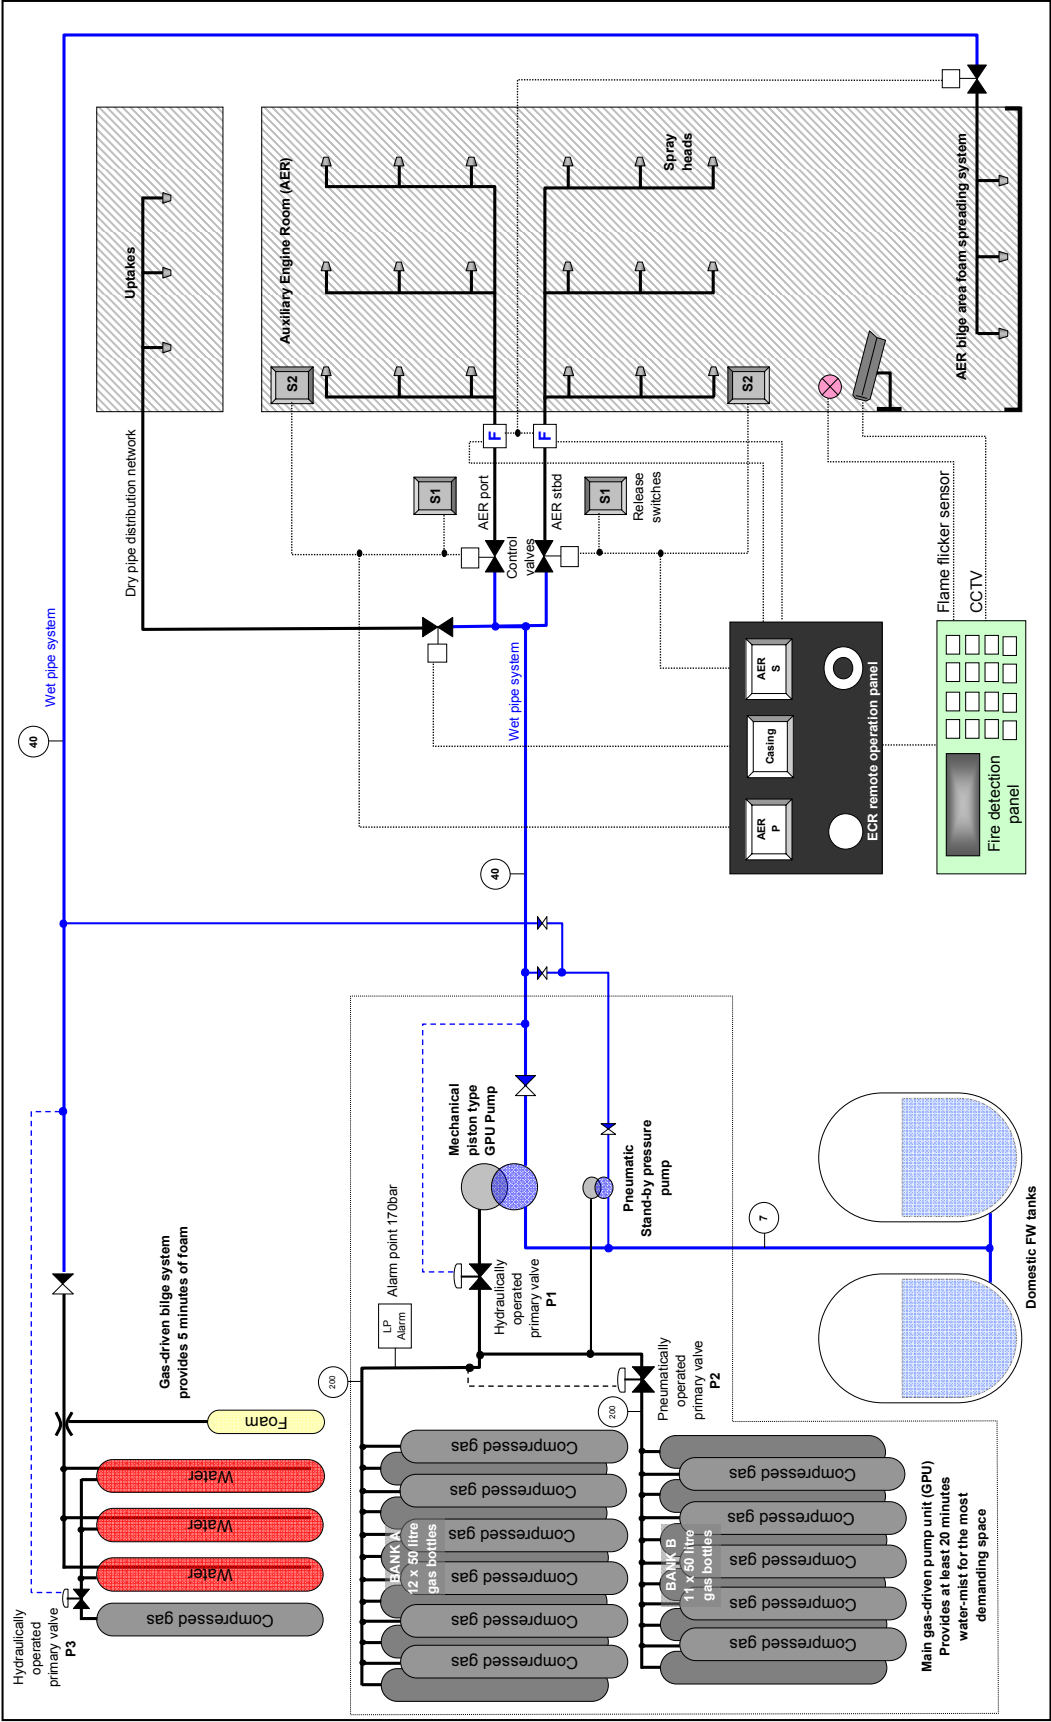
Figure 31

Simplified illustration of the Hi-fog and bilge foam flooding system

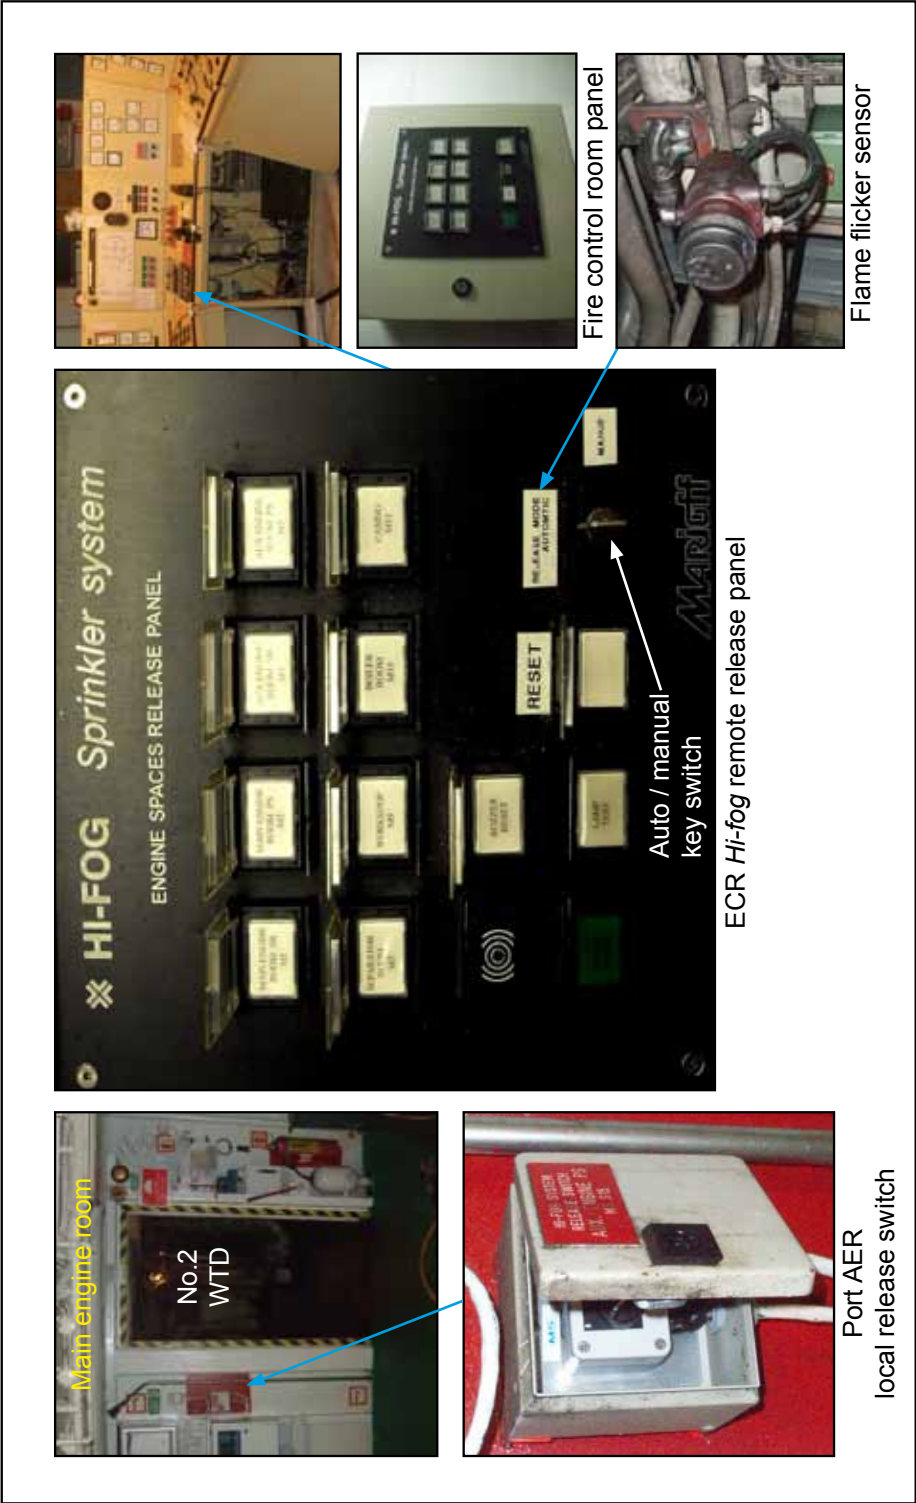
Figure 32

The AER release switch activated by the extra 2/E was in the main engine room on the port side of WTD2 (**Figure 32**). He was unaware that the switch activated only the port section control valve and did not see the release switch for the starboard section, which was located several metres away on the same bulkhead.

The activation of the auxiliary engine fuel module's flame sensor (**Figure 32**) should have triggered alarms on both the fire detection and *Hi-fog* remote release panels, and the automatic operation of the starboard AER and casing section valves. The CCTV camera for the starboard side of the AER should also have been automatically selected and displayed on the ECR monitor.

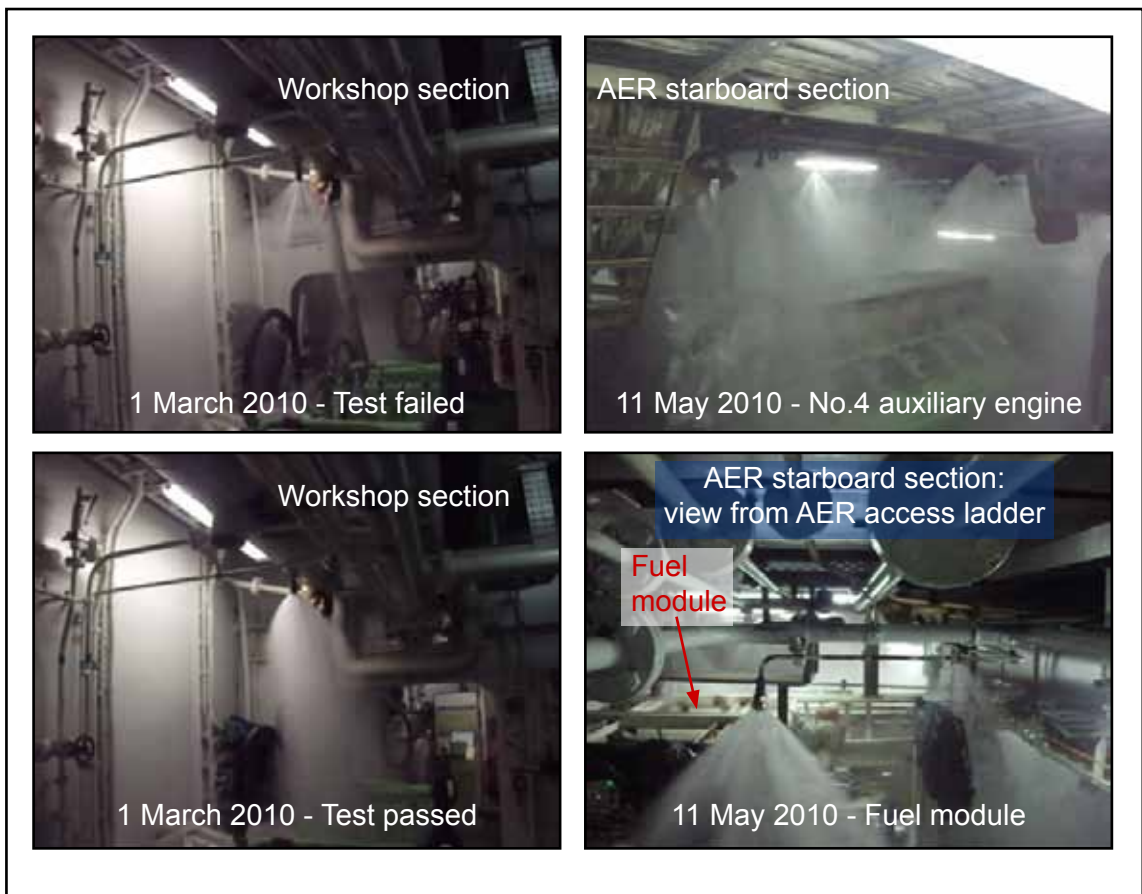
Figure 33

- the initial stand-by pressure was equal to the gas bottle pressure of 195bar
- the gas bottle low pressure alarm was set at 100bar
- the automatic CCTV function did not work
- the water-mist coverage appeared to be less substantial over the fuel module compared to the auxiliary engines (**Figure 33**)
- one gas cylinder was sufficient to conduct the test.

Hi-fog system discharge tests

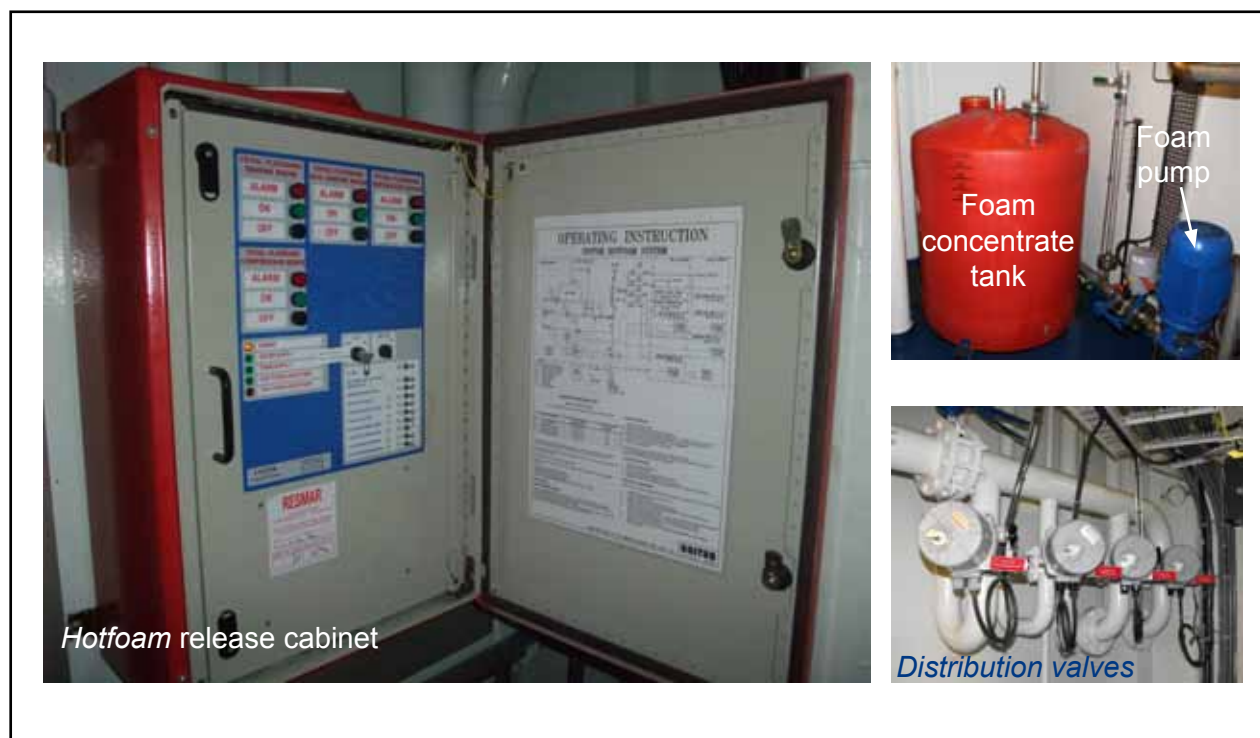
Figure 34

The *Hotfoam* system protected the main engine room, AER, separator room and compressor room. The foam generators were located inside the protected spaces and used the atmosphere inside the compartment to aspirate the finished foam. The AER had 13 foam generators, which were capable of filling the space within 3.2 minutes at a rate of 2m/min. The system was designed to be activated remotely from a dedicated compartment on deck 4 where the control cabinet and main plant were located. The compartment contained a 600 litre foam concentrate storage tank, a foam concentrate pump, a foam solution proportioner, a sea water supply valve and four foam solution distribution valves (Figure 34).

Hotfoam compartment

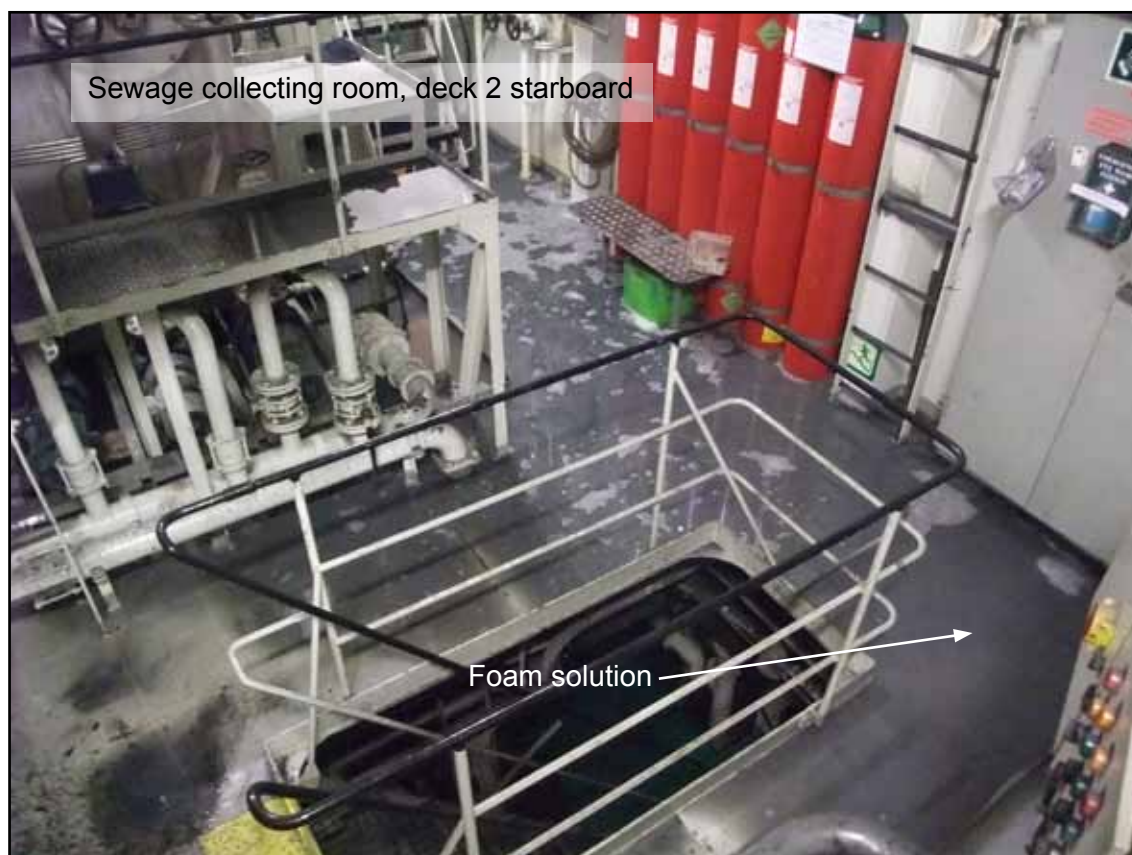
Following the fire, the system’s control valves were found to be in the correct position for a discharge into the AER. The foam storage tank was empty but no high-expansion foam was found in the AER. There was evidence that foam solution had entered the compartment via the foam generators. Liquid was dripping from some of the generator nozzles, areas of soot had been washed from the bulkheads immediately behind some of the generators, and soapy liquid was found in several machinery save-alls remote from any of the *Hi-fog* spray heads and fire-fighting efforts (**Figure 35**). Samples collected from the sewage treatment and collecting tank save-alls contained approximately 98% sea water and 2% *Hotfoam* concentrate.

Hotfoam solution delivered to the AER

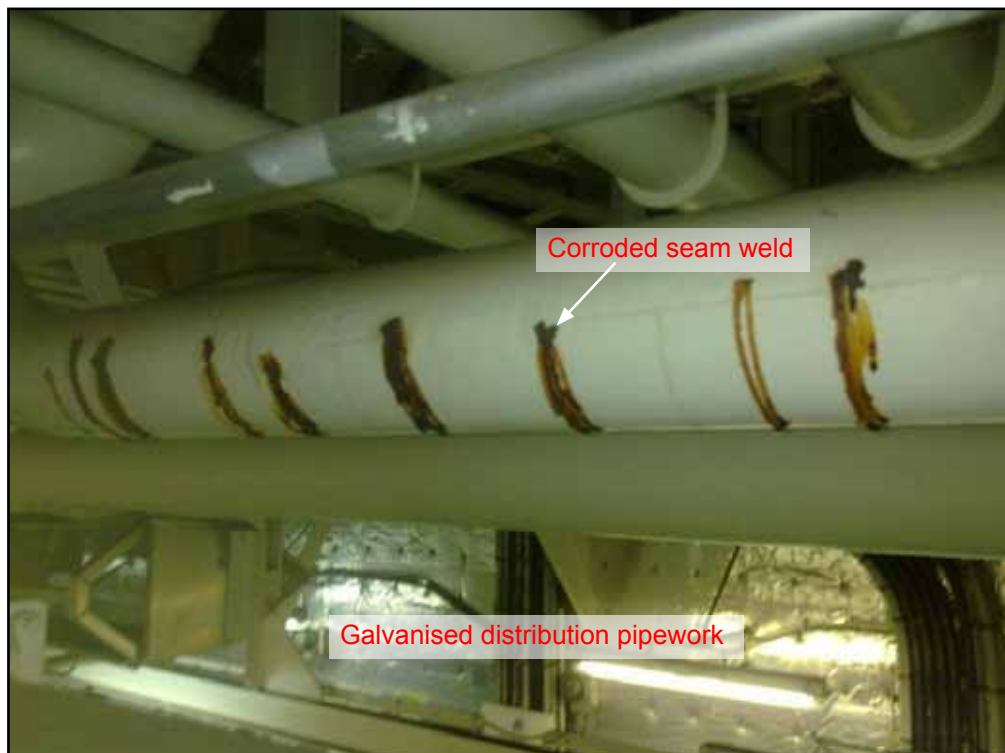
Figure 38

As a result of its findings on board *Oscar Wilde*, Wilhelmsen carried out several enhanced surveys of *Hotfoam* systems fitted to other vessels. Its service engineers closely inspected the distribution pipework and foam generator nozzles and identified that water traps were common, and that corrosion was prevalent within the dry pipe systems. They also found that welded seams within galvanised systems were particularly prone to corrosion (**Figure 38**). In addition, many foam generators could not be accessed to allow nozzles to be inspected, particularly on the larger tankers.

Hotfoam system survey on other vessels
