Report on the investigation of
The machinery space fire on board

Oscar Wilde

In Falmouth Bay

Report No 3/2011
March 2011

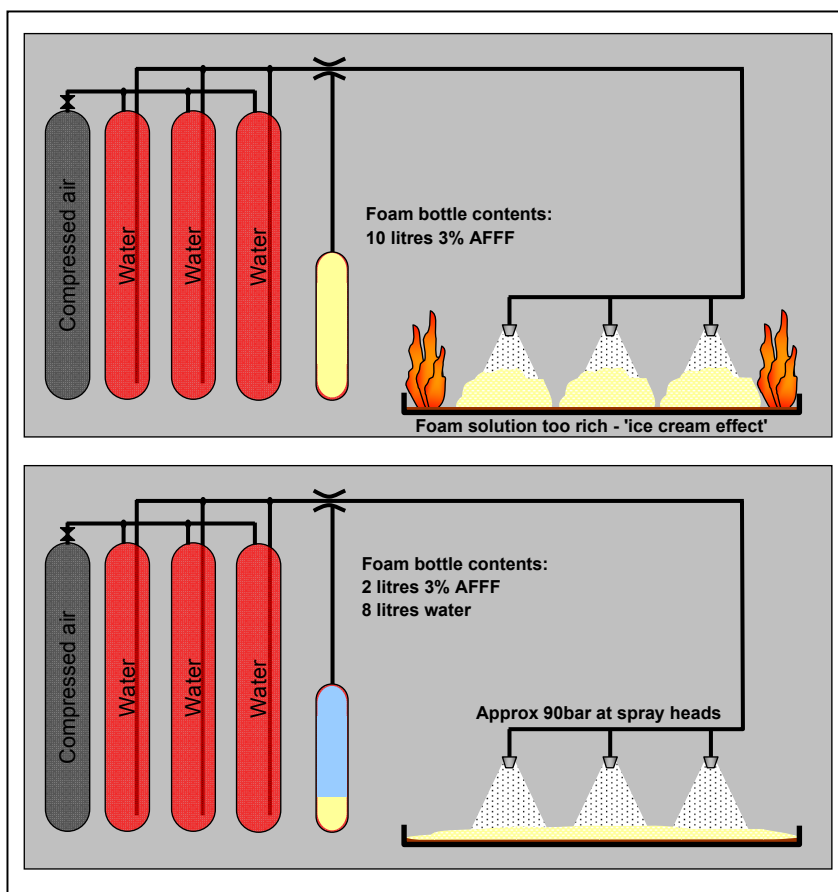
Figure 39

The system was not type approved but, in 2000, Marioff conducted a series of trials to satisfy itself and DNV that the system produced the required quality and quantity of finished foam. During the tests, the foam cylinder was initially filled with a 3% aqueous film forming foam (AFFF) concentrate, but the finished foam was too stiff to spread, and resulted in an 'ice cream' effect (**Figure 39**). The foam concentrate was progressively diluted and the optimum performance occurred when the foam cylinder was filled with 2 litres of 3% AFFF concentrate and 8 litres of water. This information was included in the manufacturer's operating and maintenance manual.

Foam concentrate

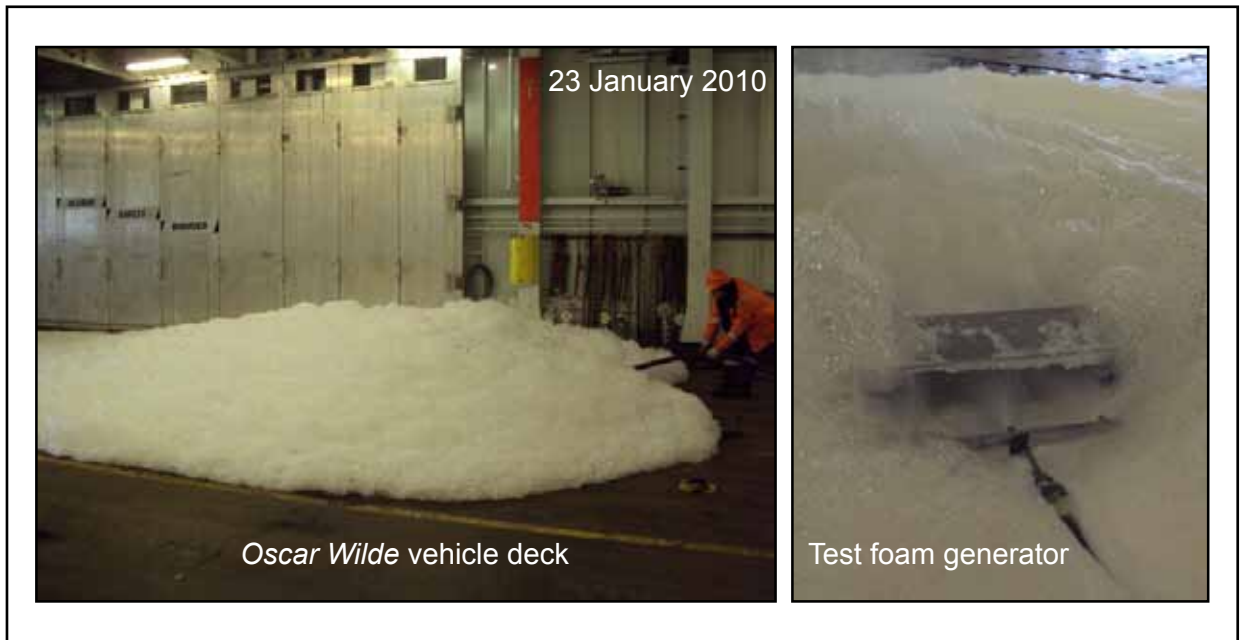
Figure 40

A Wilhelmsen service engineer last conducted the annual maintenance on 15 May 2008; again no defects or shortfalls were identified (**Annex H**). The foam concentrate test certificate stated that the foam tank had been filled in March 2002. The manufacturer recommended that the concentrate be renewed every 5 years.

Hotfoam system discharge test

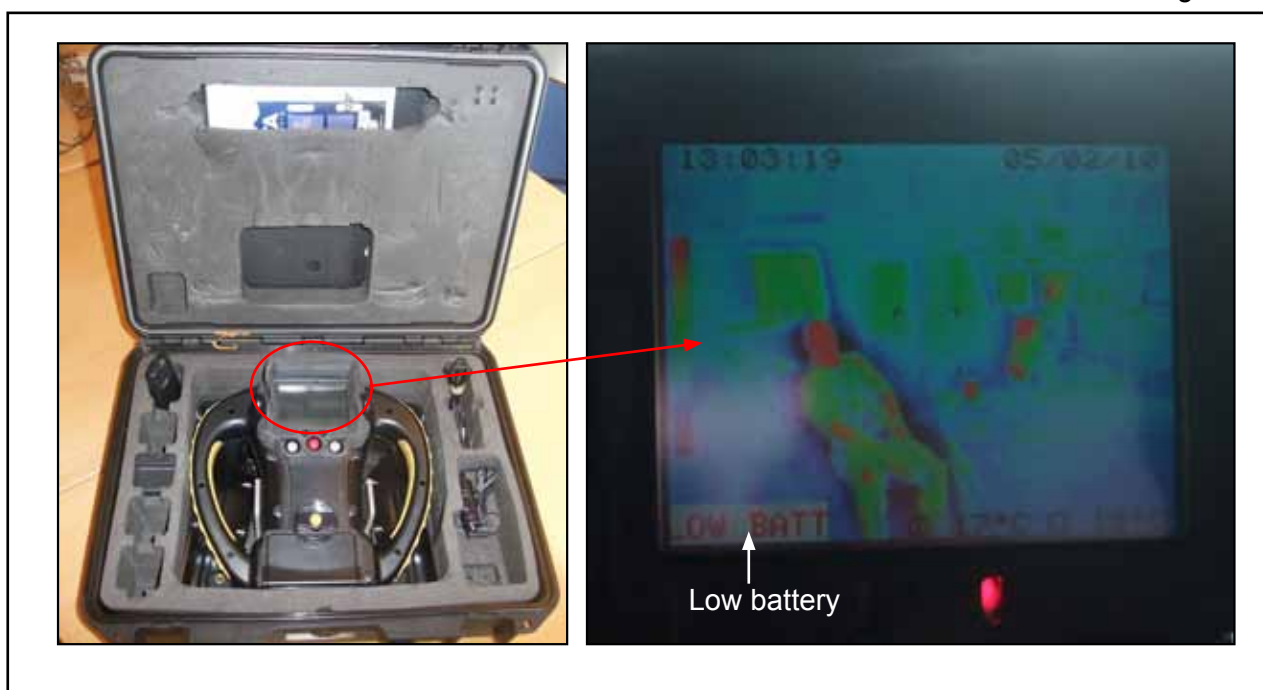
Figure 41

The ship held a thermal imaging camera which was located at the deck fire party's muster point. It was standard practice to take the camera to a scene of a fire. On this occasion, the fire party forgot to take the camera to the lower hold and it remained unused in the fire store throughout the incident. After the fire, it was found that the camera's battery had not been charged prior to sailing and only had sufficient charge to power the camera for 1 to 2 minutes (**Figure 41**).

Thermal-imaging camera

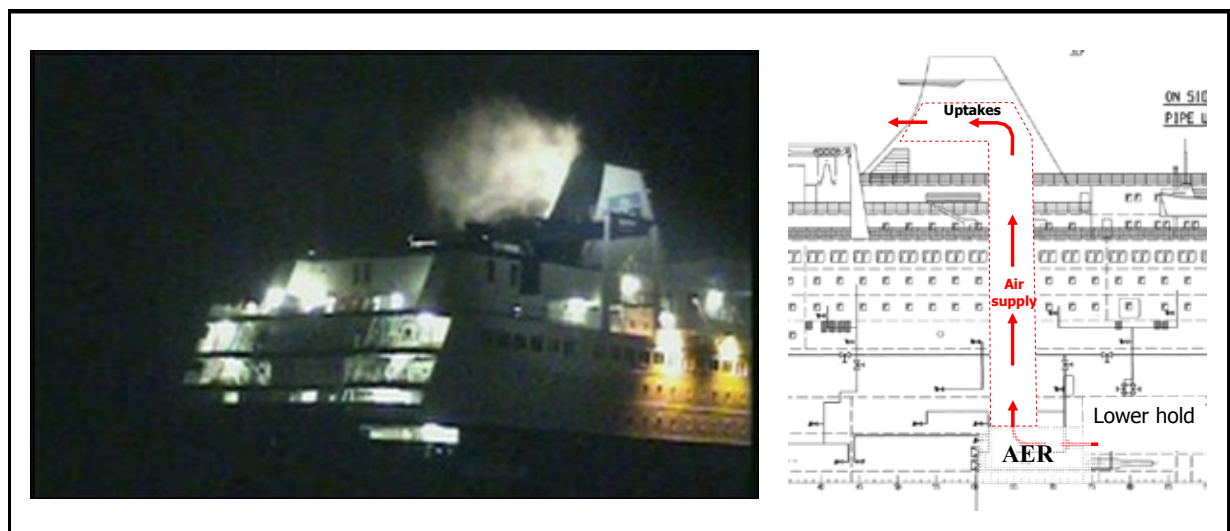
Figure 42

However, when the OSC opened WTD3 a draught was induced from the vehicle deck, through the AER, as the hot combustion gases rose up the funnel casing and escaped through the exhaust louvres. In addition, as the vehicle deck ventilation dampers had not been closed, the 25 knot winds over the deck of the anchored vessel served to create a forced draught through the compartment (**Figure 42**). The OSC was aware that the draught was keeping the smoke out of the lower hold, but the implications of fanning the fire were not considered. Consequently, the air flow from the lower hold ventilated the compartment before it had been adequately cooled, and contributed to the fire's re-ignition.

Air supply from the lower hold to the AER

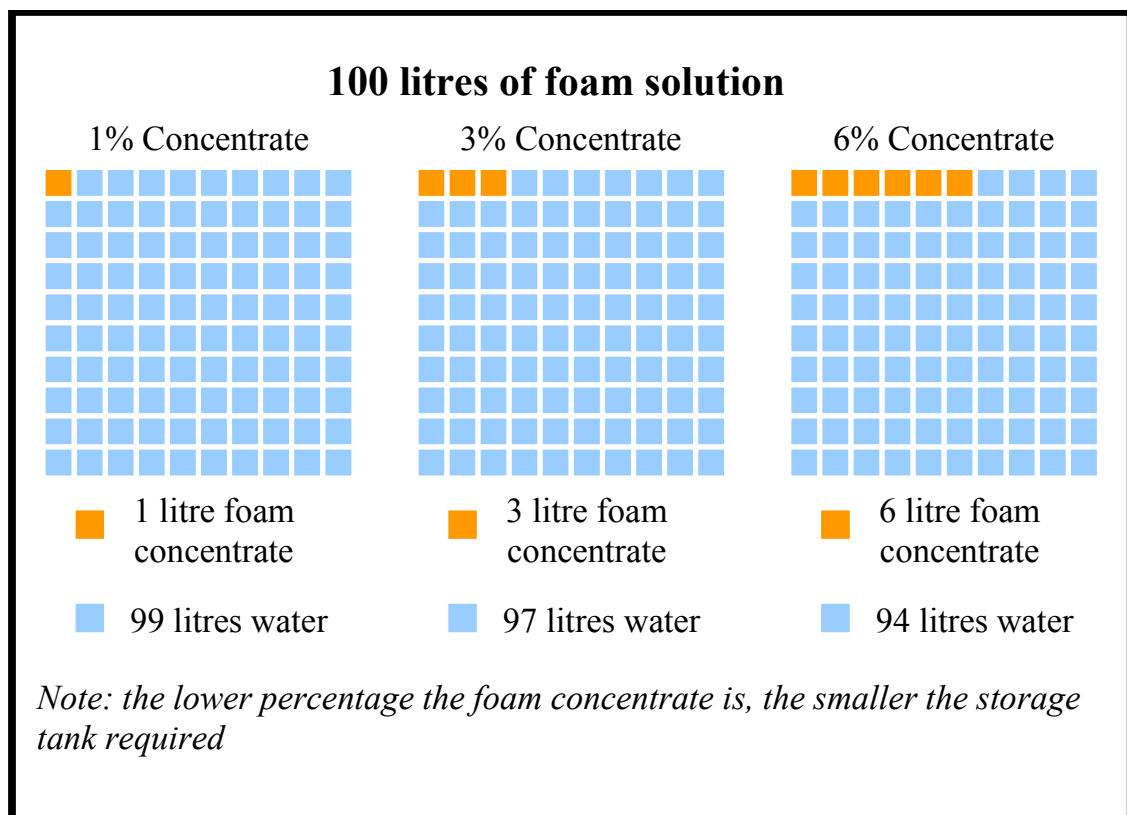
Figure 43

Foam concentrates must be mixed with water in the correct proportions to ensure optimum fire-fighting performance. They are generally supplied by manufacturers as 1%, 3% or 6% concentrates. The percentage refers to the quantity of concentrate required to be mixed with water to produce the foam solution. The lower the percentage concentration, the less concentrate needed to produce the required quantity of finished foam. Basically, 1% AFFF is six times stronger than 6% AFFF, and 3% is twice as strong as 6%. However, the fire-fighting characteristics of finished foam produced from 1%, 3% and 6% concentrates should be virtually identical (**Figure 43**).

Foam solution concentrate and water ratios

Fire-fighting systems are designed to be used with different foam concentrates and it is extremely important that the correct concentrate is used. If a 3% concentrate is used in a system designed for 6% then there will be twice the desired amount of concentrate in the foam solution. This can result in the finished foam being too stiff to flow adequately. Alternatively, the use of 6% concentrate in a 3% system will result in a lean foam solution that provides finished foam with a reduced level of fire-fighting performance.
