**The Bahamas
Maritime Authority**

M.V HARMONY OF THE SEAS

**Report of the marine safety investigation into a lifeboat
fall during an abandon ship drill on the 13th September
2016 in Marseille, France**

HARMONY OF THE SEAS

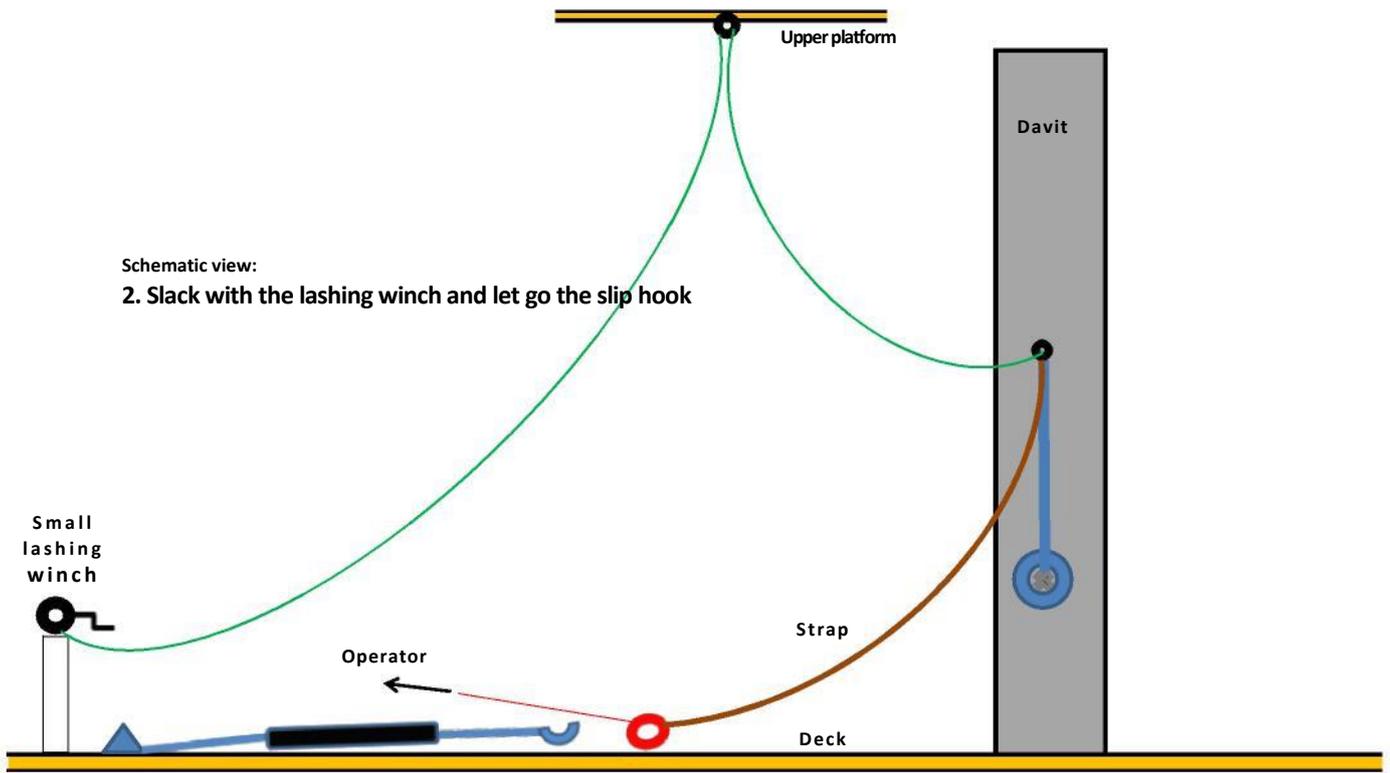
Davit. View from the lashing lever side

Contrary to the aft lashing gripe, the lifeboat's securing forward lashing gripe remained in raised position. Thus its limit switch was not activated; in these conditions, it's only the descent of the lifeboat with the electric winch that is prevented. A contrario, gravity launching is possible.

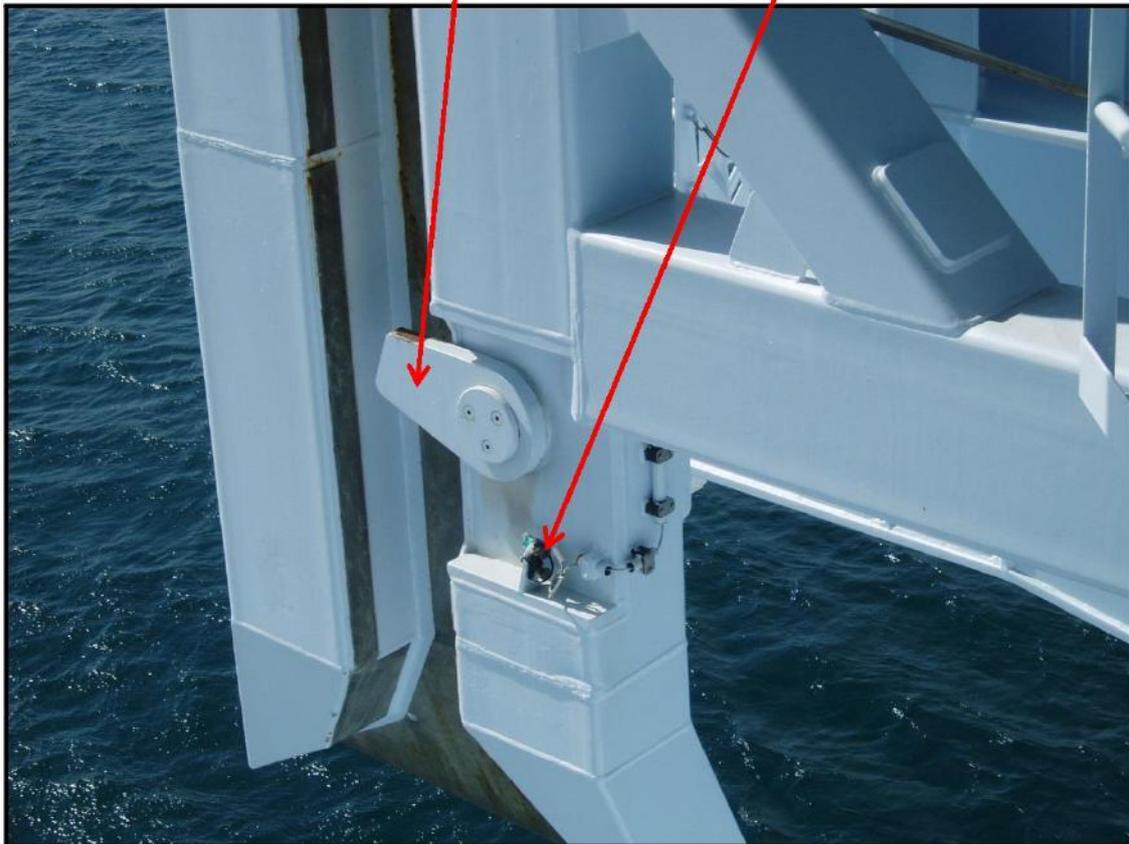
Long-link

secured by the forward long link tumbled then forward. The brutal movement caused the release of the long link from the aft hook with kinematics similar to the release of the fore part (moving of the catch hold as a result of the heavy tilt angle, shape of the hook end and lightness of the stop pawl). Releasing itself, the long link tore off the aft stop pawl (cf. appendix C1).

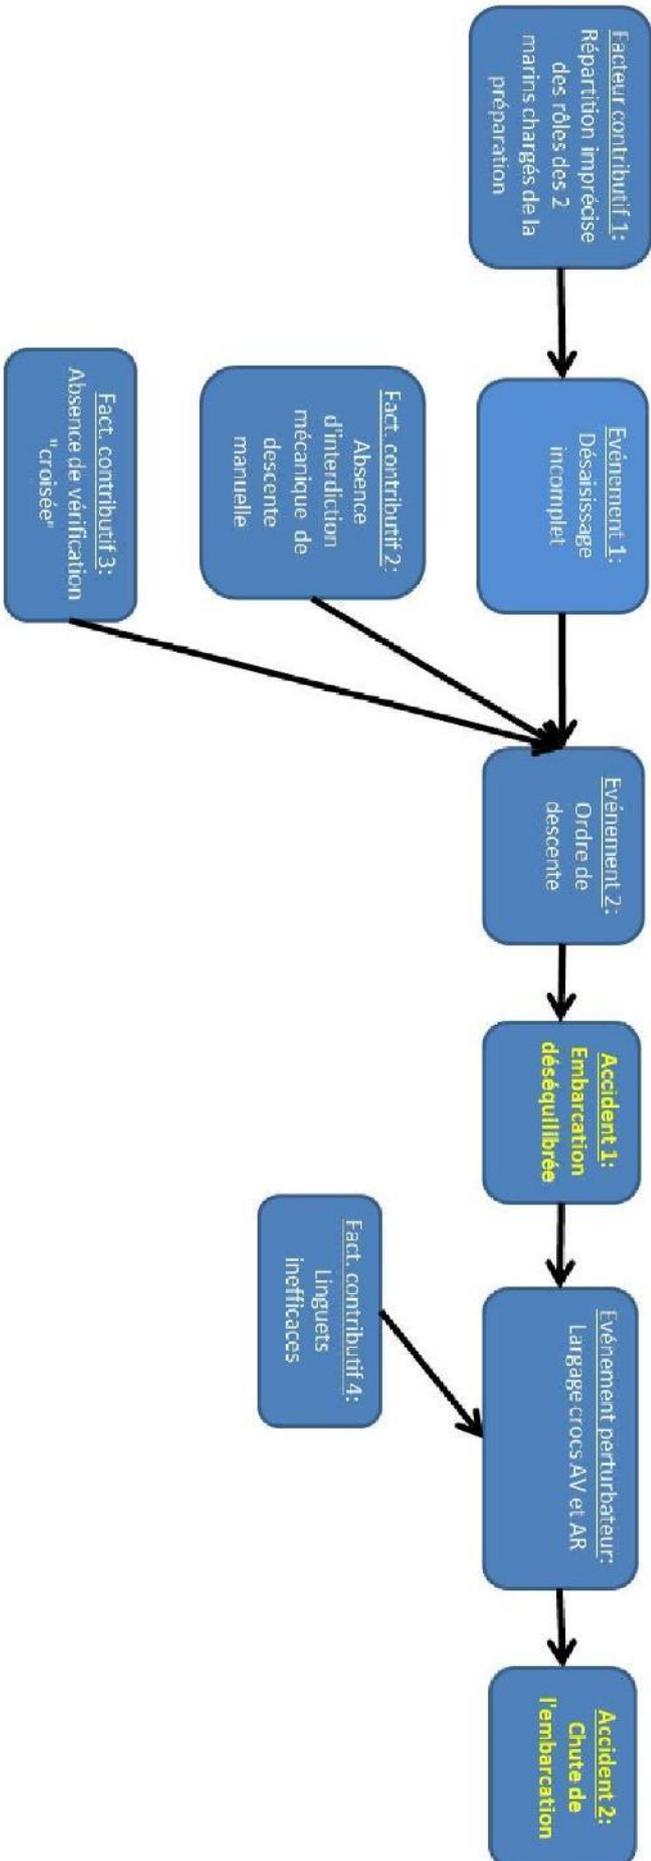
Diagram of events

The fall of the lifeboat (second accident, cf. chain of event diagram) was caused by the release of the forward and aft long links, disruptive event without action by the crew.

The lifeboat continued her descent, tilted backwards, until the after part of the lifeboat get off its guide. The tilt angle increased and caused the fore part of the lifeboat to get off being thus freed from the removable lashing gripe, then from the forward guide. The lifeboat that was no more
