The Bahamas
Maritime Authority

Marine Safety Investigation Report

into a man overboard from Castillo De
Valverde on 28 May 2020

Date of Issue: 19 April 2021
Bahamas Maritime Authority
120 Old Broad Street
LONDON
EC2N 1AR
United Kingdom

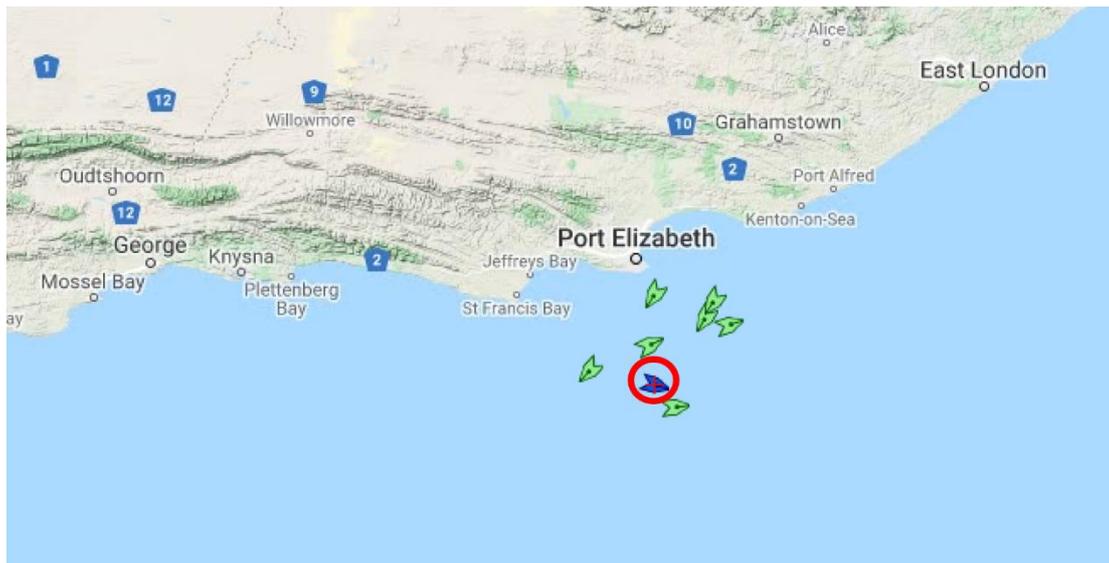
Figure 1: Location of the vessel at the time of the incident

The vessel had a mean freeboard of 6.4m. At the time of the incident, the vessel was in position 34°37.6'S 025°42.5'E, approximately 13.3NM inside the summer zone.
