The Bahamas
Maritime Authority

Marine Safety Investigation Report

into an engine room fire onboard Pride of Hull
on 20 October 2020

Date of Issue: 30 November 2021
Bahamas Maritime Authority
120 Old Broad Street
LONDON
EC2N 1AR
United Kingdom

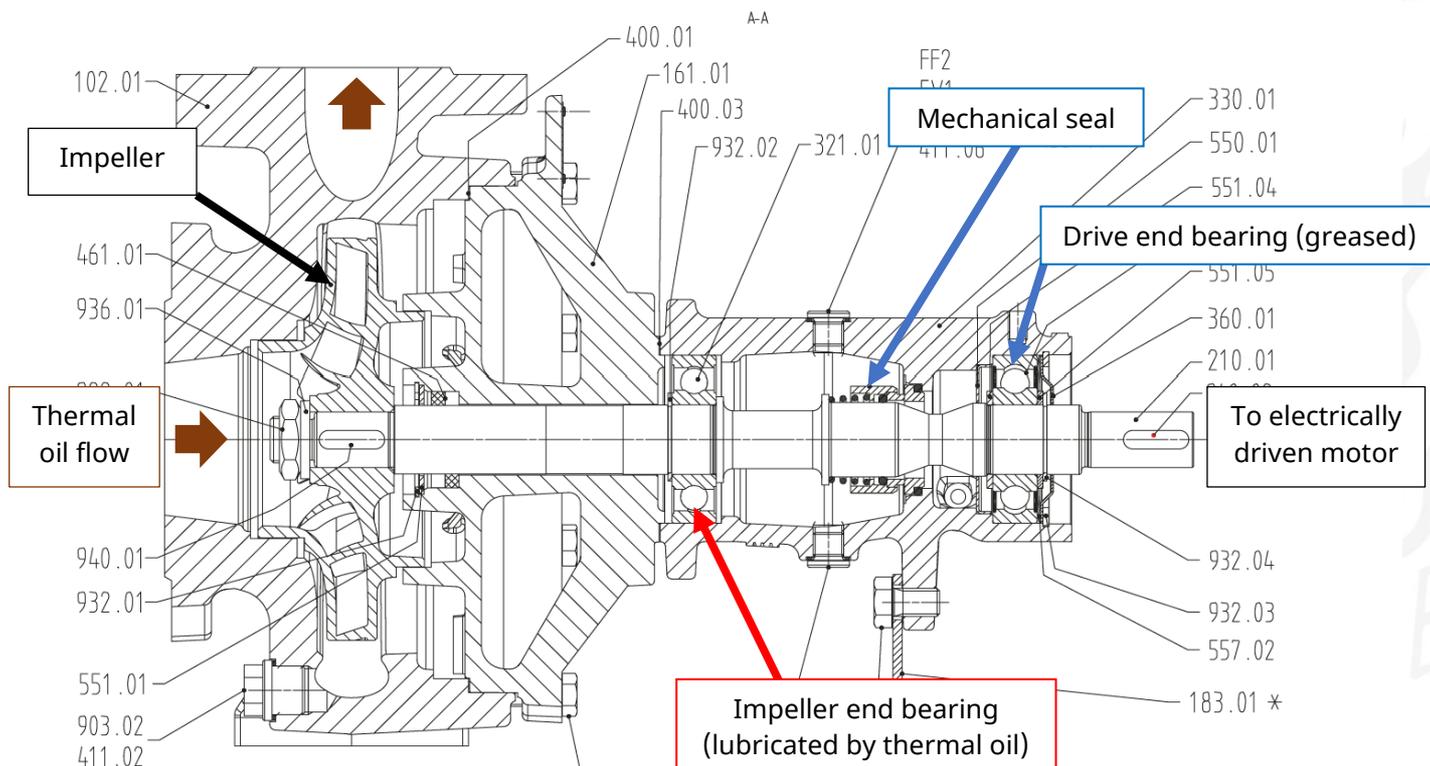
Circulation pump cross-section

The pumps had a single stage centrifugal impeller fitted to a shaft, rotating on two bearings: a grease packed single row ball bearing design at the electric motor (drive) end, and a thermal oil lubricated single row ball bearing design at the impeller end.

The thermal oil circulation pumps had a spray guard fitted to retain oil in the event of a seal failure. The original spray guard was manufactured onboard and installed by the engineering team in 2001. Removable side panels were added in 2017 and a duct, connected to the engine room ventilation system, was added in July 2018. At the time of the fire, the side panels were not in position.

Metallurgical examination identified that the damage to the pumps was consistent with a bearing failure and fire originating at pump #1. The pattern of damage to pump #1 indicates that the impeller end bearing failed first and the drive end bearing collapsed shortly afterward. This collapse led to the drive end bearing's outer race rotating in the bracket housing, which resulted in extreme frictional heating, generating temperatures in the order of 1,200°C - well in excess of the thermal oil's autoignition temperature. Due to the failure of the mechanical seals and circlips, there was a path for the thermal oil to reach the hot spot internally as well as spray to make contact externally.
