Bahamas Maritime Authority

Marine Safety Investigation Report

into an inadvertent steam release, resulting in a fatality on Navigator of the Seas, 14 July 2020

Date of Issue: 27 September 2022 Bahamas Maritime Authority 120 Old Broad Street LONDON EC2N 1AR United Kingdom

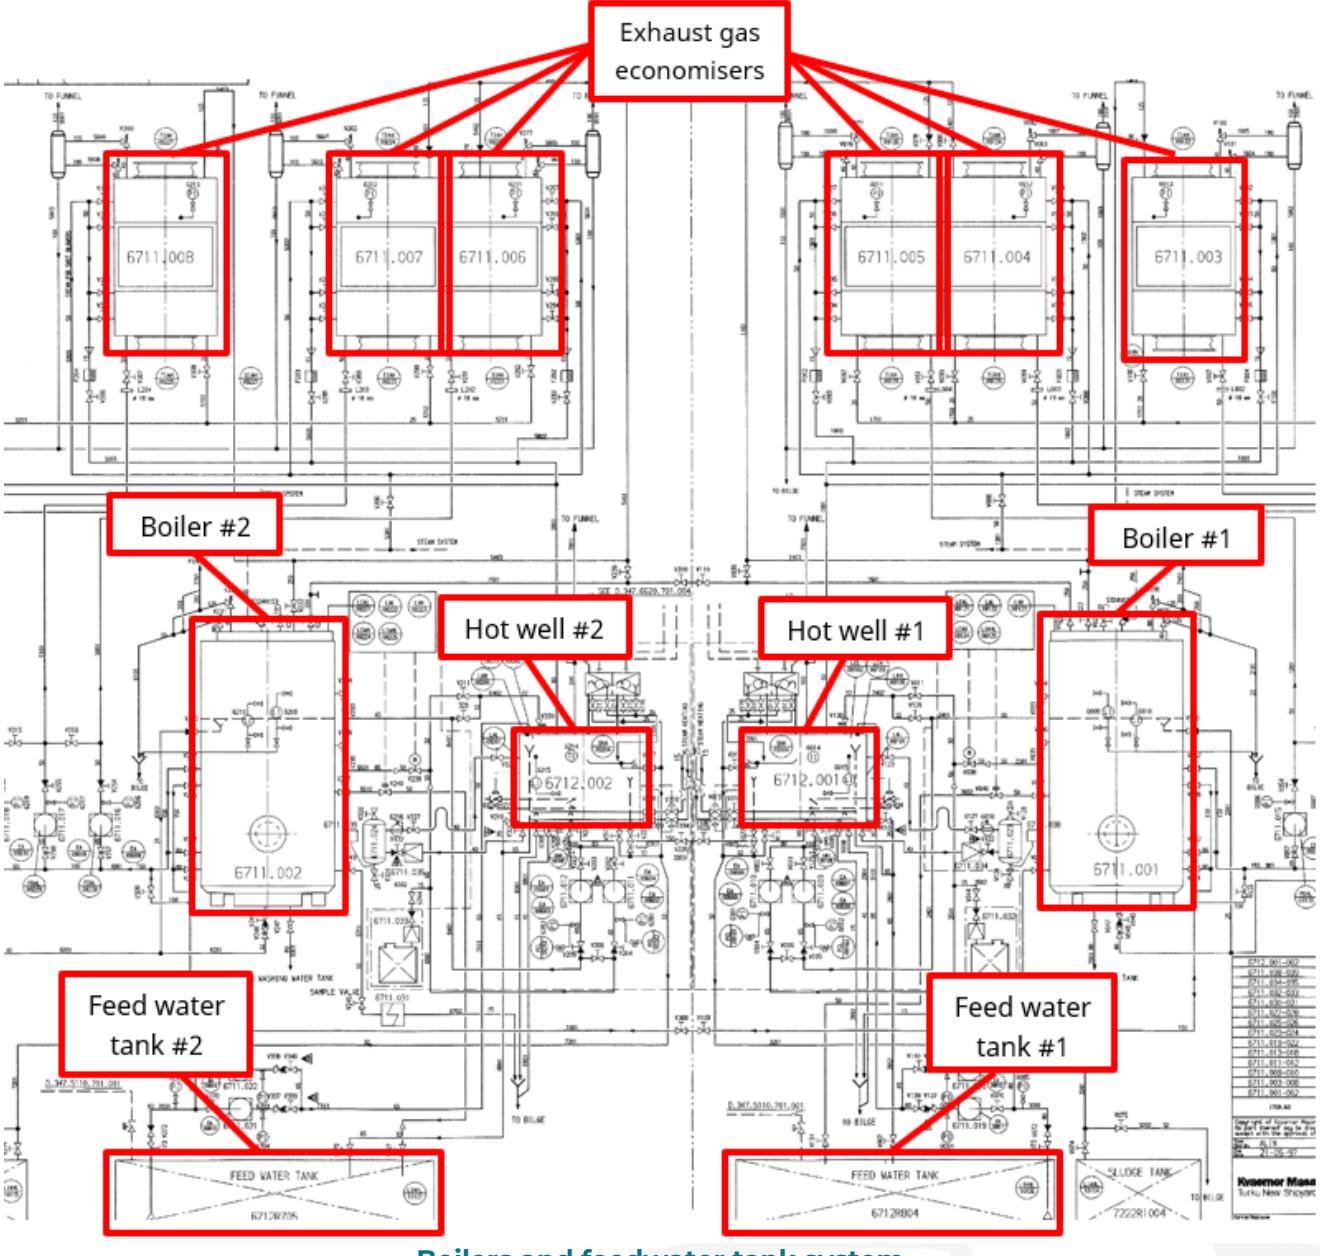
Boilers and feedwater tank system

The boiler plant consisted of two fully automatic oil-fired auxiliary boilers and six exhaust gas economisers. The auxiliary boilers were of vertical combined fire/water tube type with natural water circulation and side-mounted heavy oil burners.

The exhaust gas economisers recovered waste heat from the exhaust of the vessel's diesel generators which was subsequently fed to the boiler, increasing operating efficiency. Boiler #1 was connected to economisers on the aft diesel engines, boiler #2 was connected to economisers on the forward diesel engines.
