The Bahamas
Maritime Authority

Marine Safety Investigation Report

into a collision between BGP Prospector and
an unnamed fishing boat resulting in the loss
of one life on 5 April 2022

Date of Issue: 08 March 2023
Bahamas Maritime Authority
120 Old Broad Street
LONDON
EC2N 1AR
United Kingdom

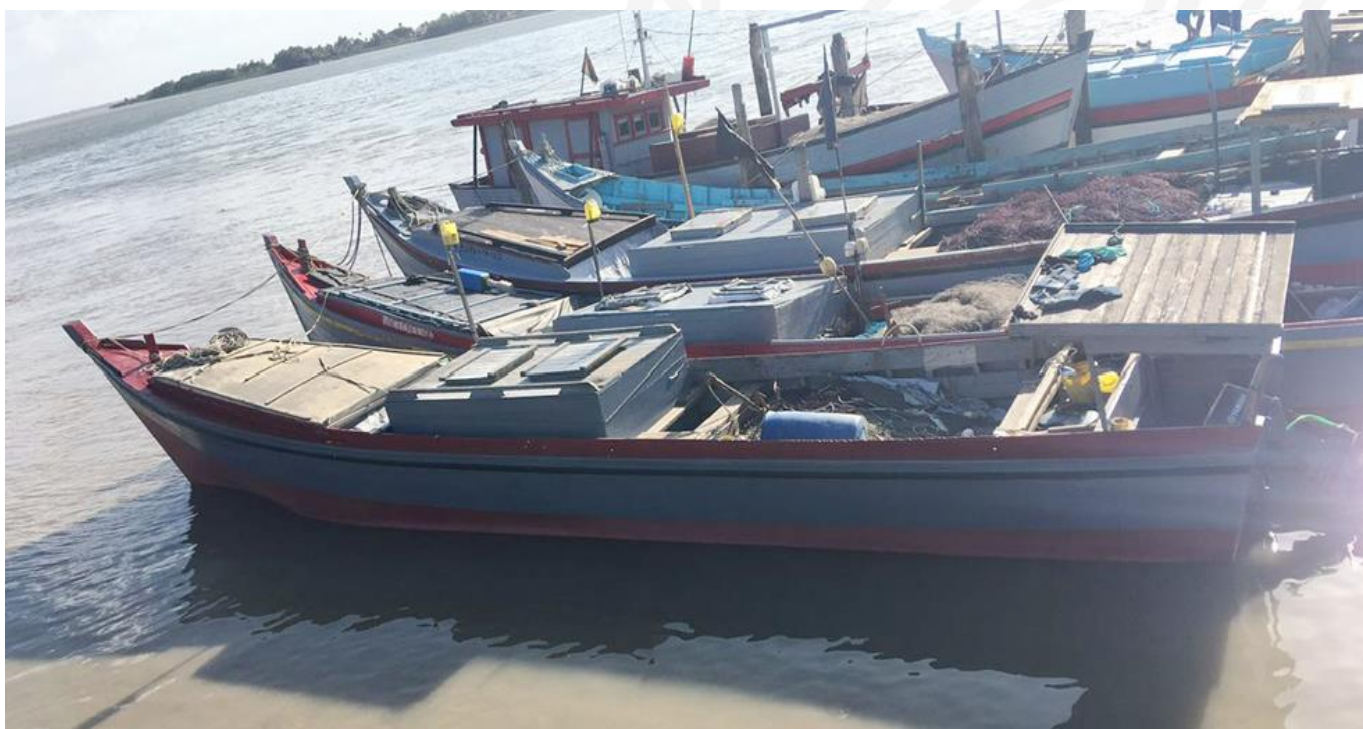
Vessel Type	Large flat bottom dory-type wooden gill netter	Flag	Guyana (unregistered)	
Built	Unknown	Propulsion	Diesel inboard/ 4 stroke petrol 40 HP outboard	
IMO No.	Callsign	Length overall	Breadth	Moulded Depth
N/A	N/A	12-15m	≤ 2m	≤ 1m

Typical Guyana gill netter: Image courtesy of The Guyana Chronicle

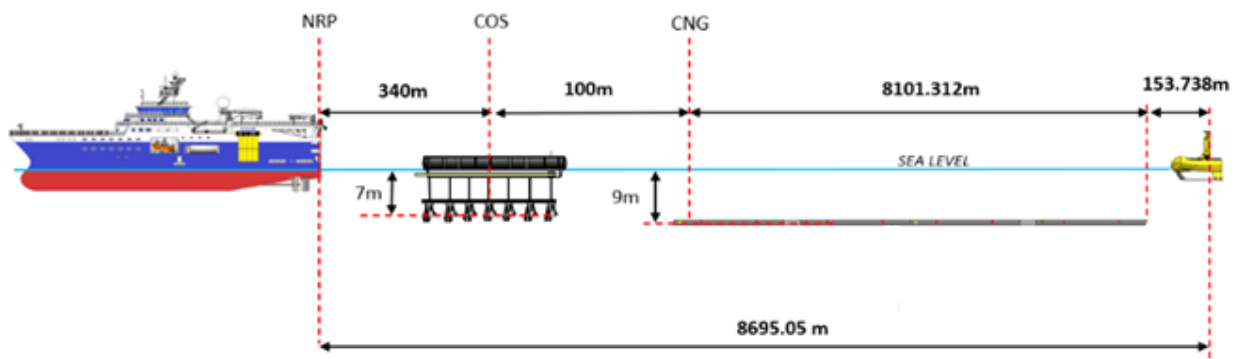
Figure 2. Cross- section of survey array

The acoustic-trawl seismic survey equipment being used comprised two wide tow ropes spanning 1100 metres in total, which were attached to barovanes positioned at the outermost part of the rig. The survey array comprised six inner airgun acoustic transceivers, which captured digital imagery of sound waves bouncing back up from the seabed to the transducers, allowing the seabed to be mapped in a three dimensional image.

These sat ahead of ten streamers with further airgun acoustic transceivers mounted, which stretched 9000 metres behind the vessel. This allowed the vessel to survey and map large areas of the seabed in a single pass. Due to the width and length of the equipment being towed the BGPP operated as a vessel restricted in its ability to manoeuvre and required a minimum 5 NM Closest Point of Approach (CPA) (figure 2).

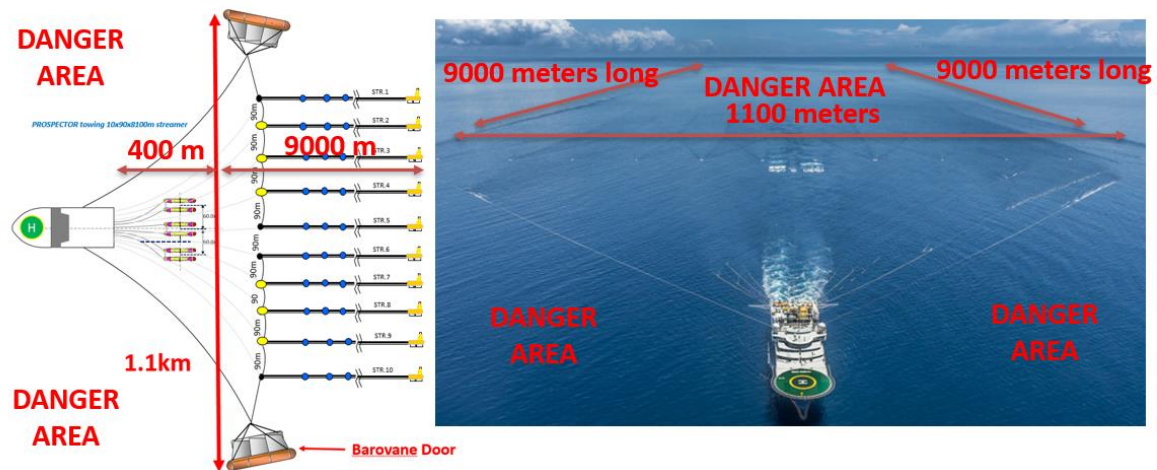
Figure 3. Danger areas – BGPP survey array

BGPP's action to avoid collision was limited to an alteration of course. This was [at least partly] informed by the restrictions imposed by the survey array: slowing down from its set operational speed would have resulted in damage and potential loss of equipment. Additionally, a reduction in speed alone would not have increased the CPA and would have proven difficult to observe by fishing boat A.

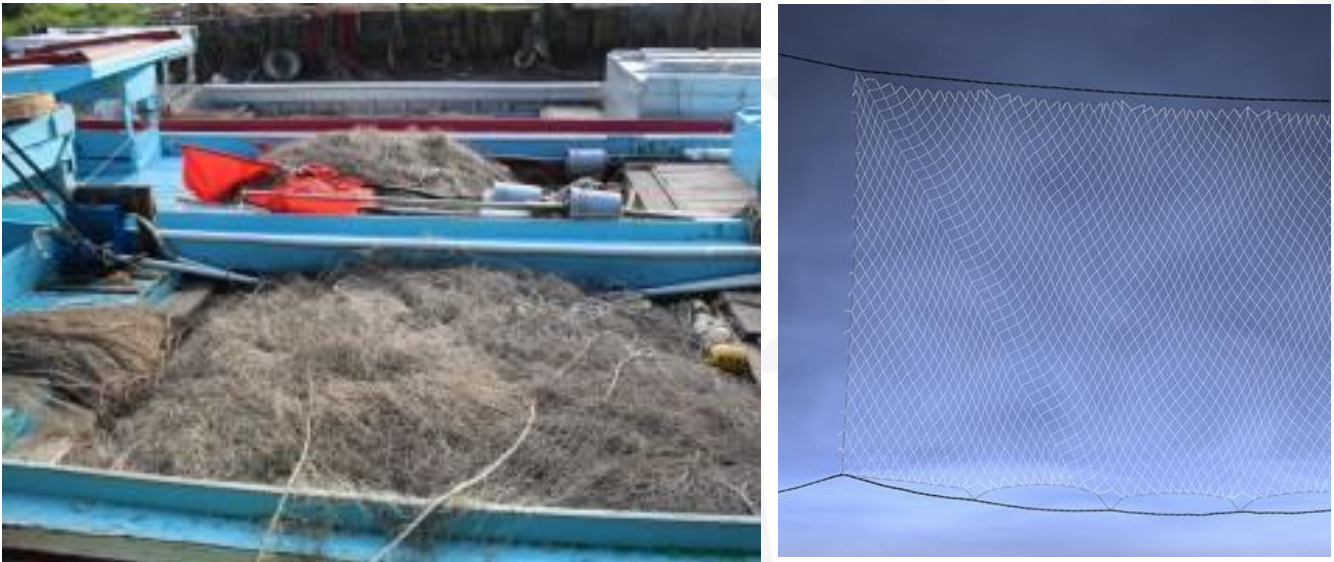
Figure 5. Typical Guyanese Gill net fishing boat (L) and section of Gill net (R)

The majority of artisanal fishing boats in Guyana are hand line boats, more widely known as gill netters. These boats are typically of wooden construction of up to fifteen meters in length, propelled by either an inboard diesel engine or outboard motor. They comprise a central open deck where nets are stored and a catch box which can hold up to five tons of ice in order to preserve their catch for up to ten days at sea. Basic essentials such as food and water are carried for the duration of the trip.

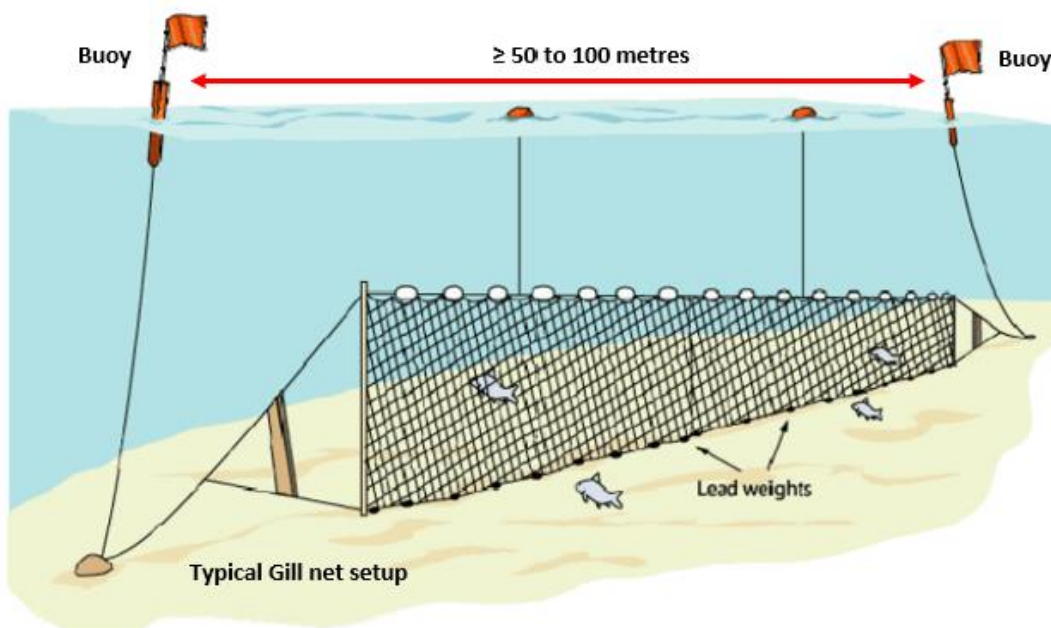
Figure 6. Typical Gill net setup

The gill nets are set near the seabed with a span of up to five hundred metres, supported every 50-100 metres by a buoy with crew responsible for two buoys each. Fishing boat A, with six crew, was fishing with a net of several hundred meters in length.

Fishing boat A, like the majority of gill netters, was not equipped with winches or net recovery equipment meaning that, once it was requested to move, it needed to recover its nets, along with the weight of any fish caught, all by hand.

As well as being commercially unadvantageous, recovering the nets would have been slow and labour intensive, especially considering the choppy conditions. The time required was a factor in why fishing boat A was unable to depart the scene sooner - the time required to complete the task of recovery was greater than the time it had to vacate the area so as to avoid a collision.
