The Bahamas
Maritime Authority

Marine Safety Investigation Report

into a fumigant poisoning fatality on board mv
Jupiter on 17 May 2022

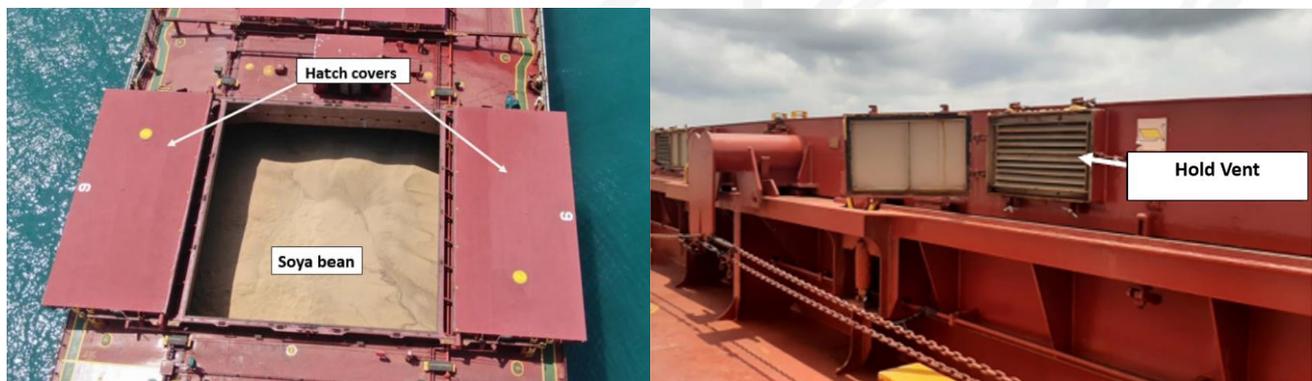
On completion of the fumigant application to all seven cargo holds, the hatch covers were secured for sea, danger signs affixed to the side of the hatches and the hold vents closed and covered over with plastic to prevent water ingress whilst on passage. All holds were to remain sealed for ten days, before the hold vents could be opened to start the ventilation and aeration process. (Figures 1&2).

Figure 1. Aerial view of No.6 cargo hold and hold vent

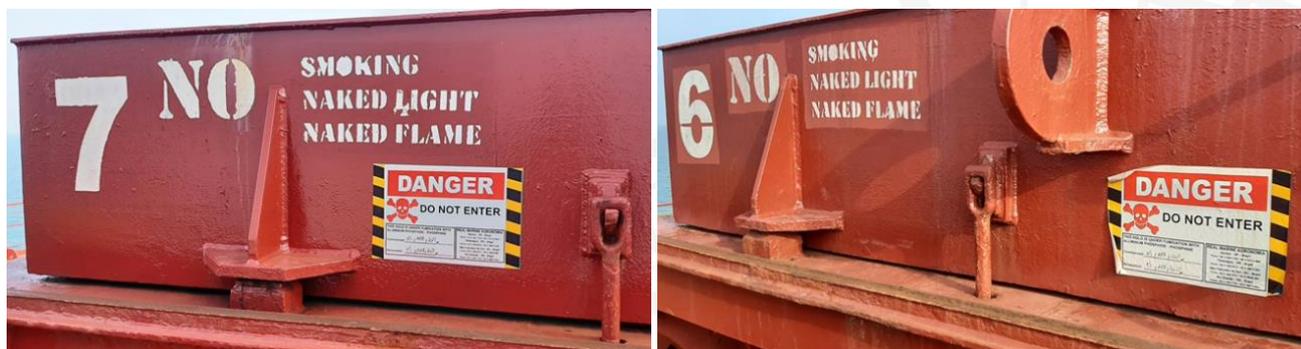
Figure 2. Danger signs affixed to sides of cargo hatches
