The Bahamas
Maritime Authority

Marine Safety Investigation Report

into a fatal man overboard during tender
operations from The World on 19 February 2022

Date of Issue: 29 September 2023
Bahamas Maritime Authority
120 Old Broad Street
LONDON
EC2N 1AR
United Kingdom

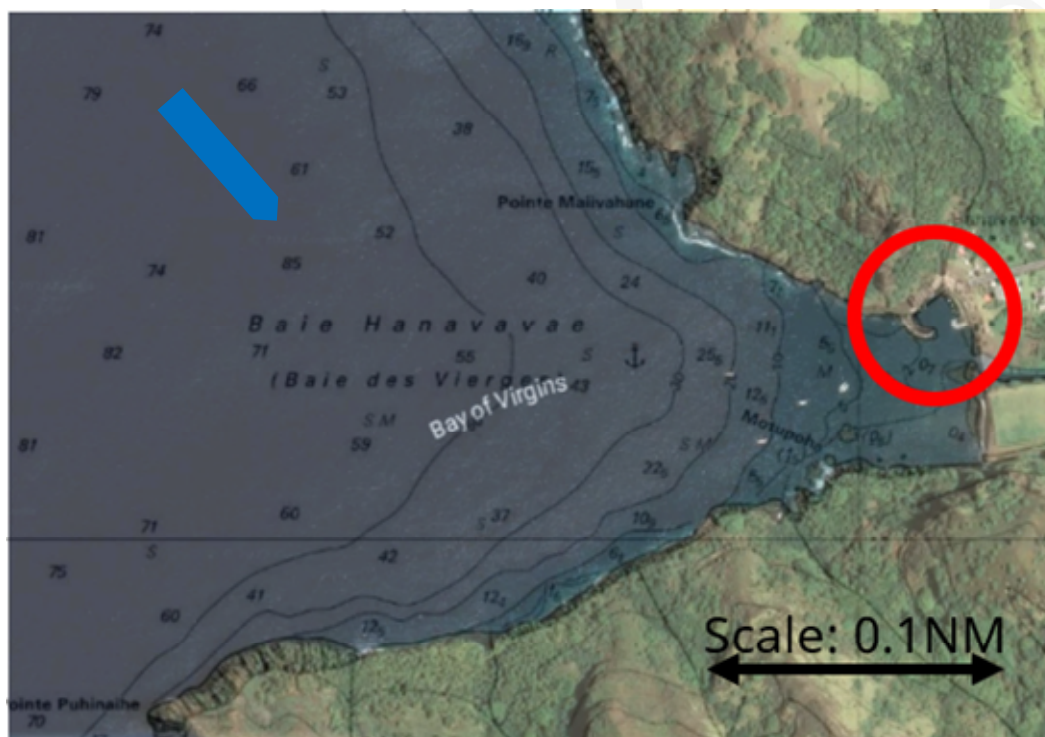
With the ship underway to its anchoring position in the Bay of Virgins, the boats repositioned by sea and surveyed the landing site – providing input for the ship's operational risk assessment of the harbour at Hanavave. It was found to have some surge but was considered workable. Locals (French speaking) that were surfing near the harbour entrance, were asked to keep clear by the English-speaking coxswains.

**Hanavave. Extract from French chart SHOM 7354 with satellite image overlay.
The World's position (to scale) shown in blue, harbour ringed.**

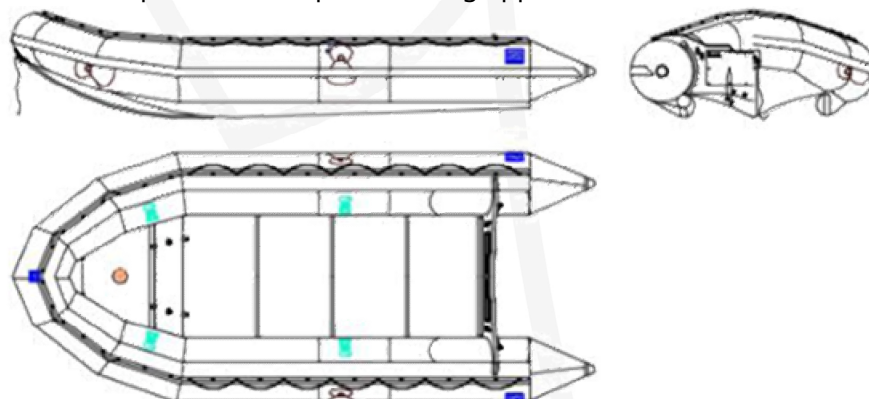
Zodiac #10 was a Zodiac Milpro Mark 5 (heavy duty) inflatable boat with a maximum capacity 15 persons (5.85m long, 1.22m wide, tare weight 250kg). It was propelled by a Yamaha 90 horsepower (electric start) outboard engine, with tiller steering and an exposed propellor. The boat and engine were ship's equipment but did not form part of the ship's lifesaving appliances.
