Report on the near-miss grounding of The Bahamas flagged passenger vessel Norwegian Prima off Reykjavík on 26 May 2023

Case nr: 2023-036 S 019

Date: 26 May 2023

Description: Near miss grounding

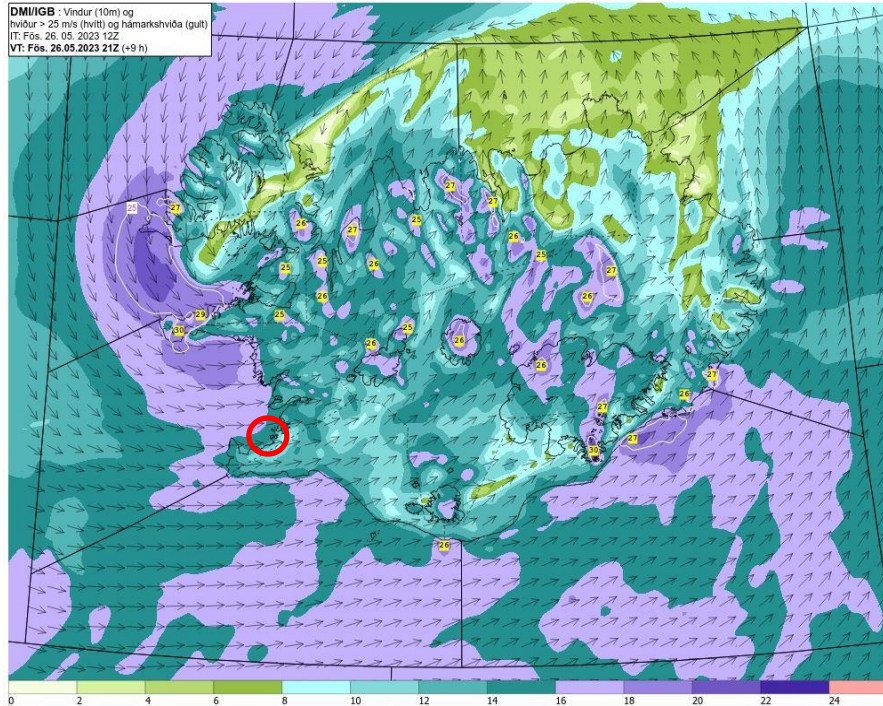
Fig. 9 - Iceland 9 hour forecast valid at 21 UTC, 26 May 2023

The Icelandic Meteorological Office uses the HARMONIE-AROME numerical weather prediction model³ for forecasting. The nine hour wind speed forecast (10 m above surface) in force at the time of departure is shown below. For Reykjavik Harbour (ringed) the wind was forecasted to be from the west with speeds of 14-16 meters per second (27-31 knots) with higher wind speed forecasted offshore.

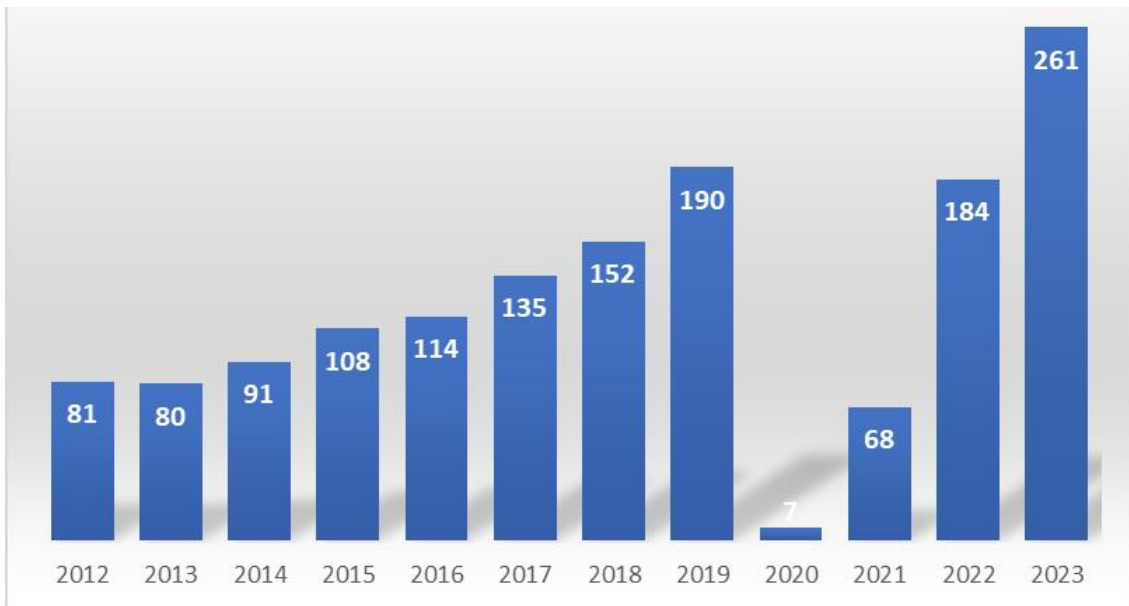
Increasing traffic of passenger vessels in Reykjavik harbour:

There is a concern of increasing traffic of passenger vessels around Iceland. The traffic in Reykjavík harbour is of concern but also traffic near sensitive areas where big vessels are sailing close to shore and sometimes letting people on shore. Many sensitive areas are of concern. This must be evaluated by appropriate authorities and actions taken.
